TEXAS REAL ESTATE CONSUMER NOTICE CONCERNING HAZARDS OR DEFICIENCIES

Joseph and Cara Stogner, 3318 S. Lake Village Drive, Katy, TX 77450

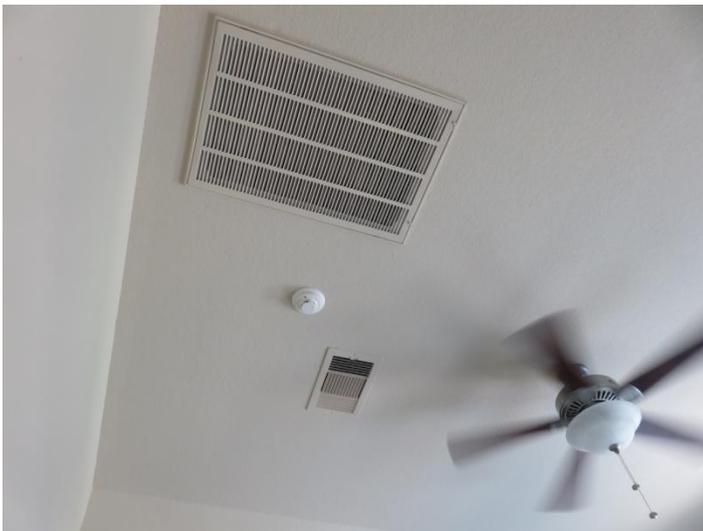
- By current standards, each living area room (common areas, offices/dens and bedrooms) are required to have a source of return air to the furnace/AC coil in the attic. The ability to refresh, circulate air in these rooms while the door is closed is required. Bedrooms, othe than the Master bedroom, lack this accommodation.

Example in a Master bedroom – all bedrooms and the office lacked a return

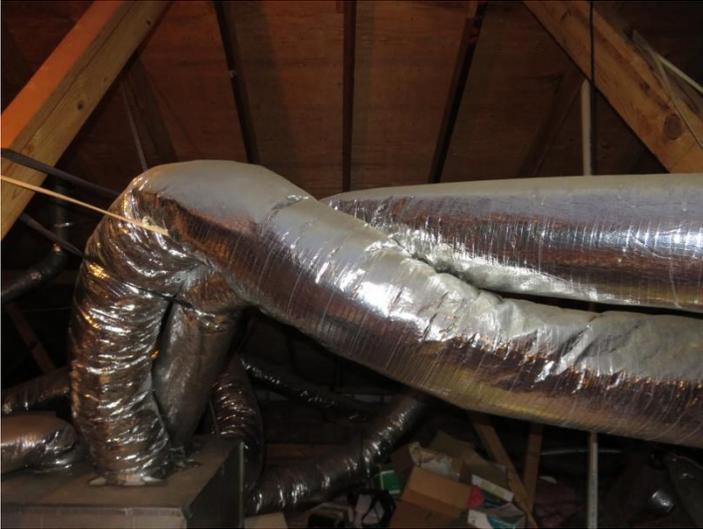
- Attic ductwork in general is prohibited from touching/coming into contact with other ductwork or installed lying on the attic floor. Insulation placed between sections is not a remedy. Damaging condensation can result.

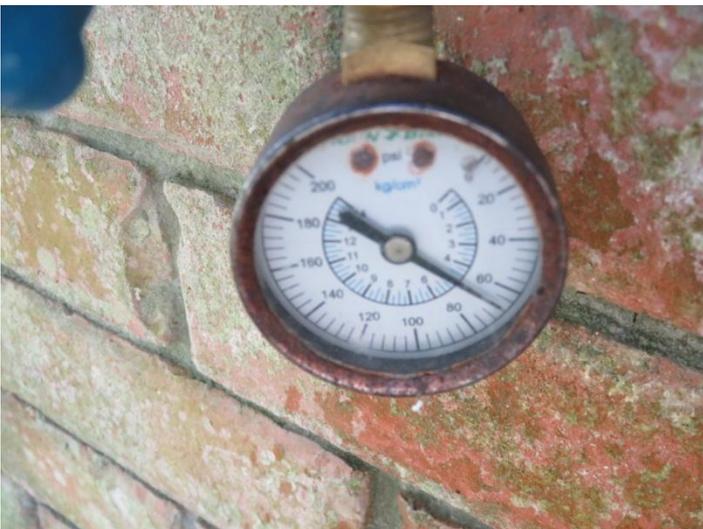
Comments: Copper water piping. Water piping beneath the ground and in the concrete slab are not able to be inspected due to the lack of visibility. It may be prudent to engage a plumber to conduct hydrostatic testing of the piping to determine if a deficiency exists beyond the scope of this inspection.

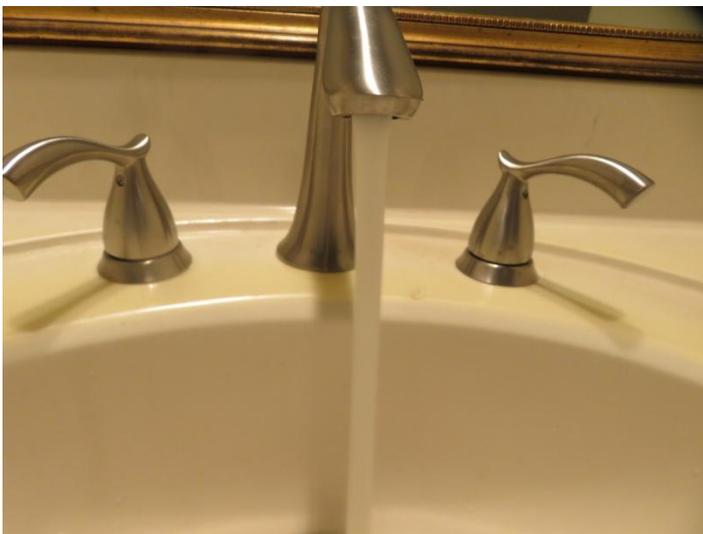
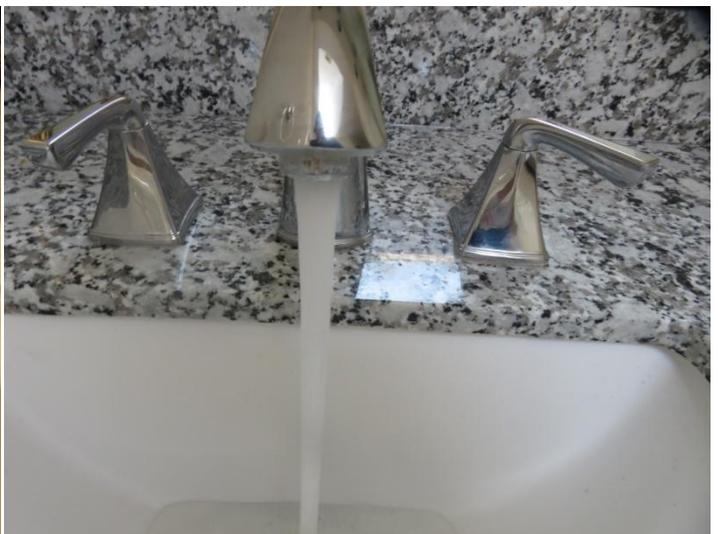
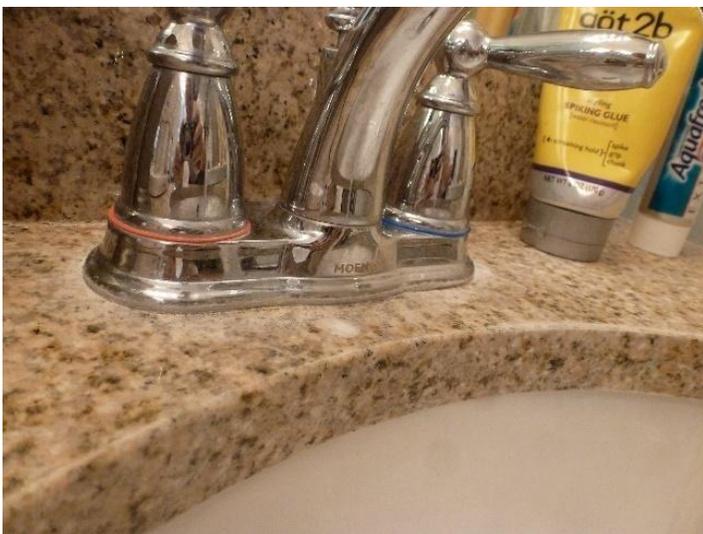
- The main water shut off for the home’s water supply, other than the meter, was not located.
- All water supply faucets should be marked by color coding, engraving or other means to identify each handle for water temperature orientation. This includes the washing machine faucets handles. Some bathroom faucets lack labeling.

Examples in the house and example of labeling

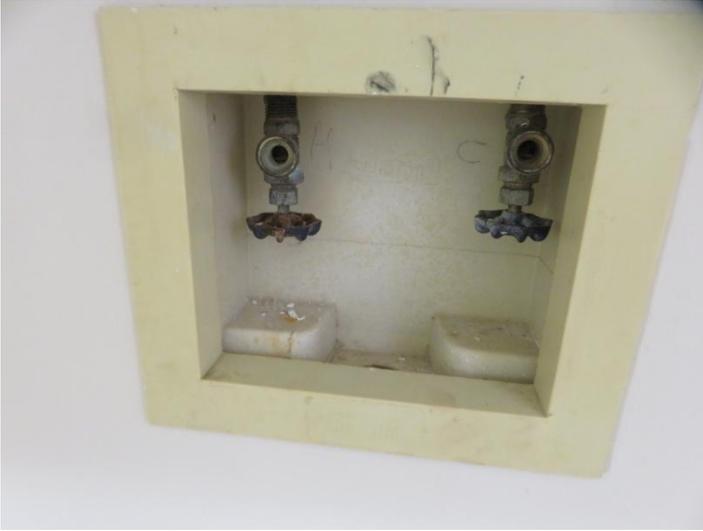
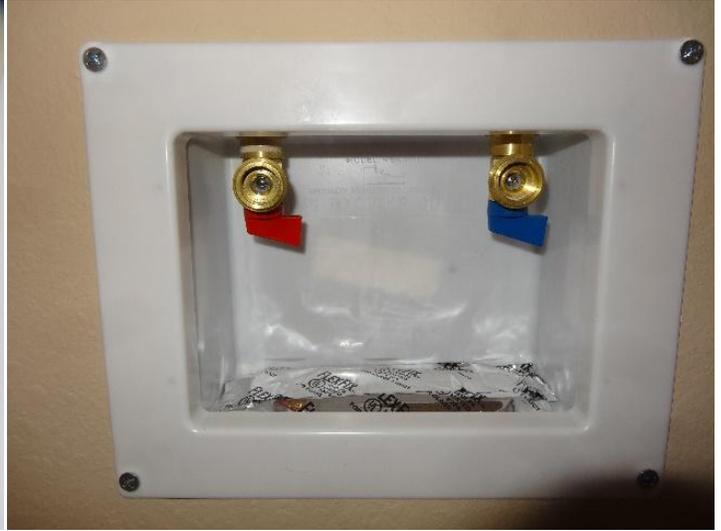
Example in the laundry and example of labeling

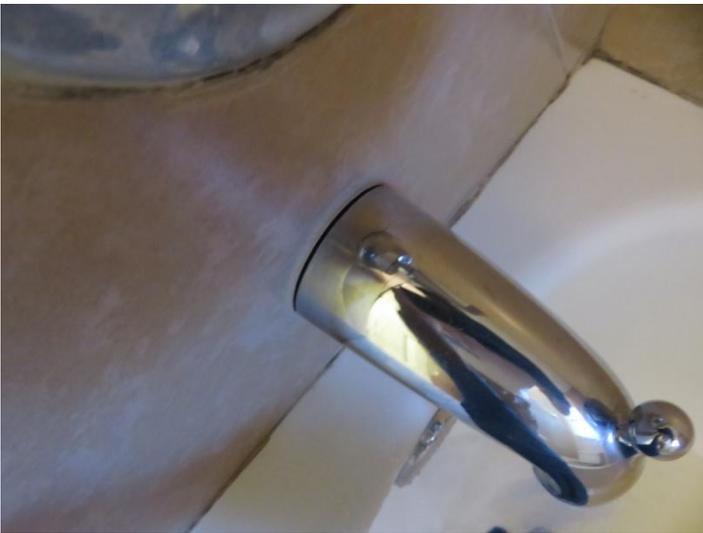
Example in the guest bathroom

- All shower/bathtub spouts should be fully caulked.

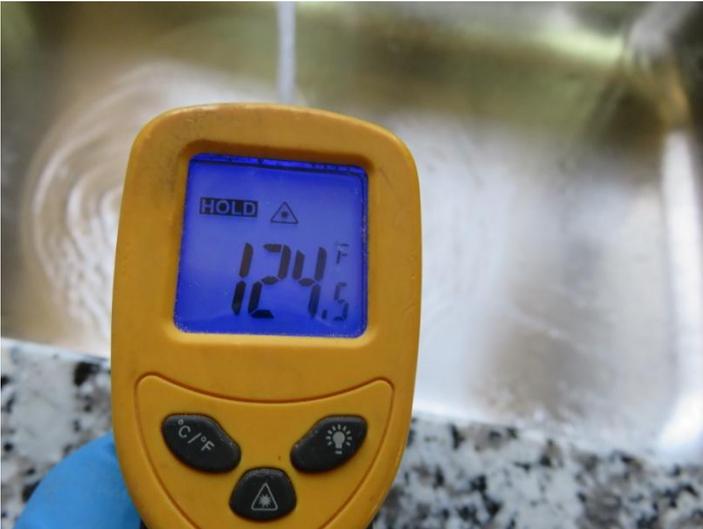
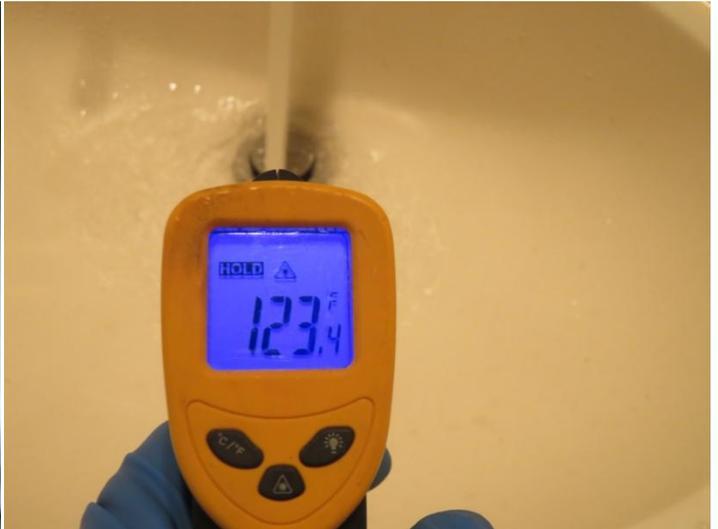
Examples

- The water temperature as recorded around the house was too hot. Temperatures in excess of 120°F can cause severe burns and scalding.

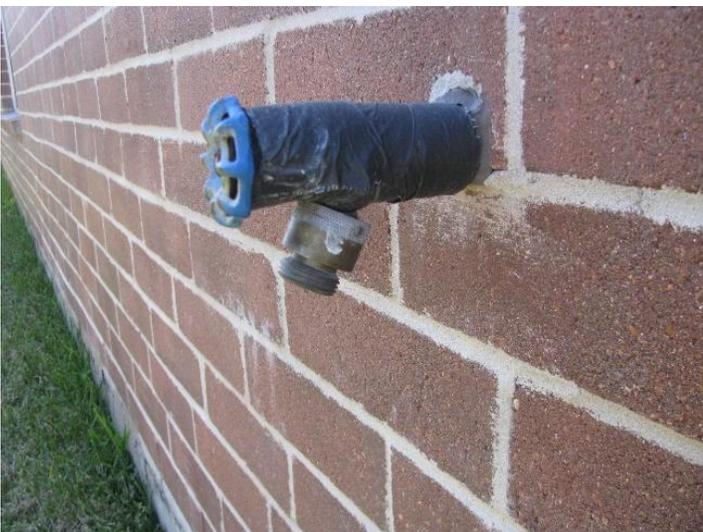
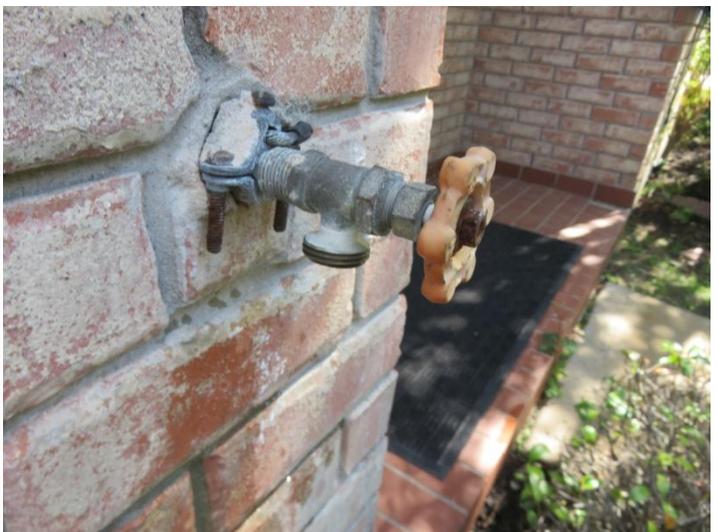
- All exterior hose bibs should be equipped with anti-siphon appendages that act to prevent gray water from being drawn back into the fresh water supply of the home.

Example of an anti-siphon apparatus and current installation example

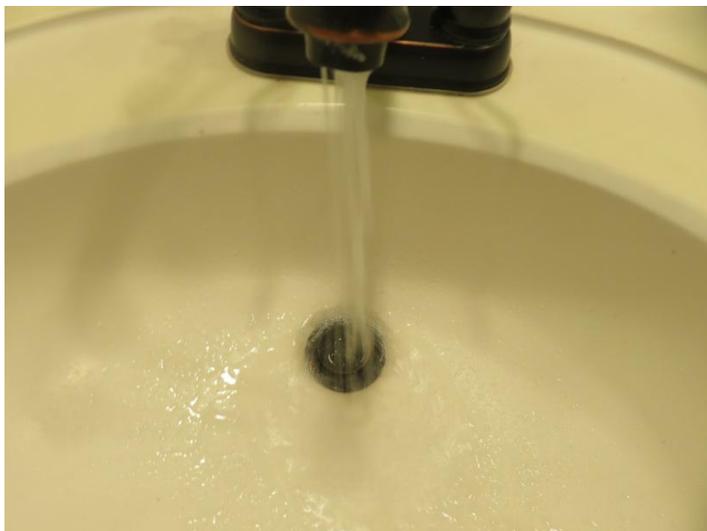
- The left sink in the guest bathroom lacked adequate water flow.

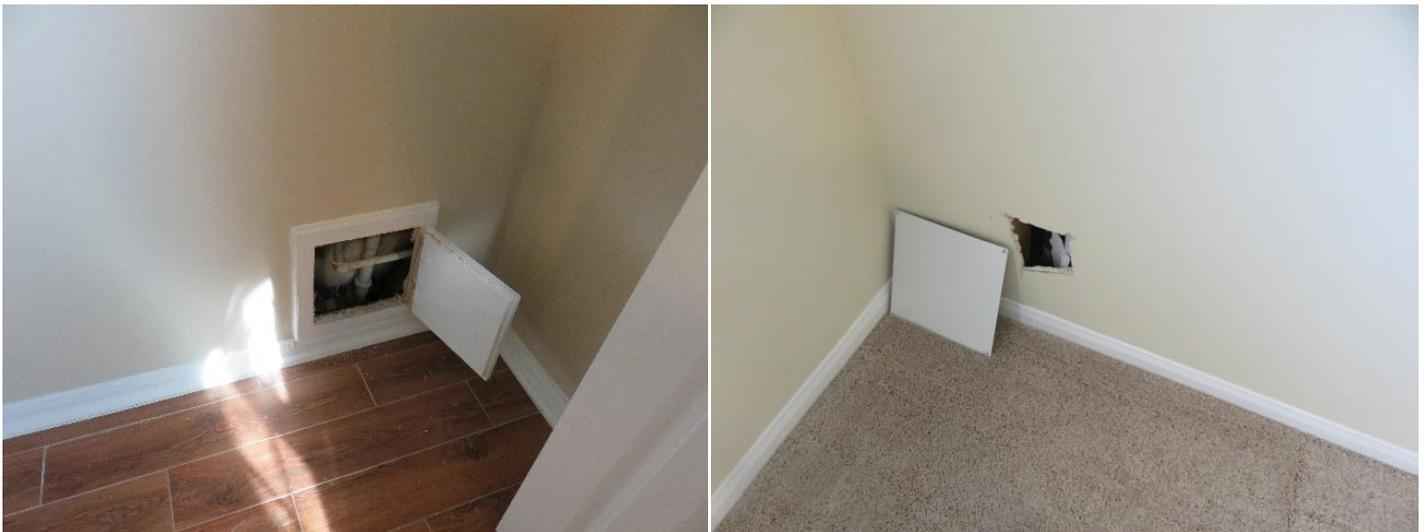
- To readily access plumbing connections in bathrooms for showers and bathtubs it is a recommended procedure to have access openings installed in walls adjacent to/behind in-wall plumbing fixtures. Currently, there are no plumbing access openings for the bathrooms of the home.

Example of opening for drain and plumbing inspection and examples of lack of access at the bathtubs

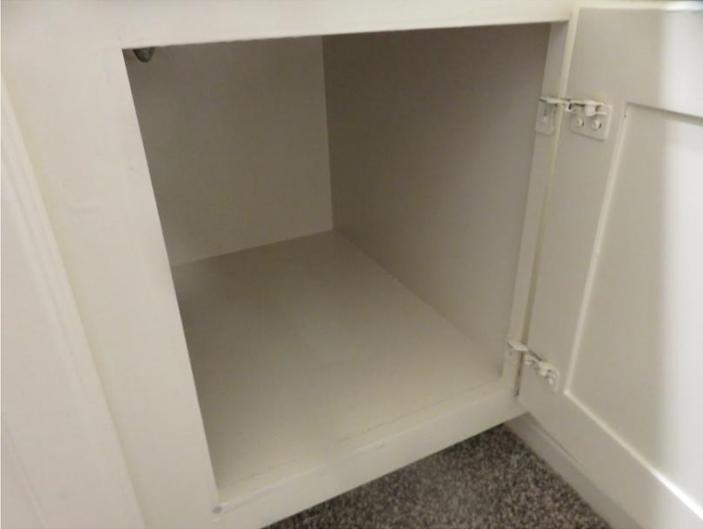
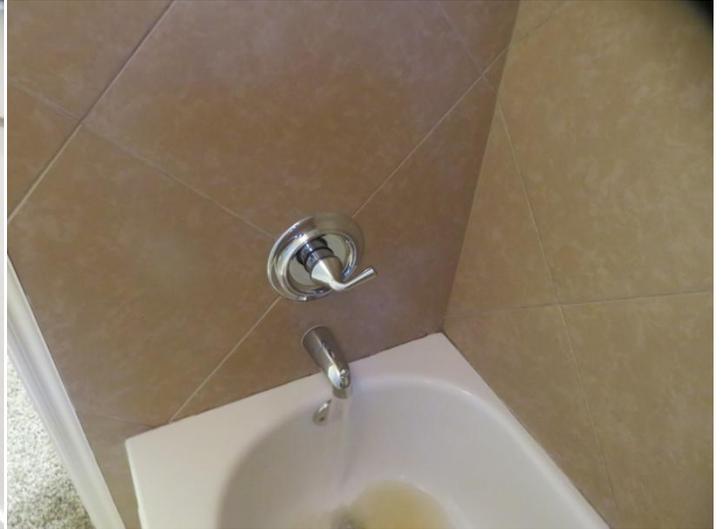
- Guest bathroom tub lacking ready access

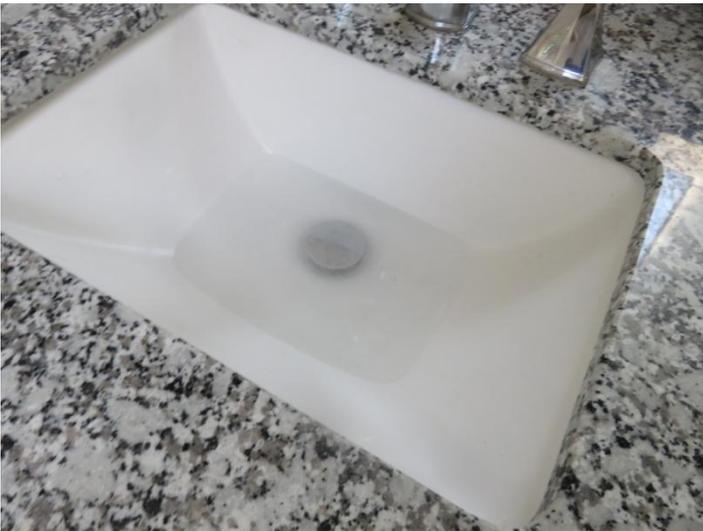
- The left sink in the Master bathroom was not functioning.

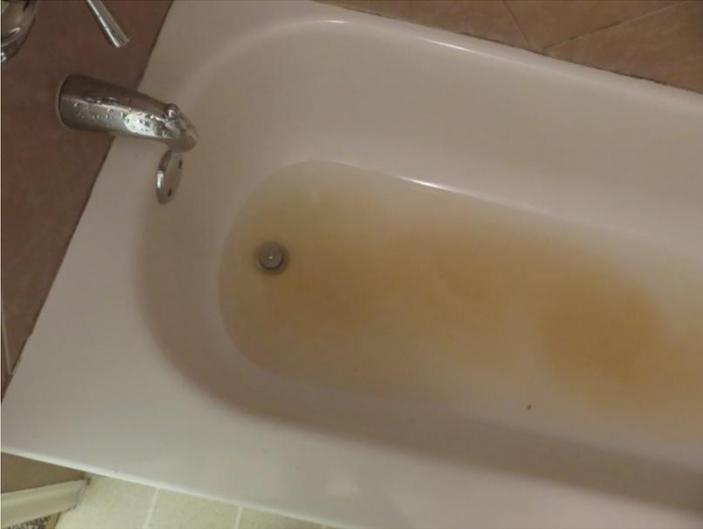
- The bathtub stopper in the guest bathroom was not functioning. Initial brownish water was present.

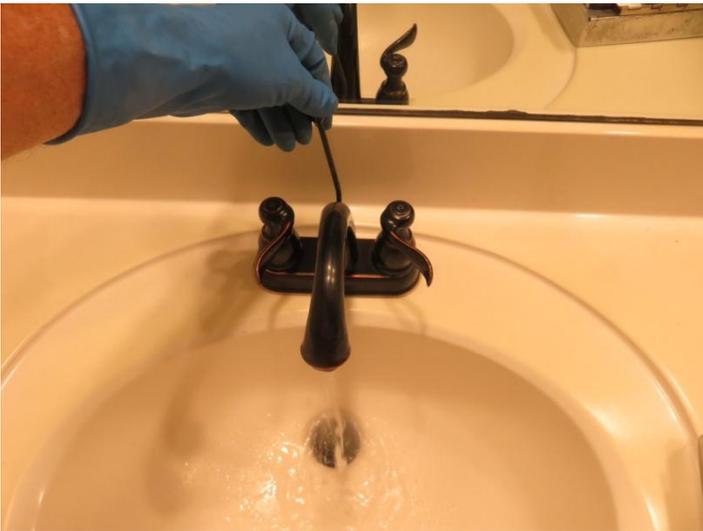
- The left sink stopper in the guest bathroom was not functioning.

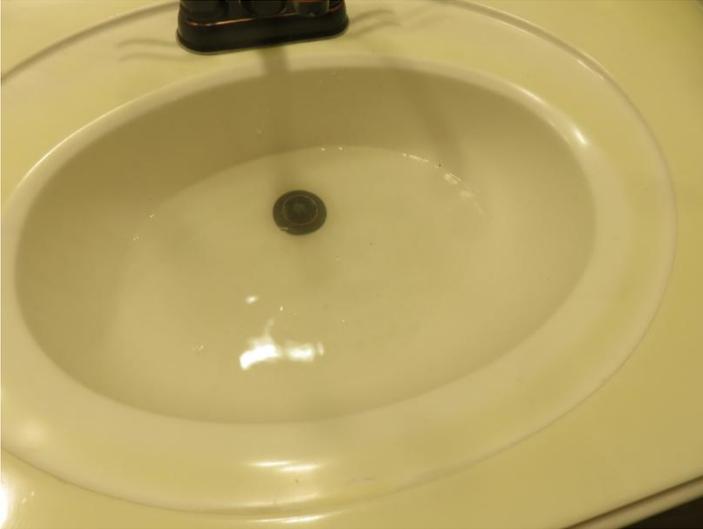
- The right sink in the guest bathroom was not functioning.

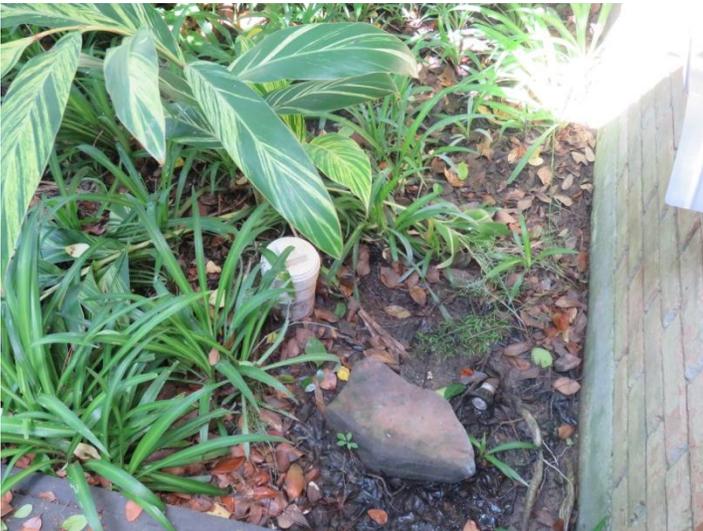
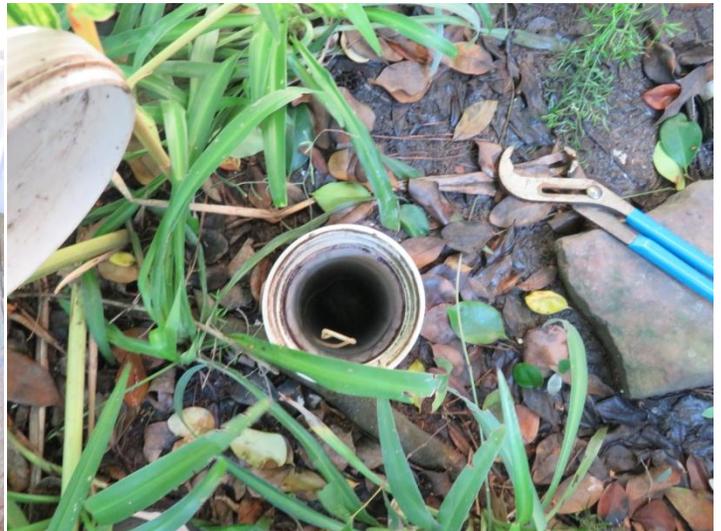
- The main drain clean-out for the home is located in the rear plantings adjacent to the deck. There is a wire extended into the drain pipe.

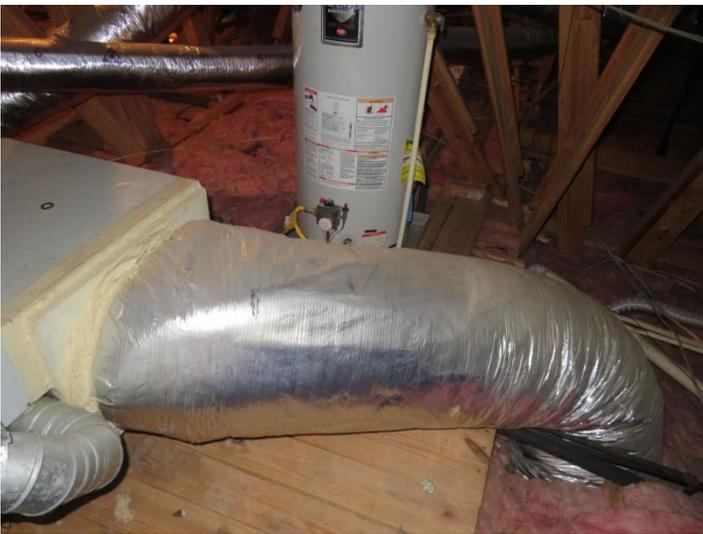
- Ready access to the appliance, that is required, is obstructed.

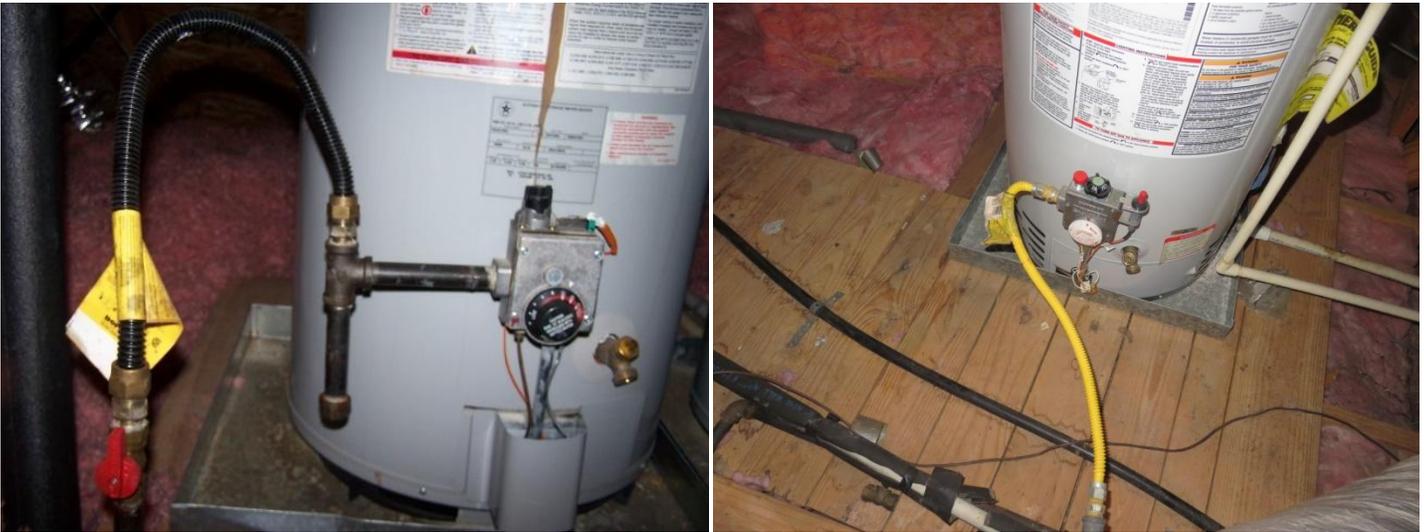
- Standards for natural gas line/pipe installations at water heater(s) should include natural gas supply lines that are installed with a dirt leg/sediment trap inserted at a point in the supply line just before the regulator and burners. The installation requires a change in direction of the natural gas flow. This dirt leg/sediment is intended to trap condensate and any wayward metal shavings, dirt and dust that could interfere with the normal operation of a water heater employing natural gas as fuel.

Example of a gas line dirt leg/sediment trap and current installation

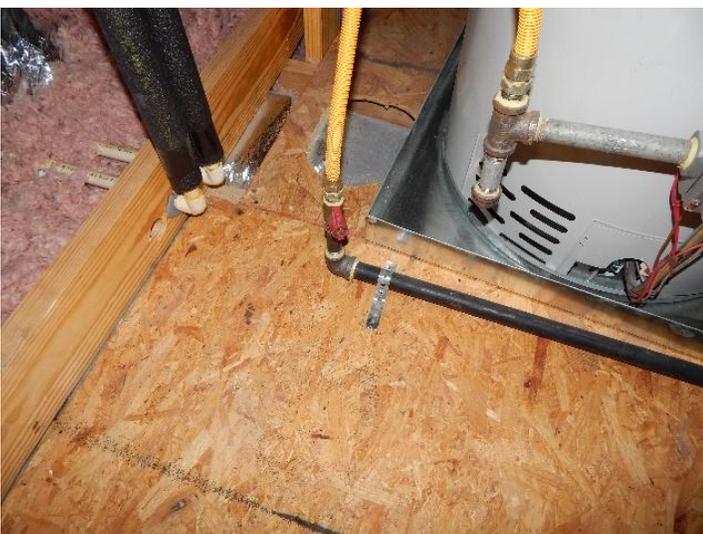
- The natural gas line for the appliance(s) is required to be secured within 12” of the shut-off valve.

Example of a secured gas supply line

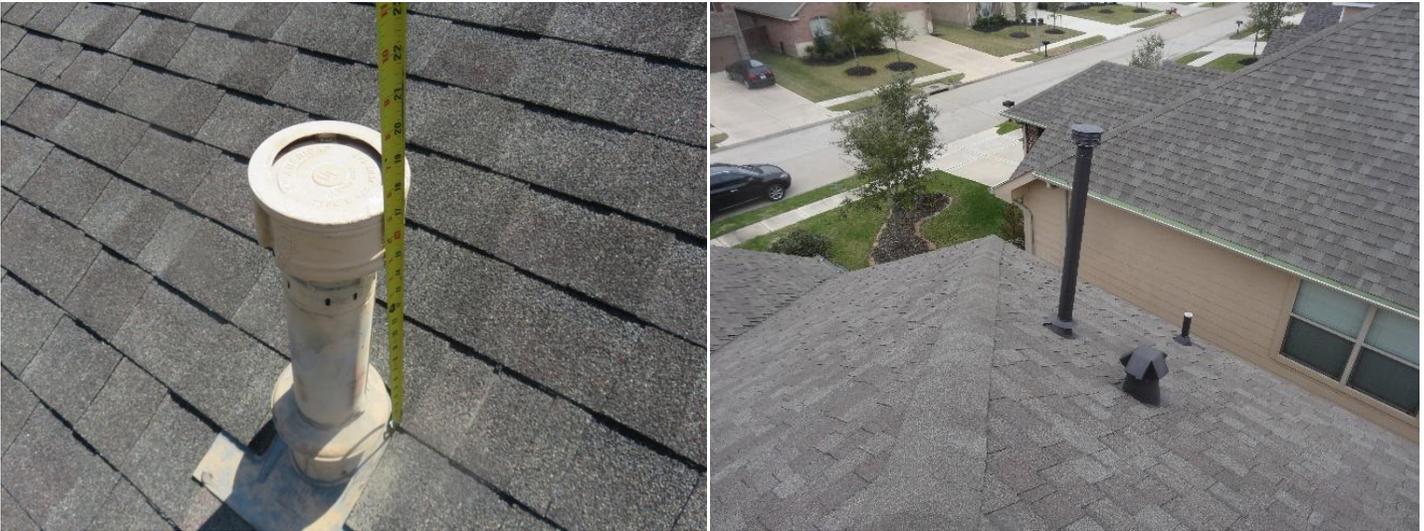
- The bottom of the “B” vent exhaust hood for the appliance(s) is required to be at least 24” above the roof deck anywhere within 10’ of any combustible materials and the roof deck. This installation also provides a preventative measure for backflow of gases back to the attic. The flue appears to be too low.

Current installation and required example

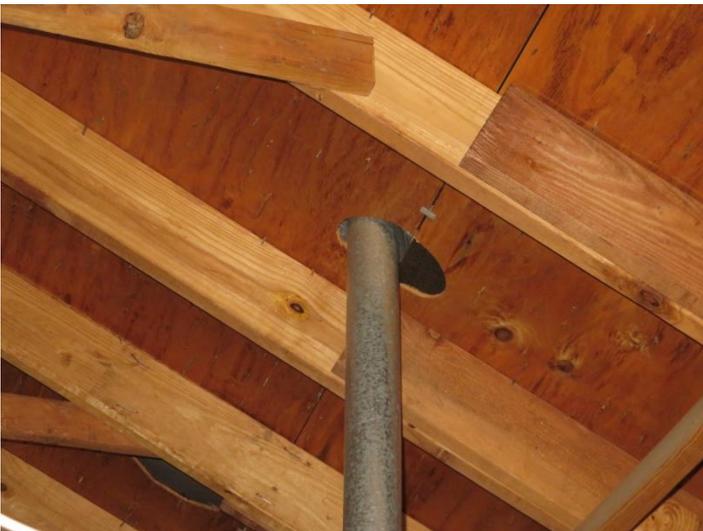
- The exhaust flue/pipe exiting through the attic/roof of the home was resting directly against/too close to the combustible lumber of the roof sheathing. To prevent a combustion condition, this flue/pipe should be repositioned.

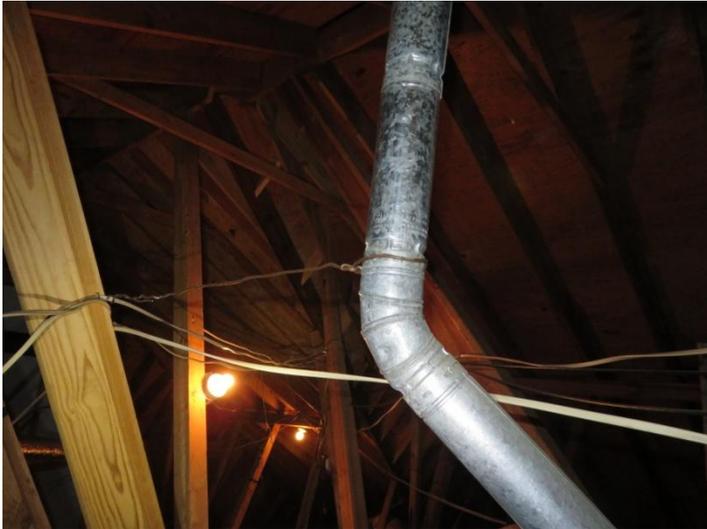
- The exhaust flue/pipe exiting through the attic/roof of the home should be properly strapped to secure it in place.

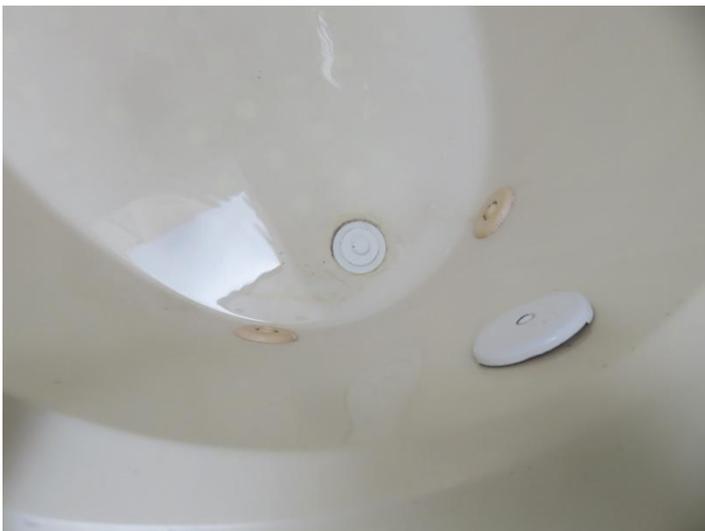
- The stopper in the tub was faulty and did not hold retain water to fill the tub for testing.

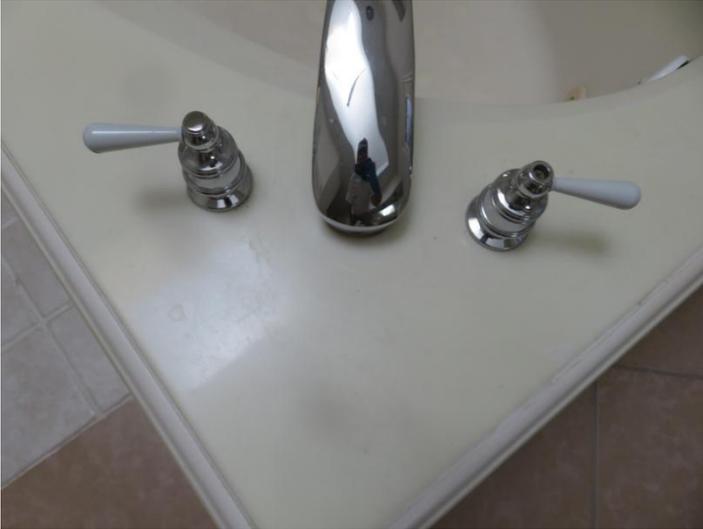
- Faucet handles are required to be labeled for hot and cold temperature orientation.

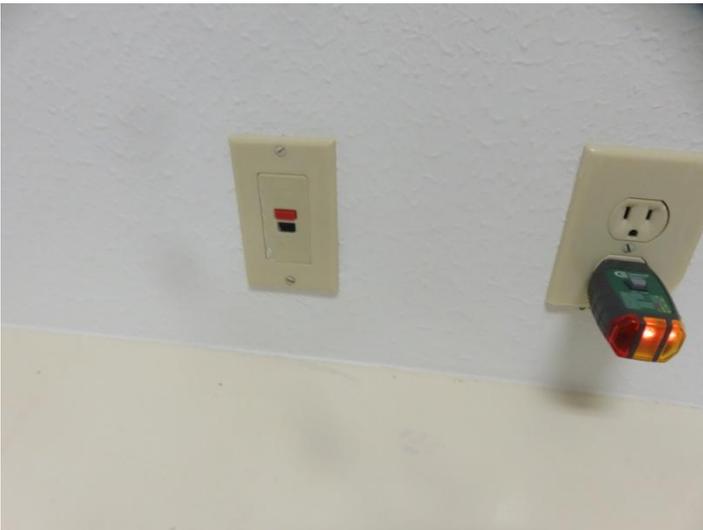
- The GFCI for the jetted tub is located in the Master bathroom closet.

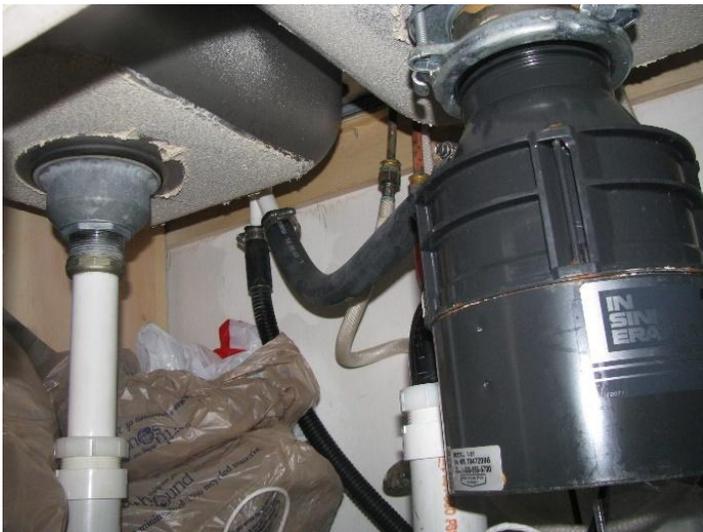
- Drainage from the dishwasher requires the drain line to be elevated above the top of the disposal with a loop at least 2” above the entry point to the disposal serving as an air gap to prevent gray water from backflow into the dishwasher. As an alternative to this method, an aerator can be installed at sink top with the dishwasher drain line going directly to the aerator. It is preferred that a second drain line from the aerator be attached to the top of the disposal to enable further processing of waste water and food particles.

Example of required installation

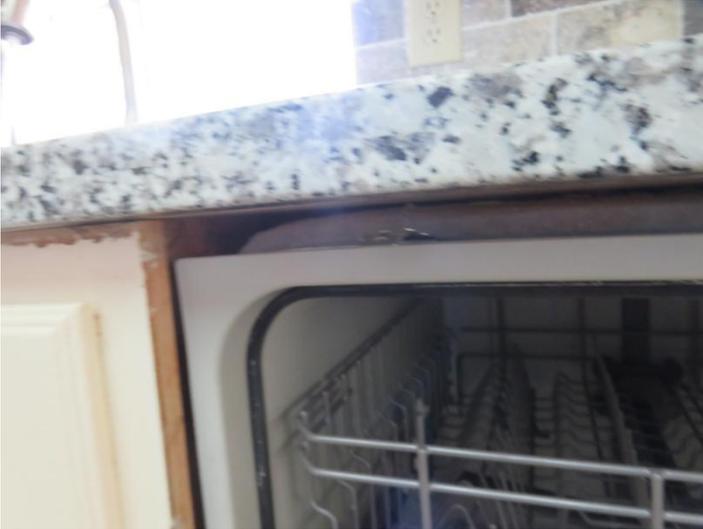
- The appliance is not secure beneath the countertop and can easily tip forward.

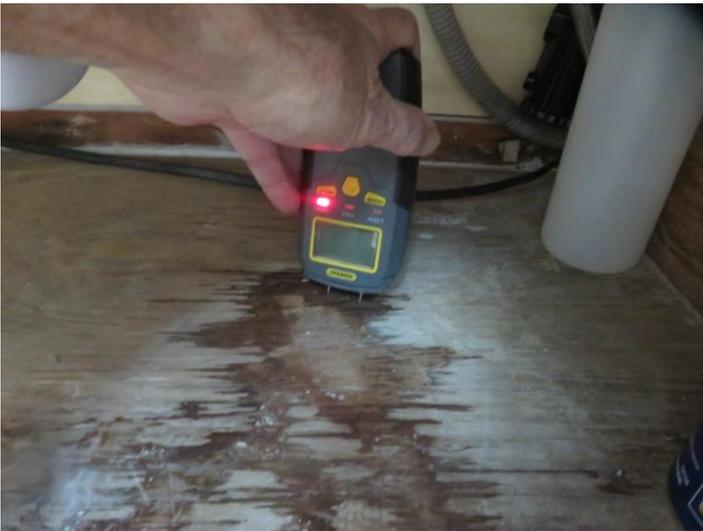
- There is a wet spot/leak beneath the kitchen sink.

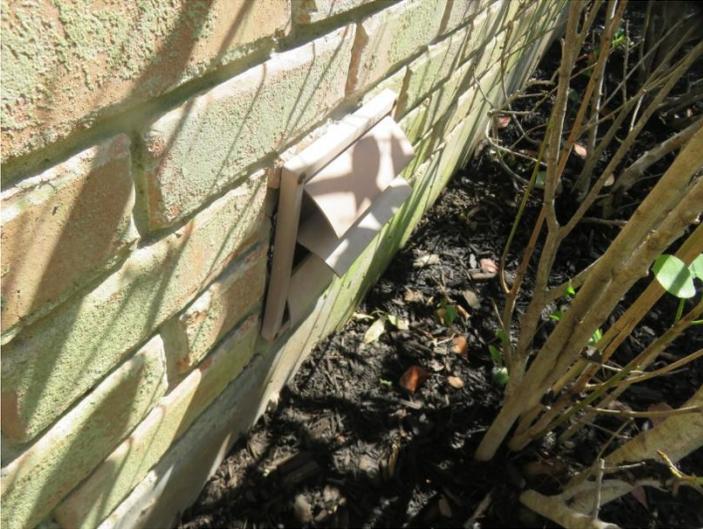
- The exterior hood should be fully caulked around its perimeter.

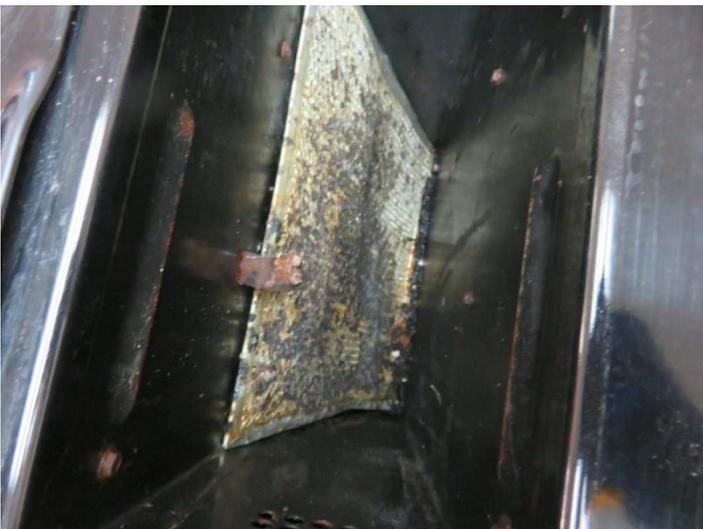
- The filter is rusty, greasy and warped.

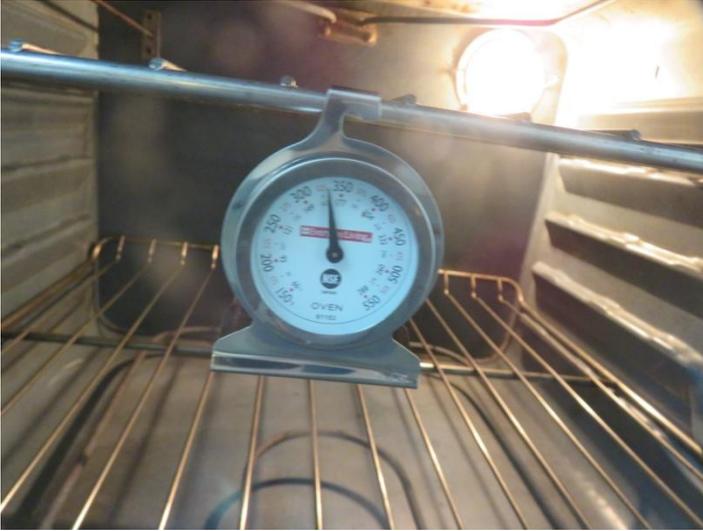
- The oven set at 350°F failed to achieve this temperature.

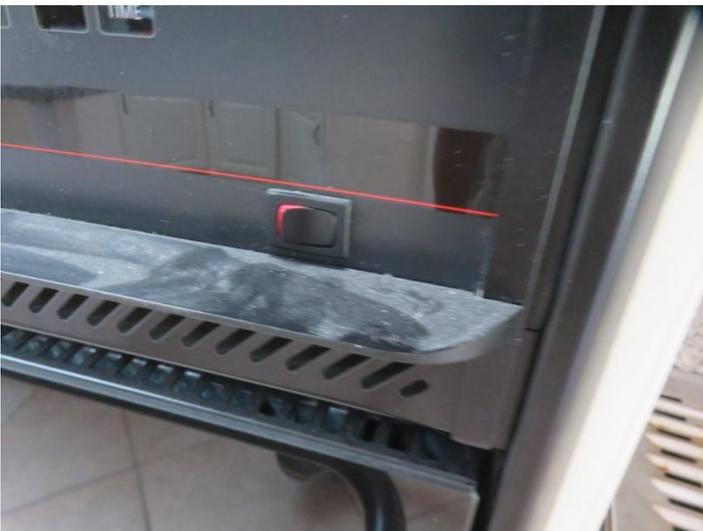
- The oven light switch did not function.

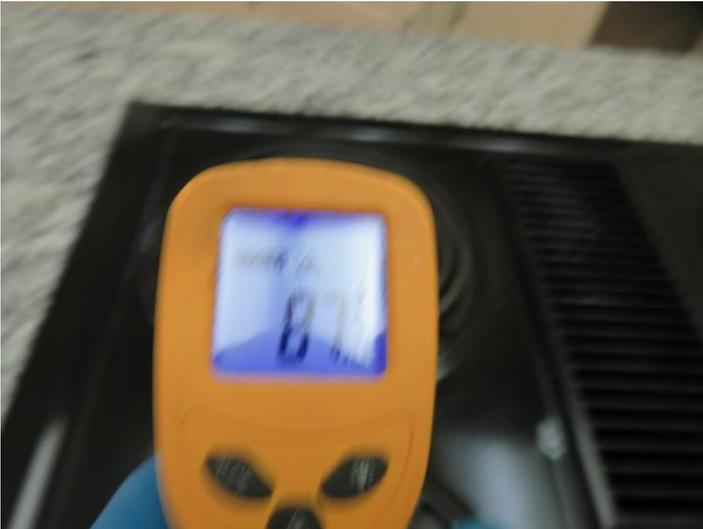
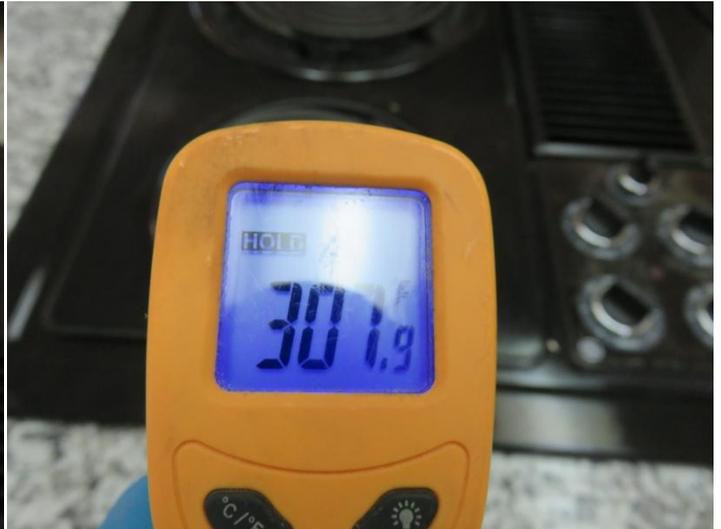
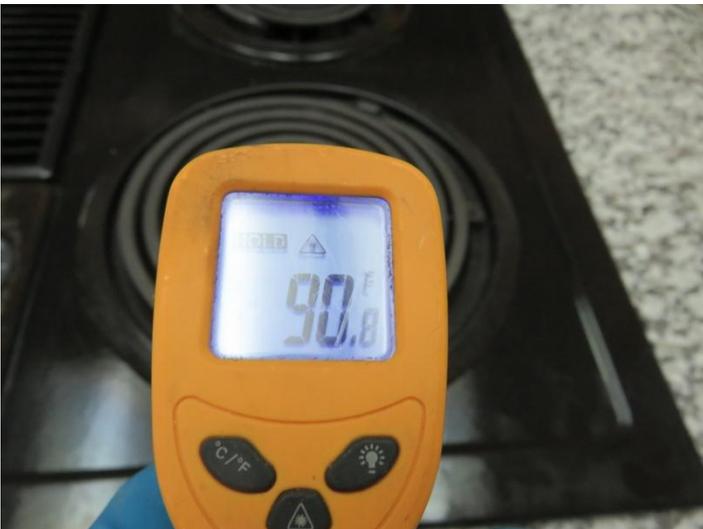
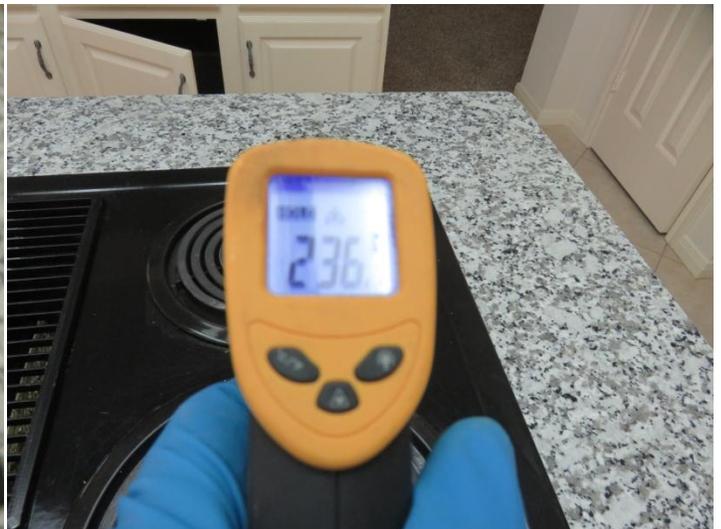
Top left, bottom left, bottom right and top right

- The top left and bottom right burners did not achieve like temperatures as others while on the LO setting.

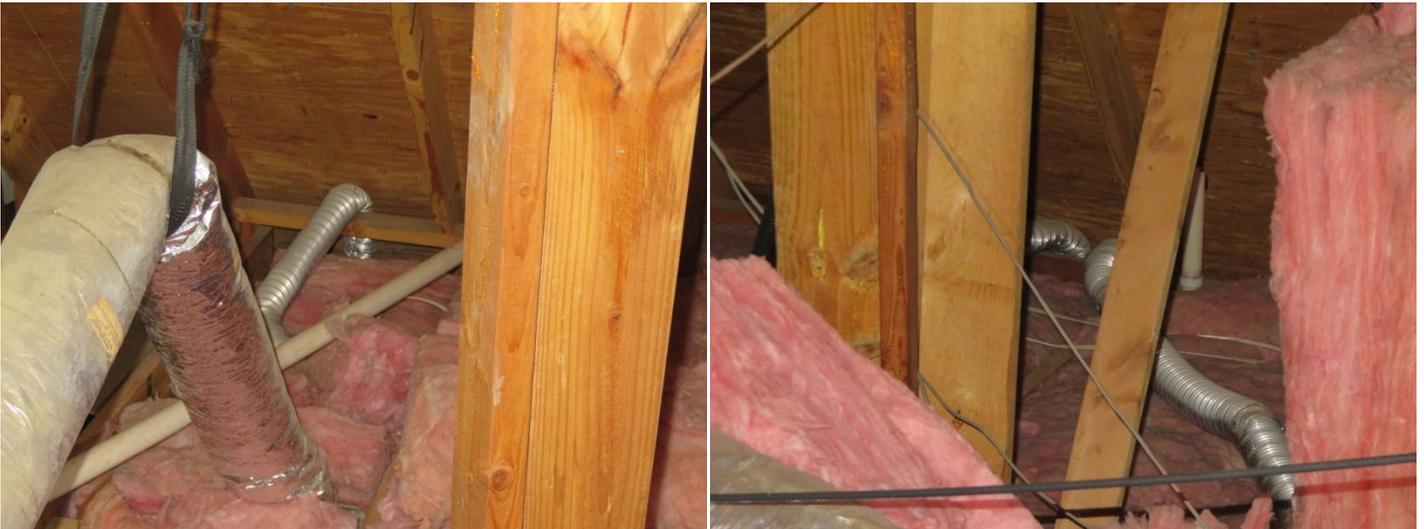
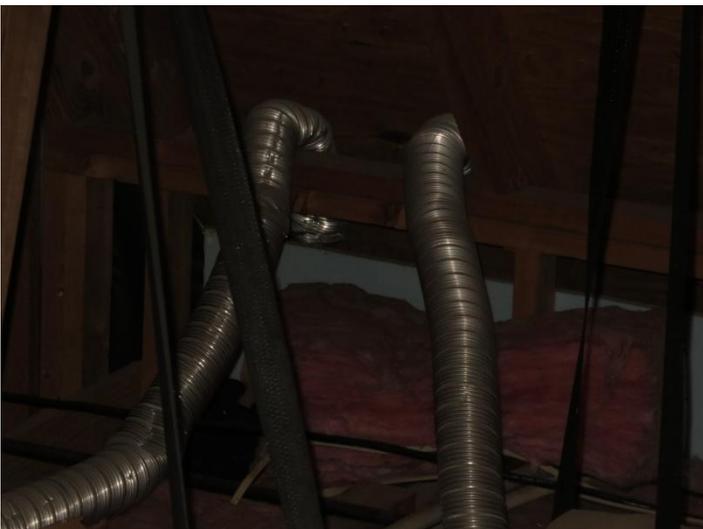
Examples of ductwork terminating in the attic/roof edge soffit

- Bathroom and laundry room (lacking openable windows) exhaust ductwork is required to exit outside the home to fresh air either through a hood at the sidewall of the home or directly through the roof with approved hoods. Attic exhaust ducts terminate at the soffit roof edge where hot, humid air can deteriorate roof decking and soffits. Air must be exhausted directly to the outside – 2006 IRC [303.3X]. May not discharge to crawlspace or attic – 2006 IRC [1506.2].

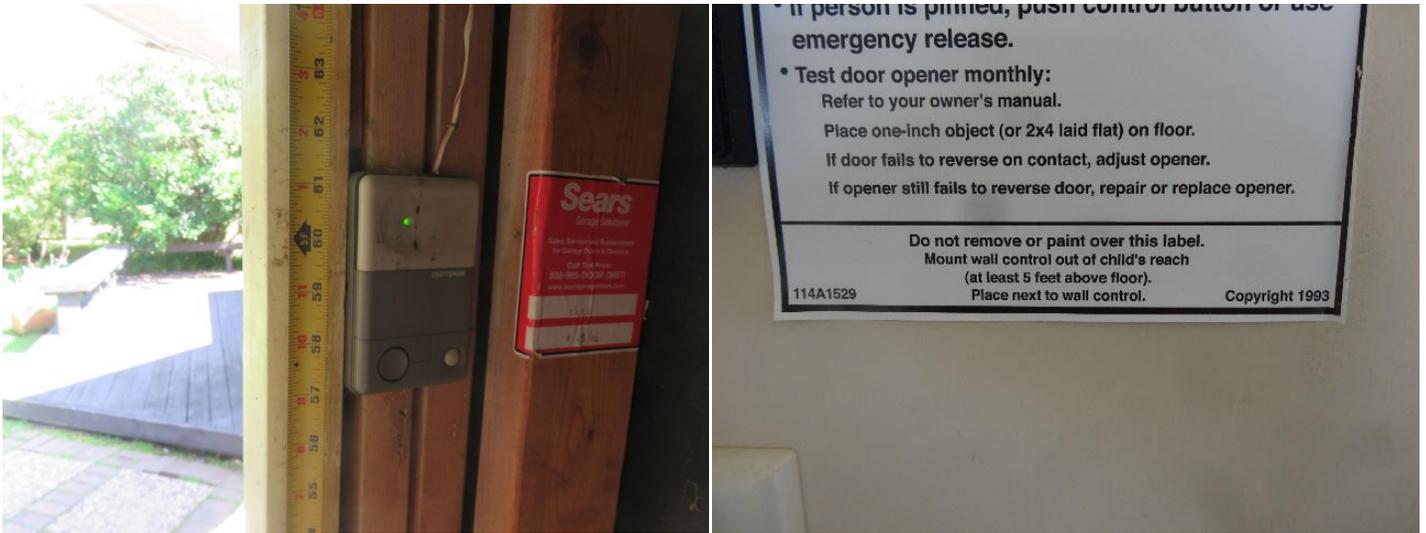
Current installation and required statement of installation

- The automatic garage door control button is too low compared to its recommended height of at least 5' above the floor or highest point of access. Preventing small children from being able to access and activate this button is a child safety feature of the door.

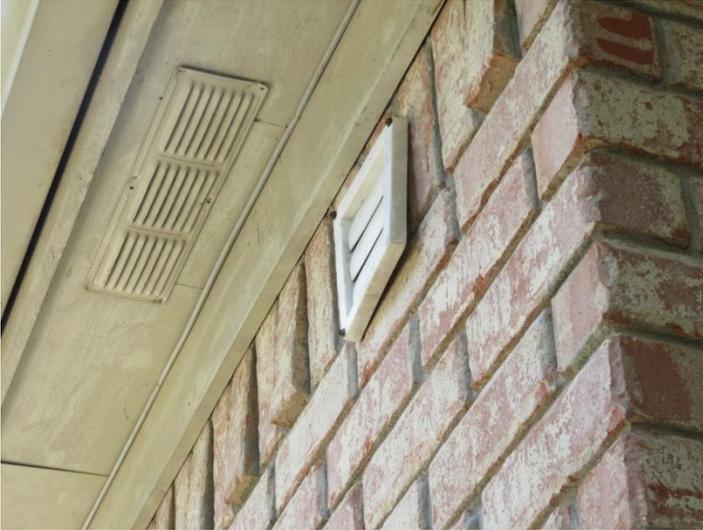
- The dryer hood should be secure against the exterior wall and caulked around its full perimeter.

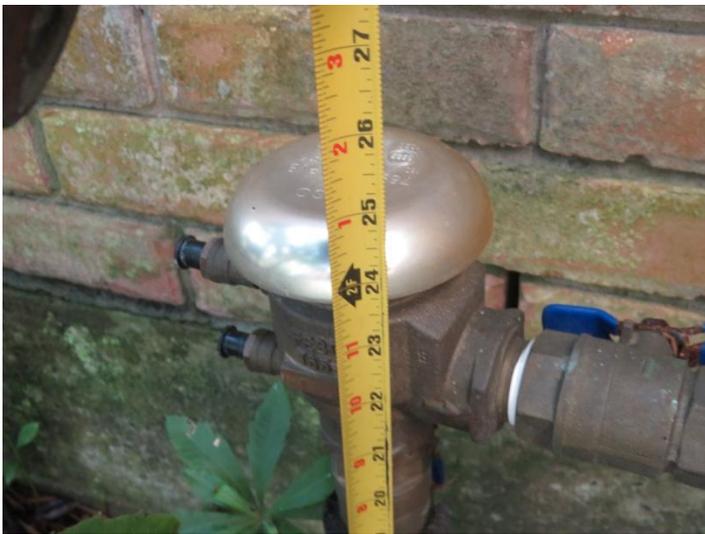
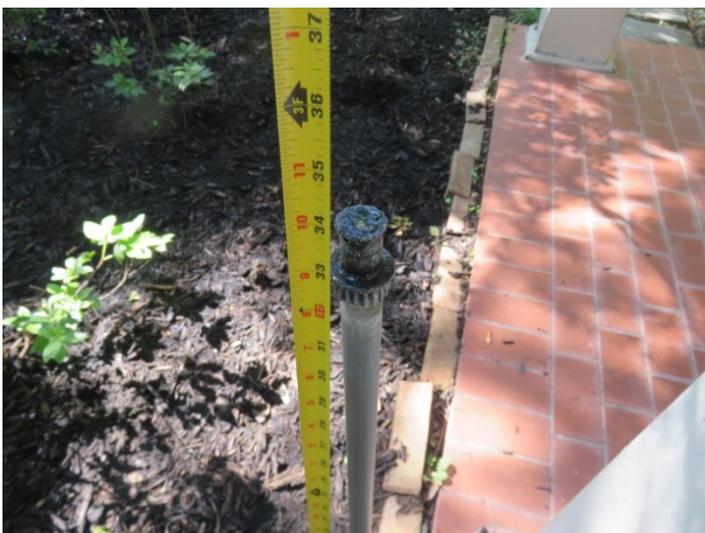
- The installed backflow device for the sprinkler system has been installed too low to the ground in relation to the highest sprinkler heads about the home. To prevent gray water reversal to the home and fresh water system, the backflow device should be installed at least six inches (6") higher than the highest sprinkler head.

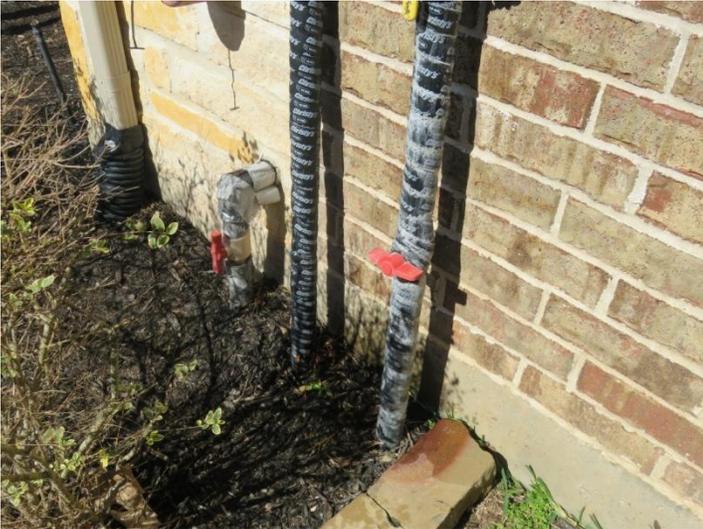
Example

- The backflow preventer should have an intermediate shut off valve on the supply side.
