TEXAS REAL ESTATE CONSUMER NOTICE CONCERNING HAZARDS OR DEFICIENCIES

Joseph and Cara Stogner, 3318 S. Lake Village Drive, Katy, TX 77450

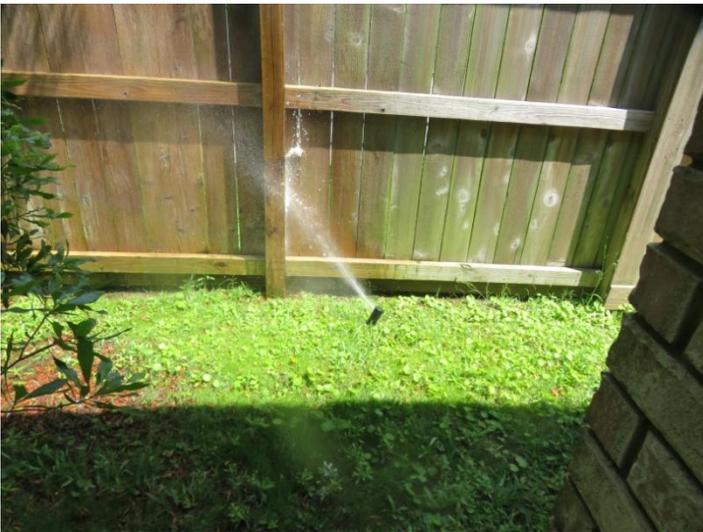
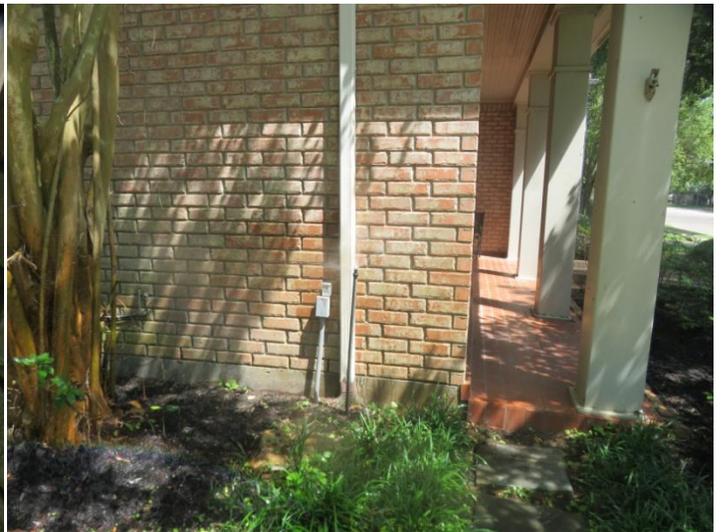
- Sprinkler heads should spray on the lawn and flower beds. A head in Zone 3 sprayed on the right fence and one in Zone 4 sprayed on the house.

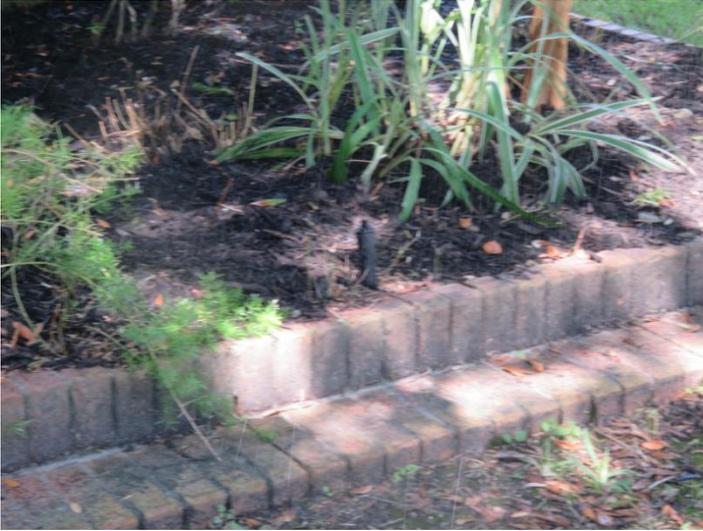
- A head in Zone 4 (front right beds) lacked water spray.

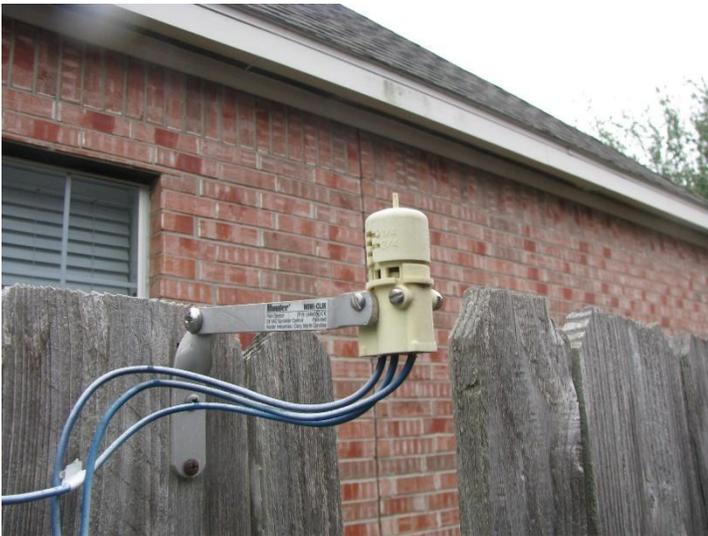
Example of a rain sensor

- The sprinkler system appears to lack a rain sensor that acts as an automatic shut-off during rainy and wet periods.
