HOME INSPECTIONS, LLC

Inspection Report

Property Address:

210 W Bayou Dr
Dickinson TX 77539

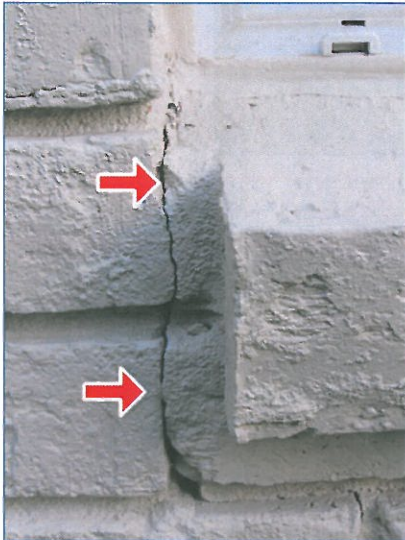
E. Item 4(Picture)

(3) **Stress Cracking on Exterior Walls:** Stress cracking in mortar lines is typically the result of foundation movement caused by differential soil movement. It will follow the rules for crack closures but is typically oriented diagonally. Cracks follow mortar lines because the mortar is weaker than the brick. We observed a number of stress cracks on the exterior walls. This could be caused by foundation settlement or other house movement. **Recommend having these areas fixed and repaired as needed.**

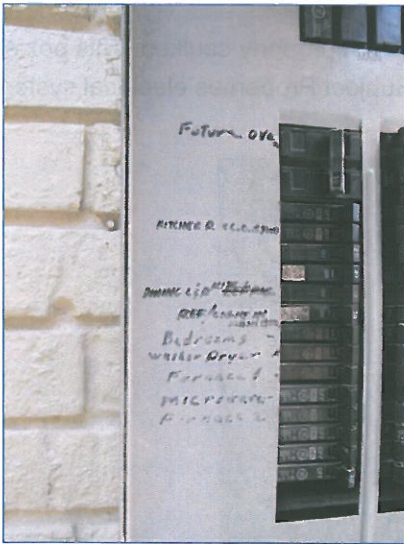
A. Item 10(Picture)

(3) **Inadequate Labeling:** The dead front on the electrical panel box is inadequately labeled. **Recommend having this panel box properly labeled.**

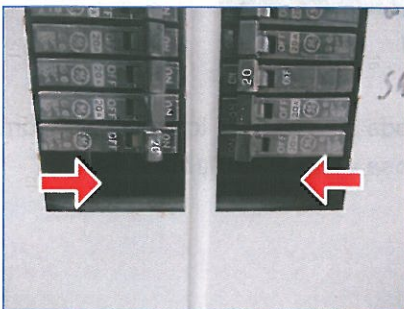
A. Item 12(Picture)

(4) **Dead Front Repair:** Dead front is in need of repair. **Recommend having this corrected as needed.**

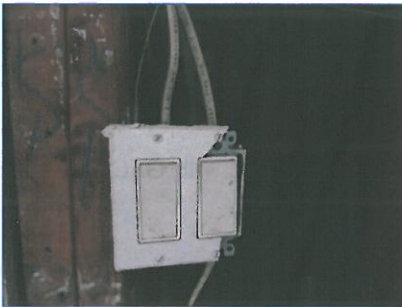
B. Item 9(Picture)

(6) The garage has a number of switches and outlets that are not properly covered. Junction boxes that are exposed.

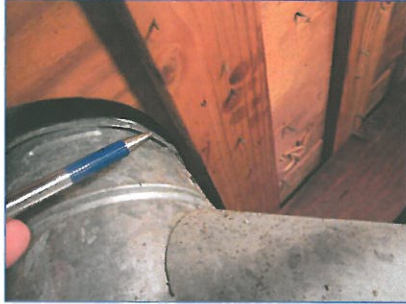
A. Item 7(Picture)

(3) **2 Inch Clearance Required:** The furnaces flue does not have the required 2 inch clearance between flue and (roofs) sheathing. This could be a safety issue and needs to be corrected. **Recommend having this fixed or repaired as needed.**

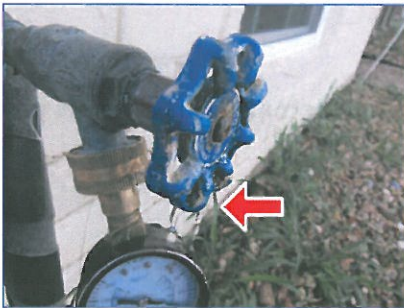
A. Item 9(Picture)

(4) **Exterior Faucet Leaks:** Several of the exterior faucets leak when turned on. **Recommend having fixed or repaired as needed.**
