PROPERTY INSPECTION REPORT

Prepared For: Ron Nelson
(Name of Client)

Concerning: 4042 Wilderness Falls Trail, Kingwood, TX 77339
(Address or Other Identification of Inspected Property)

By: Thomas Christopher Duhon, Lic #10577 04/13/2020
(Name and License Number of Inspector) (Date)

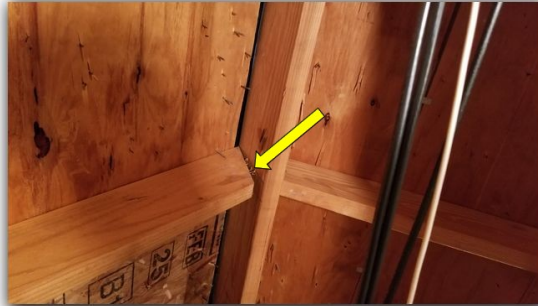
Common rafters have greater than ¼" gap at peak ridge board. Install minimum 3' (2 x 6's or 2 x 8's) at rafters run flush and toe-nailed to ridge board to correct.

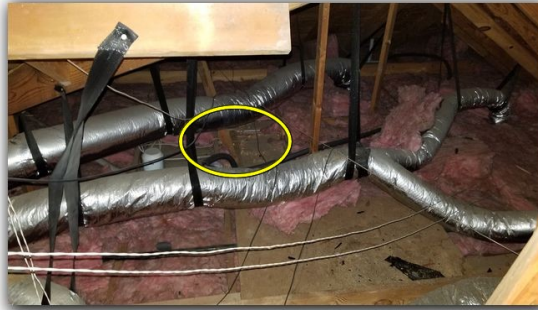
In multiple areas at roof peak(s) where peak ridge vent are installed may have insufficient air flow due to roof decking not cut or too close to peak ridge board. Roof decking at peak(s) with peak ridge venting should be cut back 1" to 2" on each side of peak ridge board for proper exhausting, per manufacturers specification.

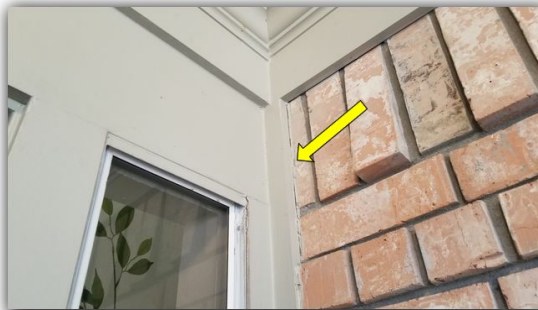
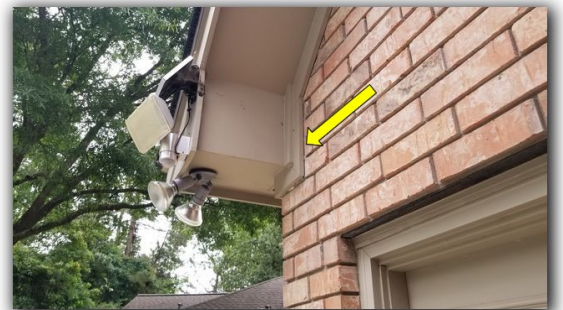
Seal and paint exterior siding/trim at nail heads, overlap edges, butt joints, separations, vertical joints... etc. to prevent water penetration at dings, scuffs and holes to extend life.

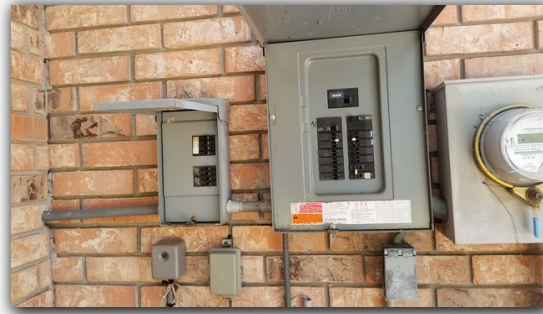
AFCI breakers are not noted at all living areas where required, per current electrical code, however these were not required when home was built.

Aluminum feeder wire should have been anti-oxidant treated prior to installation at main lugs.

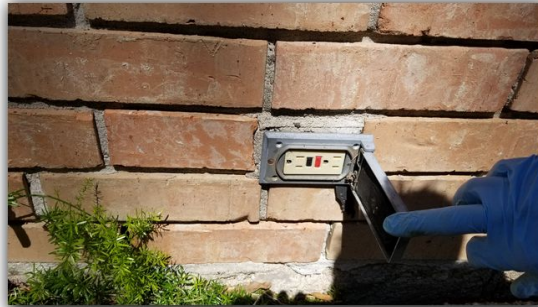
GFCI receptacle noted at north east exterior wall, master closet, and north exterior wall did not trip/reset when tested and is in need of proper replacement.

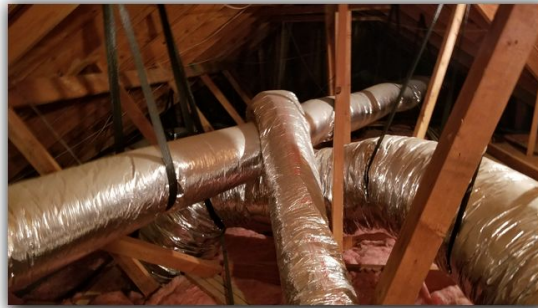
Install insulation or other approved material between ducts coming in contact with one another to prevent possible condensation forming as needed in attic. A/C duct work should be strapped up off of floor with 1 ½ " straps at no more than 4' intervals, ½ " or less sag, per foot, between straps and three straps per turn without crimping and restricting duct work around or over framing.

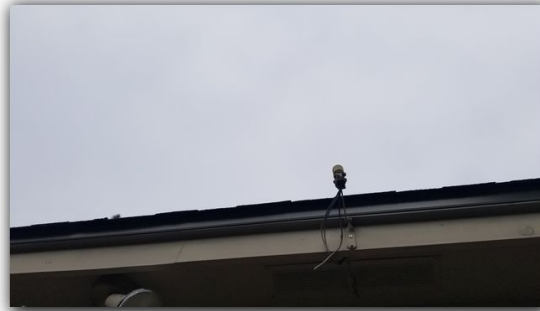
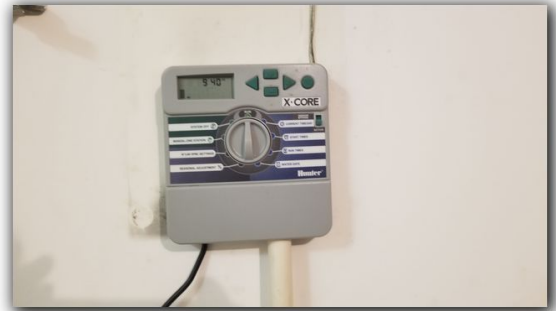
Cannot locate backflow prevention device, which is currently required.

Missing and/or broken head noted at station 1.

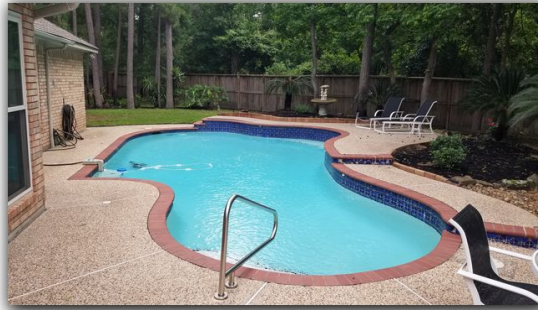
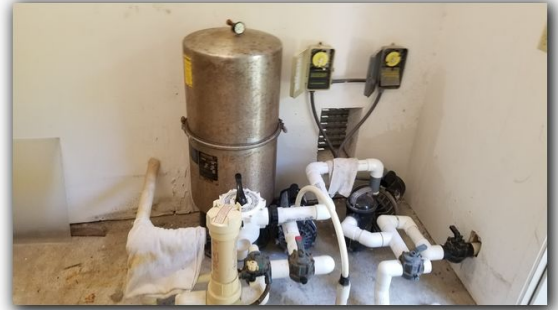
Pool surface material appears to be performing as intended at this time with average wear for age. Estimated approximately 3/4 through life expectancy.

Remove all debris collected at skimmer baskets.

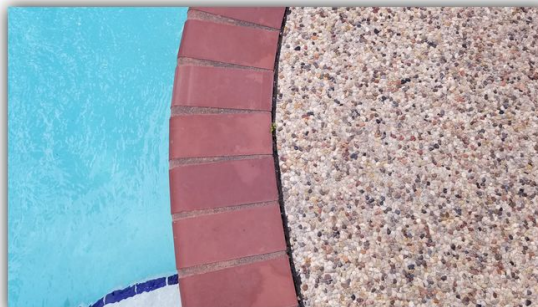
Recommend sealing all voids and cracks at exterior decking and/or pool coping/tile with grout, elastomeric caulk, or other approved material, as needed. Multiple locations noted as having broken or missing tile and are in need of repair. Uneven decking noted at north side of pool, which is recommended to be properly repaired to prevent tripping hazard.
