1st Rate Inspections

Property Inspection Report

5907 Bridgegate Dr, Spring, TX 77373
Inspection prepared for: Anthony Echevarria
Real Estate Agent: -

Date of Inspection: 12/10/2019 Time: 1:30 PM
Age of Home: 1976 Size: 1380
Order ID: 13986

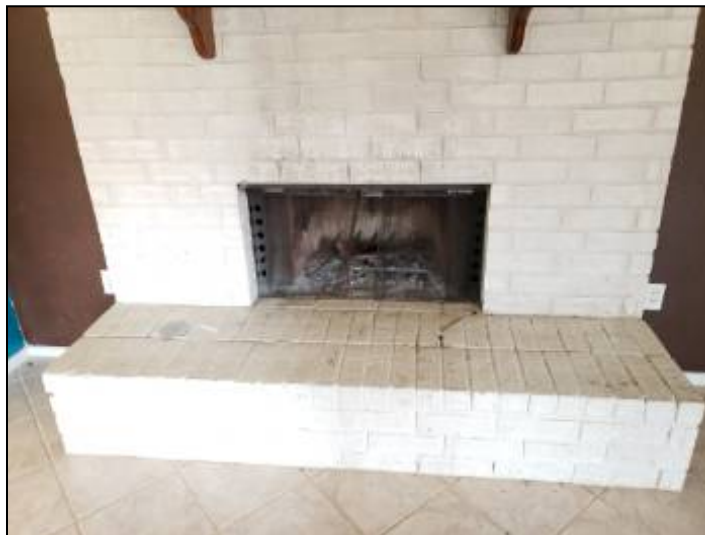
Overview of fireplace

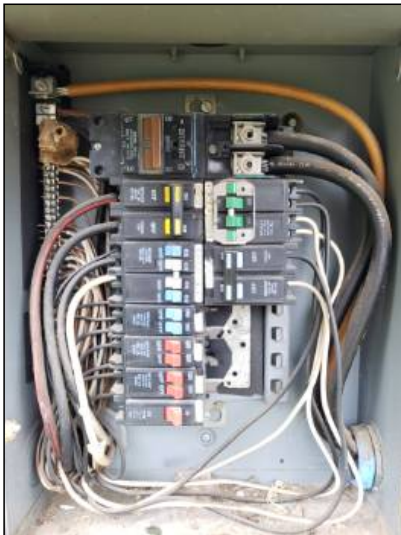
Overview of main electrical panel

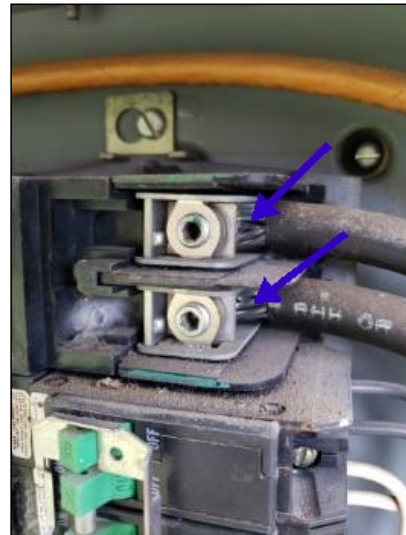
-There is no antioxidant on main aluminum feeds to the panel box. This should be used to help prevent overheating.
