**311 Summer Haven Court
League City TX 77573**

Client(s): Perez
Inspection Date: 4/7/2020
Inspector: Steve Fusselman , TREC 10405

Concerning: 311 Summer Haven Court, League City, TX 77573

By: Steve Fusselman TREC 10405 / BPG Inspection, LLC 4/7/2020

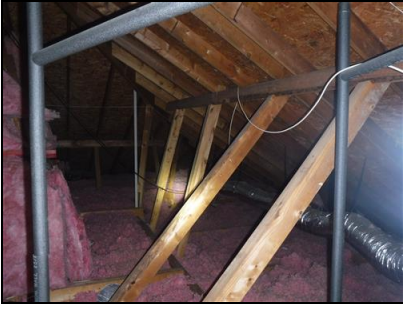
Observed the attic pull down ladder/hatch is not insulated completely, nor does it have weather stripping installed at edge of door that meets ceiling framing. Recommend fully insulating the attic stairway to keep the house more energy efficient. On average the insulation R-value for the entire attic area will drop approx. 27% when the attic stairs/hatch is not fully and properly insulated. The reason for this is that, although the attic stairs/hatch account for only 1% of the total attic area, the rate that heat flows through them by conduction (per square foot) is 38 times higher than in the insulated part of the attic.

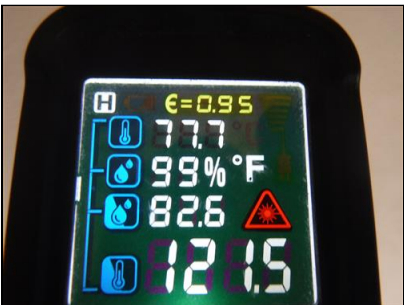
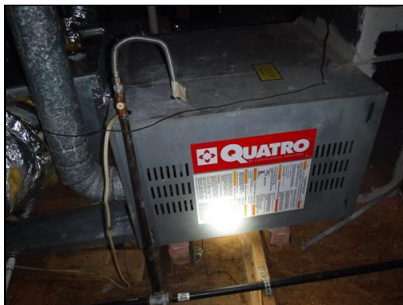
Gas supply to unit is missing a sediment trap, or drip leg as called for by current standards.

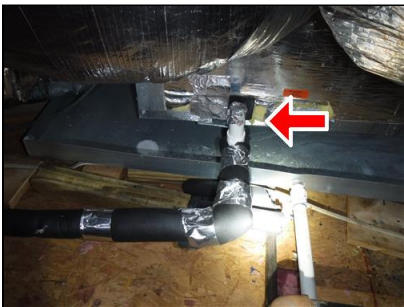
There is no emergency float electrical cutoff switch installed as called for by today's standards. These devices prevent condensate from overflowing into the interior house structure, and turn the unit off until service is performed to the unit. I recommend updating to current standards to prevent water incursion.

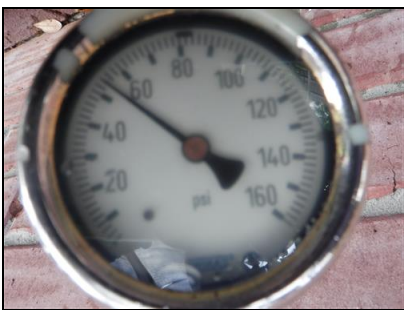
Some exterior hose bibs (faucets) are missing back-flow check valves as called for by today's standards

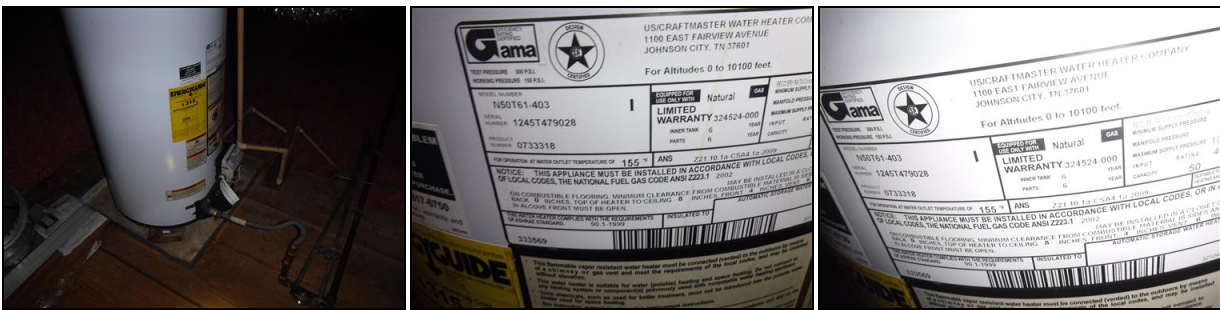
Temperature readings at sinks were measured at a higher than suggested setting. The U.S. Consumer Product Safety Commission (CPSC) urges all users to lower their water heaters to 120 degrees Fahrenheit. In addition to preventing accidents, this decrease in temperature will conserve energy and save money. Most adults will suffer third-degree burns if exposed to 150 degree water for two seconds. Burns will also occur with a six-second exposure to 140 degree water or with a thirty second exposure to 130 degree water. Even if the temperature is 120 degrees, a five minute exposure could result in third-degree burns. Consumers should consider lowering the thermostat to the lowest settings that will satisfy hot water needs for all clothing and dish washing machines.

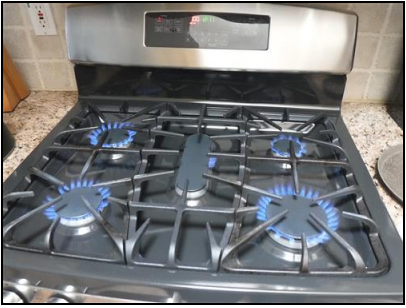
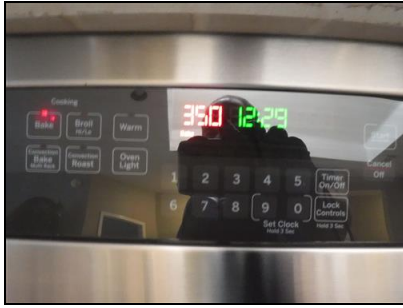
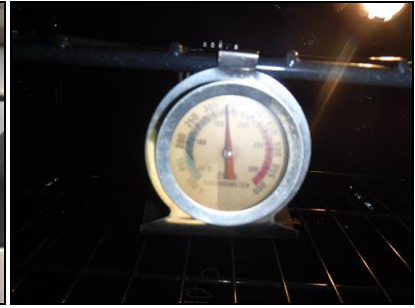
Noted that one burner will not ignite when tested. Most of the time, when a gas burner refuses to light or runs poorly when lit, the cause is dirt or grease. Fine particles of dirt or grease spatters can clog the flame openings on the burner, or could be electronic igniter failing. Recommend having appliance technician evaluate concern and repair or replace as needed.
