PROPERTY INSPECTION REPORT

Concerning: 22502 Westbrook Cinco Ln., Katy, TX 77450
(Address or Other Identification of Inspected Property)

By: Rudolph Depena Lic. 5191 10- 12- 2016
(Name and License Number of Inspector) (Date of Inspection)

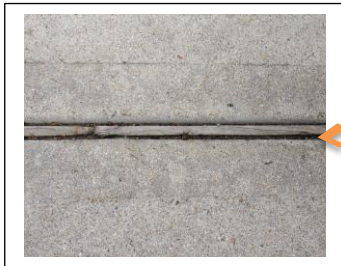
Floating concrete slabs were observed at the driveway, front walkways, and at the rear area around the swimming pool deck.

OBSERVATION: One of the concrete upper quadrants of the rear side appears to be sliding in an easterly direction. Visible gap between the concrete slab step transition is noted with fracture from one slab quadrant to the other, due to soil under-pressure with water traveling through soil capillaries under the concrete slab area from improper grading and drainage in this sloping area. It is the opinion of this inspectors to recommend implementation of proper grading and drainage within the surrounding terrain and others areas of the patio to prevent further movement (sliding) and/or lifting of this floating slabs quadrant around pool (see grading and drainage section for further comments). It is also recommended to fill the gap between the floating slab and step with self-leveling sealant.

Refill fractures and driveway expansion joints gaps between driveway floating concrete slab quadrants with self-leveling sealant (latex material), to avoid water penetration and deterioration. Keep these areas watertight to avoid the unnecessary excess of soil pressure underground.

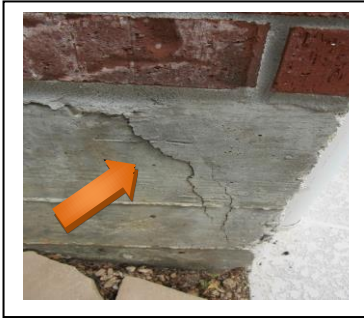
These areas with spalling effect in concrete structure (i.e., hairline crack, chips, corner pops) are common and are not necessarily related to foundation settlement. Cracking or chipping at those corner concrete slab location may occur since at time of construction 'forms' are used to pour concrete. With the forms these corners retained excess of moisture not permitting the concrete to dry (cure), at the same rate causing differential thermal expansion of the concrete mix. Additionally in this case the post tension reinforcement tendons start approx. 6" from corners at both sides of perimeter and when forces are applied to tense the cables it may create the cracks at this sensitive area.

Recommended: Seal with proper concrete sealant the corners with crack or chip at the S.E. perimeter of the foundation wall of the slab. Avoid deterioration.

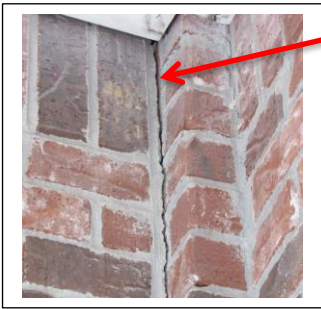
NOTE: A vertical fracture was noted at the inside corner of brick wall transition between the arch of the carport and the N.W. (front left) column. Indicating that, the independent concrete footing of this column appears to be affected by settlement/movement of footing-foundation from improper grading and drainage in the surrounding area. At this point it is these inspectors opinion, that this structural element those not need underpinning reinforcement. If after adequate drainage installed the columns deflects or settlement continuous a professional in the field should be consulted. See grading and drainage and exterior wall section for further comments.

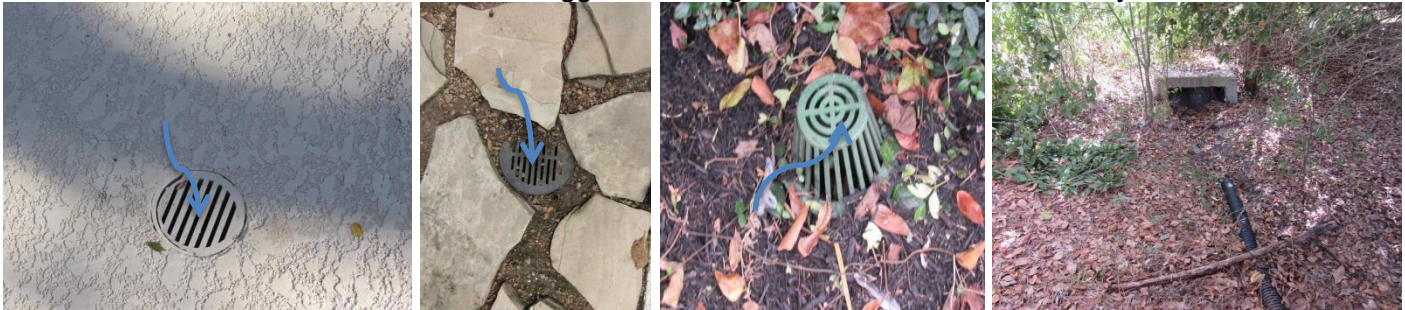
This property is noted with drain pipes at the S.E. area of the pool deck and at the patio of the east and south side with visible grates over the drain pipe. The drain system in place appears to discharge (exit) towards the lower area of the lot and to the rear bayou storm water drain community system. The present patio-drain system of the dwelling appears to be in need additional implementation of drain to function within sloping terrain in general, including and not limited to enhance present drainage of the lowest point of the terrain where the water appear to be standing for extended period of time and in the higher areas where water runs towards the foundation perimeters and rear floating slab. It is highly recommended for mechanical drain system as the one suggested being maintained-clean periodically.

The concrete gutter in place between floating slab steps is recommended to be connected to a patio drain and clean periodically. An additional concrete gutter is recommended to be installed in the area of the step/concrete floating slab indicating lifting and with sliding movement.

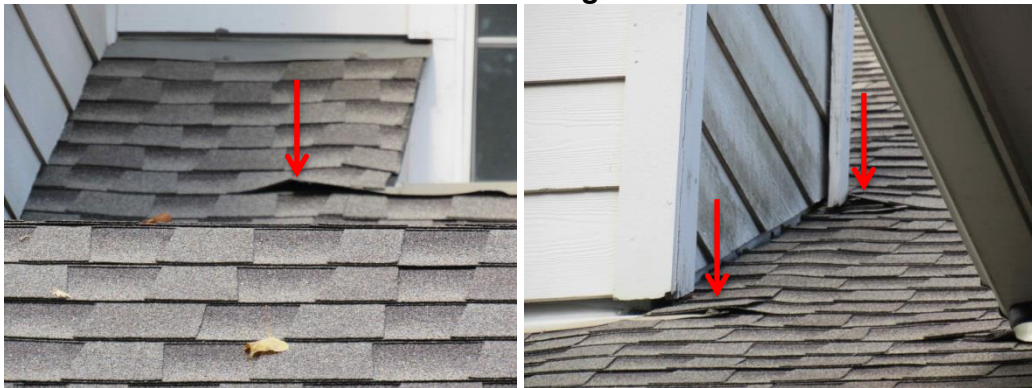
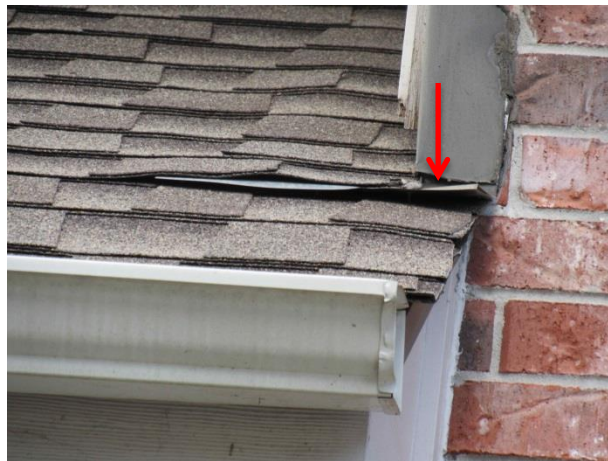
D - Metal flashing lifting shingles is noted at the rear slope of the dormer windows, including lifted sidewall flashing at the rear pony wall.

Re-nail the metal flashing and seal over nail heads.

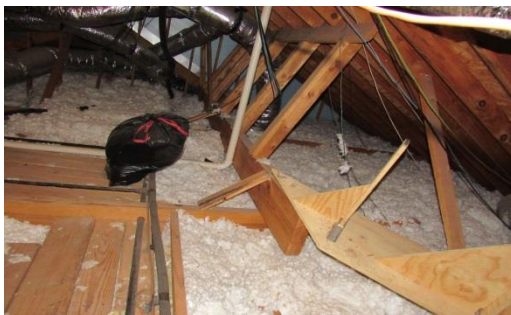
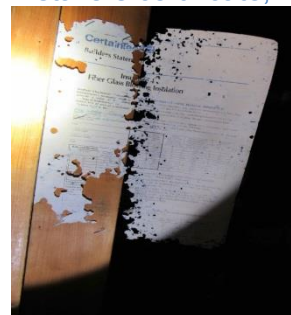
Blown fiberglass insulation with approx. depth of 12.0” of a ratio of R-30+. Insulation installer’s certificate was visible, but deteriorated paper to read it.

Insulation at the attic does not meet current IECC code 2008 (international Energy Conservation Code) of R-38 or higher.

[Installers certificate, not readable.](#)

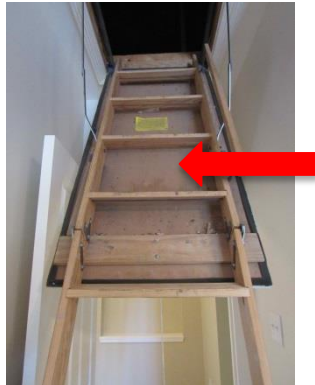
D - It is recommended to place a piece of blanket or foil faced foam board insulation and insert it at the attic face of the attic pull-down-stairway in between the steps and the plywood cover. Prevent HVAC air leaks to the attic.

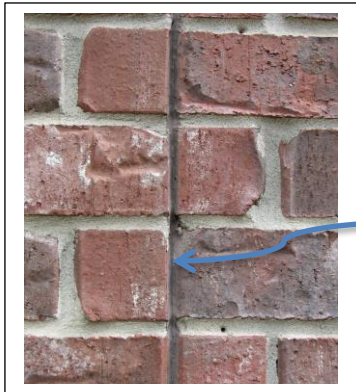
Exterior walls on the day of this inspection appear to be performing their intended function. Visible expansion joint are noted at brick veneer wall.

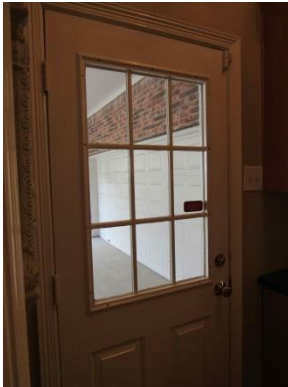
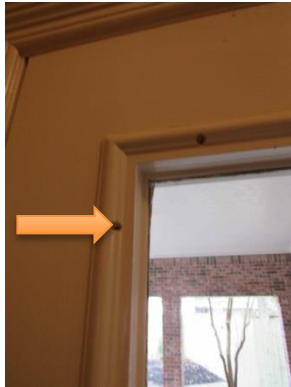
Hole caps/screw covers were not installed at this north side exterior door. Install them to cover exposed screw heads.

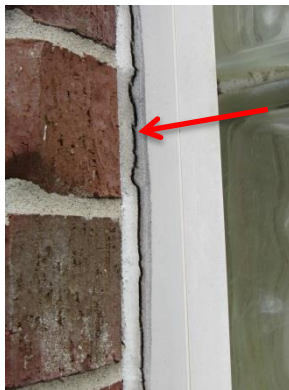
- D - One of the windows at the north wall has damage window screen.
- Seal around some of the window trim/brick veneer transition.
- Glazing bead in some of the windows are crack or broken. Replace to keep window pane in place and prevent HVAC air from leaking.

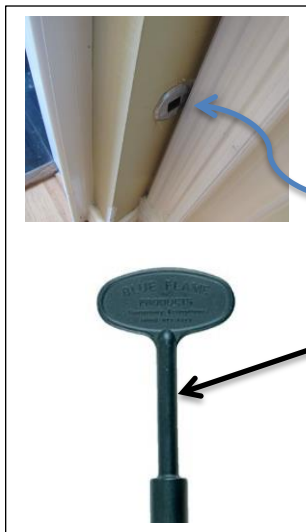
Gas shut-off is located to the right side of the fire box. Recommend to have the key to the gas valve at all times when in use. Key was not available or visible at time of inspection recommend to request one from the current owners.

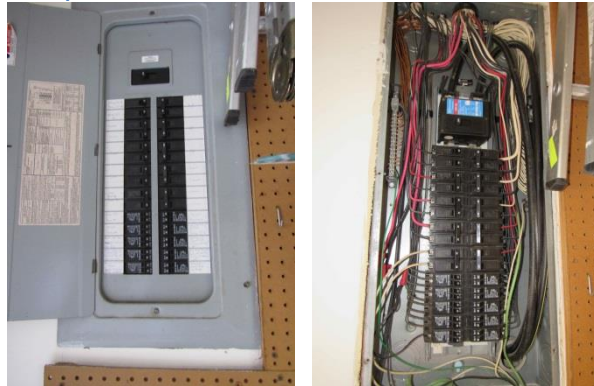
Main panel box.

Main service rating 200 amps breaker as main service disconnect located at the exterior south wall with 31 breakers.
NO "AFCI" ARC- FAULT circuit interrupter breakers present.
This is to comply with bedroom receptacles of 125 volt, single phase, 15-and 20 ampere outlets, of the 2002 to 2006 NEC (National Electric Code) Listed to provide protection to the entire branch circuit.
 This is NOT complying with the NEC 2008 to be placing ARC- FAULT circuits at all rooms where GFCI are not present including the garage ceiling outlets. Some of the older boxes prior to 2008 do not accept ARC-FAULTS, consult with licensed electrician to see if this box may accept these breakers and/or when changing electrical box. **This is for Safety or Fire hazards of the electrical system adopted by NEC current standards.**

D - Main panel was tested for hot spots. Increase of temperature due to high resistance, noted with the infrared camera, to the connection of wiring to the top right 50 and left 20 amps double pole breakers. License electrician to check for loose wiring terminal or proper installation of multi-strand wire loose connection.

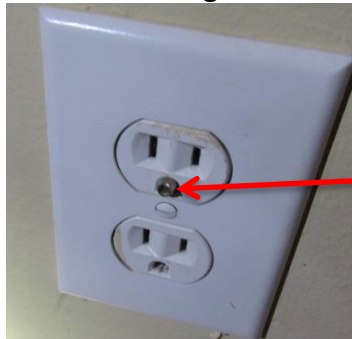
- Outlet located at the curb wall of the stairway has the ground prong plugged with a leg left from an electrical cord, leaving the top prong not functioning as intended, remove the leg or replace the outlet.

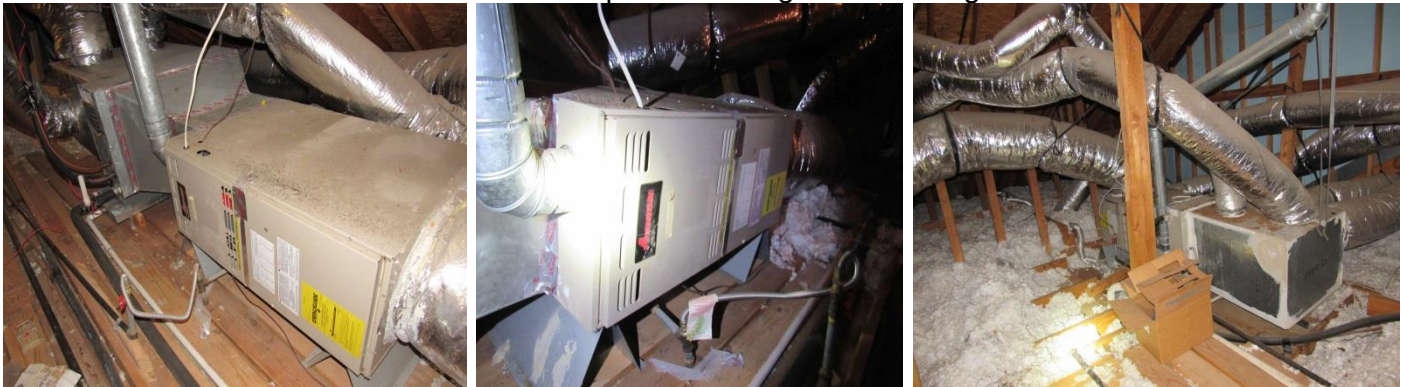
- 1 & 2) 2- Horizontal units: AMANA; Approx. 46,000 BTU. Model GUC045CA30.
- 3) Horizontal unit: AMANA: Approx. 88,000 BTU. Model was not accessible.

Furnaces were tested briefly and appear to be functioning as intended. Burners' cannot be visible from the opening. They were tested briefly due to exterior temperature being above 60 degrees.

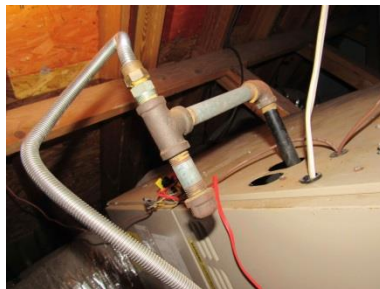
Information: Drip leg (sediment trap) is present on the gas lines of the furnace. An inverted "└" connection to the gas line close to the flex line. This is manufacture requirement not enforced in some cities or municipalities, depending of the type of gas in use.

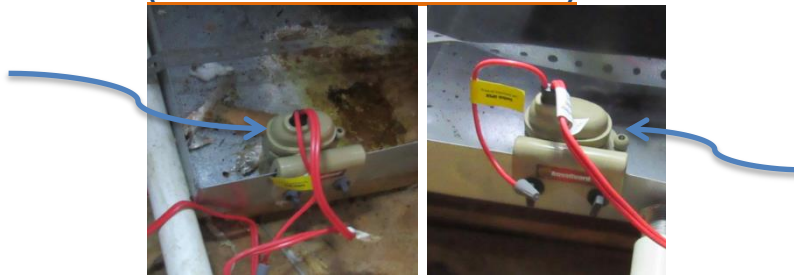
- Electronic float are present within two of the unit's emergency pan.
- It is recommended to have an electronic float to one of the units (located at the north attic area).

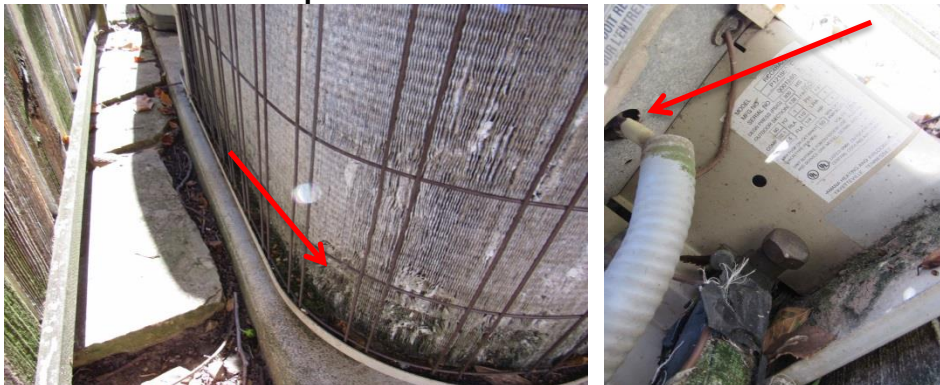
- Condenser unit fins are observed with damages. Recommend to have an HVAC technician to evaluate them further.
- Electrical Connector to the electrical flex entering the unit is not present.

HVAC system Repairs and Evaluation are to be done with a Licensed HVAC Technician.

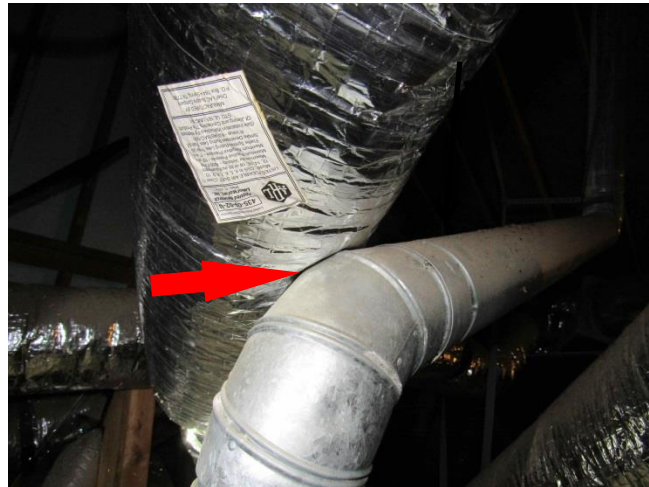
D - One Duct is in contact with the exhaust vent pipe of the Furnace.
 This condition can damage the duct and create **Fire**, since the exhaust vent pipe of the furnace reaches high temperature when the furnace is in use. Considered **fire hazard** condition.

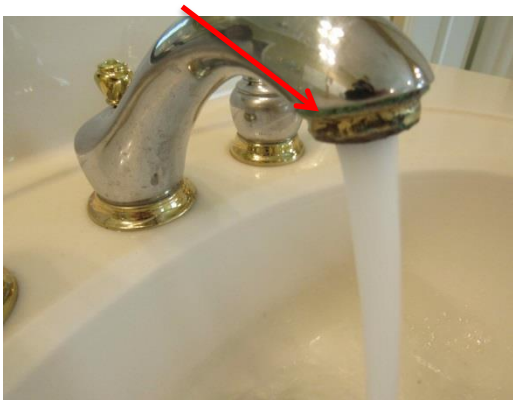
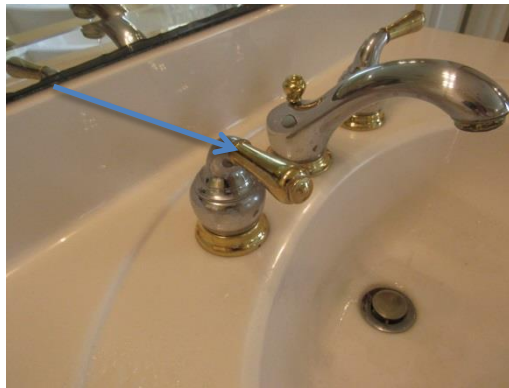
- D -** Leaks are noted at two aerators of the lavatories, master bathroom and north bathroom when the faucets are ON.
- Hot water faucet valve at the master lavatory appears to have a leak. Valve was found OFF.

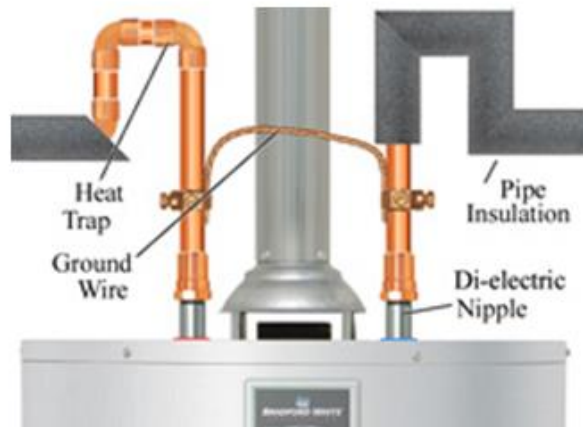
Note: Bonding protection is NOT present. The bonding jumper (electrical wire) runs between the hot and cold metal water lines if applicable or to the metal gas pipe; because some water heaters are made of nonconductive materials, which will interrupt the ground circuit. The jumper also allows the heater to be replaced when needed without disrupting the ground connection. See photo below.

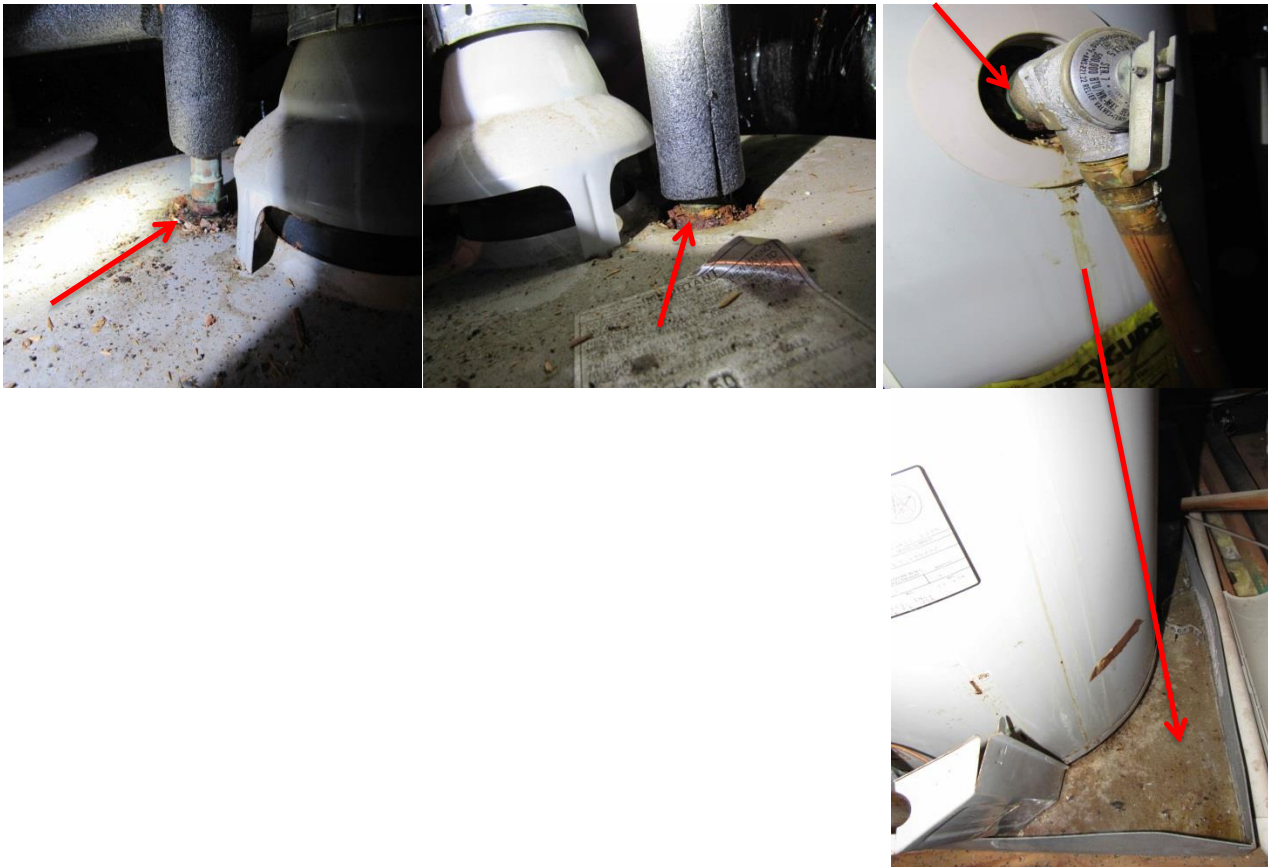
D - Nipples of the water heater (hot and cold water) located at the right side (south side) are viewed with corrosion. Licensed plumber needs to determine to repair or replace the unit. This water heater is not functioning, although the gas valve is ON and water heater appears to be in functional, unit is not light-up.

- Temperature Pressure Relief (TPR) valve appears to be leaking at the water heater located at the right side (south side). Drain pan under the unit contains water from excess leak.

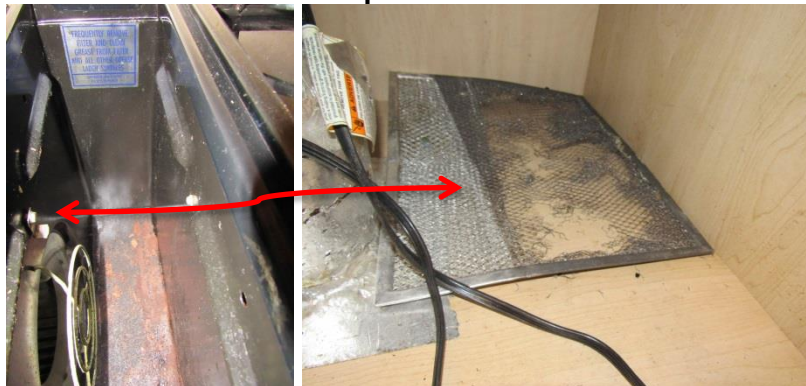
D - Filter to this unit is not in place. It is visible torn under the cook top.

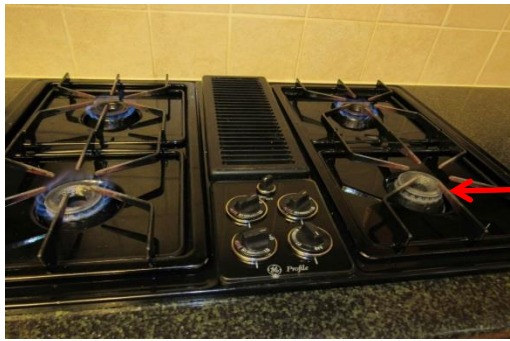
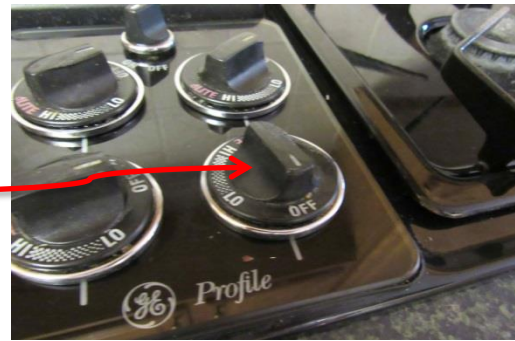
D - Front right burner is not functional. Its controlling knob does not rotate to place in any setting. An Appliance technician to restore the burner knob.

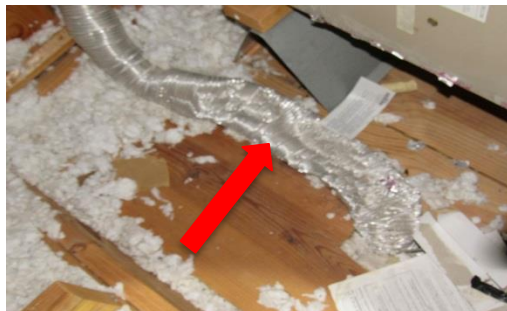
D - North exhaust flex vent pipe at the attic is crushed. Not performing the function since it is restricted to exhaust properly. Replace the exhaust pipe, and relocate it so that it is not in front of the HVAC unit.

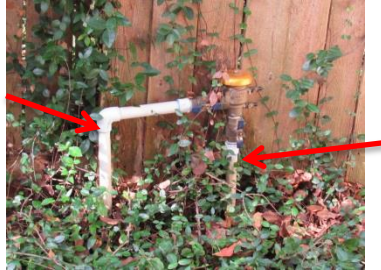
D - Insulation both standing PVC pipes of the vacuum breaker present at the south patio.

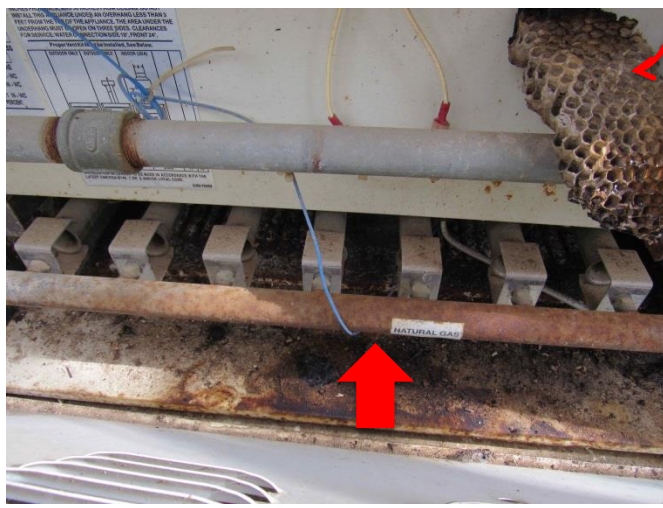
- D - Pool Heating Unit needs to be service by a technician with cleaning and evaluation of the Heating exchanger and its component. Excessive rust residue within the chamber was visible.** Units are not tested during this inspection.
- **Beehive panel to be removed with Caution from interior of the unit.**
