RESIDENTIAL INSPECTION REPORT

2506 Sand Bar Ct
Seabrook TX 77586

Jeremy Ellison
APRIL 18, 2020

PROPERTY INSPECTION REPORT

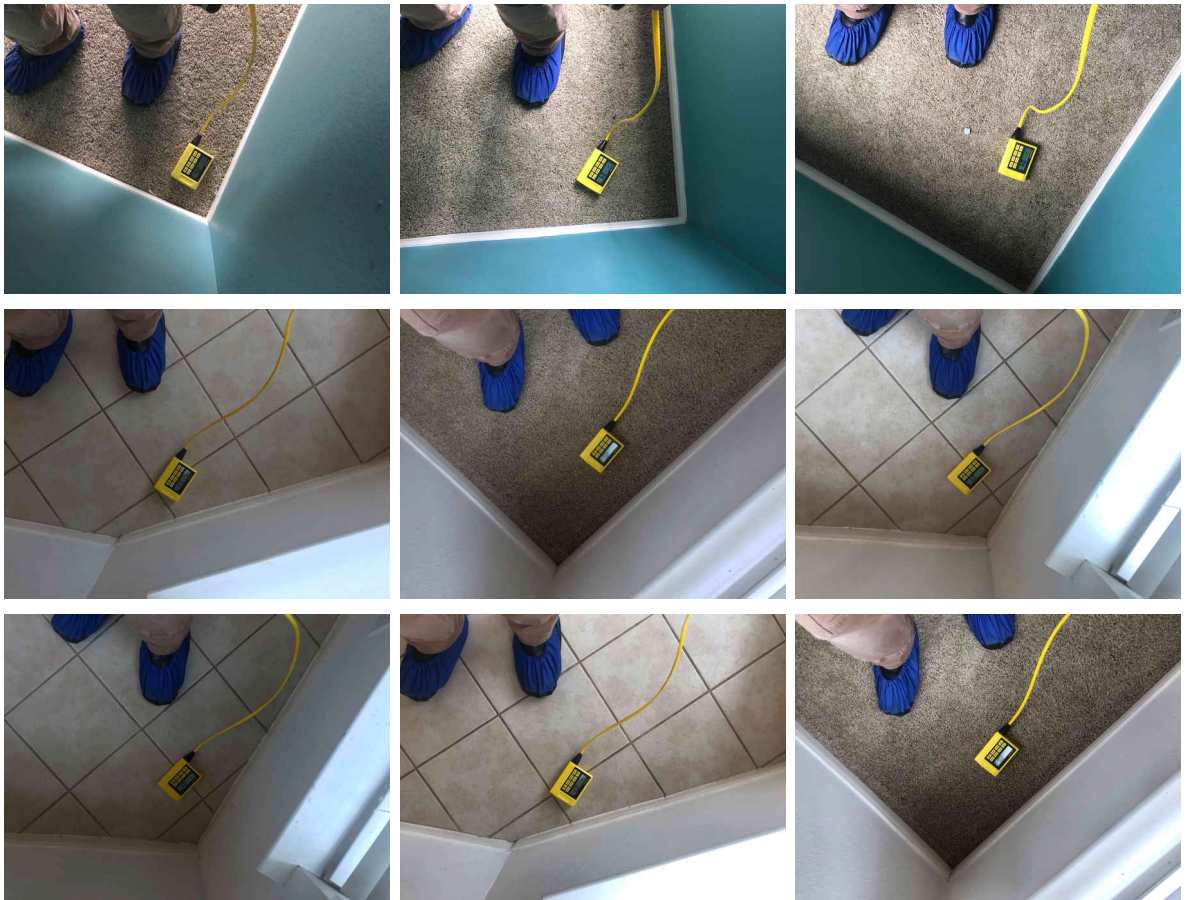
Foundation Inspected with Digital Level:

This foundation was measured with the use of an electronic digital measurement tool. Multiple elevation points were registered on the foundation throughout the property to determine if there were elevation variations that indicated excessive movement of the foundation. At the time of this inspection the measured areas did not indicate any variations that, in this inspector's OPINION, indicated any need for invasive repairs to the foundation.

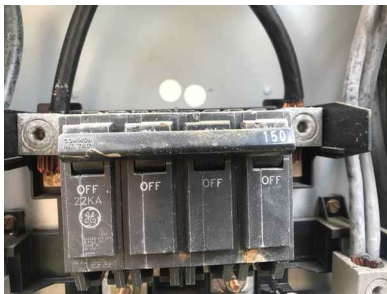
1: Arc-Fault Safety Protection Missing

🚫 Recommendation

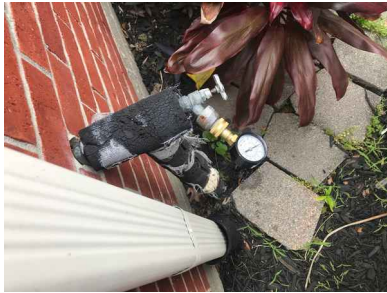
Location of water meter: Front yard near street

Location of main water supply valve: Exterior Wall - Right Side

Static water pressure reading: 50-55 psi

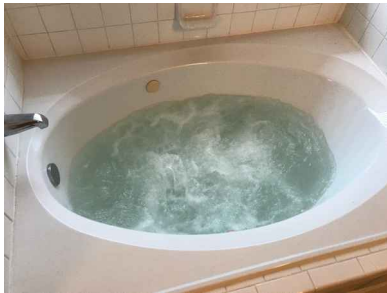
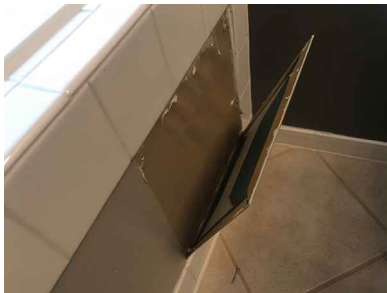
D. Hydro-Massage Therapy Equipment

No pump access:

No motor access:

Limited visibility:

Limited access to the area under the tub limited visibility of all under-tub components.
