Inspection Report

Property Address:
3111 Windmill St
Suagr Land Texas 77479

Texas HomeSpection Inc.

Date: 9/11/2017	Time: 11:30 AM	Report ID: 20170911-3111-Windmill
Property: 3111 Windmill St Suagr Land Texas 77479	Customer: Mr. Joseph Chen	Real Estate Professional:

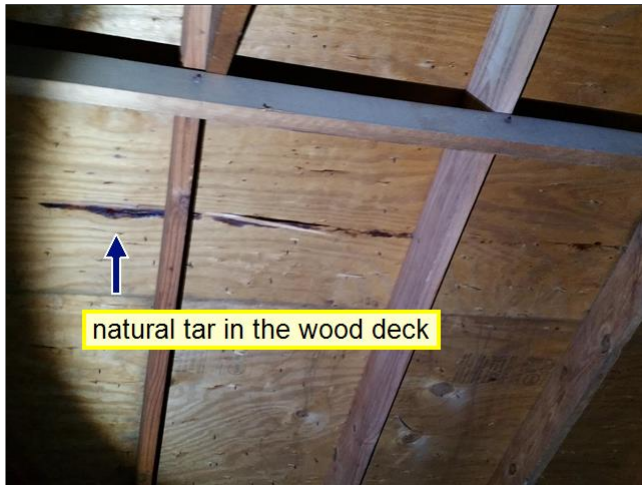
D. Item 4(Picture)

Missing/broken roof deck was found in the second attic (with evaporator and furnace) near A/C supply-air duct and shall be repaired.
