RESIDENTIAL INSPECTION REPORT

12463 Mooremeadow Ln
Houston TX 77024

Dayna Owens
APRIL 12, 2019

Jeff Marquardt

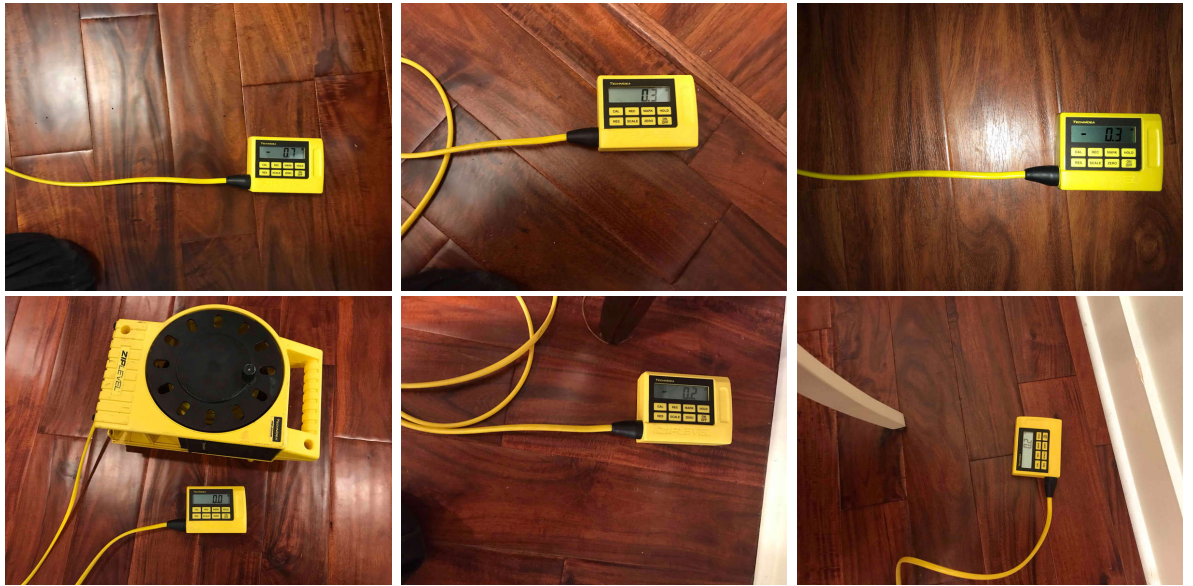
Foundation Inspected with Digital Level:

This foundation was measured with the use of an electronic digital measurement tool. Multiple elevation points were registered on the foundation throughout the property to determine if there were elevation variations that indicated excessive movement of the foundation. At the time of this inspection the measured areas did not indicate any variations that, in this inspector's OPINION, indicated any need for invasive repairs to the foundation.

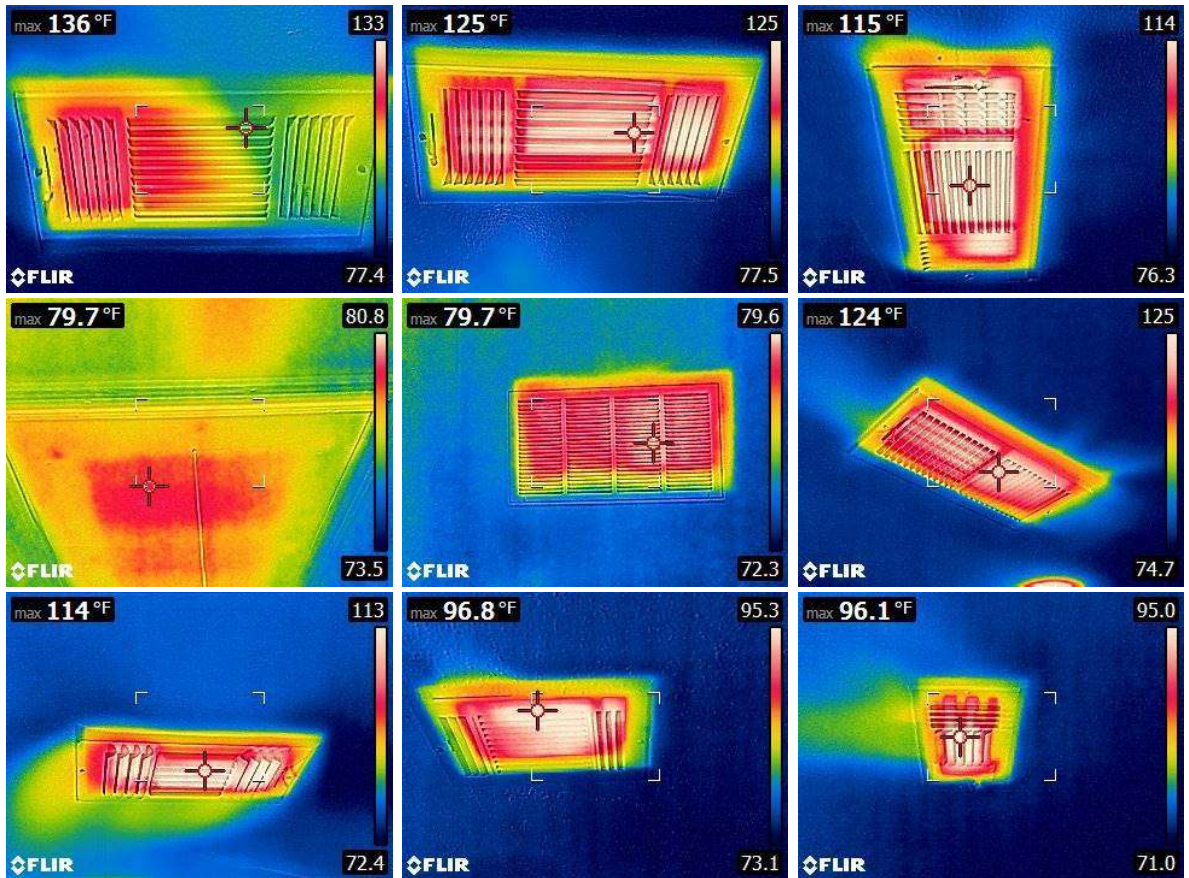
Heating System was Functioning:

The Heating System was functioning at the time of inspection. Refer to the Inspection Report for any further recommendations.

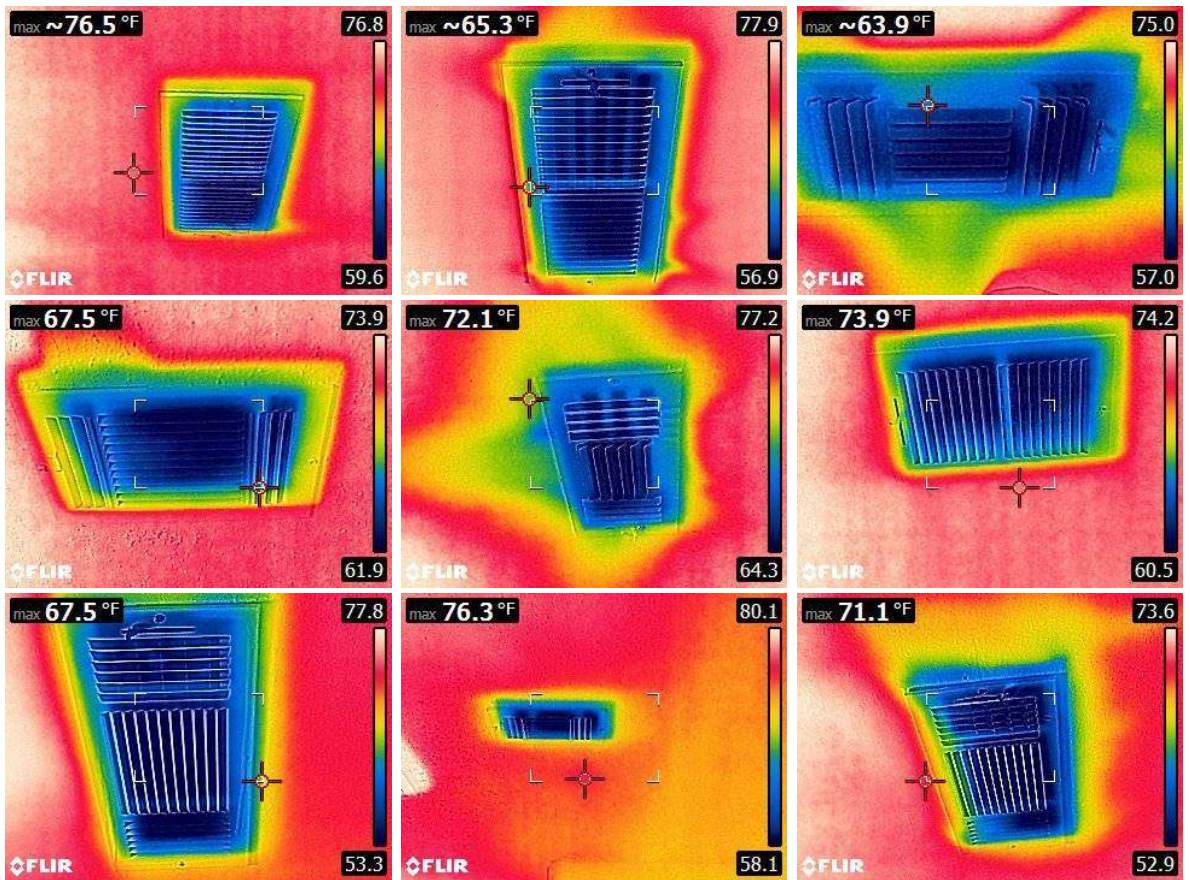
Older Equipment: Cooling:

Note: Operation of the unit shows the unit was cooling at the time of the inspection. Due to the age of the system, routine maintenance should be considered.

Temperature difference (delta) - First Floor: 19°

Temperature difference (delta) - Second Floor: 17°

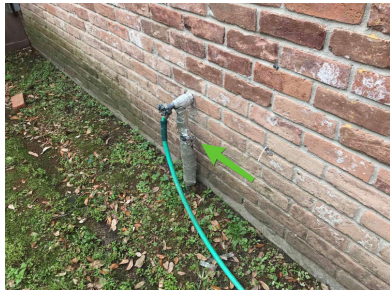
Static water pressure reading: 50-55 psi

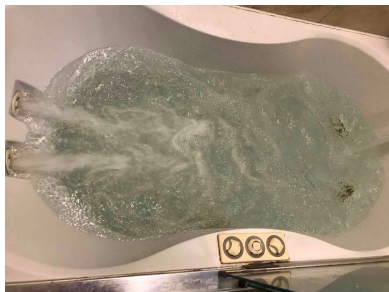
1: No visible GFCI

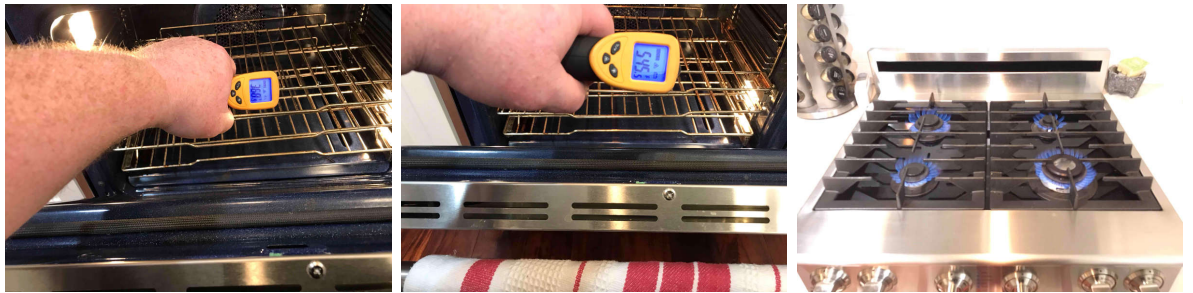
D. Ranges, Cooktops, and Ovens
Comments:
Range/Oven Energy Source: Gas
Oven/Range Were Operating As Inteded at the Time of the Inspection:
