# PROPERTY INSPECTION REPORT

Concerning: 2705 Beatty St., Houston 77023  
(Address or Other Identification of Inspected Property)

By: Ruben Santillan, Lic #5570 07/14/2020  
(Name and License Number of Inspector) (Date)

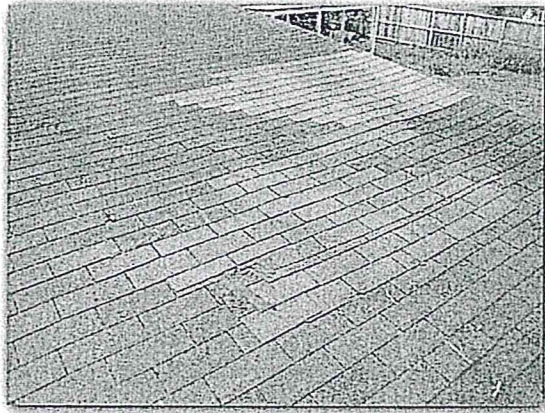
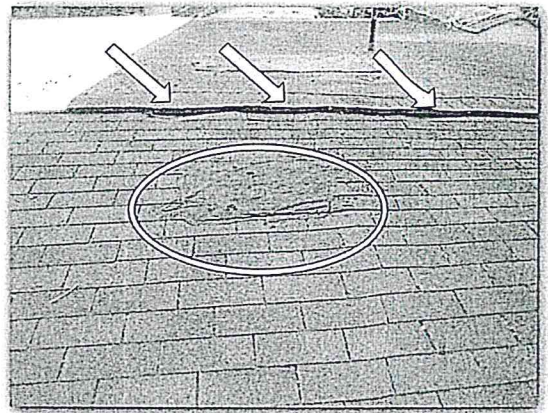
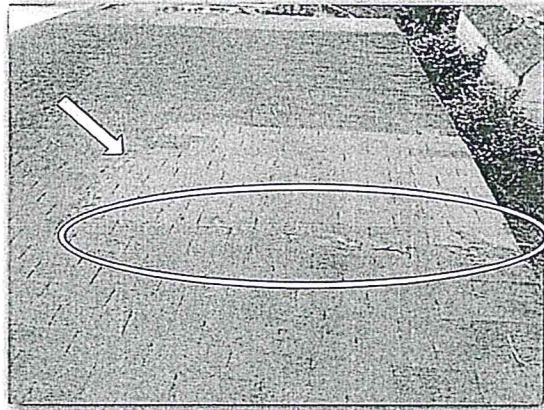
**Area(s) of soft/spongy and/or rotted roof decking observed while walking on roof.  
The extent of any damage is beyond the scope of this inspection.**

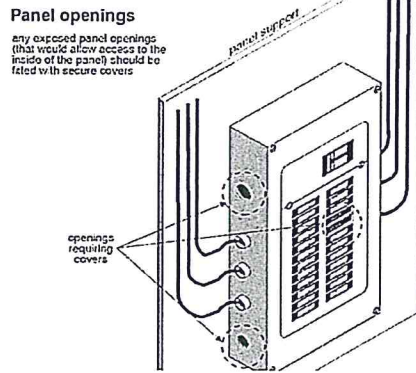
Panel exterior circular knock out(s) need to be sealed to prevent wasp / bee infestation.

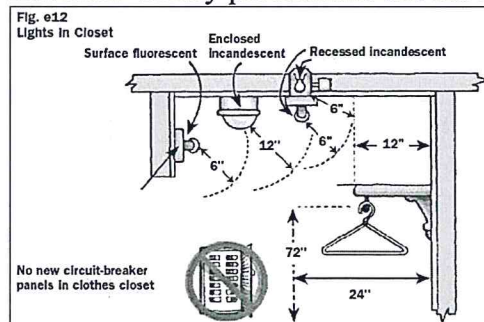
One or more of the closet light fixture(s) appear to be mounted to close to combustible material. Safety precautions should be taken around these light fixtures.

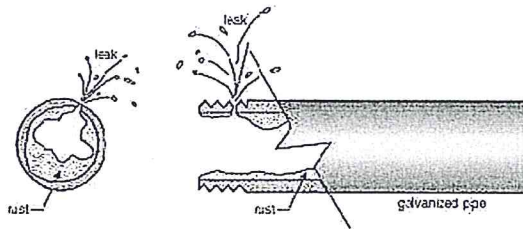
rusting of galvanized pipe can greatly reduce water pressure and will eventually cause leaks as rust creates holes in the pipe wall:

problems are likely to occur sooner on pipes carrying hot water, horizontal pipes and all threaded (thinner) sections

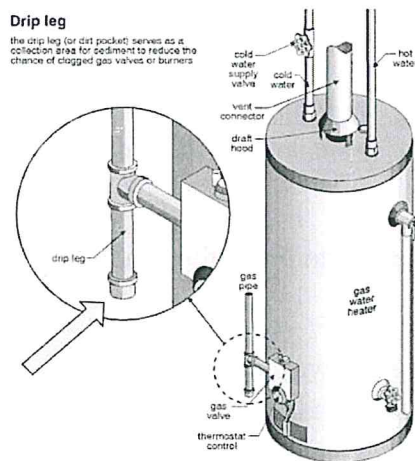
*Did not observe gas line drip leg(s) on gas house heater and/or gas water heaters which is called for in the manufactures installation instructions.*

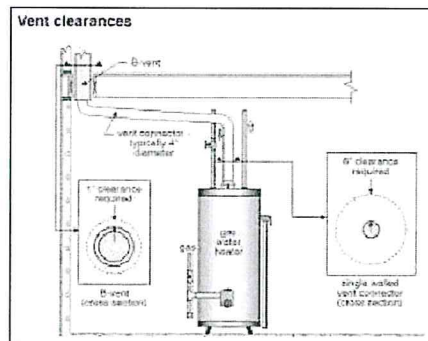
Exhaust vent pipe is in contact or does not have required minimum 1" clearance from combustible material, [wood roof decking].

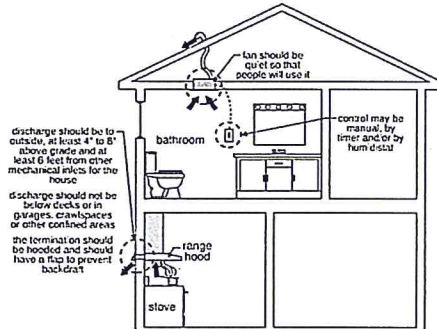
Improperly vents into attic. Should vent to exterior.(not all to the exterior) The only one that had evidence of terminating to the exterior was for the front unit. This motor was not functional and the plastic vent is not rated to be used in the attic. The vent is also damaged probably by rodents.
