HOME INSPECTION REPORT

Prepared For:	Miguel Valdez	
	(Name of Client)	
Concerning:	17114 Ross Lake Ct, Humble, TX, 77346	
	(Address or Other Identification of Inspected Property)	
By:	Charles Rowden 22155 David Jones 22116	5-6-2020
	(Name and License Number of Inspector)	(Date)
	(Name, License Number of Sponsoring Inspector)

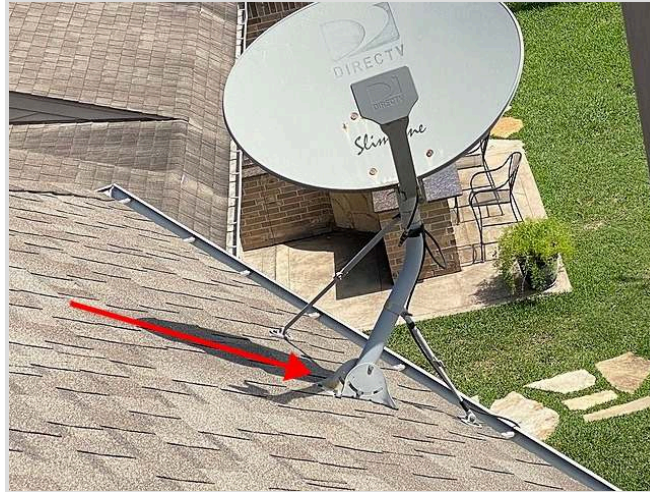
Installed over shingles

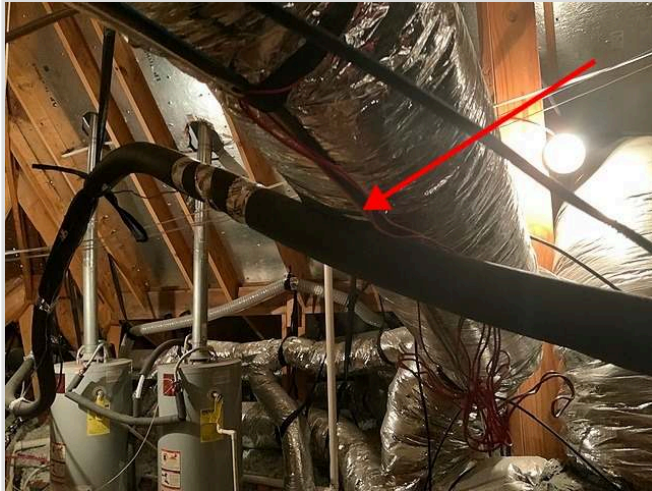
Ducts in the attic space were in contact with refrigerant lines and other ducts. Points of contact between these items has been known to create condensation (sweating) in the attic space. Common industry standard calls for supply ducts to be elevated over insulation, not in contact with refrigerant lines/other flex ducts and/or HVAC units in the attic space.

Ducts in contact with refrigerant lines

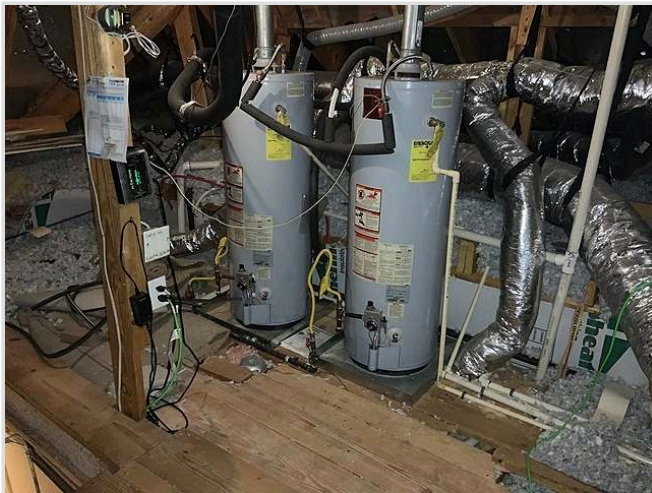
Relief valves were not tested (units in the attic).

Units in the attic

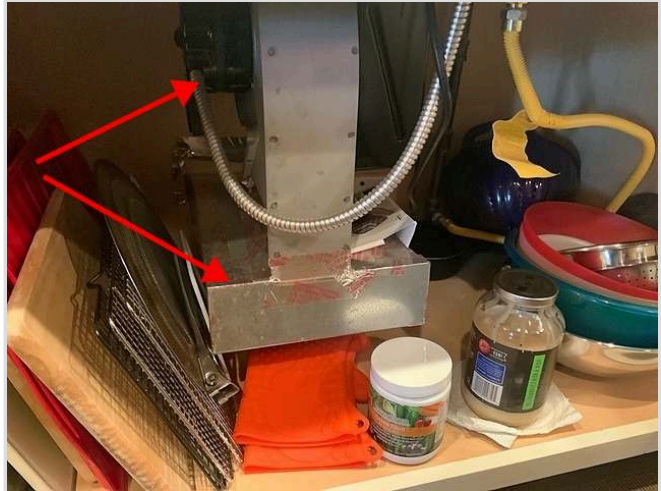
Motor and vent of range exhaust

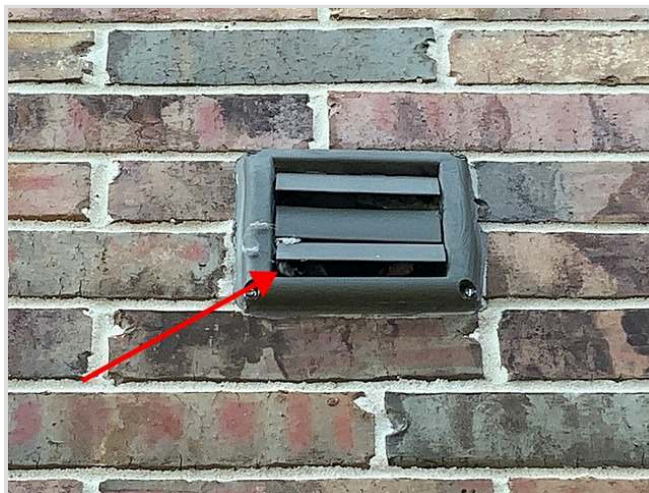
The dryer exhaust had excessive lint buildup and needed to be cleaned.

Needed to be cleaned
