Your Inspection Report

1112 13th St
Galveston, TX 77550

PROPERTY INSPECTION REPORT

Concerning: 1112 13th St, Galveston, TX
(Address or Other Identification of Inspected Property)

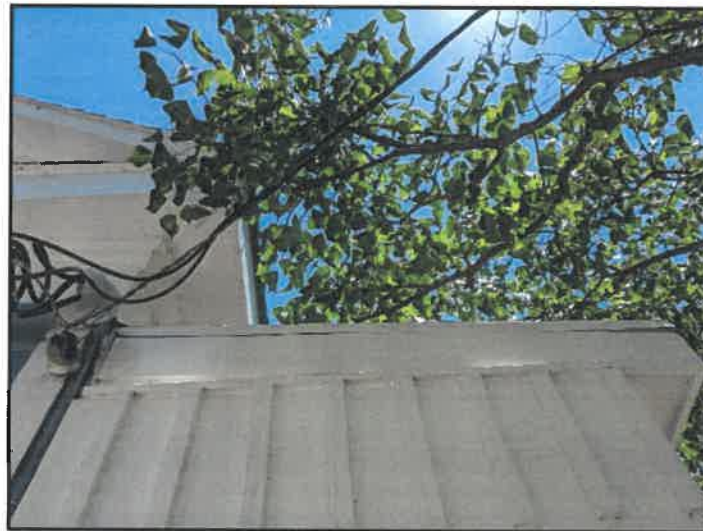
3. Tree branches touching roof

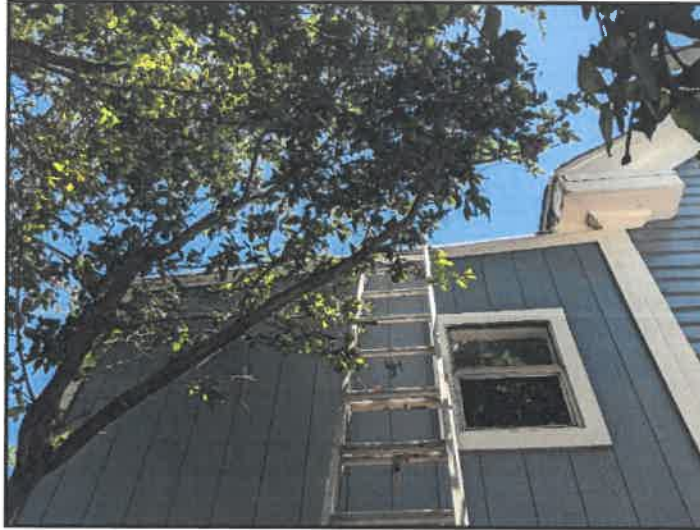
11. *Tree branches touching roof*

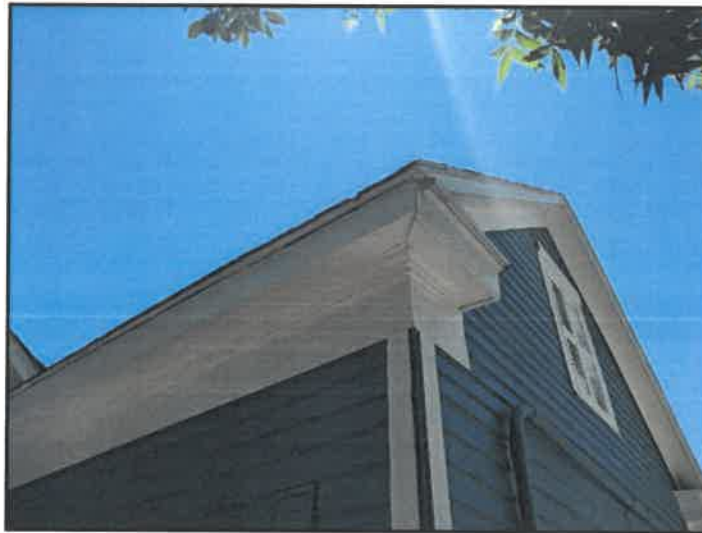
15. Vents - ineffective / missing

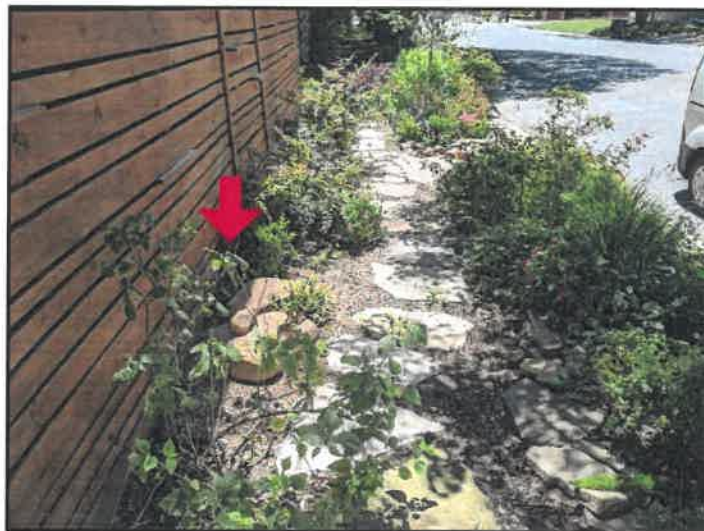
17. Too close to grade

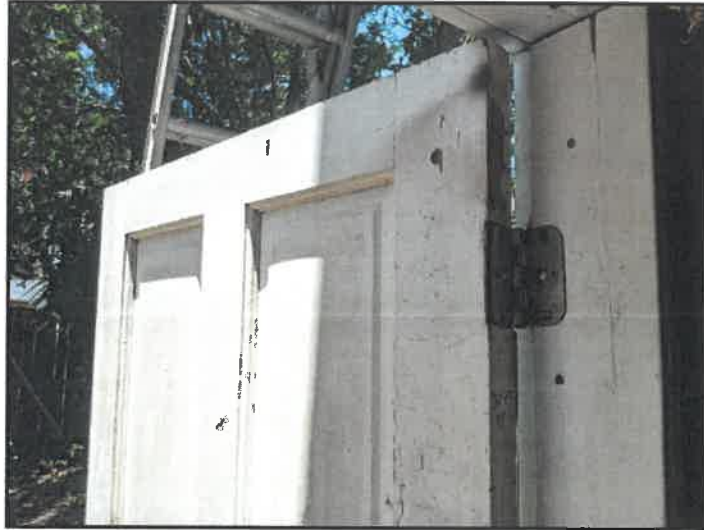
24. Loose or poor fit

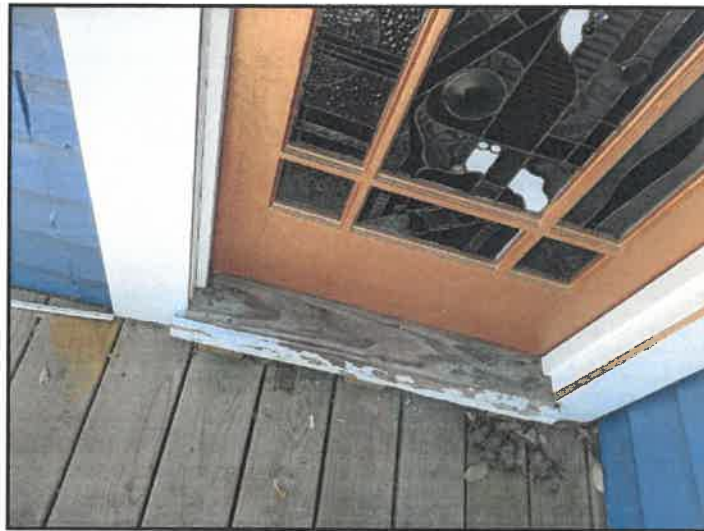
25. Paint or stain needed

Task: Correct

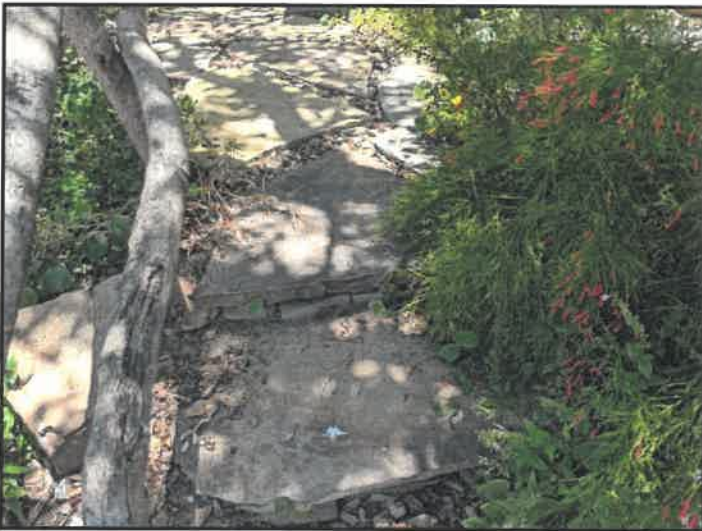
34. Stair rise too big or not uniform

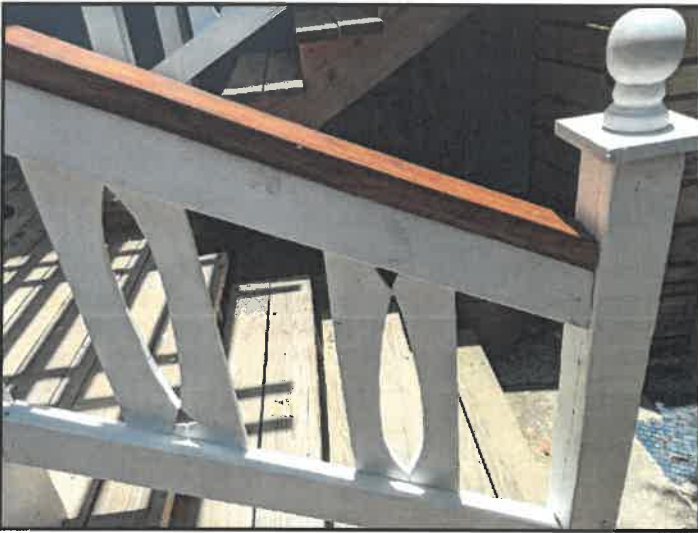
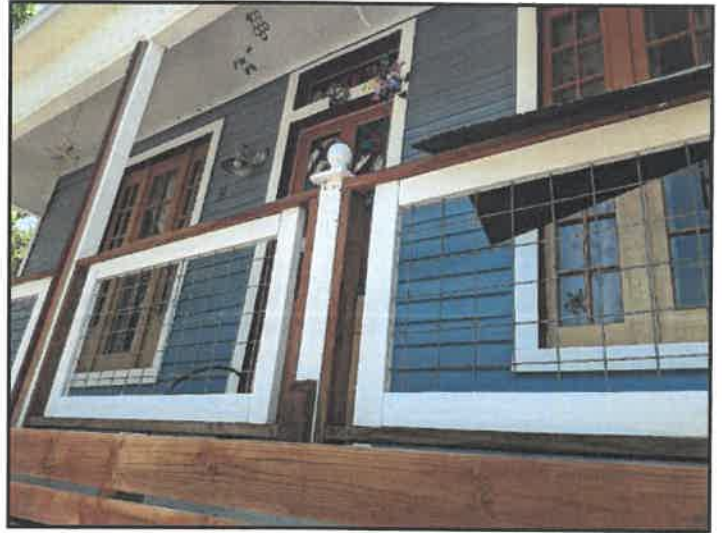
38. Openings between spindles (balusters) too...

32. Condition: • [Openings between spindles \(balusters\) too large](#)

Implication(s): Fall hazard

Task: Improve

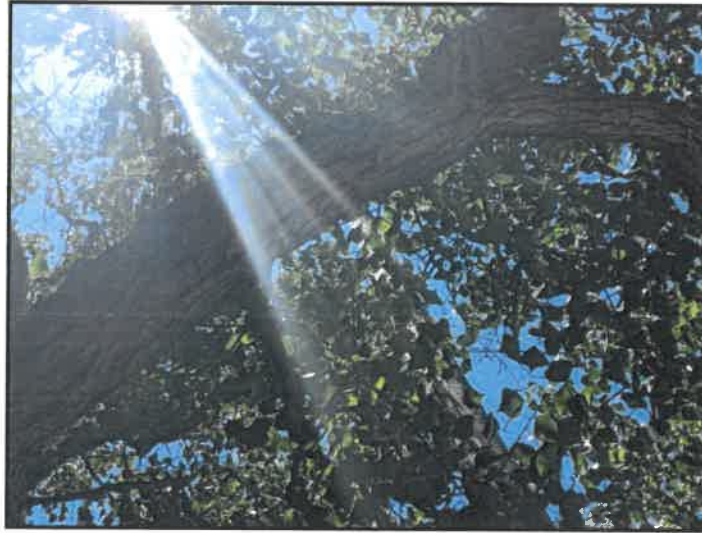
53. Branches / vines interfering with wires

43. Condition: • [Branches / vines interfering with wires](#)

Implication(s): Damage to wire | Electric shock | Interruption of electrical service

Location: Front Yard

Task: Correct

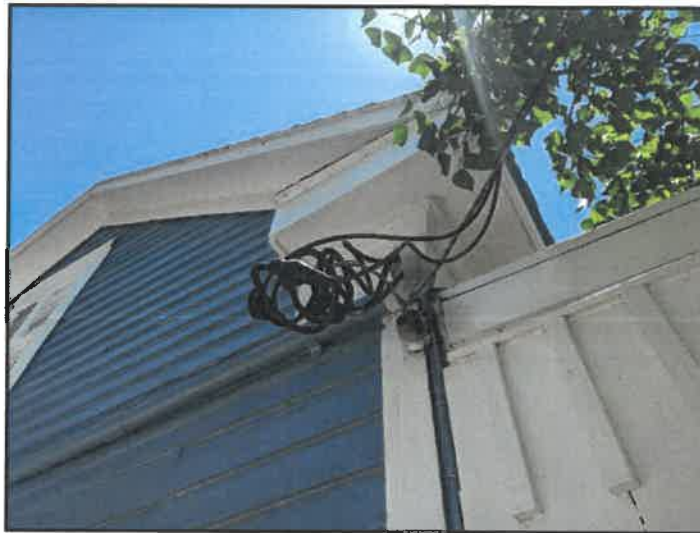
54. Wires too close to roof

44. Condition: • [Wires too close to roof](#)

Task: Improve

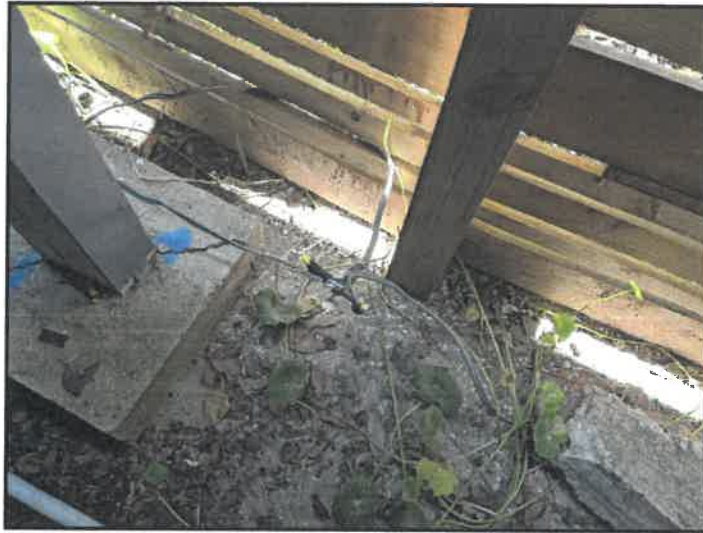
59. Wires too close to grade

50. Condition: • [Wires too close to grade](#)

Implication(s): Damage to wire | Electric shock

Location: Middle Porch

Task: Improve

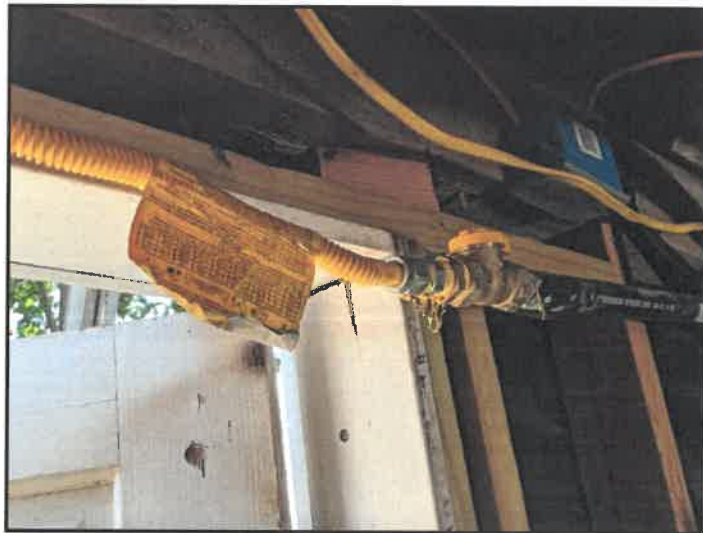
73. Condition: • No drip leg (sediment trap/dirt pocket)

Implication(s): Equipment failure

Location: Garage

86. No drip leg (sediment trap/dirt pocket)

Task: Provide

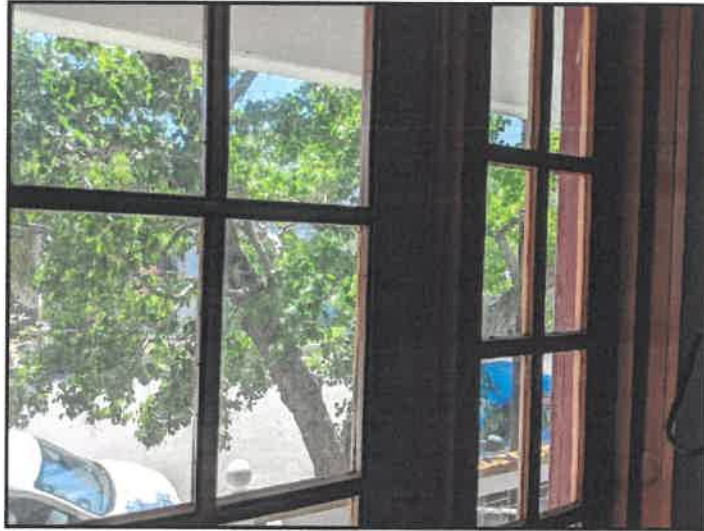
80. Condition: • Safety glass not installed

Location: Various Throughout

95. Safety glass not installed
