# Inspection Report

**Property Address:**  
7278 Avocet Ln  
Houston TX 77040

# PROPERTY INSPECTION REPORT

**By:** Anthony Byrd 21925 / Byrd's Eye Inspection 8/3/2020

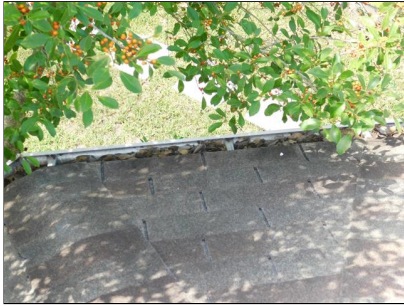
B. Item 2(Picture)

(4) Debris was observed in the gutters. This condition prevents proper drainage of water off and away from structure. Debris in gutters can conceal rust, deterioration or holes that are not visible until cleaned.

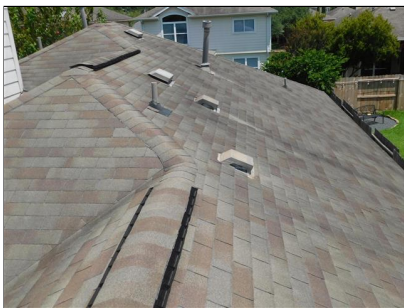
C. Item 1(Picture)

(2) The condition of the roofing material is consistent for its age and there are visible leaks or repair requirements. Based on present condition and normal weather patterns, it is reasonable to expect additional years of service life. This does not preclude the occurrence of leaks or the need for repairs during that period. This inspection is not a guarantee against isolated roofing leaks in the future.

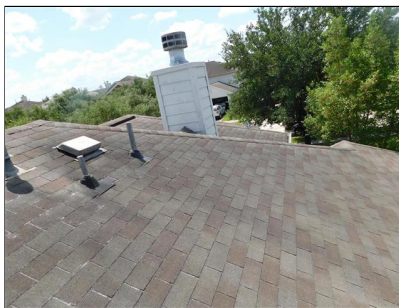
C. Item 2(Picture)

(3) Tree limbs that are in contact with roof or hanging near roof should be trimmed back 3-5' to prevent any damage to the roof covering.

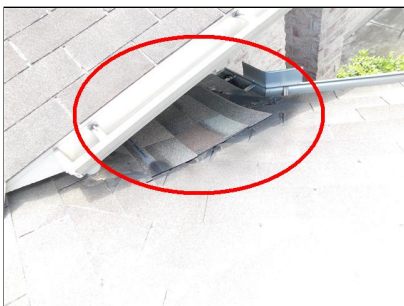
C. Item 6(Picture)

(6) There were vent, counter or step flashings observed to be raised and improperly sealed. A qualified roofer should reseal and seal these roofing components as needed to prevent any future water penetration.

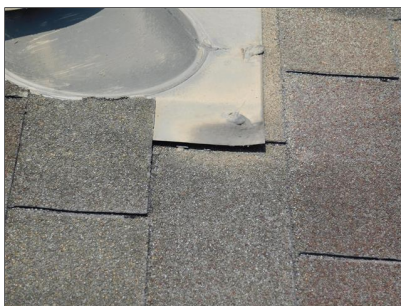
C. Item 8(Picture)

(7) The shingles are damaged/ worn with granular loss in various areas. A roofer should perform a maintenance check on the covering for needed repairs, patching or replacement of worn shingles.

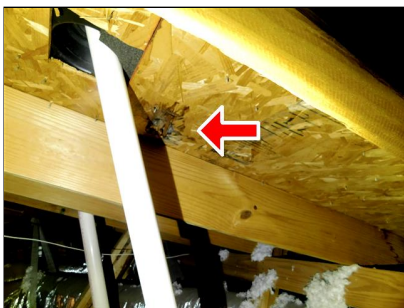
D. Item 1(Picture)

- (1) Only areas of the attic determined accessible by the inspector are inspected.
- (2) The structure was in good condition. However, the following exceptions were observed:
- (3) There was evidence of leaks in areas of the attic (flue pipe penetrations, chimney, valleys etc.). It could not be determined if any areas of the deck require repair. Replacement of flashing, jackboots or parts of covering at these areas may be necessary to ensure it is leak free. Roofer should evaluate roof covering, deck and exterior flashings and jackboots for need of repair or replacement.

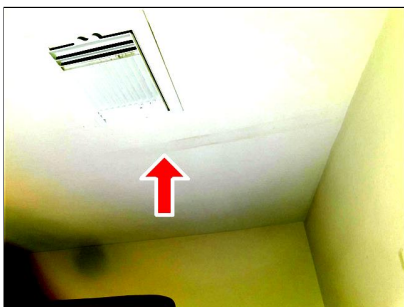
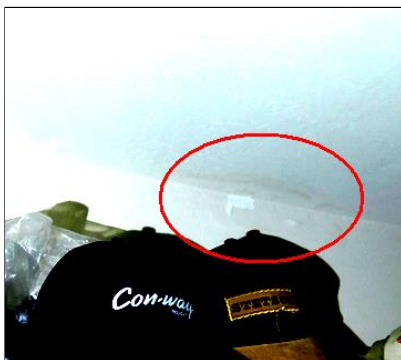
F. Item 1(Picture)

- (1) Observation of floors are related to structural performance and water penetration only. The inspection does not include obvious damage to carpets, tiles, wood, laminate or vinyl flooring
- (2) There is evidence of previous leaking observed by presence of stains on the ceiling . Recommend query owner for history, damage and any repairs performed to prevent further water intrusion. If no repairs, evaluation and repairs by qualified contractor recommended.

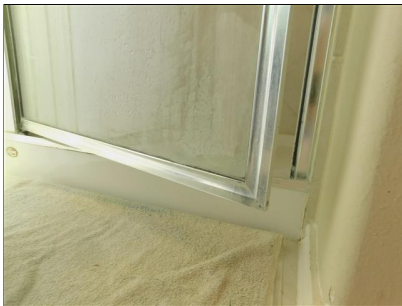
G. Item 1(Picture)

- (1) Cosmetic items and obvious holes are not included in this report. It is common in the course of climate changes that some doors may bind mildly or the latches may need adjustment.
- (2) Bottom seal on the shower door in the master bath is damaged or missing and should be replaced to prevent splashing of water outside of shower.

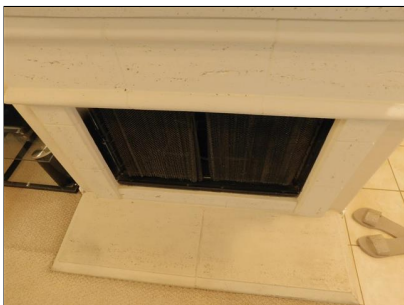
J. Item 1(Picture)

(2) Sealant (fire-rated/high temp caulk) is needed around the gas log starter line at cabinet knock-out penetration.

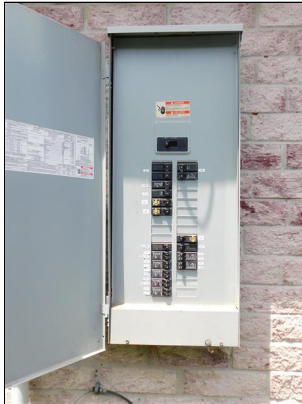
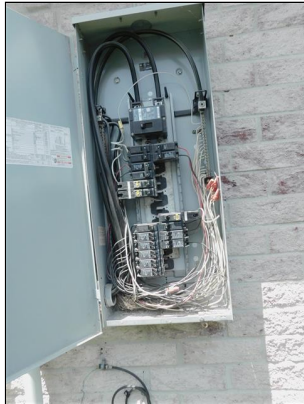
A. Item 1(Picture)

(2) At least one of the service conductors has been damaged/cut. This essentially reduces the gauge and amperage rating of the conductor. Though a common occurrence it is technically incorrect, and should be corrected .

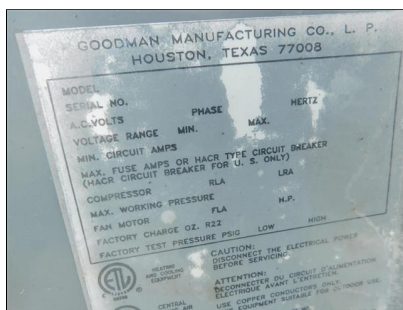
B. Item 3(Picture)

(3) The condenser outside (AC unit) is older and may last a few years more, but maybe not. I have seen units fail shortly after a home inspection during the seasonal change from mild to hot weather. I cannot determine how long your AC will last before a replacement is necessary. Average life span is 13 to 15 years.

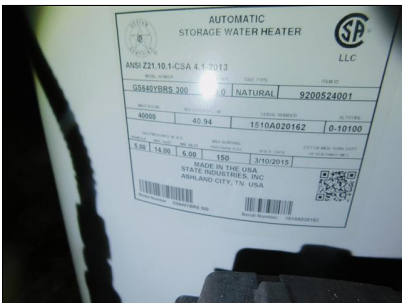
C. Item 1(Picture)

(3) Flue vents not properly secured at elbows with sheet metal screws. Tape is currently being used, which can become a source of combustion. Remove tape and properly secure vents with sheet metal screws.
