HOUSECHECK REAL ESTATE INSPECTIONS

PROPERTY INSPECTION REPORT

Concerning: 9118 Petersham Drive
(Address or Other Identification of Inspected Property)

By: George Szontagh, TREC Lic. #2212 12/5/2018
(Name and License Number of Inspector) (Date)

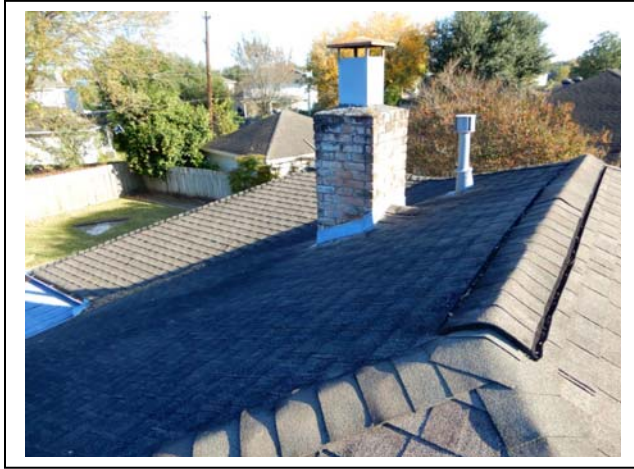
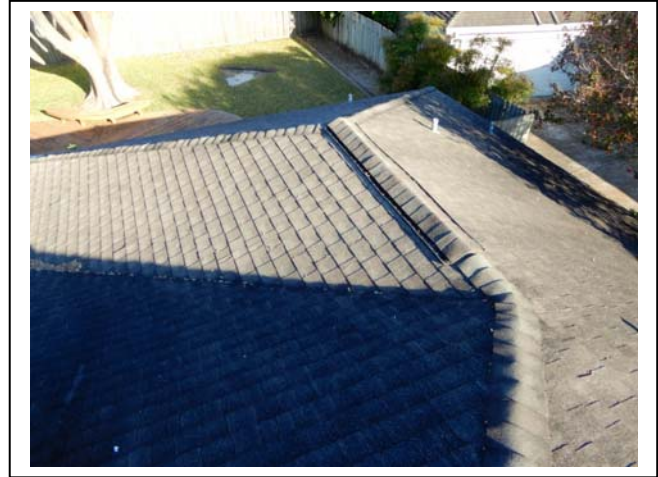
The main roof is a laminated style fiberglass-reinforced asphalt strip shingle roof, laid over OSB decking.

Accessed areas of the main roof appear to be in good to fair condition. Shingles are becoming rigid but have not sustained substantial granule loss.

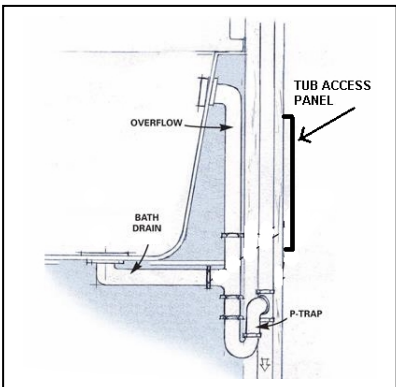
Hall bath:

← Access to tub supplies, overflow, and drain is adequate for inspection purposes. Removable panel present.
