Home Inspection Report

9934 Valley Mill Ct
Houston, TX 77078

PROPERTY INSPECTION REPORT

Inspection Date: 07/28/2020

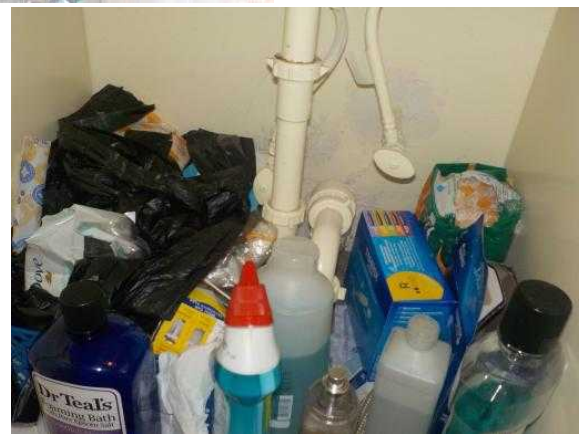
Performing as intended at the time of inspection.

The drain under the sink is PVC. Cannot determine what the sewer line material is composed of due to it being underground.

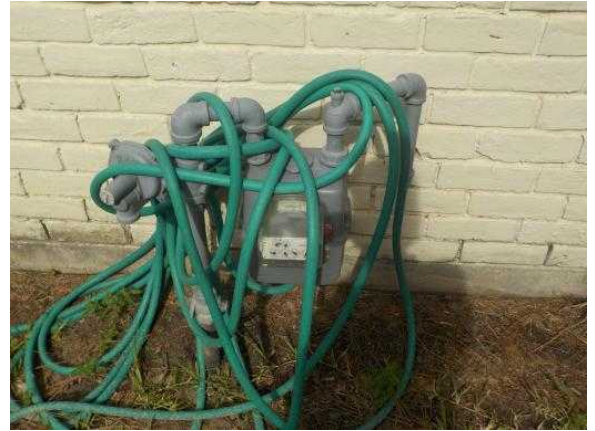
E. Other - Comments: Gas Supply,

Performing as intended at the time of inspection. No gas leaks detected.
