PROPERTY INSPECTION REPORT

Concerning: 113 Dolphin Ave, Galveston TX 77550
(Address or Other Identification of Inspected Property)

By: Neal Harris - TREC #23748 11/19/2020 9:00 am
(Name and License Number of Inspector) (Date)

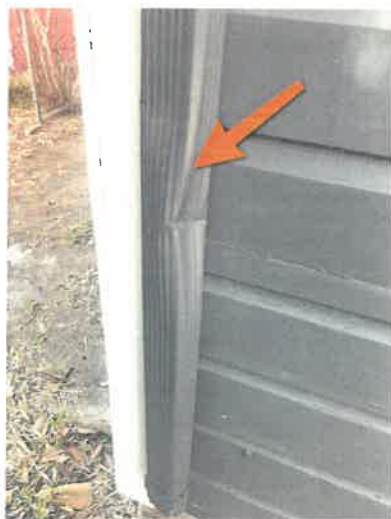
3: Gutters & Downspouts: Damaged

Further evaluation of the gutter and drainage system is recommended.

Recommendation: Contact a qualified landscaping contractor

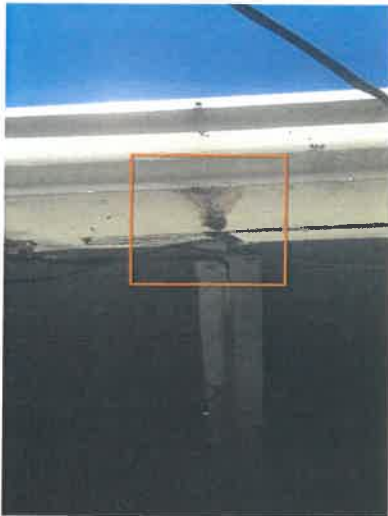
5: Gutters & Downspouts: Rusted

Further evaluation of the gutter and drainage system is recommended.

Recommendation: Contact a qualified landscaping contractor

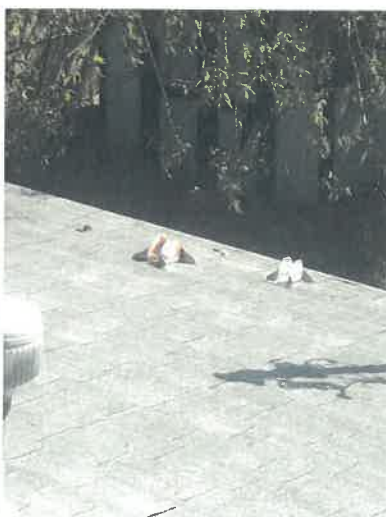
Satellite dish(es) mounted to the roof. The inspector was unable to determine the condition of the roofing materials underneath. Remedy as needed.

Recommendation: Contact a qualified roofing professional.

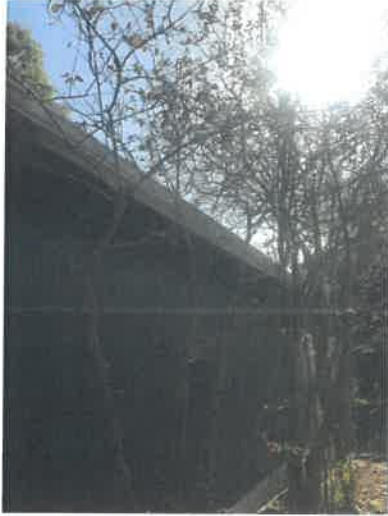
2: Tree limbs on/near roof

Tree limbs that are in contact with roof or hanging near roof should be trimmed to prevent damage to the roofing materials.

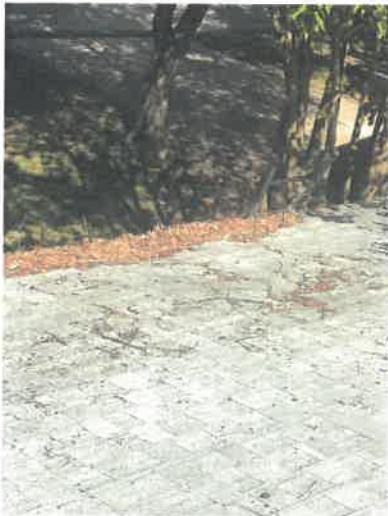
3: Debris on roof

Debris was present on roof surface. The condition of the roof covering underneath could not be determined. Removal of debris and evaluation of the roofing materials underneath is recommended.

Recommendation: Contact a qualified professional.

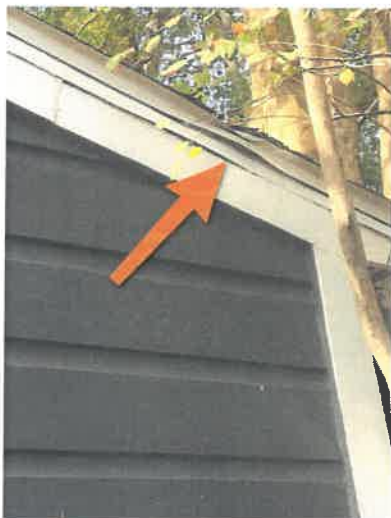
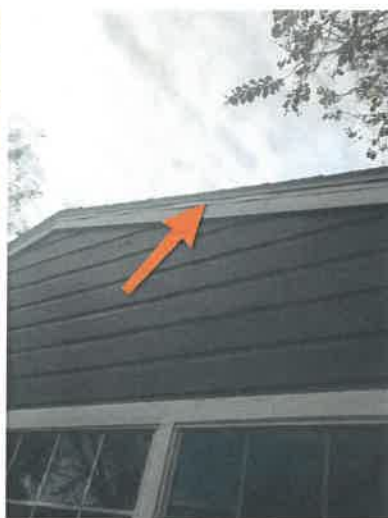
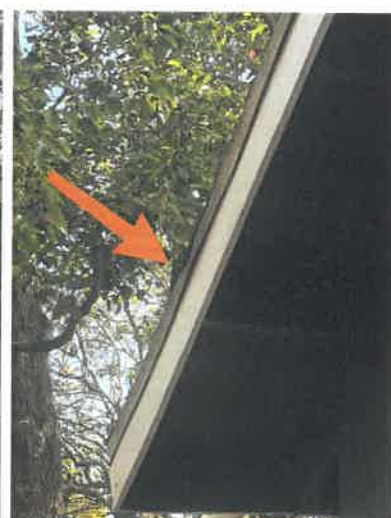
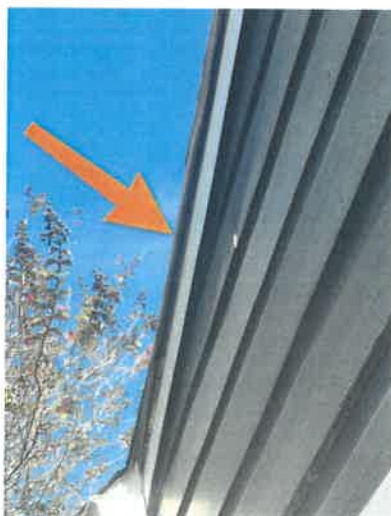
5: Drip Edge: Loose, Damaged, or Not Continuous

Sections of drip edge were loose, damaged, or not continuous.

Recommendation: Contact a qualified roofing professional.

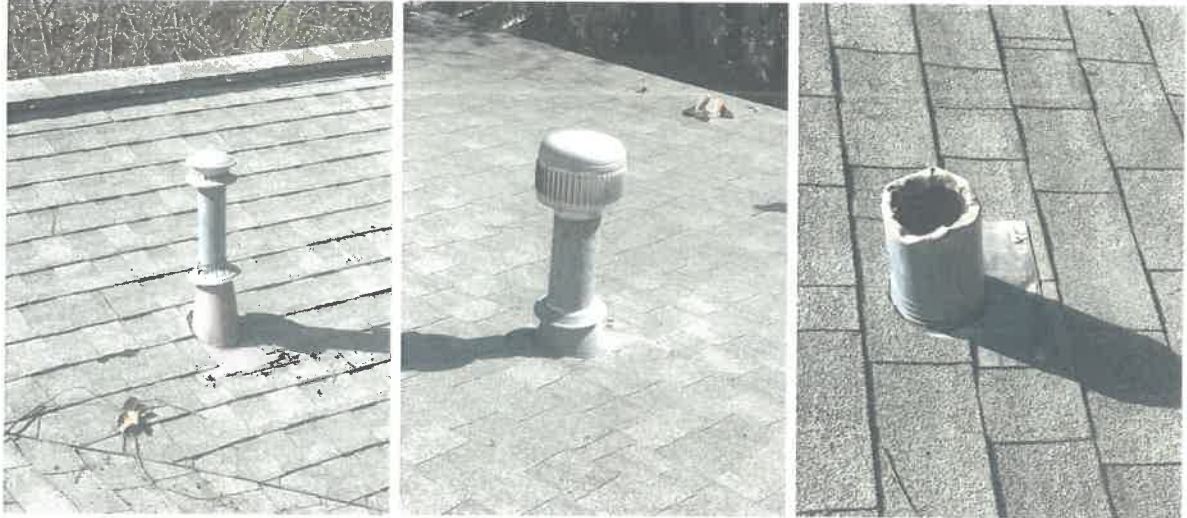
Roof materials were not painted (flashings, roof jacks). This can help extend the life of the flashing material, but also helps maintain a consistent look with other roofing materials. Remedy as needed.

Recommendation: Contact a qualified roofing professional.

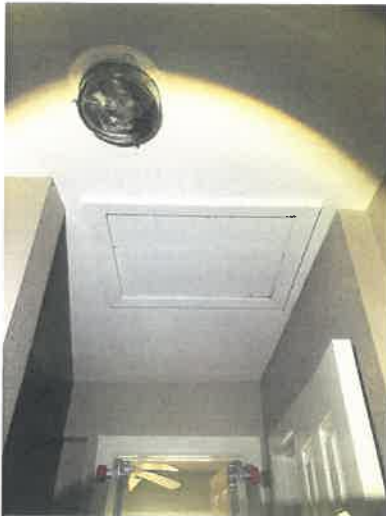
No access to the attic area:

This area was inaccessible at the time of inspection. If you are interested in having this area inspected, please contact our office about a follow-up inspection.

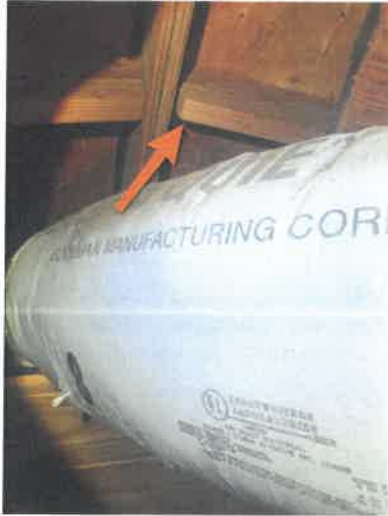
Rafters were not bearing fully on the ridge board. Further evaluation is recommended.

Recommendation: Contact a qualified professional.

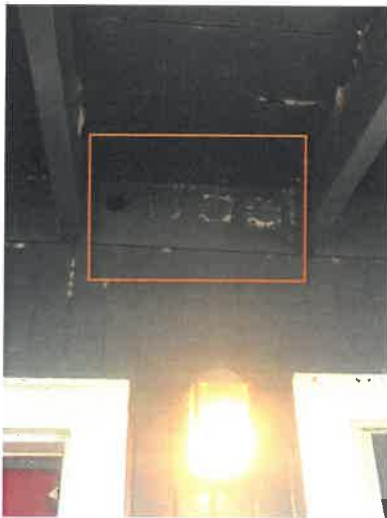
2: Venting: Damaged Soffit Vent Screens

One or more soffit vent screens were damaged at the time of inspection. Evaluation and remediation by a qualified professional is recommended.

Recommendation: Contact a qualified roofing professional.

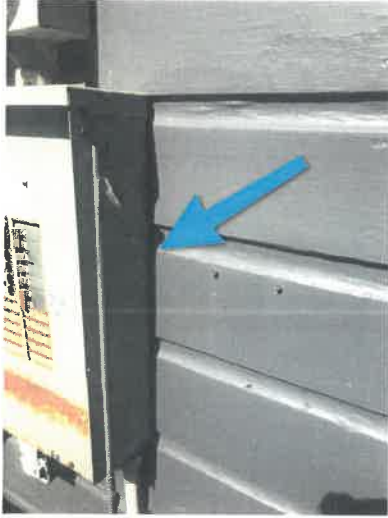
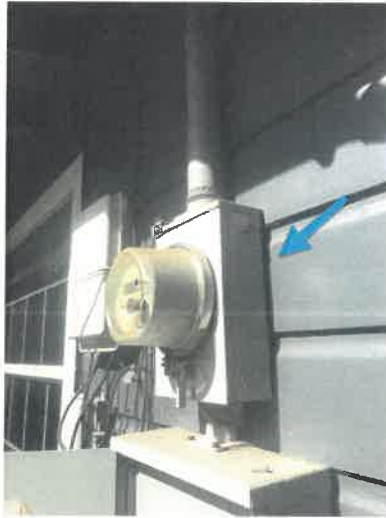
1: Exterior: Seal Wall Fixtures

Note: Modern building practices recommend sealing around components that are mounted on or pass through the exterior wall to limit moisture intrusion.

Recommendation: Recommended DIY Project

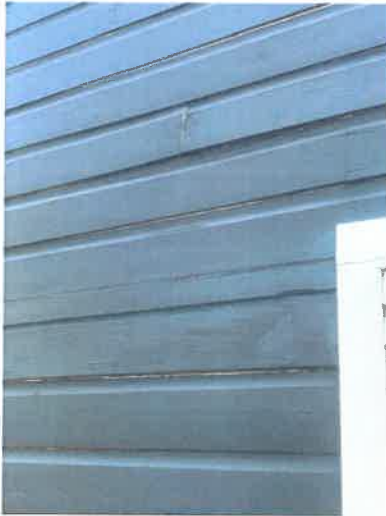
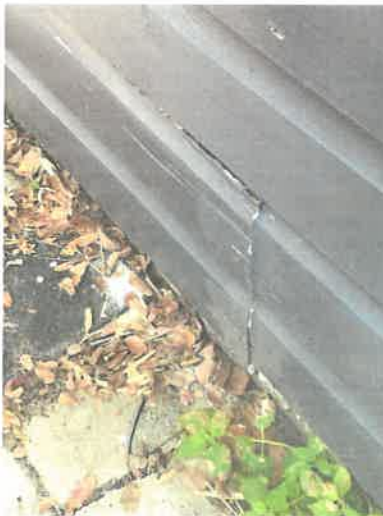
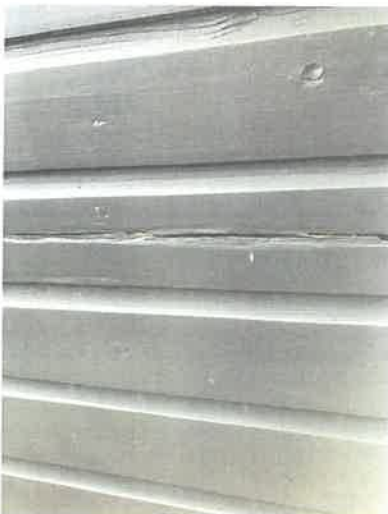
2: Exterior- Siding: Siding Damage

There was damage to exterior siding.

Recommendation: Contact a qualified professional.

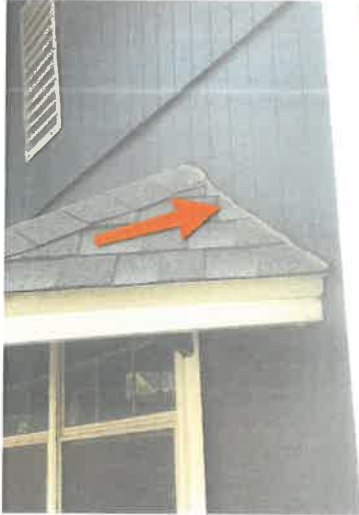
The siding does not adequately clear the roof surface. Installation guidelines generally require 1-2 inches of clearance between the siding and the roof covering. Evaluate and remedy as needed.

Recommendation: Contact a qualified professional.

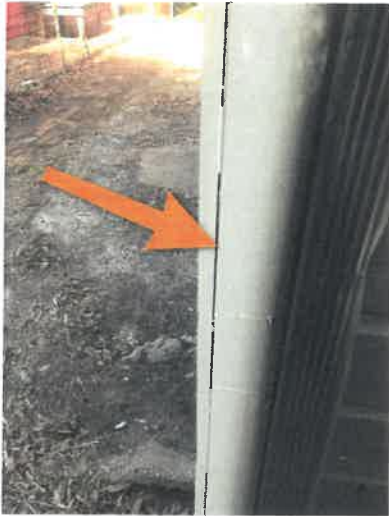
4: Exterior- Caulking: Deteriorated/Missing

Caulking around siding or trim was deteriorated or missing.

Recommendation: Contact a qualified professional.

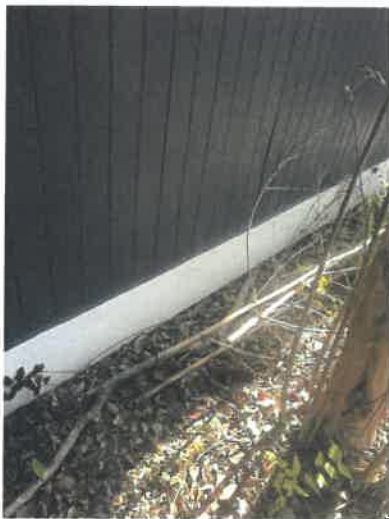
Siding should be a minimum of 6 inches above finished grade. Brick and stone should be a minimum of 4" above grade. Remedy as needed.

Recommendation: Contact a qualified professional.

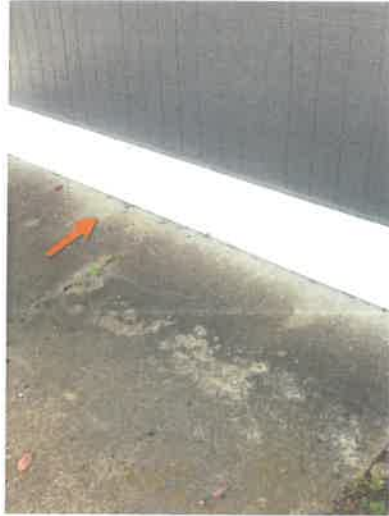
8: Exterior: High Soil

A high soil level was observed. The foundation should have at least 4 inches of exposure. Remedy as needed.

Recommendation: Contact a qualified landscaping contractor

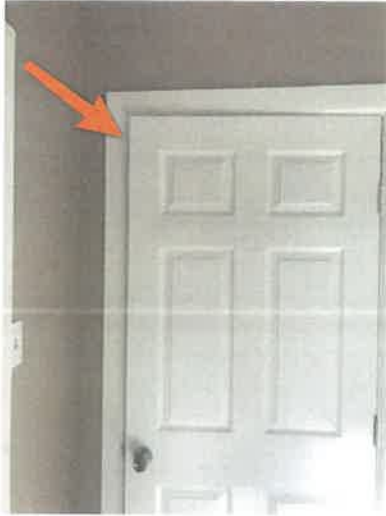
3: Door: Noticeable Gap at Frame

Gaps were observed between the door and frame, which could result in energy loss. Evaluate and remedy as needed.

Recommendation: Contact a qualified door repair/installation contractor.

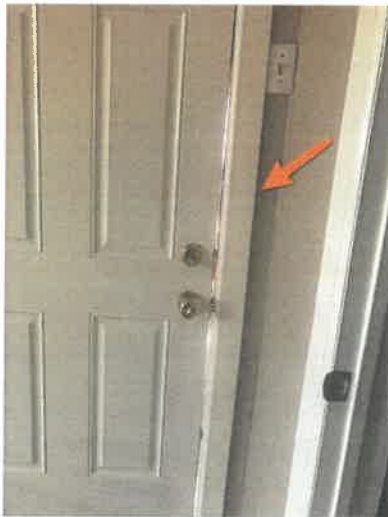
4: Doors: Closet Door Off Track

Evaluate and remedy as needed.

Recommendation: Contact a handyman or DIY project

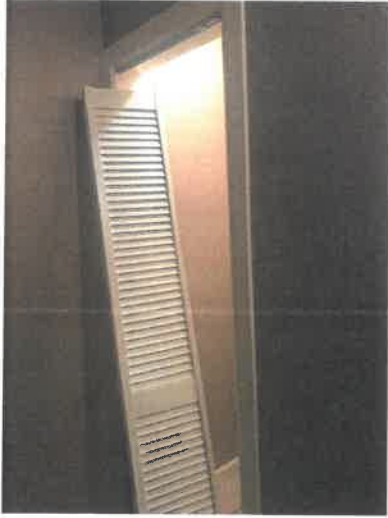
5: Door Hardware: Missing/Damaged Hardware

One or more door had missing or damaged hardware. Evaluation and remediation is recommended.

Recommendation: Recommended DIY Project

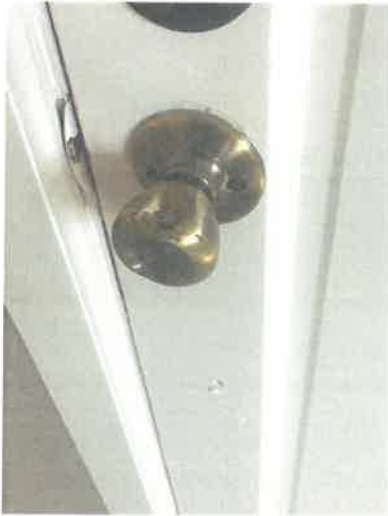
6: Door Hardware: Missing Doorstops

One or more missing doorstops were observed. Replace any missing doorstops to prevent damage to the drywall.

Recommendation: Recommended DIY Project

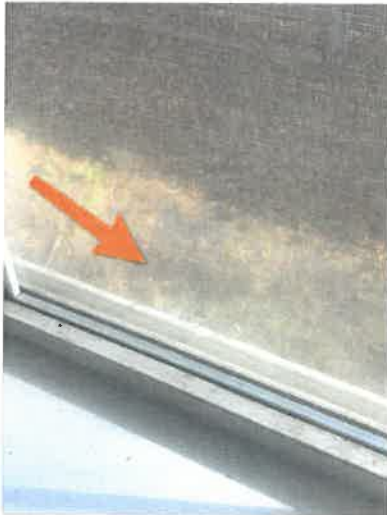
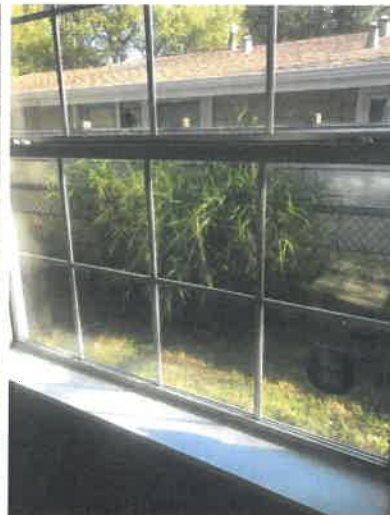
2: Cracked/Broken Glass Panes

Cracked or broken glass panes were present. Remedy as needed.

Recommendation: Contact a qualified window repair/installation contractor.

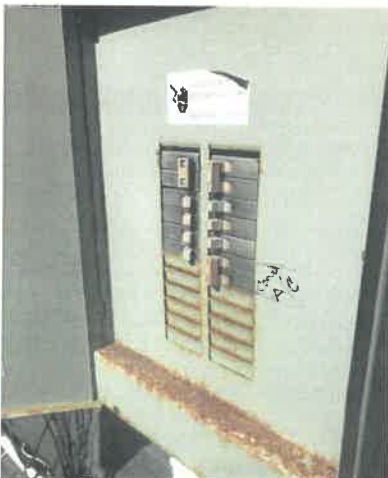
1: Circuits Not Labeled

Circuits in the distribution panel were not properly labeled. Remedy as needed.

Recommendation: Contact a qualified electrical contractor.

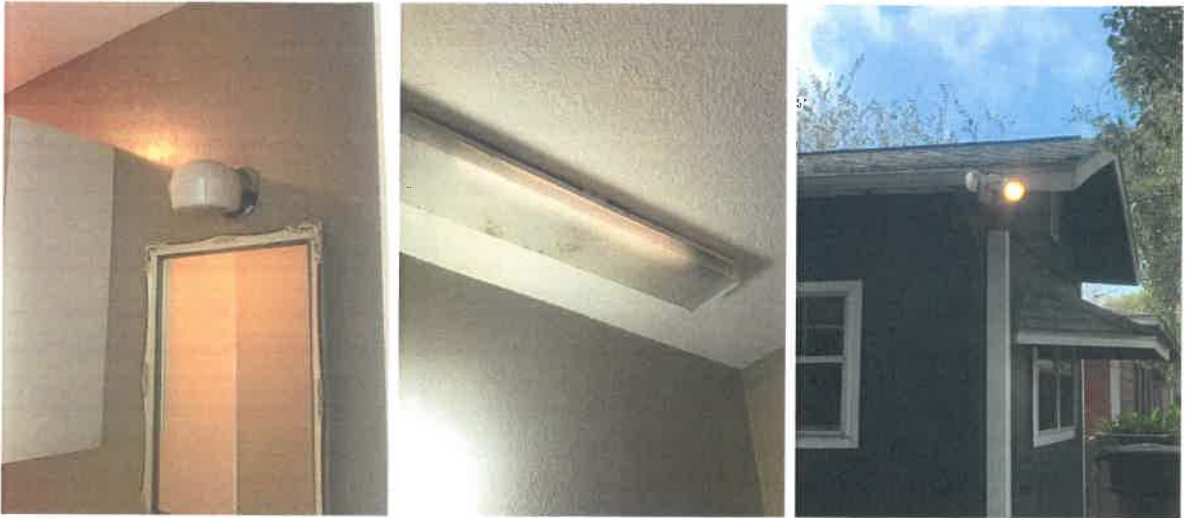
9: Light: Globe Damaged/Missing

Missing/damaged light globe was observed. Remedy as needed.

Recommendation: Recommended DIY Project

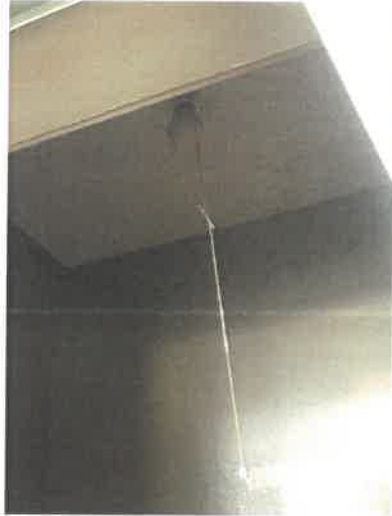
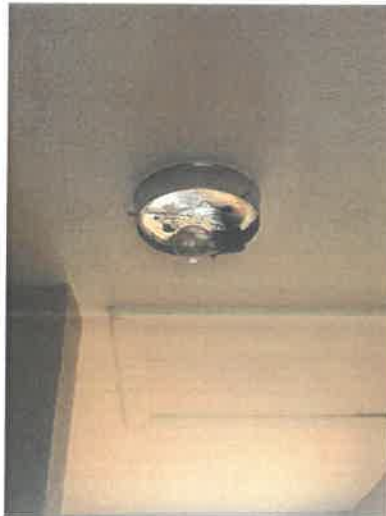
10: Wiring: Exposed Ends & Splices

Exposed wire connections, splices, and ends were present. All wire connections and charged wires with exposed ends and splices should be covered in junction boxes for safety. Evaluation and/or remediation by a licensed electrician is recommended.

Recommendation: Contact a qualified electrical contractor.

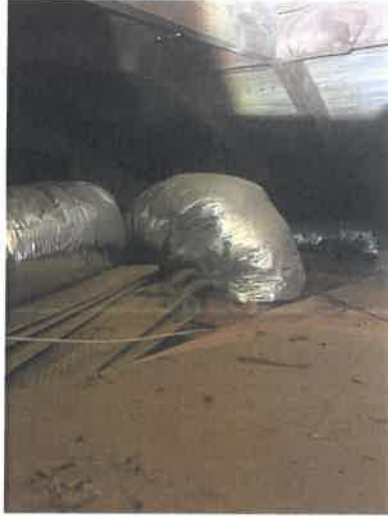
2: Ducts: Ducts resting on each other.

Ducts were resting on each other. This can result in condensation forming between the two sections of ductwork. Remedy as needed.

Recommendation: Contact a qualified professional.

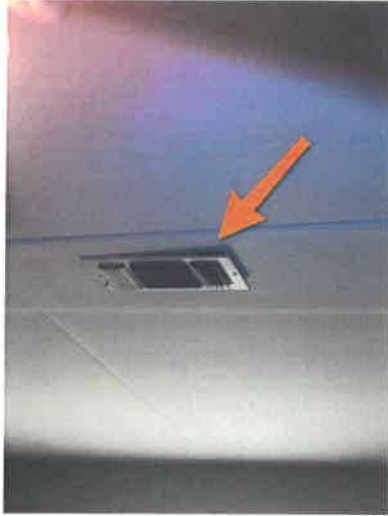
4: Visible substance observed on Supply Register

A dark substance was observed on an air supply register in the home. Servicing and cleaning of the system by a qualified HVAC contractor is recommended, as this can be a result of excessive water vapor/humidity in the conditioned air.

Recommendation: Contact a qualified HVAC professional.

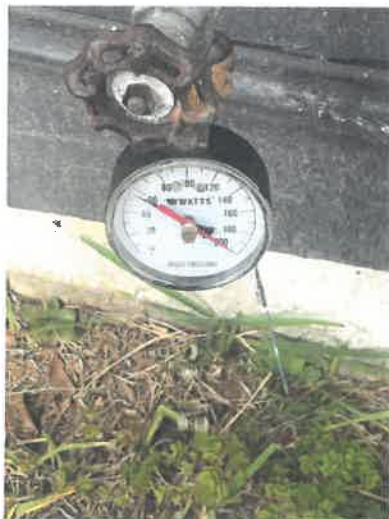
1: Hose bibb (outdoor faucet): Backflow Prevention Missing

A hose bibb was missing a backflow preventer. These devices are inexpensive and easily installed, and help to prevent contamination of potable water. Remedy as needed.

Recommendation: Contact a handyman or DIY project

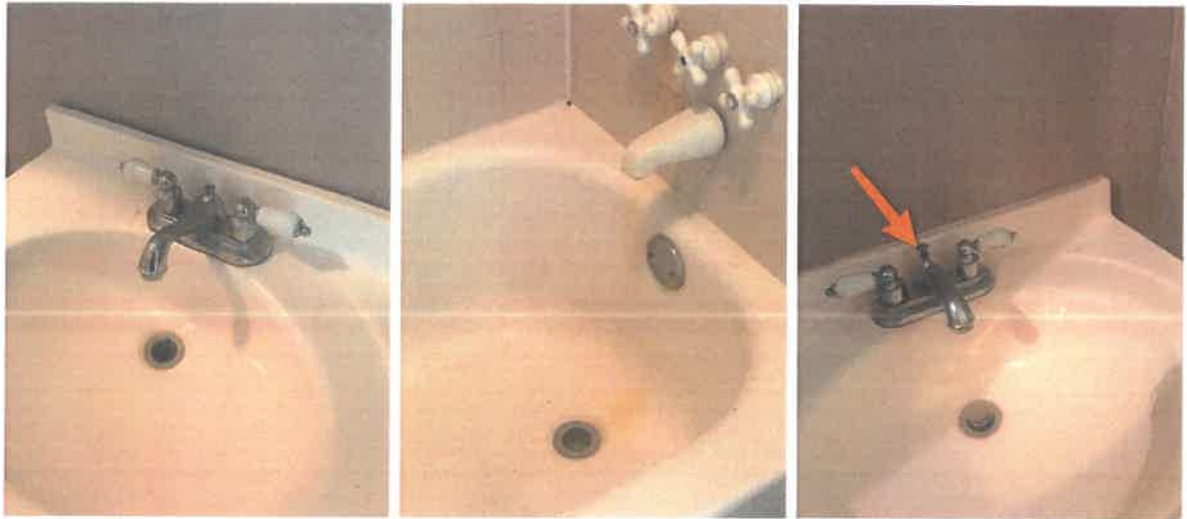
3: Fixtures: Stem Leaking

The faucet stem leaked when operated. Remedy as needed.

Recommendation: Contact a qualified plumbing contractor.

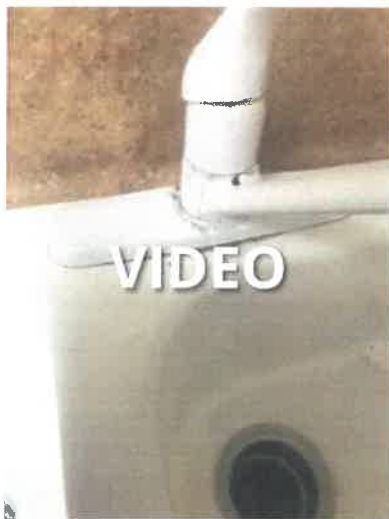
4: Fixtures: Not Sealed at Wall

Recommendation: Contact a handyman or DIY project

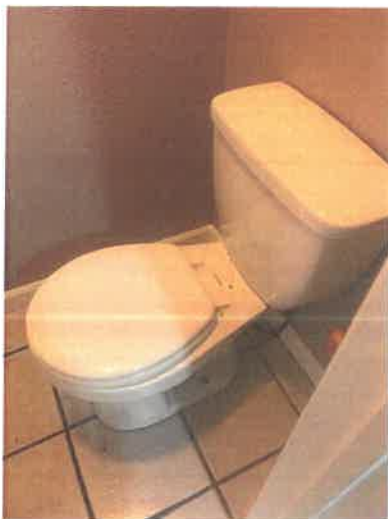
7: Toilet: Caulk needed at base

The toilet base was not caulked at the floor. Remedy as needed.

Recommendation: Contact a handyman or DIY project

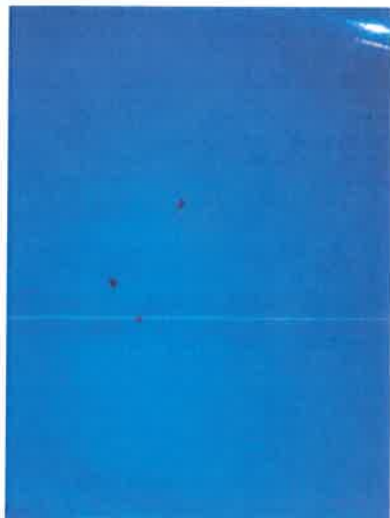
9: Tub: Rust at overflow (not leaking)

Rust was observed at back of tub around overflow drain, but no leaks were observed. Monitor for future leaks or consult a plumber if further evaluation is desired.

Recommendation: Recommend monitoring.

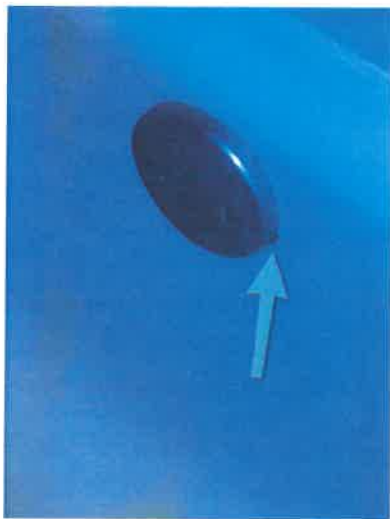
10: Sink: Surface Defects

Surface defects in one or more sinks were present at the time of inspection. Evaluate and remedy as needed.

Recommendation: Contact a qualified professional.

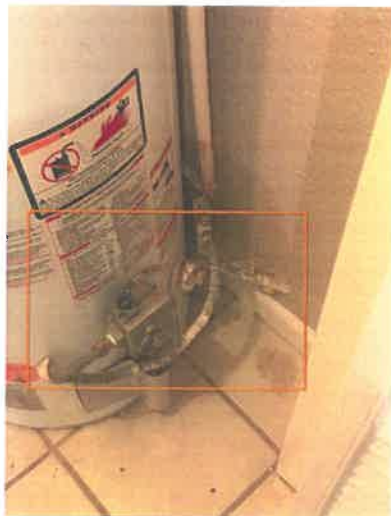
4: Tank: Missing Drain Pan

Recommendation: Contact a qualified professional.

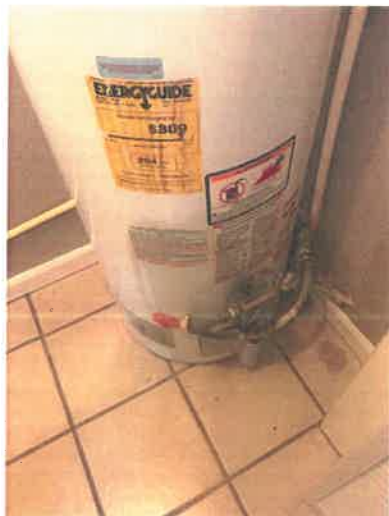
5: Tank: Not 18 inches above floor

The water heater was not raised at least 18-inches above floor for safety. Remedy as needed.

Recommendation: Contact a qualified professional.

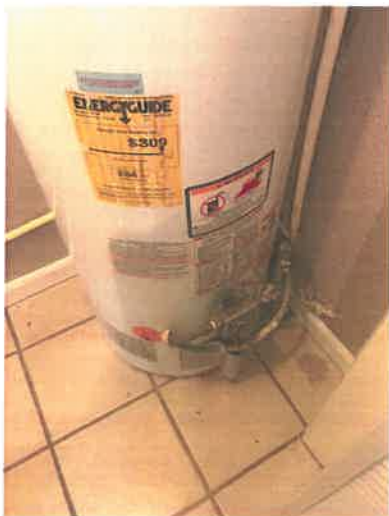
6: TPR Valve Note: Replacement may be needed

The manufacturer recommends replacement of the pressure relief valve every three years to ensure proper emergency function. The inspector does not test TPR valves due to safety hazard or possible damage to unit.

Recommendation: Contact a qualified professional.

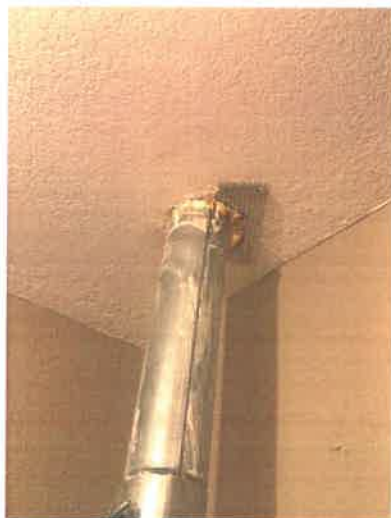
7: Venting system: Missing/loose ceiling collar

The collar was missing/loose where the flue passes through the ceiling. Remedy as needed.

Recommendation: Contact a qualified professional.

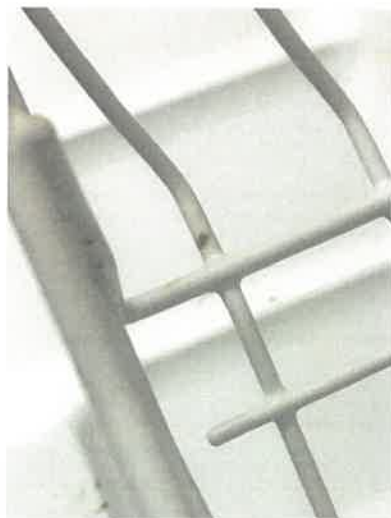
2: Rusted Dish Racks

There is evidence of rust on dishwasher racks. Evaluate and remedy as needed.

Recommendation: Contact a qualified professional.

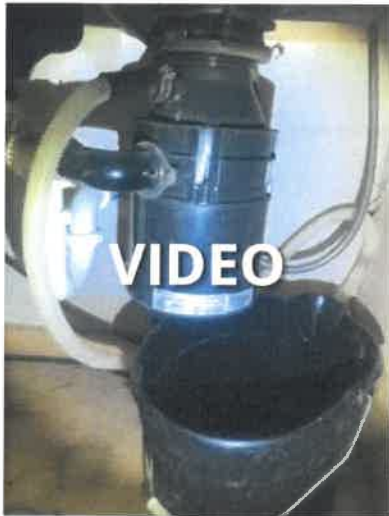
2: Leaking

The disposal leaked at the time of inspection. Evaluate and remedy as needed.

Recommendation: Contact a qualified plumbing contractor.

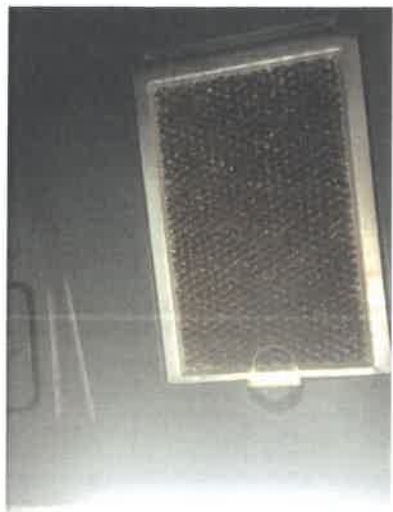
Kitchen exhaust filter had excessive grease build-up. Clean and/or replace as needed.

Recommendation: Contact a qualified professional.

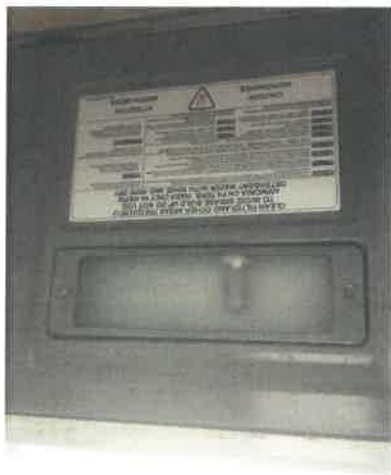
2: Exhaust Light Out

The light did not function at the kitchen exhaust. This may be the result of a bad bulb. Replace and test or remedy as needed.

Recommendation: Contact a qualified professional.

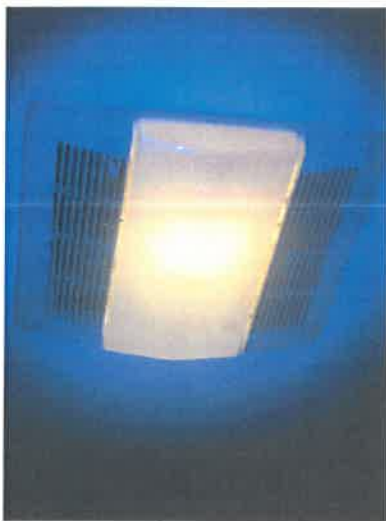
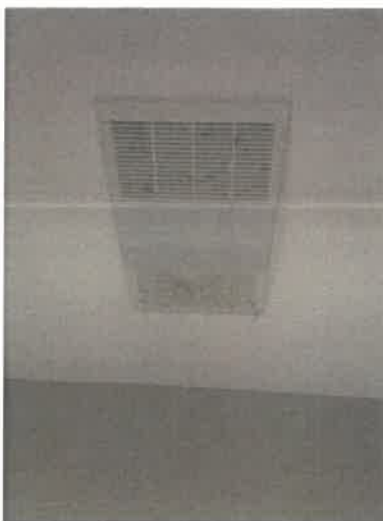
Cleaning of the exhaust vent cover is needed to ensure unrestricted air flow.

Recommendation: Contact a qualified professional.

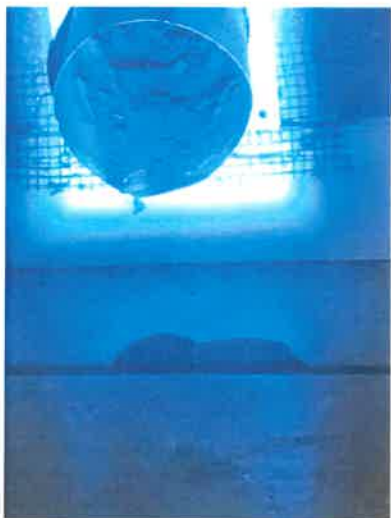
1: Cleaning Vent Recommended

Cleaning of the dryer exhaust vent is recommended as normal maintenance and to prevent excessive lint build-up in the line.

Recommendation: Contact a qualified professional.
