**A Town Home Inspection Report On
11568 S. Kirkwood, Stafford, TX
Sold by Sandra McClusky, Listed By**

Monday, January 27, 2020

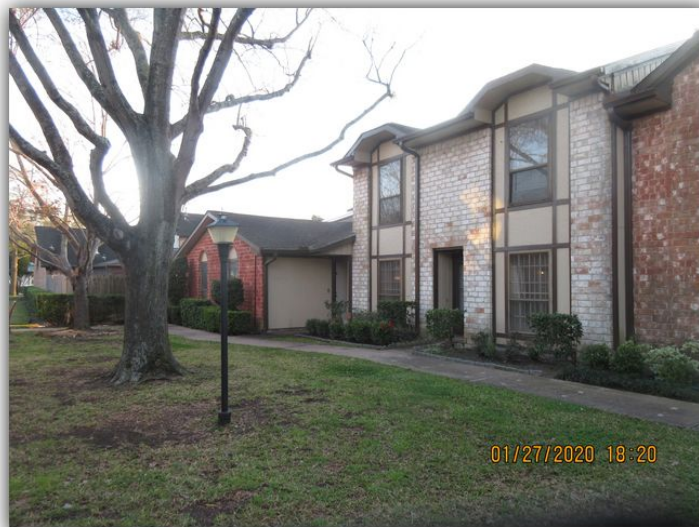
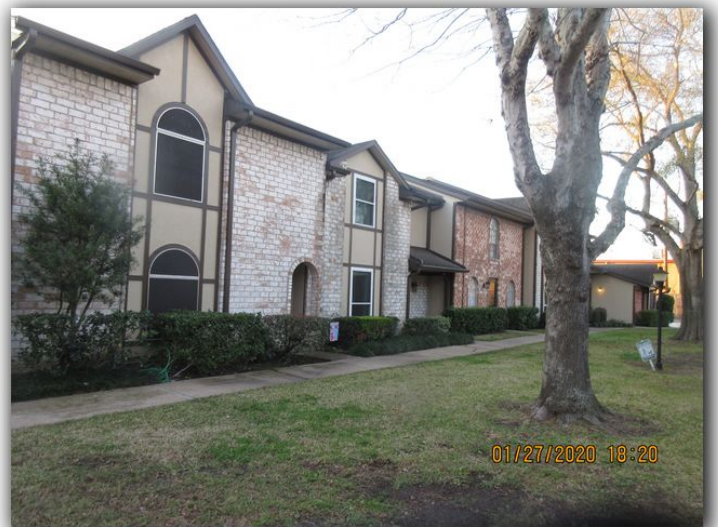
11. Subject property is a two story town home in condominium.

12. Town home has a slab on grade type of foundation

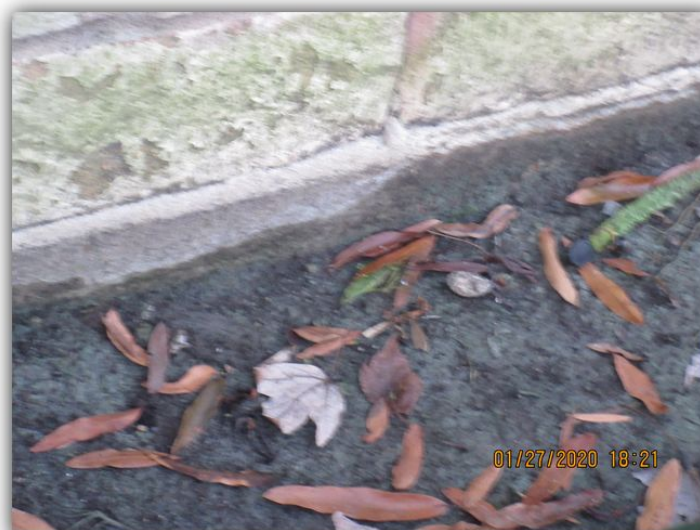
24. Various points around the perimeter beam of the foundation the soil is too high, it must be at least six inches from the ground to avoid water intrusion and/or pest infestation.

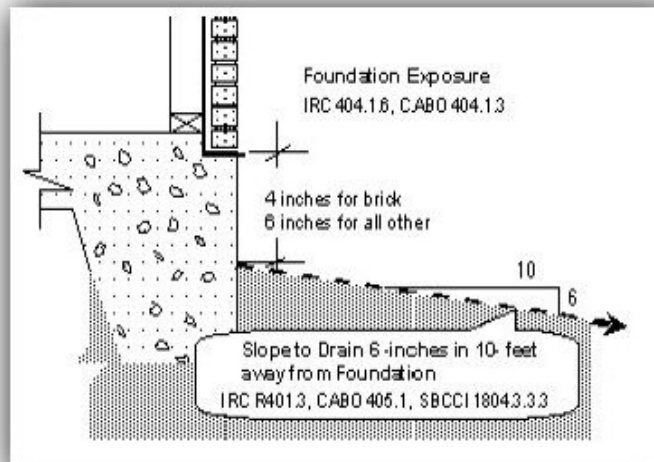
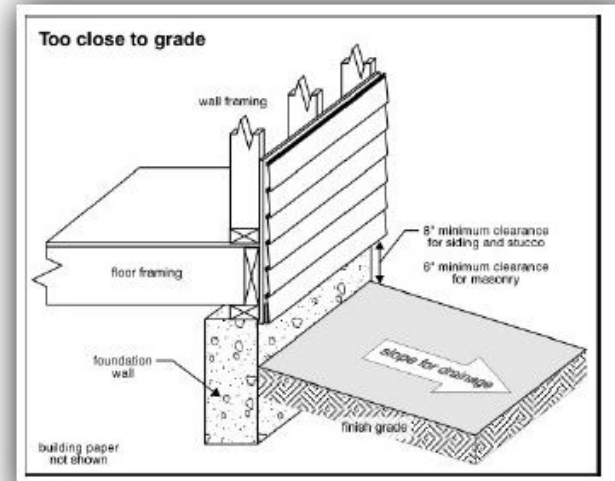
25. Note: Any area where the ground or grade does not slope away from the structure is to be considered an area of improper drainage. Six inches per 10 feet.

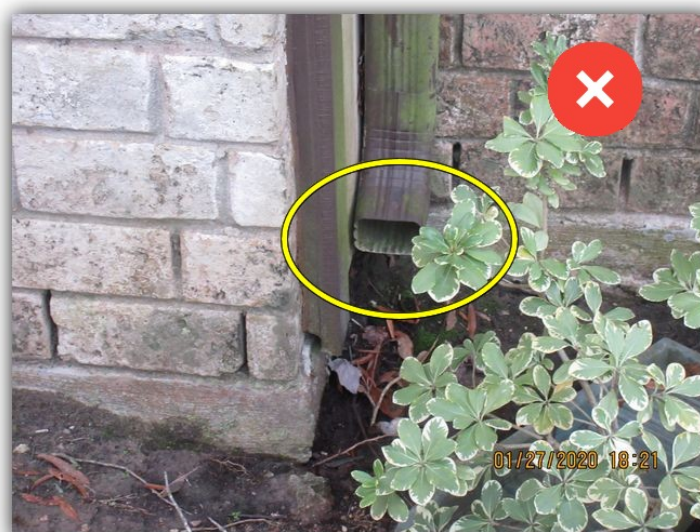
27. Front down spout terminates next to the foundation and is too close to the sidewalk, thus a "flex pipe" must be installed that goes under the sidewalk and terminates to the front yard for proper drainage towards the street as required by code.

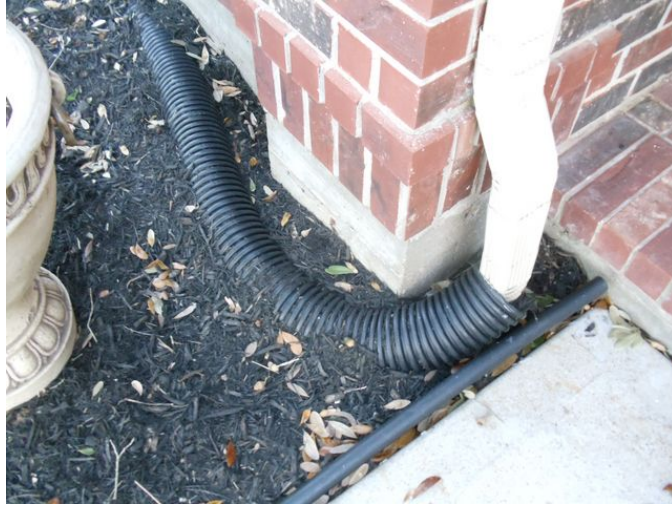
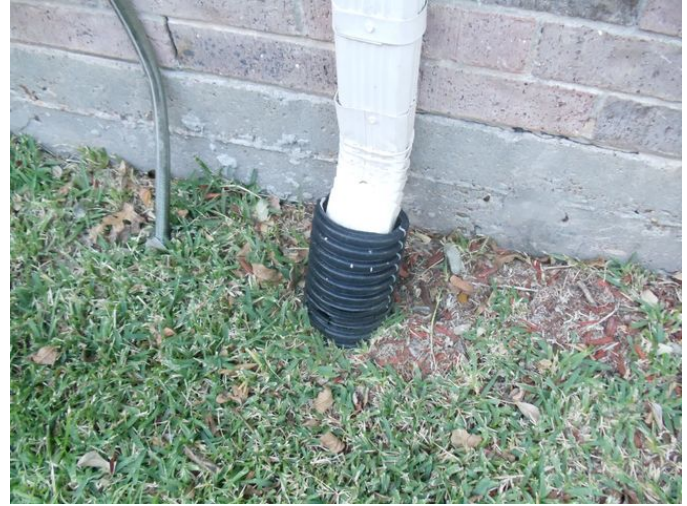
28. Ponding noted at several points around the foundation or near the foundation all low spots should be filled, compacted and caused to drain away from the foundation to avoid future foundation settlement issues.

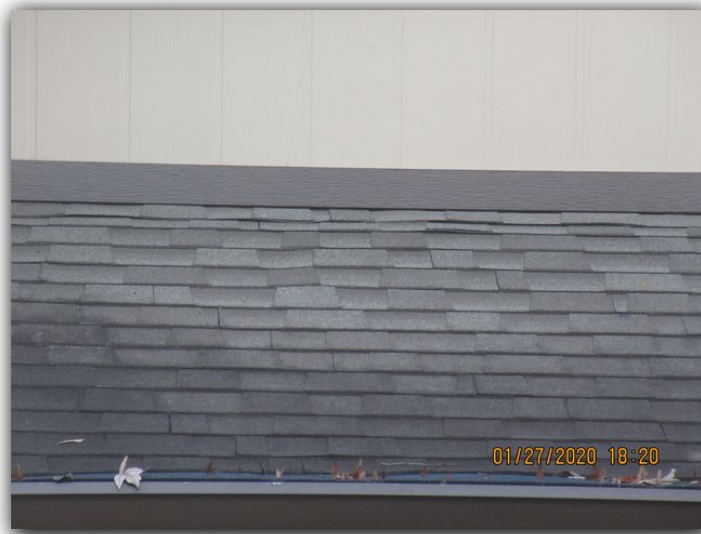
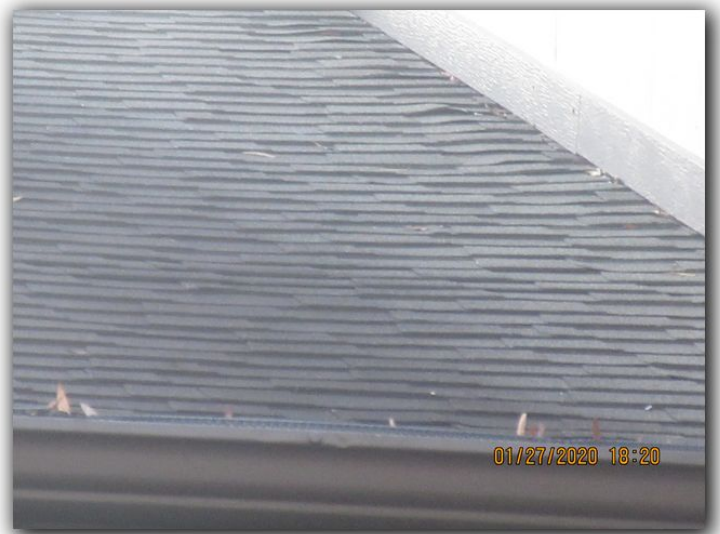
2. The subject property has a common roof covering.

3. Buyer is encouraged to investigate with the town home association management company to request the history of the roof covering, age, and if there are plans to replace the roof covering in the near future and how it may affect the common area maintenance fee on the subject property.

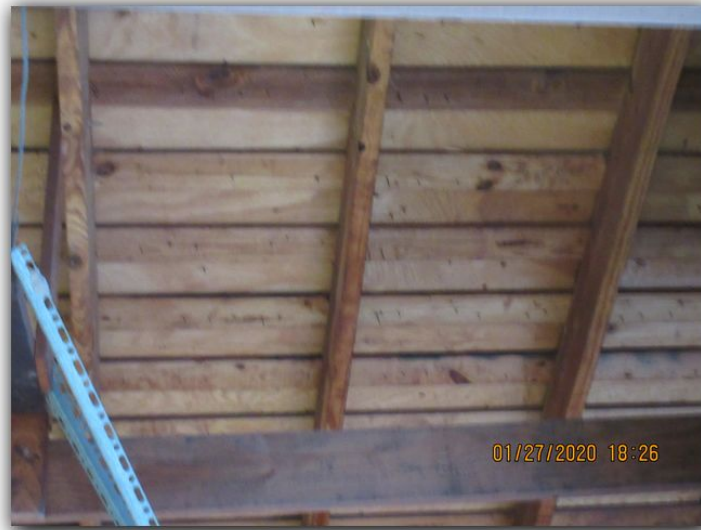
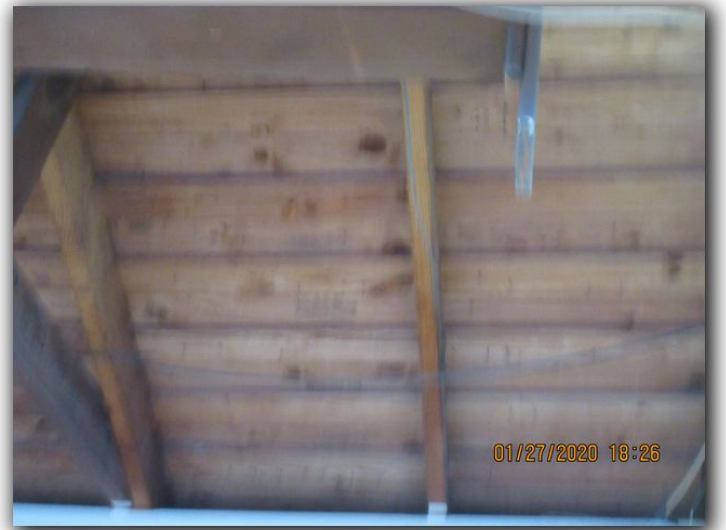
- The home has a laminated composition roof shingle covering over wood decking on slats.

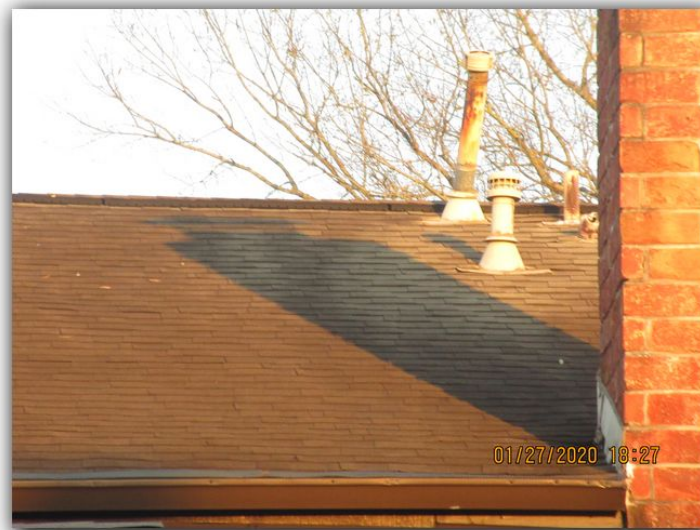
- Shingles were not raised to count the nail order, it damages the shingle glue tab adhesion which is designed for only one seal.
- The buyer was told that the roof covering is going to be replaced soon and that funds are available in the association escrow account.

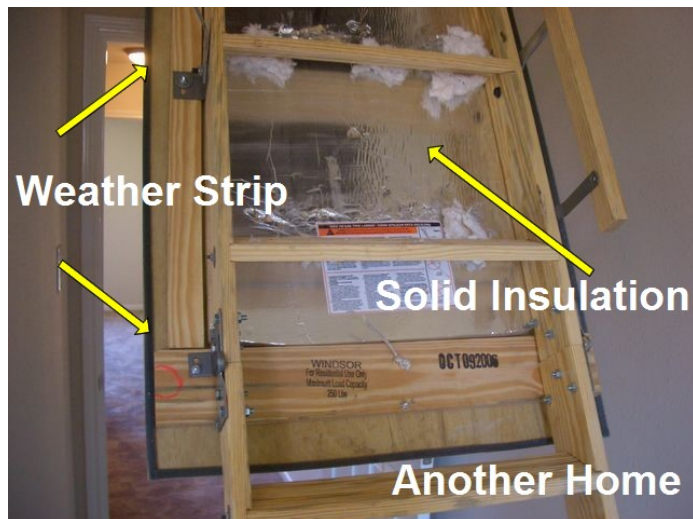
Subject property on the right and it is correct on the left side

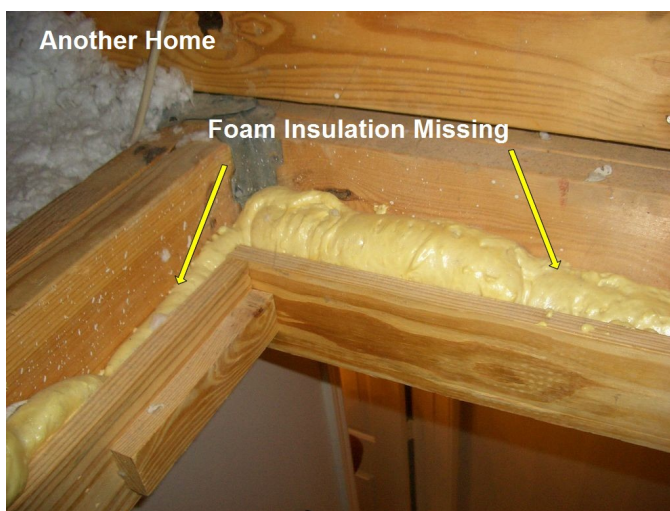
14. Missing foam insulation at the perimeter of the attic ladder frame as per code.
15. N1102.1.10 Air leakage. All joints, seams, penetrations, window and door assemblies and their respective jambs and framing; and other sources of air leakage (infiltration and exfiltration) through the building thermal envelope shall be caulked, gasketed, weather stripped, wrapped, or otherwise sealed to limit uncontrolled air movement (see photo below)

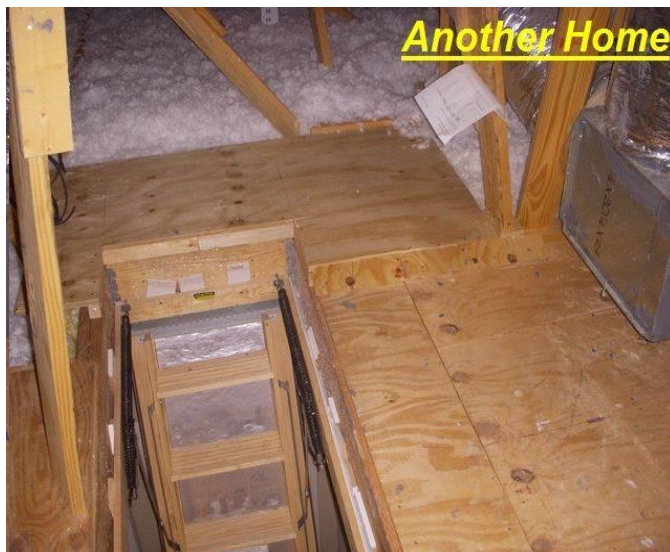
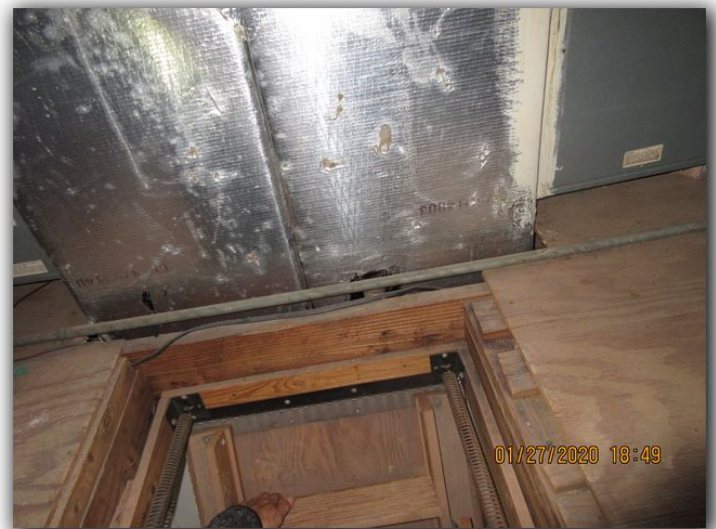
16. Missing a clear landing at the top of the stairs as required by code.

17. **R312.1.1 Landings for stairways.** There shall be a floor or landing at the top and bottom of each stairway.

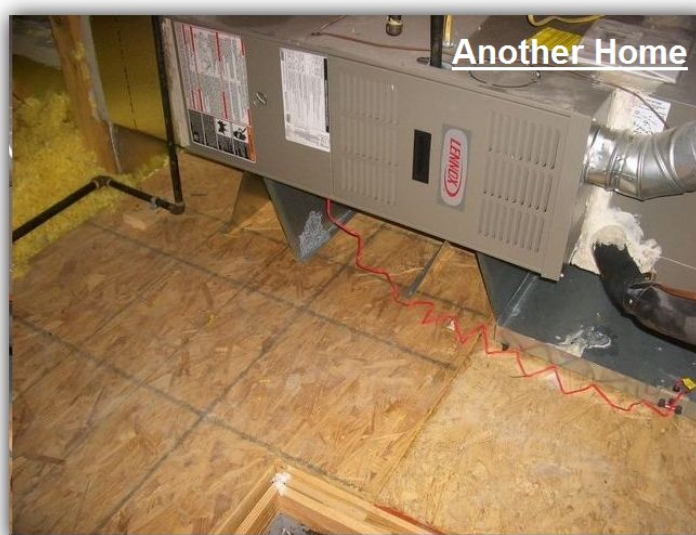
18. Improper decking methods, attic decking must be solid plywood with no obstructions in front of the furnace as per code and as seen on the left lower photo below.

19. One of the furnaces is installed backwards and has no work space.

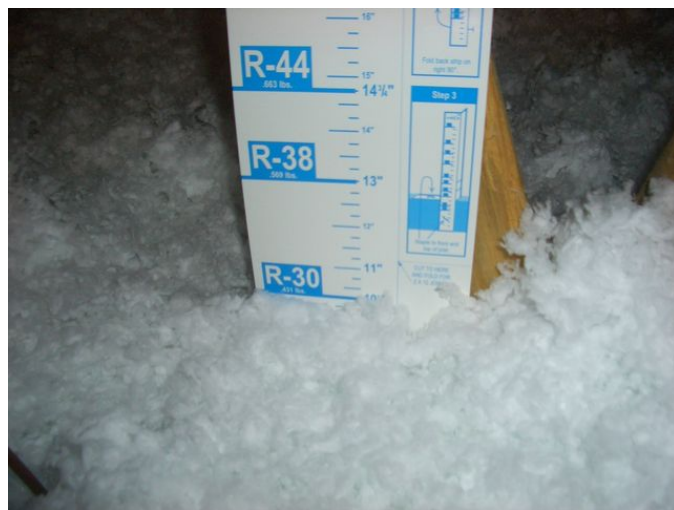
22. The insulation meets code R-38 or at least ten inches as per code.

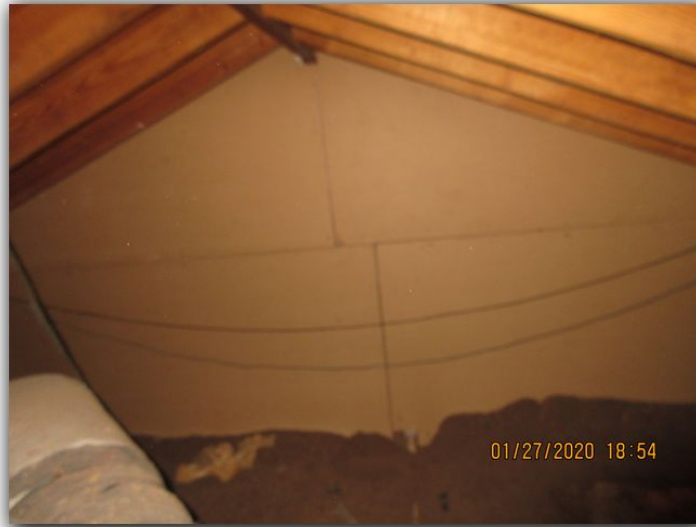
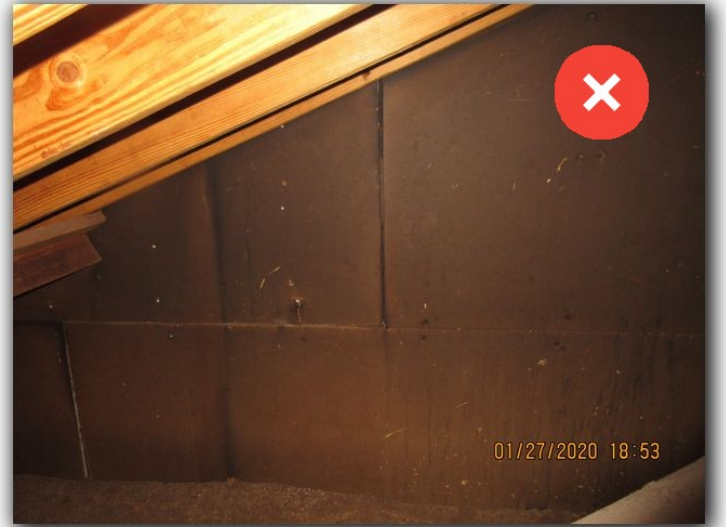
23. Missing a proper firewall between the units in the attic as required by code.

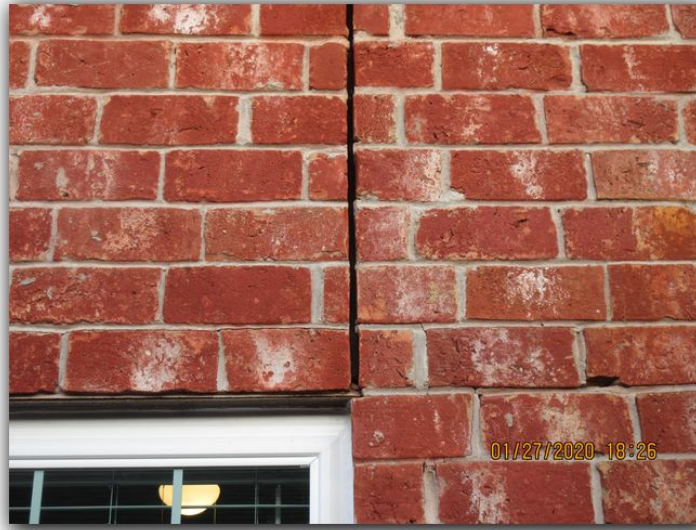
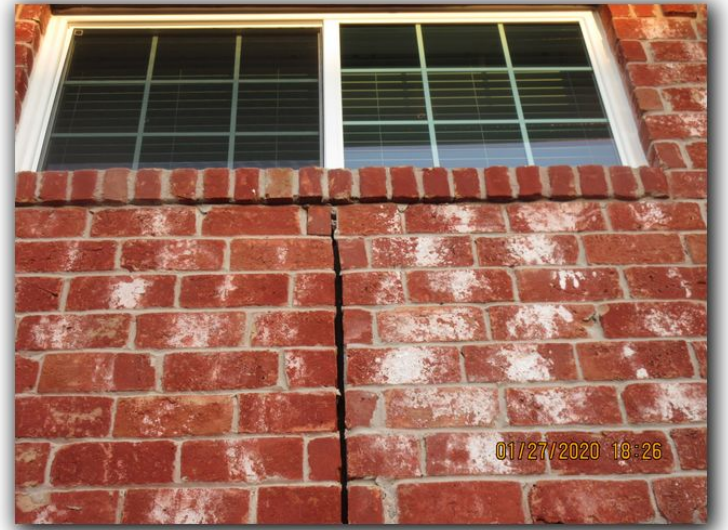
36. The siding is in generally good condition.

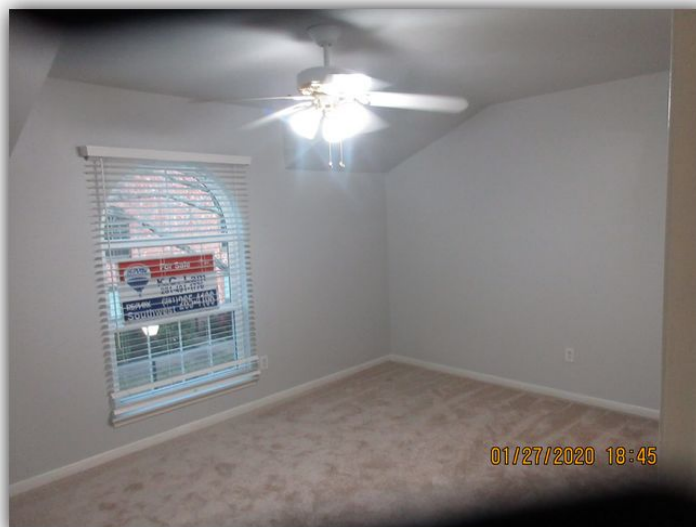
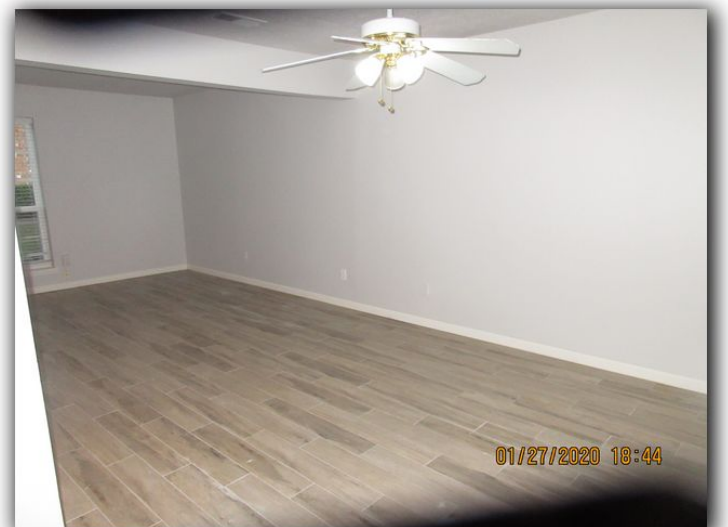
38. The interior walls have no significant deficiencies

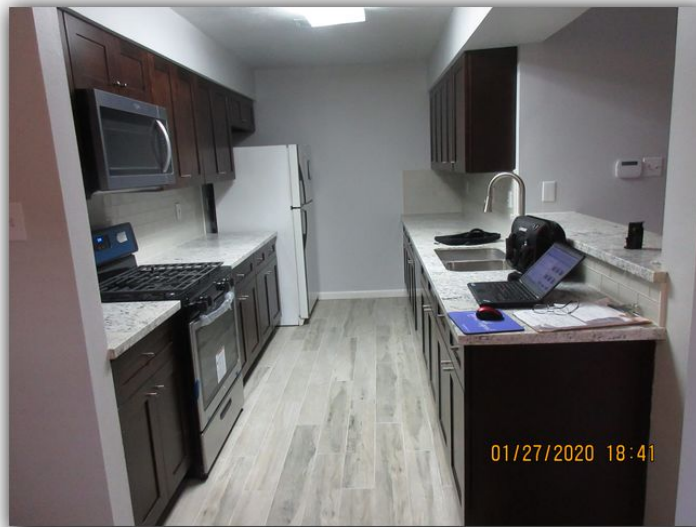
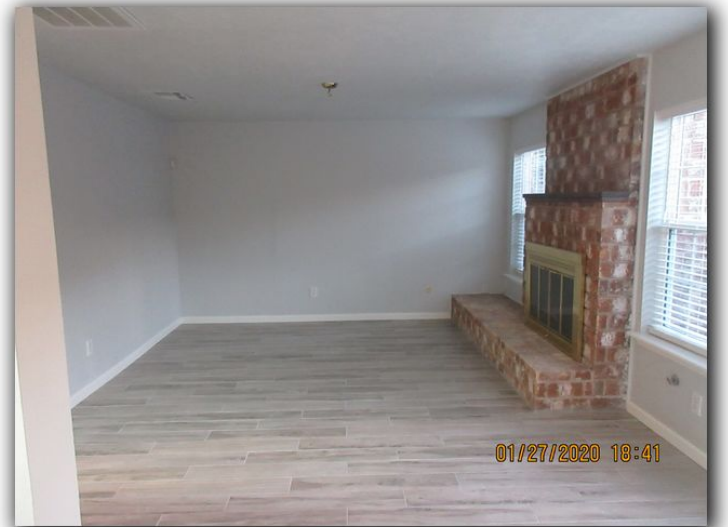
41. Floor coverings are made up of carpet, a type of what appears to be wood flooring but may be porcelain or ceramic, but it is in new and in good conditions.

42. The flooring in the kitchen and family room are in good condition.

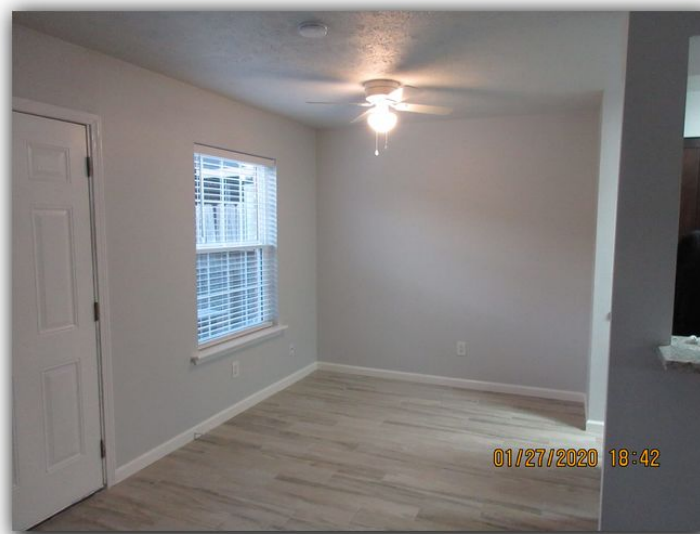
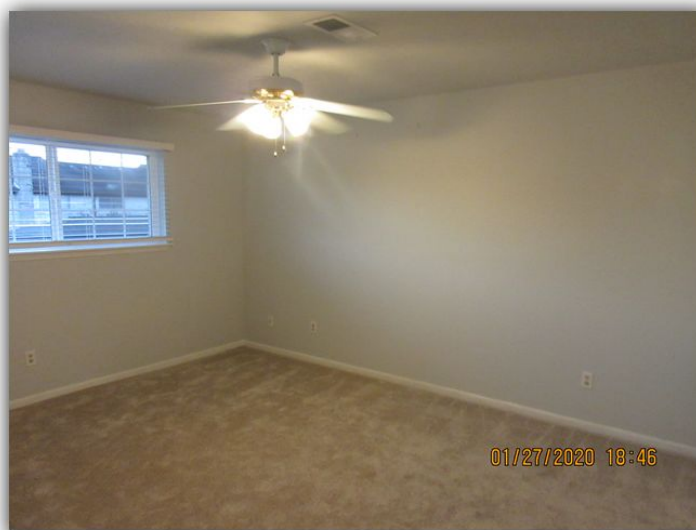
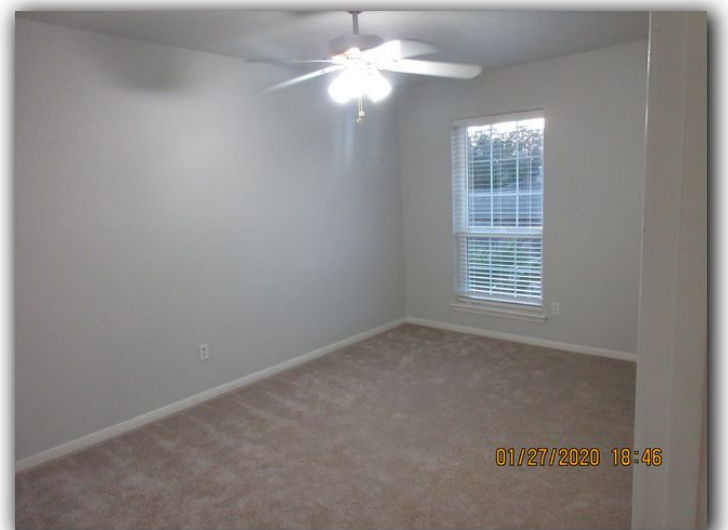
43. The flooring in the bedroom are also in fair condition as viewed at random.

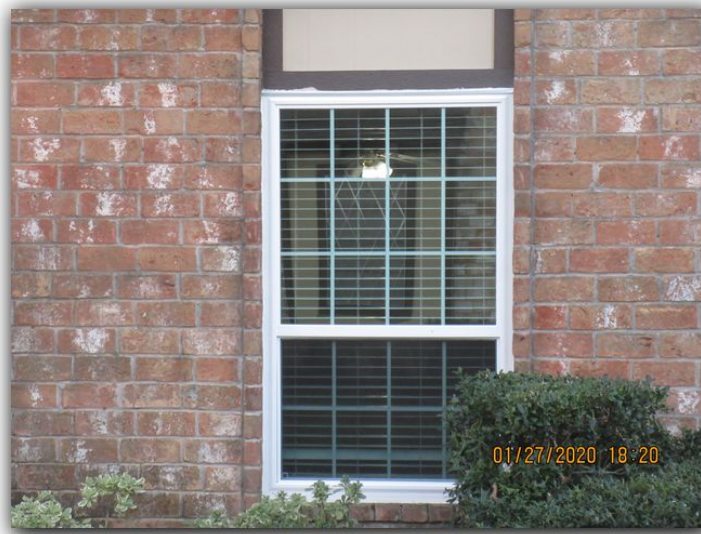
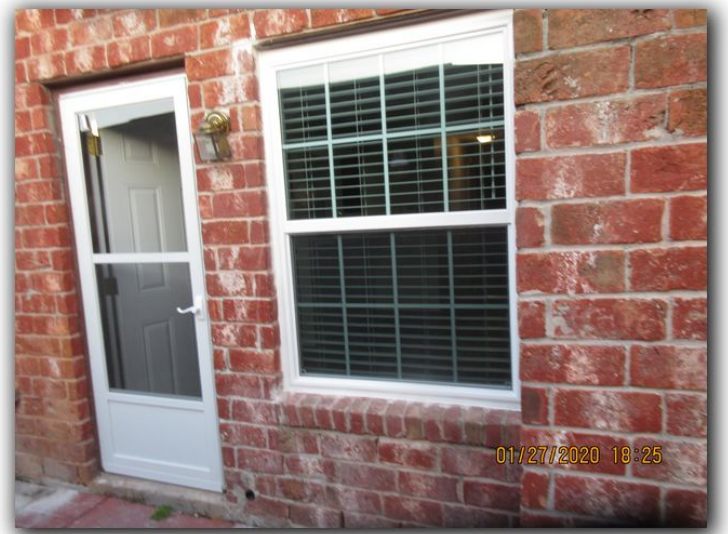
1. Home has windows with double pane and low e that meets code.
2. The windows have been updated.

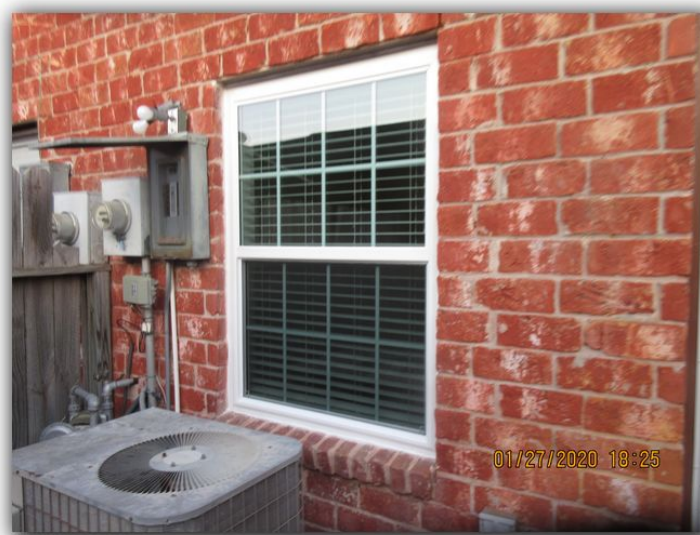
3. Home has window screens as required by code.

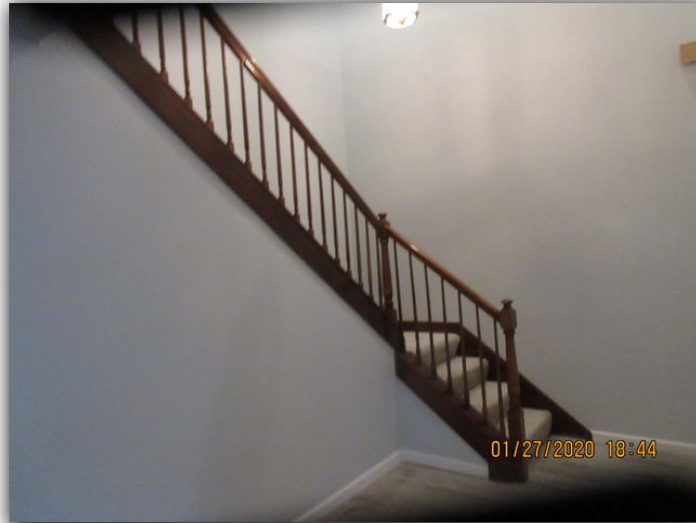
- The home has a stairway that is in good condition.
- The stair way has a proper three way switch, one on the bottom and a second on the top of the stairs as per code.

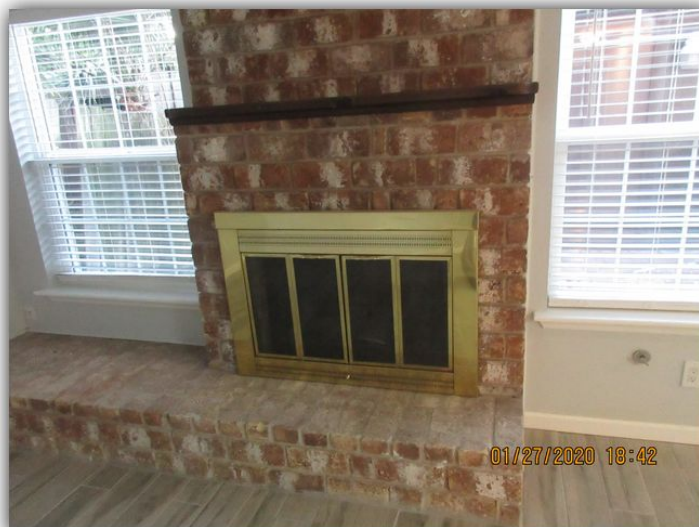
10. Fireplace and chimney must be serviced prior to use.

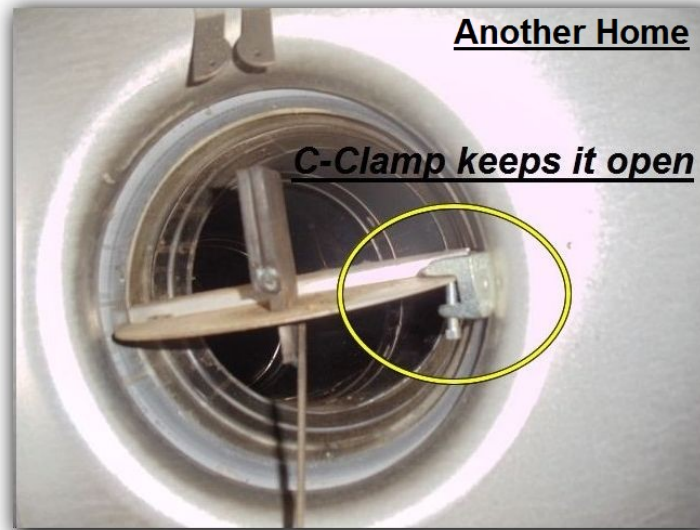
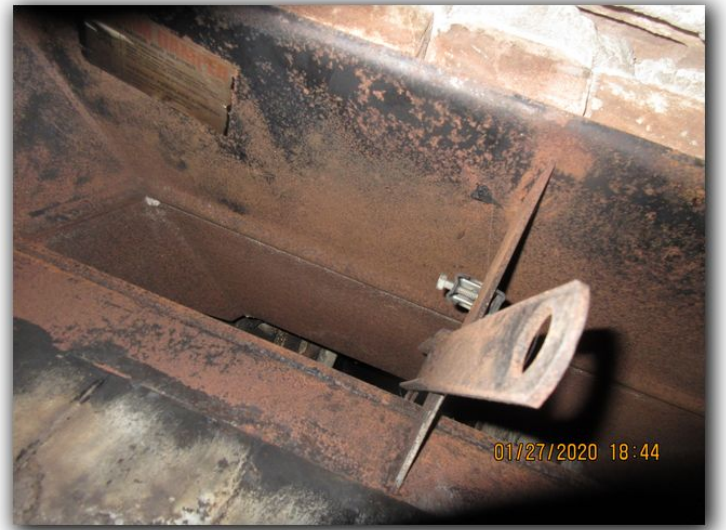
11. Missing a c-clamp, c-clamp on the damper keeps it open for carbon monoxide venting, however when the fireplace is not in use such as in the summer, the vent should be closed.

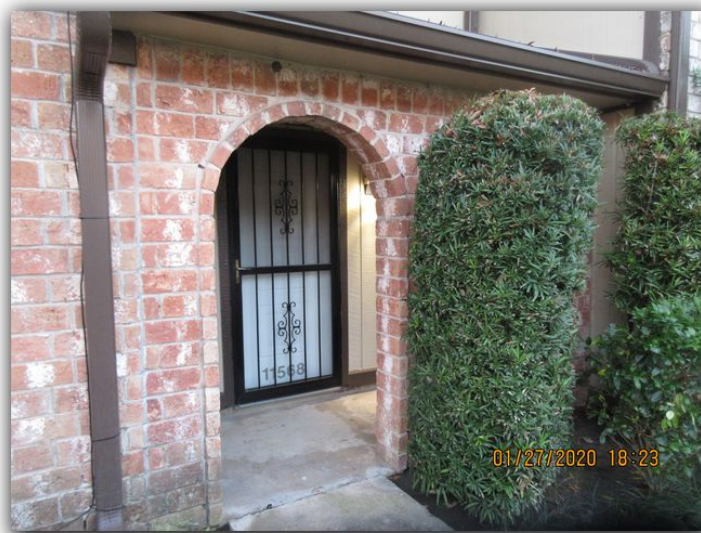
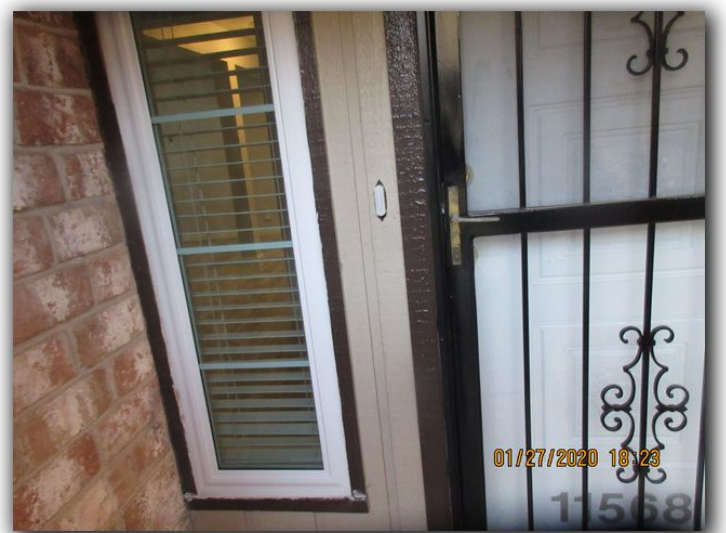
12. The home has a small front porch area.

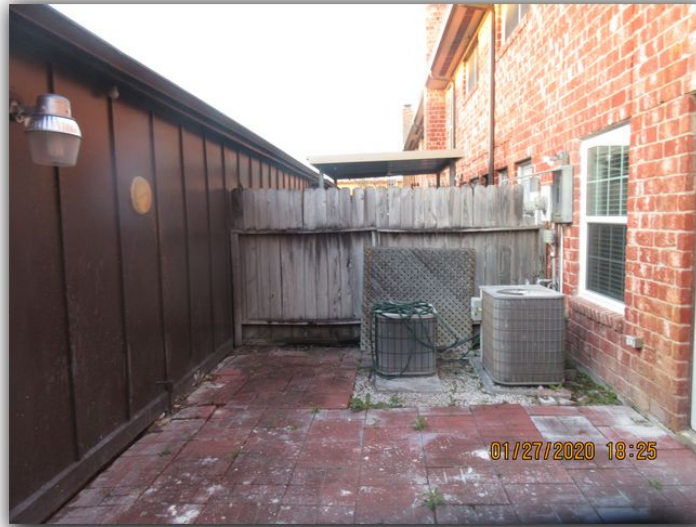
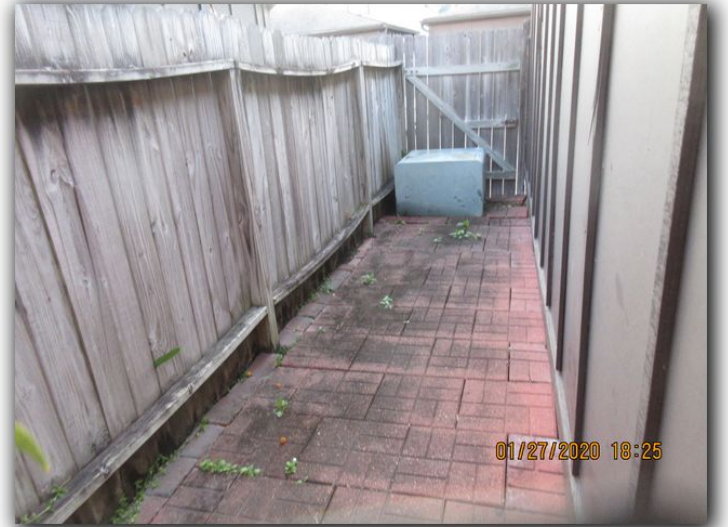
13. Home has a patio between the garage and the home.

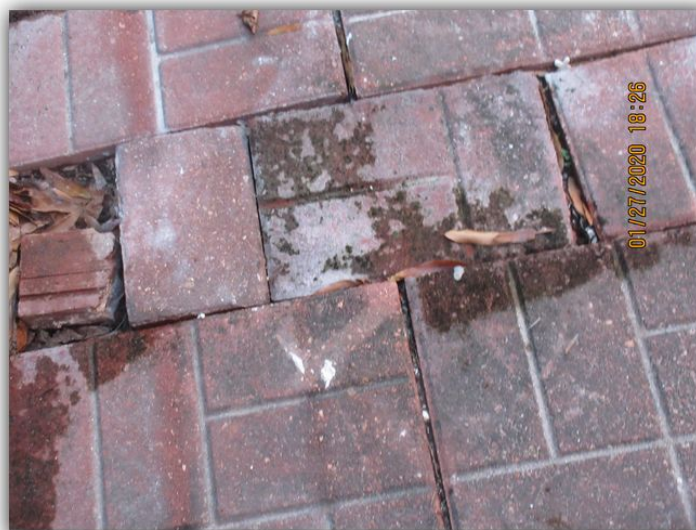
14. The patio has loose pavers and some that are in need of repair, a trip hazard.

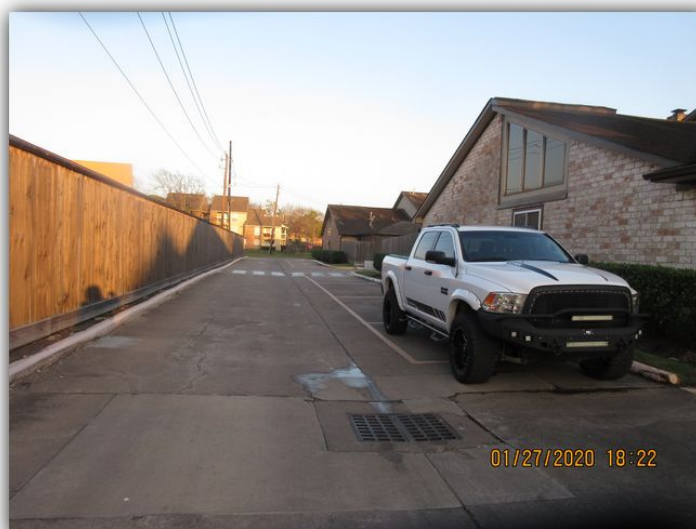
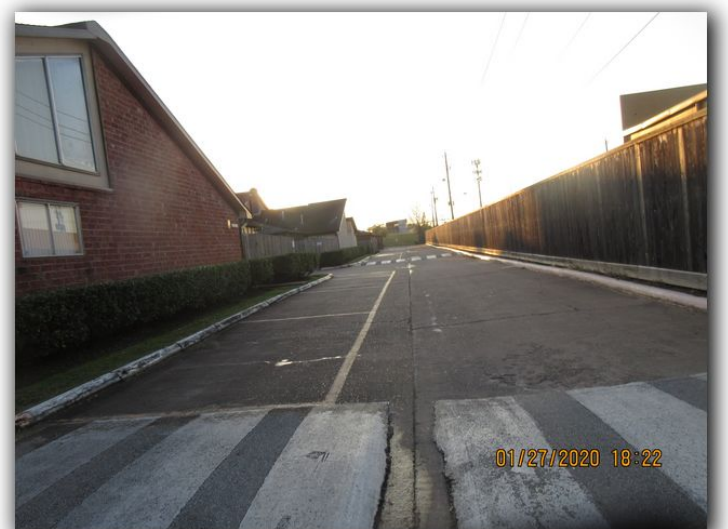
15. The home has paved drives that are in good condition.

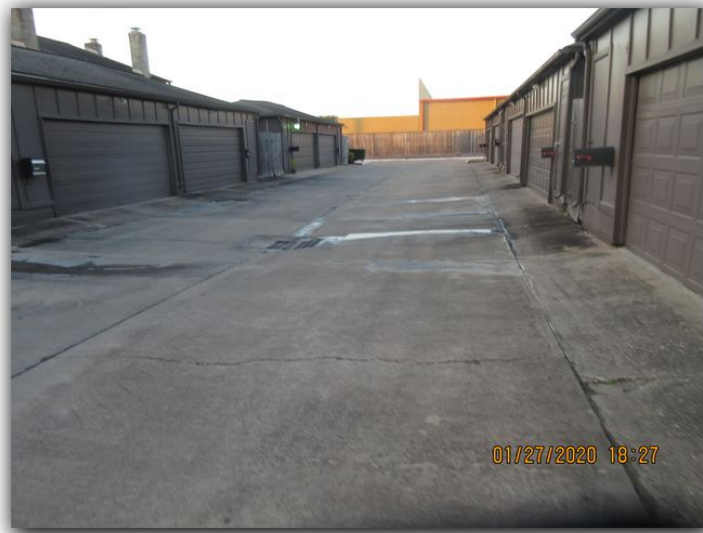
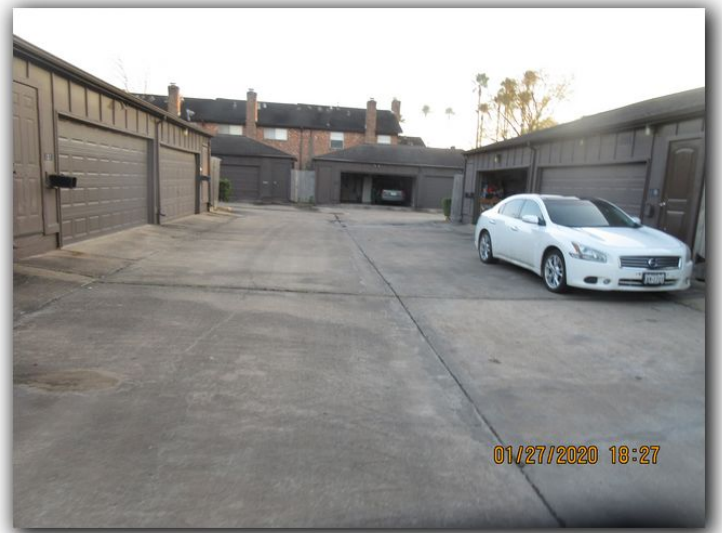
16. The home has concrete entrances to the garage which are in good condition.

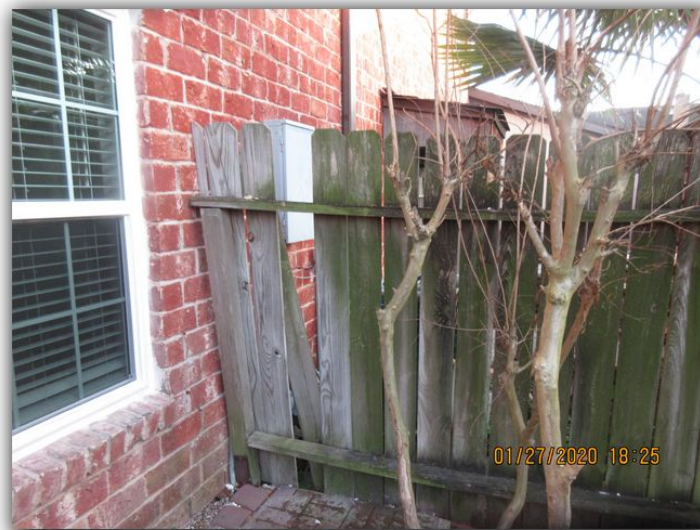
17. Wood perimeter fence is in need of repairs at various places

18. Some of the fence has minor wind damage.

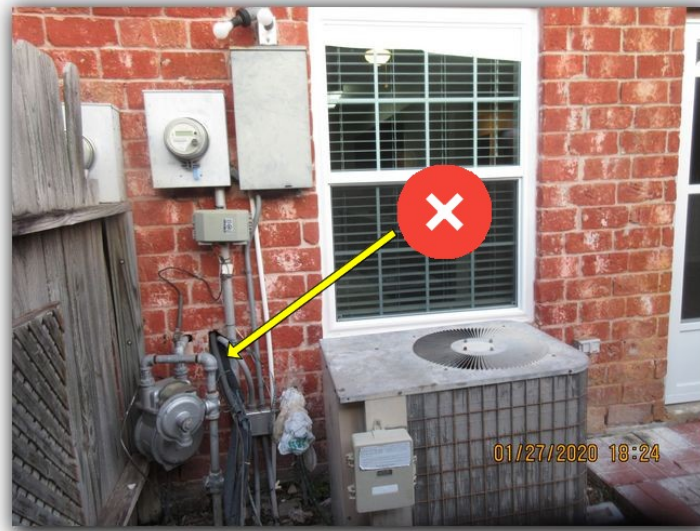
19. The main panel is missing the required 3 ft x 3 ft unobstructed space in front of the panel as per code.

20. There is a gas meter under the main panel, a violation of code and a hazard.

21. Insufficient space in front of the main panel as required by code, code requires at least 36 inches in front of the main panel, as installed the clearance is not sufficient for safety issues.

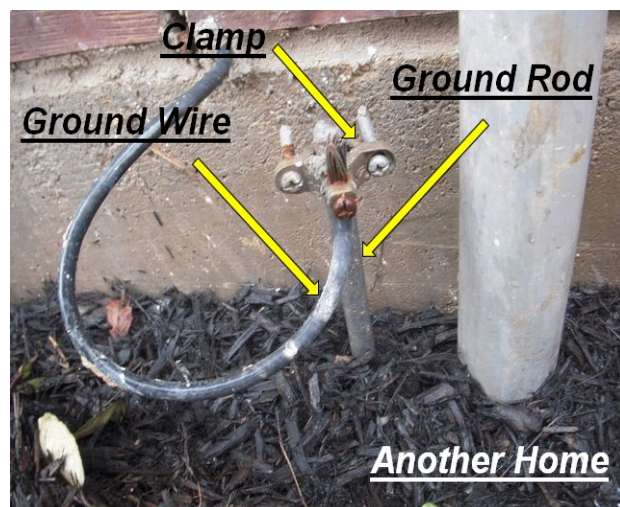
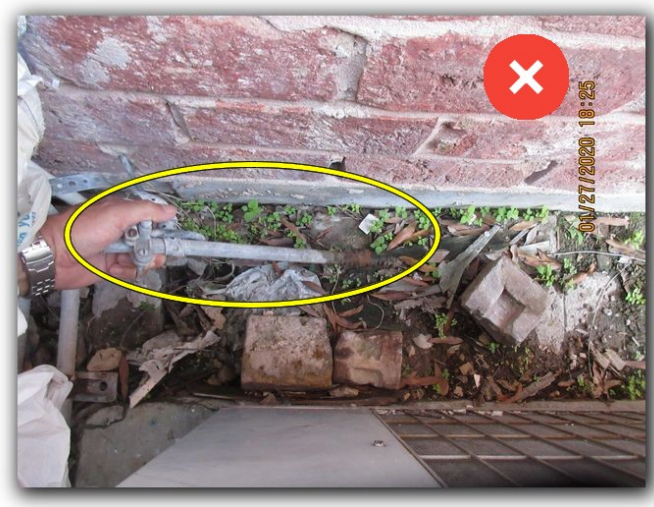
26. Improper ground rod, it is extremely too short, it must be at least six feet made of copper bonded steel rod. [Press Here to see one at ACE.](#)

27. At this time there is no ground rod protection.

28. Ground rod must be above ground and visible, the ground rod clamp must be visible, the ground rod should extend at least six inches above the ground to be able to inspect and maintain the ground rod clamp, see photo below of another home with a properly installed ground rod.

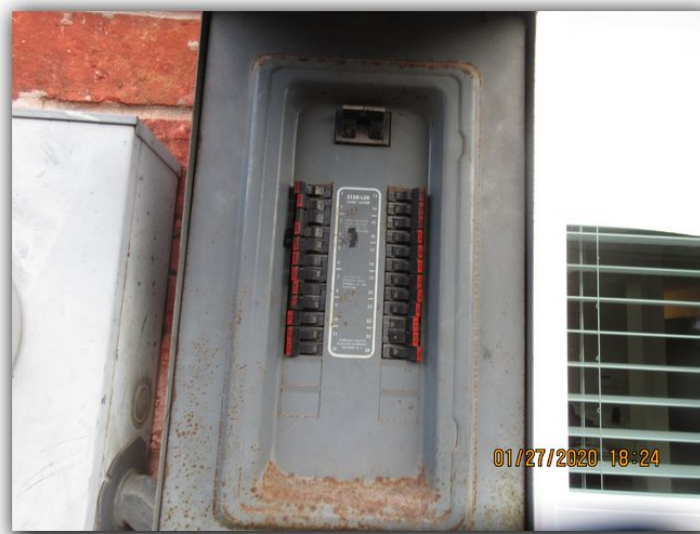
29. Main panel dead front cover is not labeled as per code.

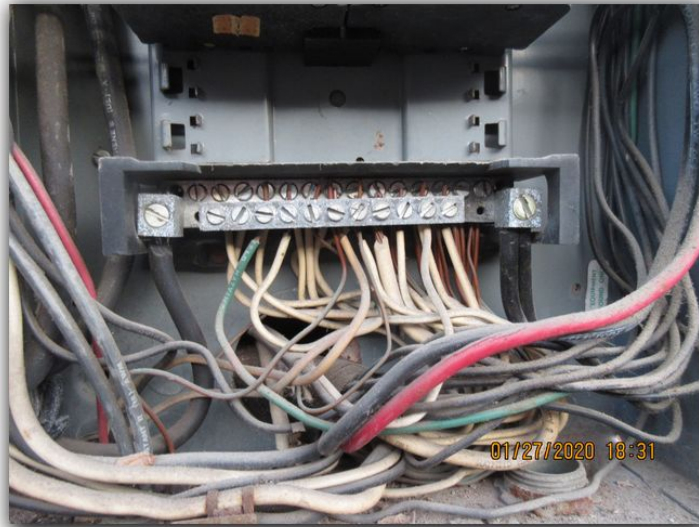
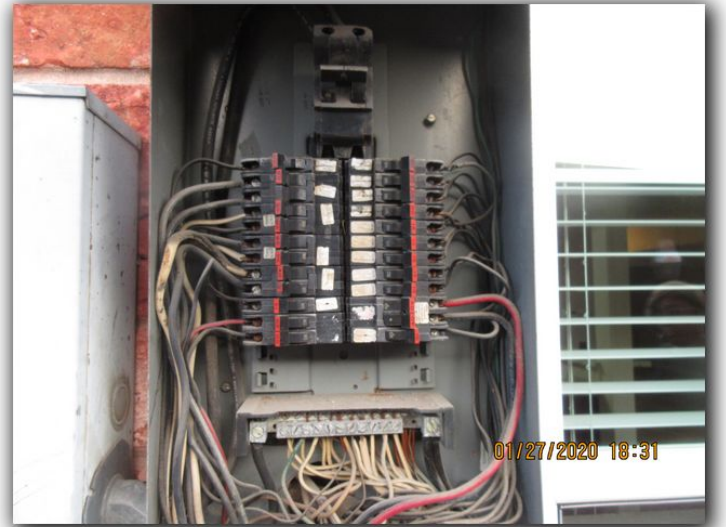
30. The main panel has copper wiring going into the home as per code.

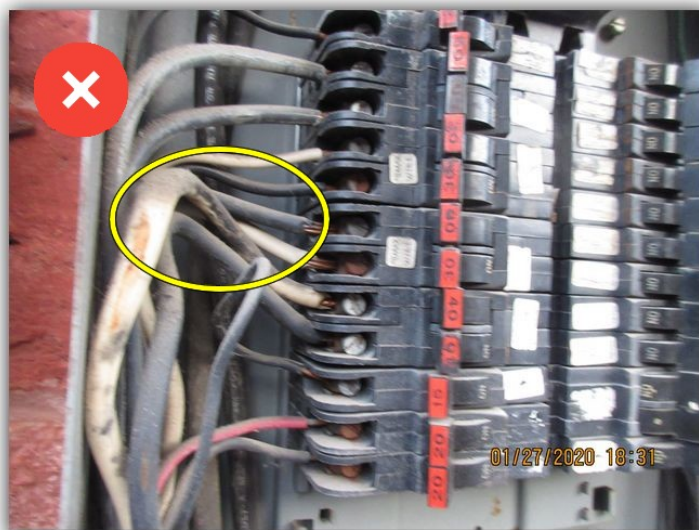
- 31. Improper wiring methods, there is one double lugged breaker and what appears to be an over heated wire on the top right bank as seen below, it needs immediate repair.
- 32. There is a damaged white wire on the left bank as seen below on the left side, needs repair.
- 33. An electrician should make further assessment to confirm that the main panel was not damaged due to an over current resulting from a defective ground rod.

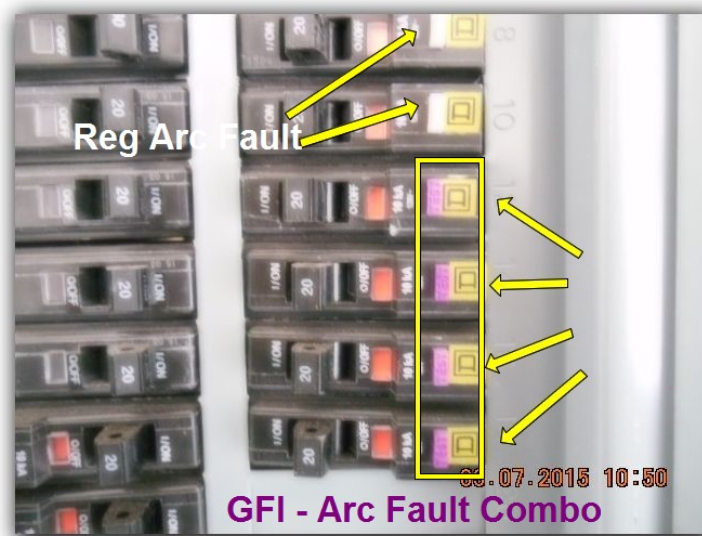
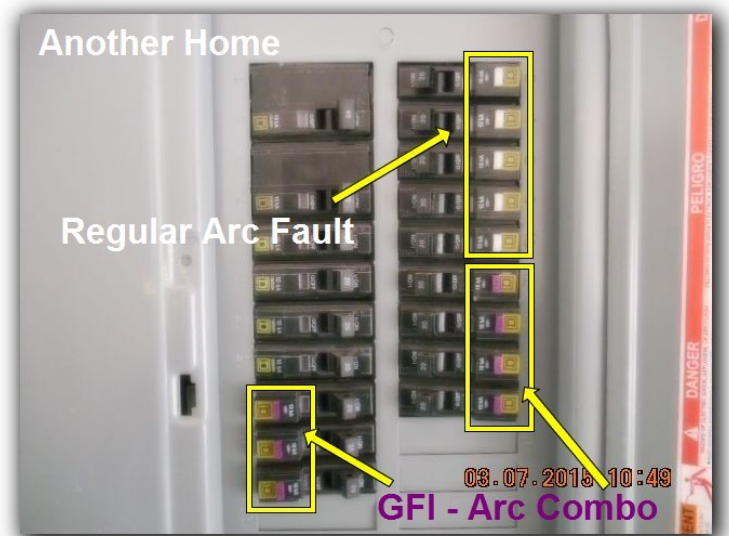
37. Home is missing arc fault protection on the GFI's as required by current code.

38. See another home below with proper dual purpose breaker (purple button).
