**A Town Home Inspection Report On
11568 S. Kirkwood, Stafford, TX
Sold by Sandra McClusky, Listed By**

Monday, January 27, 2020

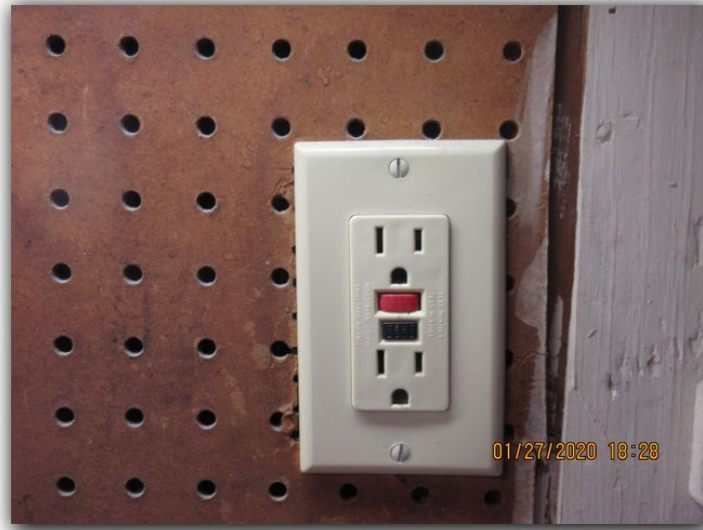
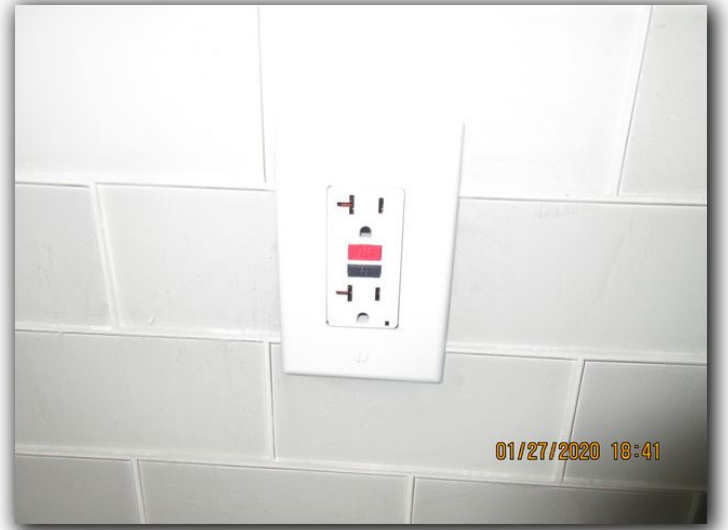
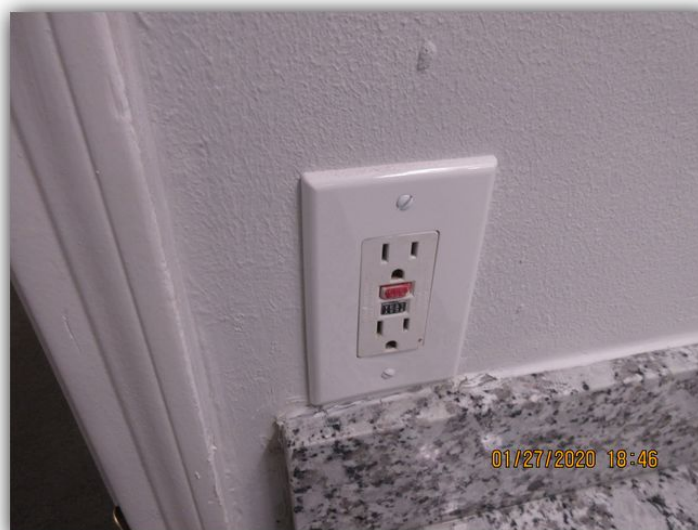
39. Home has proper GFI protection as noted below.

| Exterior: | <input type="checkbox"/> Yes | <input checked="" type="checkbox"/> No | <input type="checkbox"/> Partial | <input type="checkbox"/> Defective | |

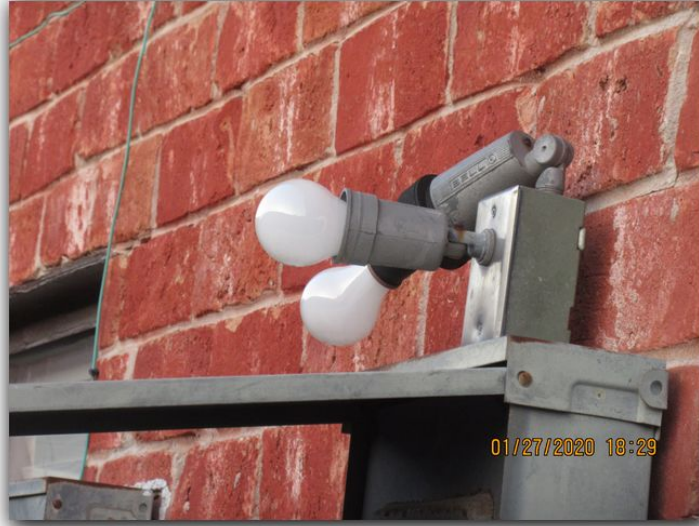
46. Rear lamp at the brick wall is not properly installed.

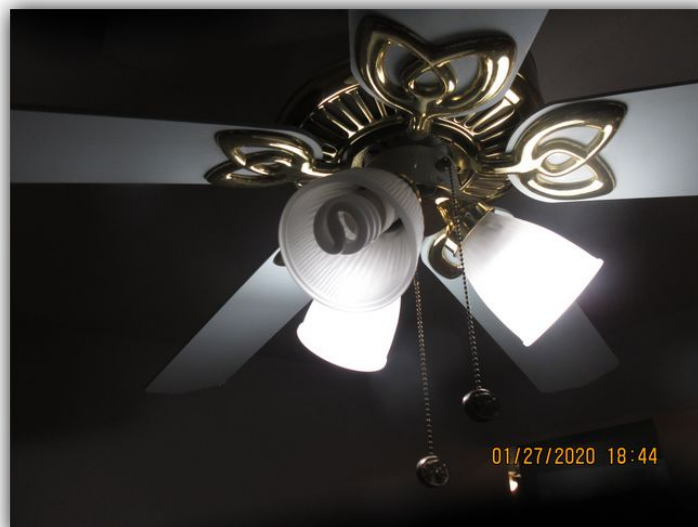
47. Missing some luminaries (bulbs) in some light fixtures.

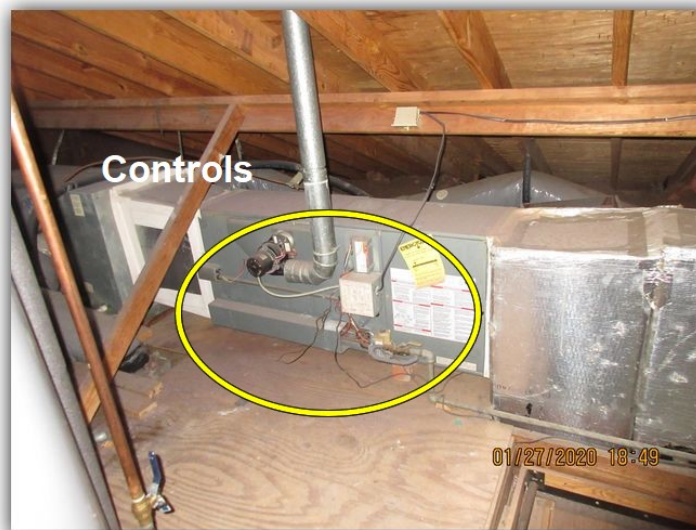
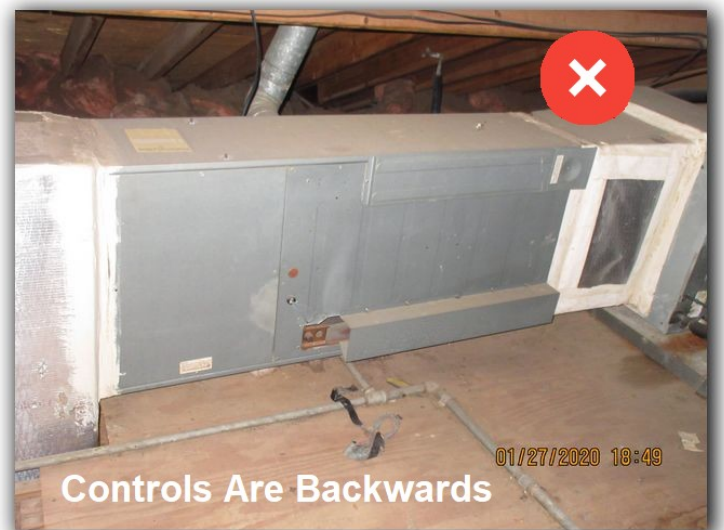
51. The right side furnace is installed backwards, the controls are not accessible.

52. The controls must be properly installed to face the work platform as required by code.

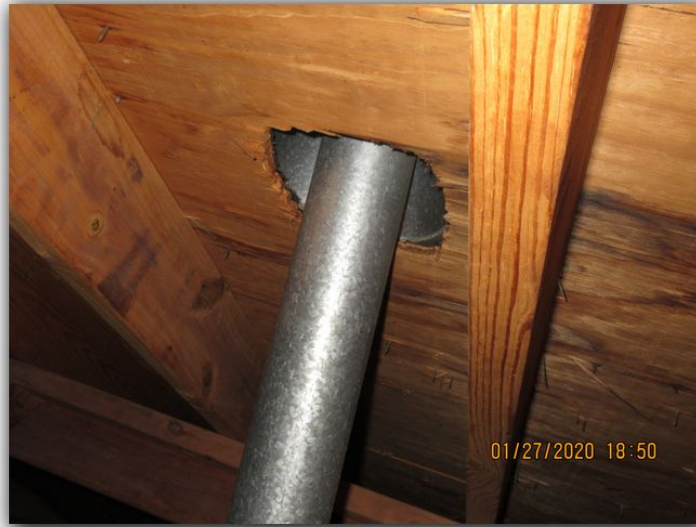
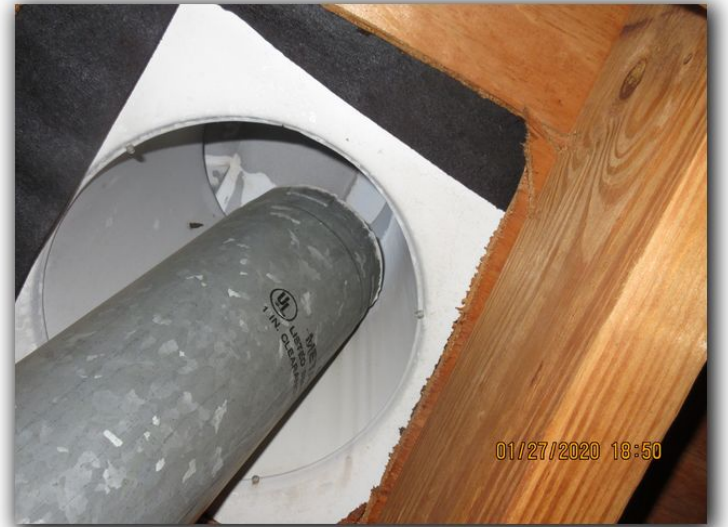
53. The vent pipes are not properly secured to the rafters as per code.

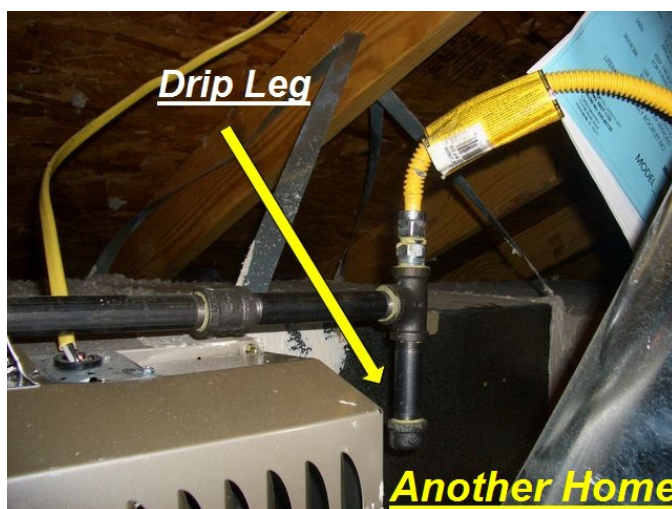
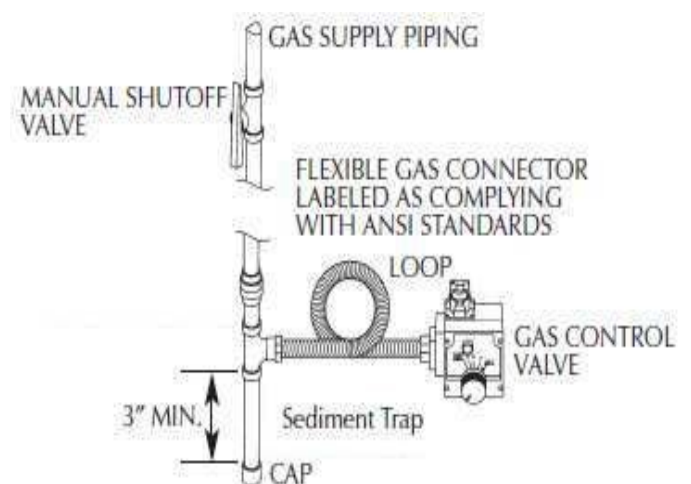
59. Missing a drip leg at the gas connector/gas flex as per code, see photo below of another home with a proper drip leg.

- 60. All natural gas line installations require a sediment trap or drip leg to trap condensate, oil, metal shavings and other debris and impurities, which might otherwise clog the burner orifice or lodge in the gas valve.

- 61. Proper installation of the needed drip leg will help maintain the proper functioning of the gas furnace and water heater units but also help prevent a safety hazard. The sediment trap should be installed as close to the water heater or furnace inlet as possible.

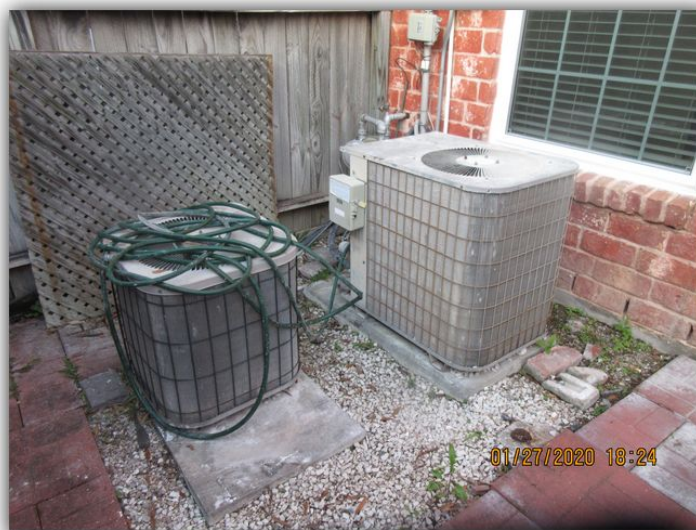
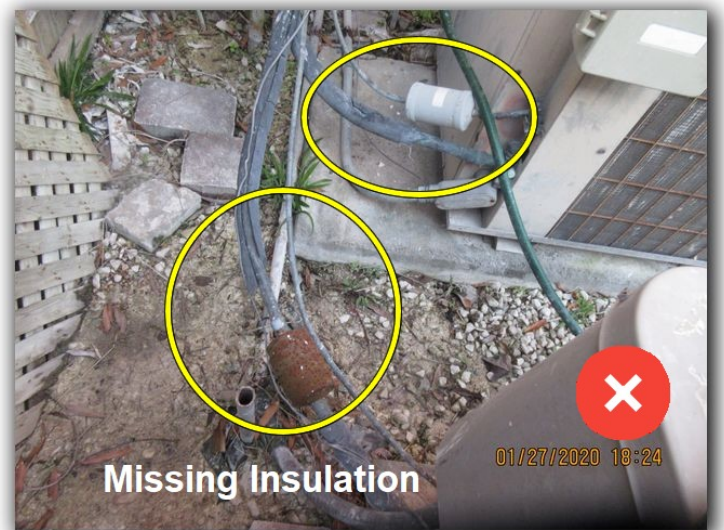
1. The town home has a central a/c system with two condensers on the exterior and two evaporators on the interior the typical split a/c system.
2. Both of the systems were active at the time of the inspection but not tested, too cold to run effectively.
3. Both condensers are at the end of their useful lifespan.

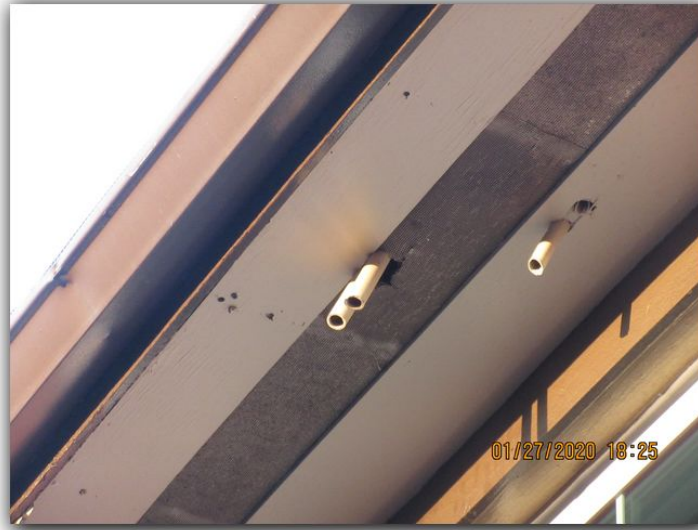
- 8. Both of the drain pans in the attic were clear.
- 9. One drain pan has minor rust spot.
- 10. The drain pan has a secondary drain line connected, termination not confirmed.

12. Note: Termination of the secondary drain line was not confirmed other than that reported above. The secondary drain lines normally run under the attic insulation and the whole run is not viewable.

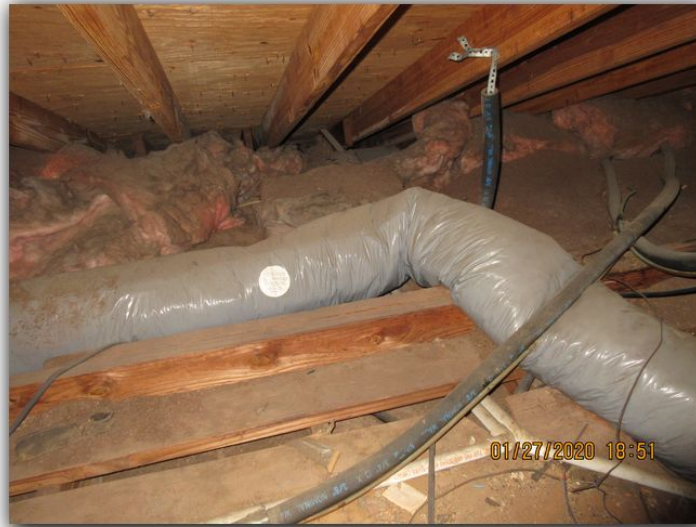
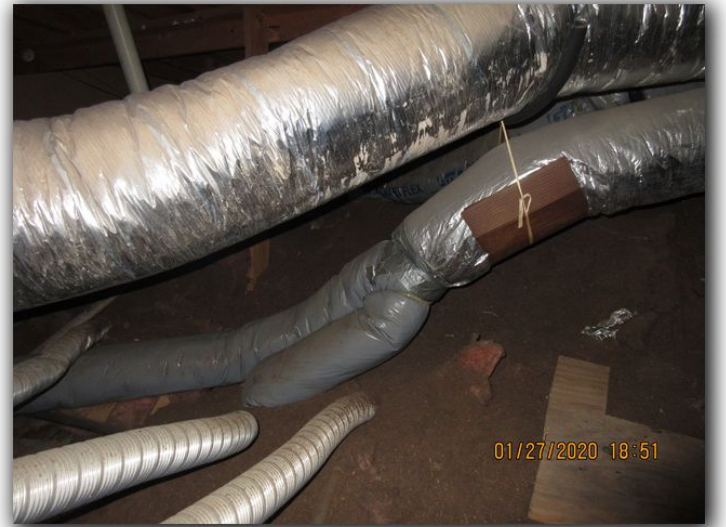
16. Various ducts are damaged and are in need of replacement.

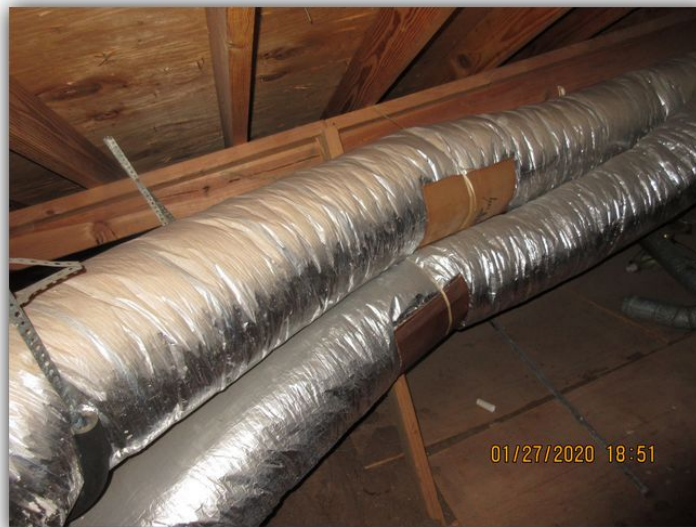
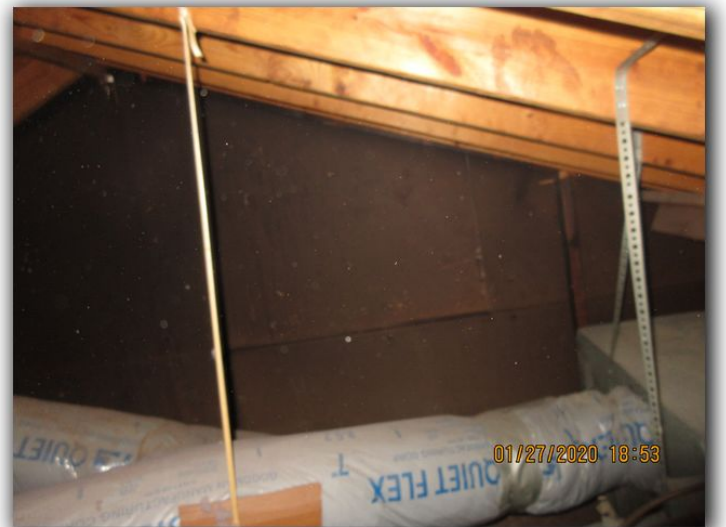
17. The ducts must be elevated and supported from the rafters.

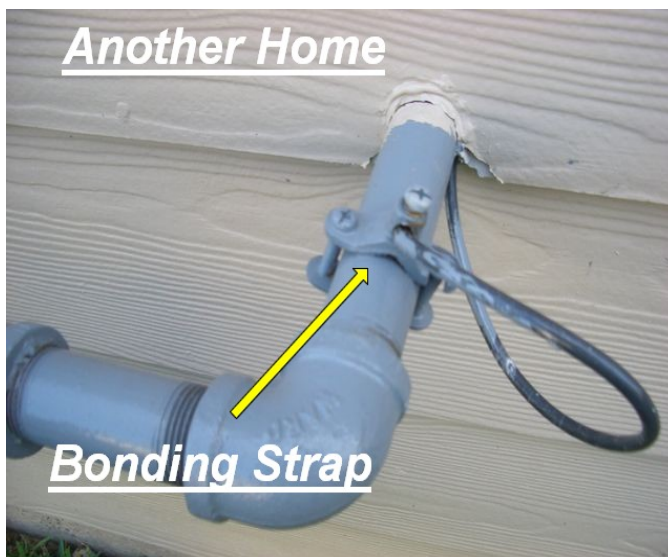
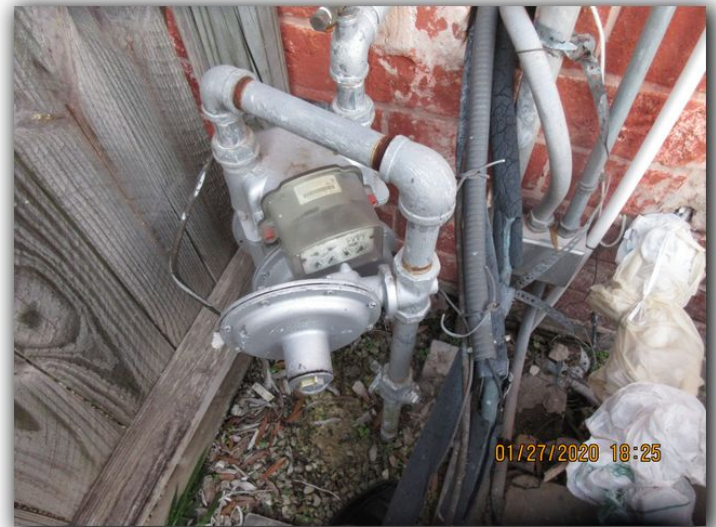
21. There is a gas leak at the gas meter that is under the main panel, a hazard, needs immediate attention.

pipng system upstream from the equipment shutoff valve shall be electrically continuous and bonded to the grounding electrode system.

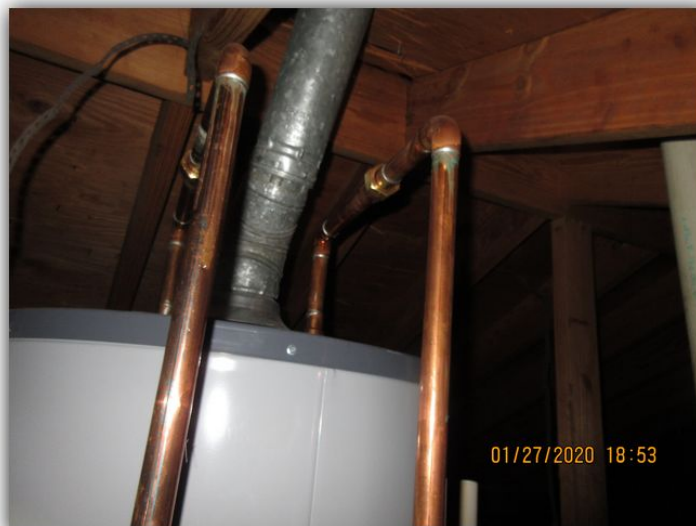
31. In this case some of the water lines appear to have been upgraded to copper at the new water heater as seen below.

32. The copper water lines on the water heater are not insulated.

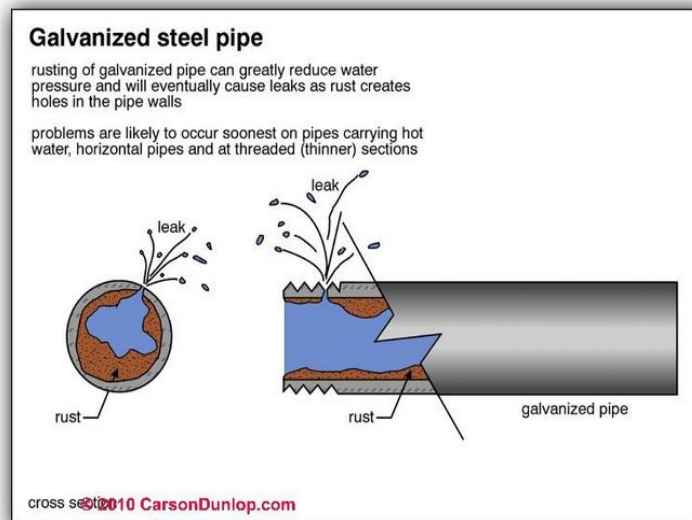
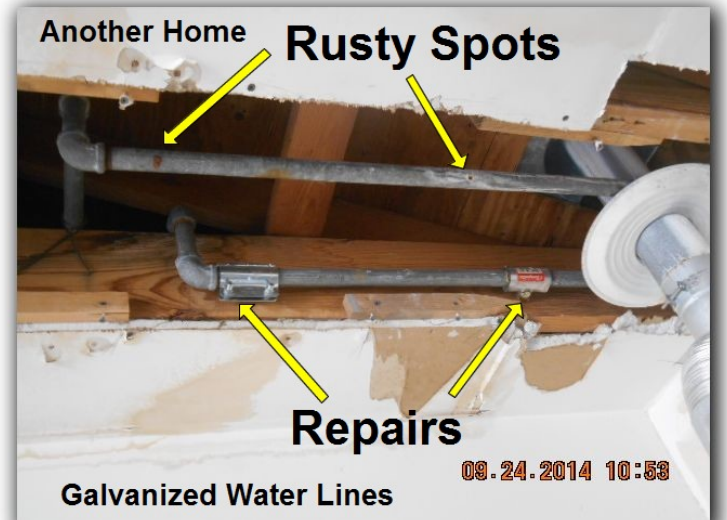
33. Home of this age normally has galvanized water supply lines that with time can clog and have to be replaced, at the time of the inspection all of the fixtures flowed adequately except the kitchen.

- 34. Galvanized pipes have a general life expectancy of 50 years, but this can be shortened considerably by the amount of minerals in the water supply. Houston has hard water, and galvanized pipes here tend not to last longer.
- 35. Two things happen to galvanized pipes as they age. First, minerals tend to slowly build up on the inner walls of the pipe decreasing the inside diameter. In extreme cases, this can slow the water flow to a trickle. The other common problem with galvanized pipes is corrosion at the joints. In the process of cutting the threads for the pipe fittings, the protective galvanizing is cut away exposing bare metal. Over time, these threaded joints will corrode and eventually break.
- 36. If the pipes are original I would definitely consider replacing them. If you are not sure how old they are, a plumber should assess the plumbing pipes in the home

- 37. Home may have galvanized water lines as other homes of this age have.
- 38. This inspector recommends if the home has galvanized pipes that they be upgraded in the near future to a PEX water supply system which is a modern type of water pipes that replaced copper water lines and pvc water lines.
- 39. PEX water lines are usually found with a central manifold and a "home run" type of water lines with individual cut off valves.
- 40. A manifold is not code required and may not be possible in an upgrade, check with a plumber.

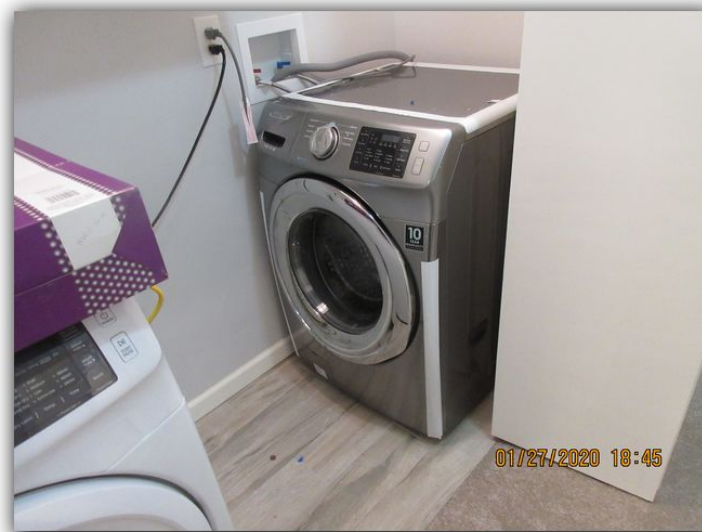
1. The inspector operated at least three fixtures to test for proper water flow in the drain system.
2. No obstructions were viewed at the time of the inspection.
3. Missing drain pan under washing machine at second level utility room as required by code with a two inch drain line that terminates to exterior. IRC P-2719.1.
4. The utility room does not have a drain on the floor.

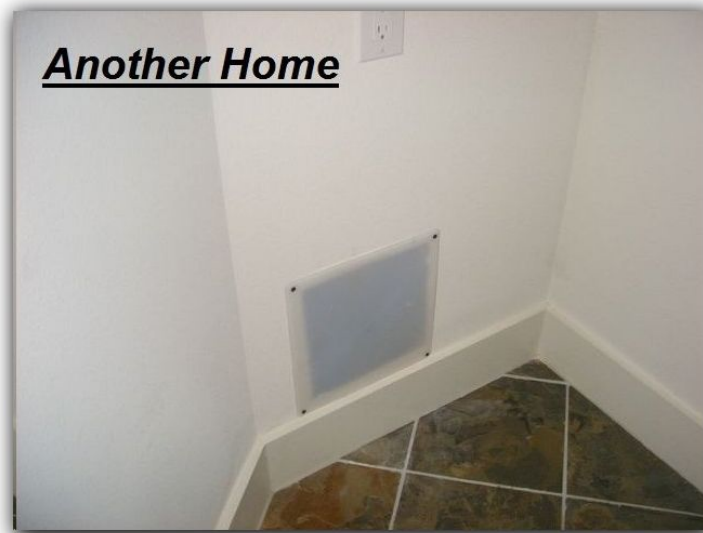
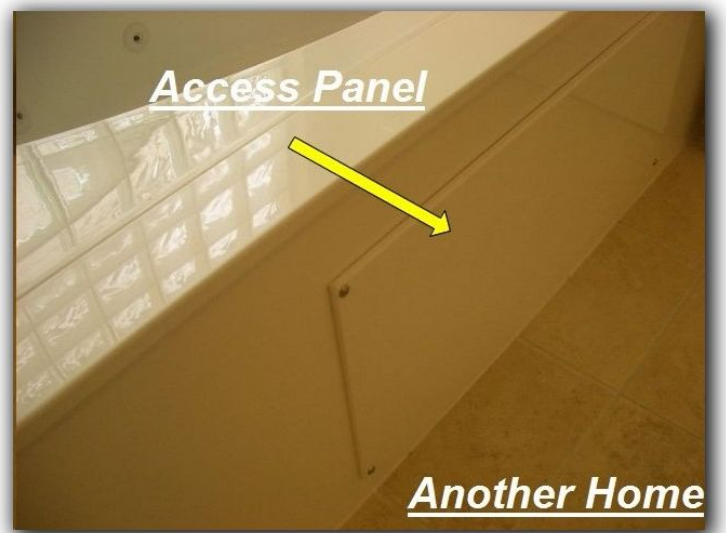
5. Missing tub access panel at sheet rock wall as required by IRC code P-2704.1.

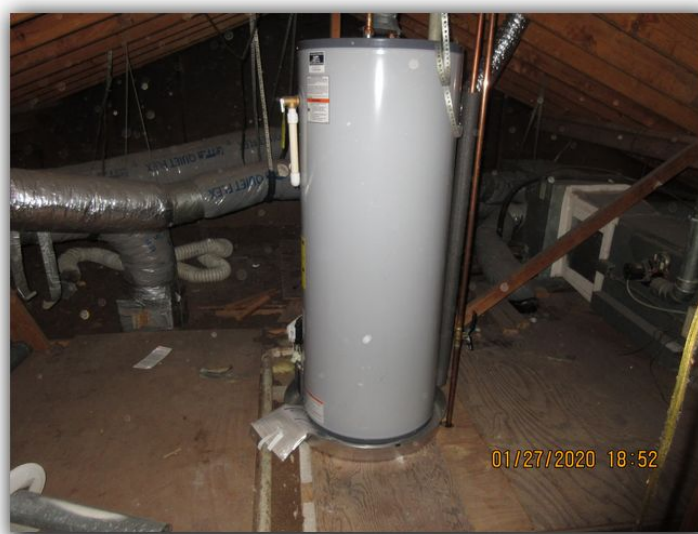
- 6. The water heater is located in the attic area.
- 7. The water heater has been recently installed.
- 8. The water heater is gas and was active at the time of the inspection.

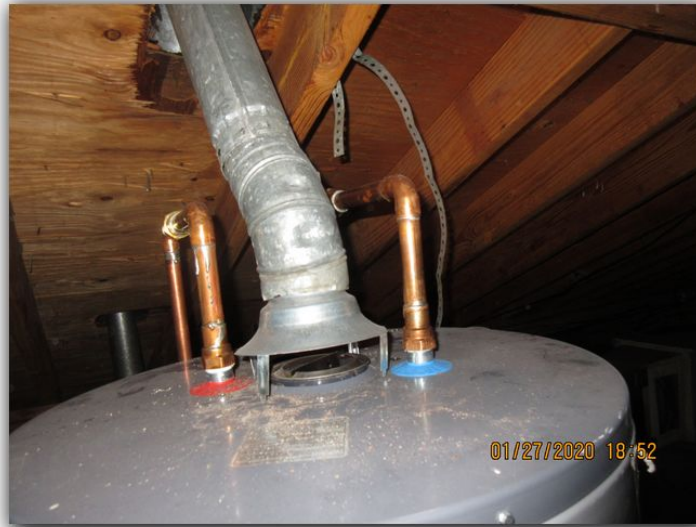
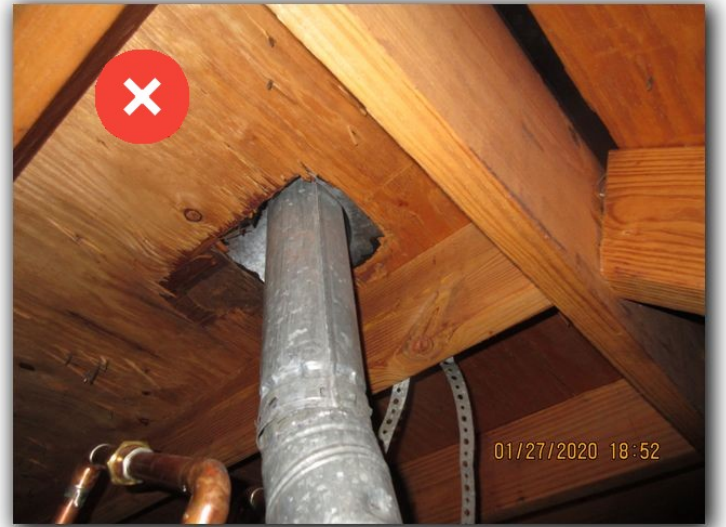
- 9. The vent pipe is not properly secured to the rafters as per code.

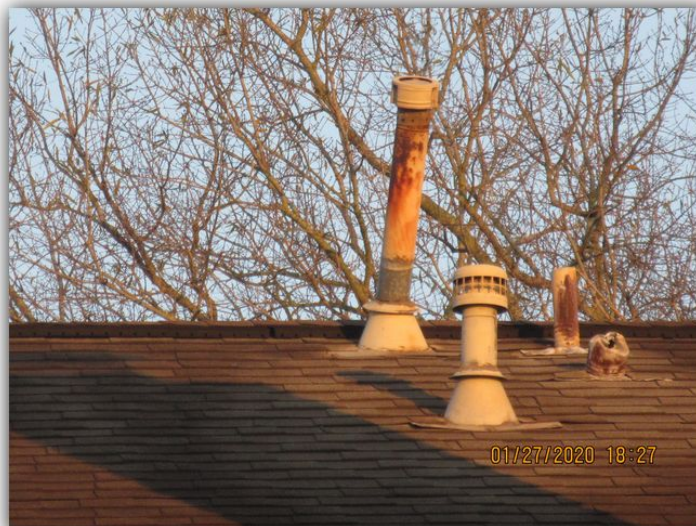
11. The vent pipe at the roof level is rusty and it may be due to a blockage that has caused over heating, the vent pipe and cap need to be replaced.

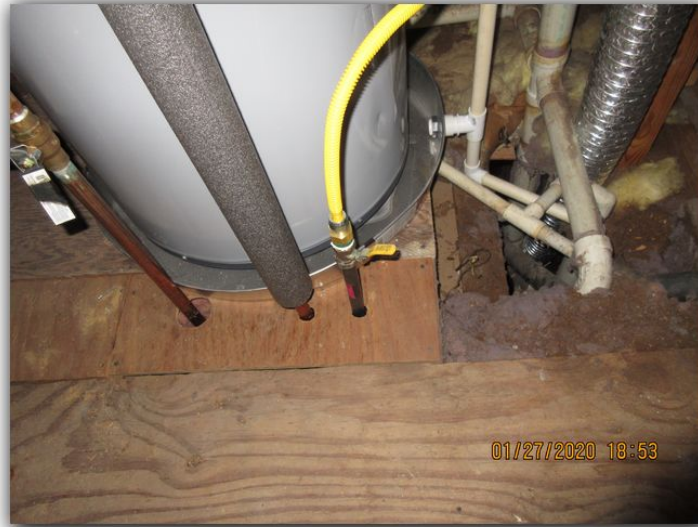
12. The water heater has a proper drain pan under the tank as per code.

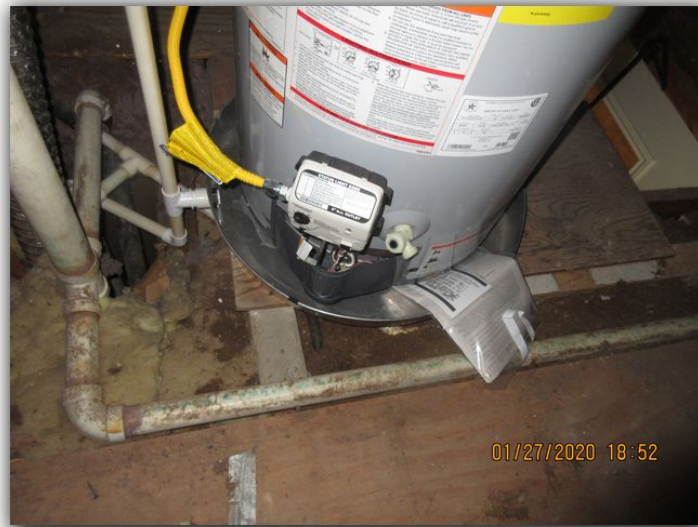
- 14. The water heater has a flex gas line.
- 15. The gas line is missing a bonding wire as required by code.

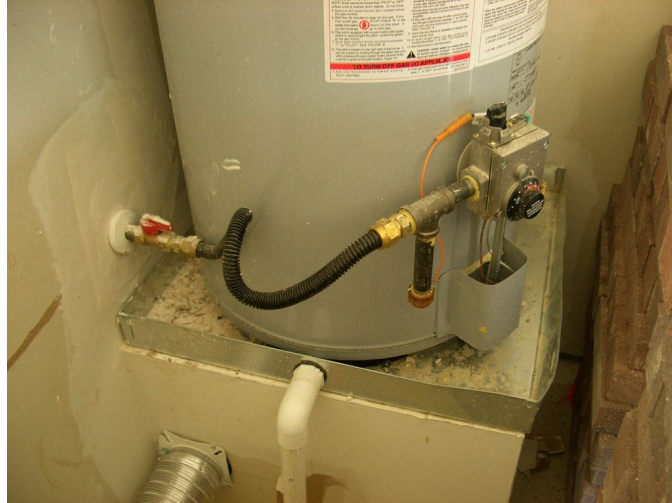
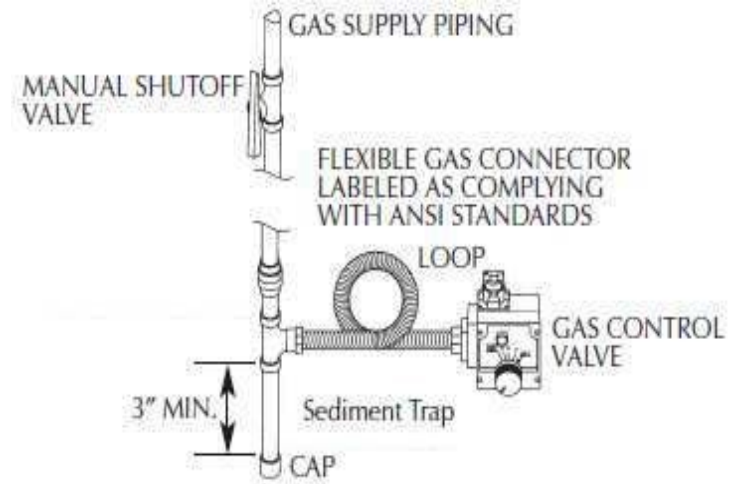
- 16. Missing a drip leg as per code.

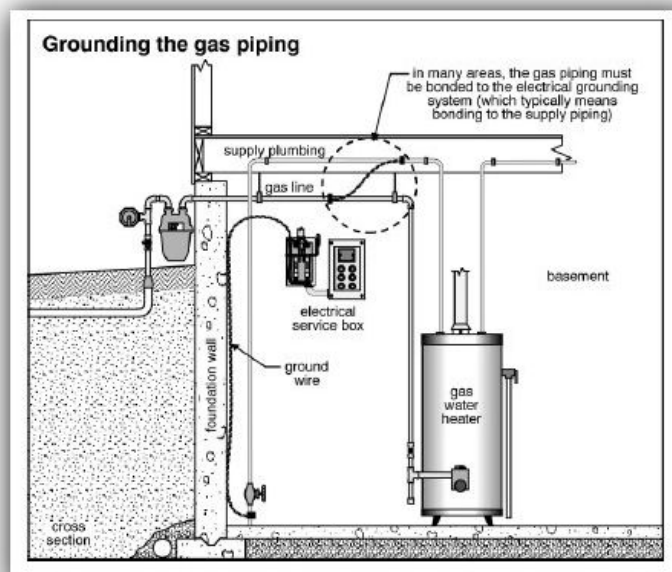
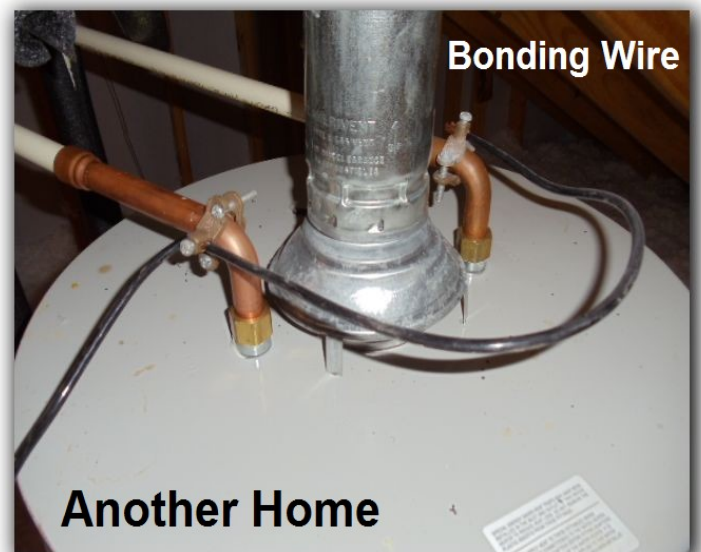
17. The hot and cold water lines were not bonded to the gas line as per code

18. **E3509.6 Metal water piping bonding.** The interior metal water piping system shall be bonded to the service equipment enclosure, the grounded conductor at the service, the grounding electrode conductor where of sufficient size, or to the one or more rounding electrodes used. The bonding jumper shall be sized in accordance with Table E3503.1. The points of attachment of the bonding jumper(s) shall be accessible.

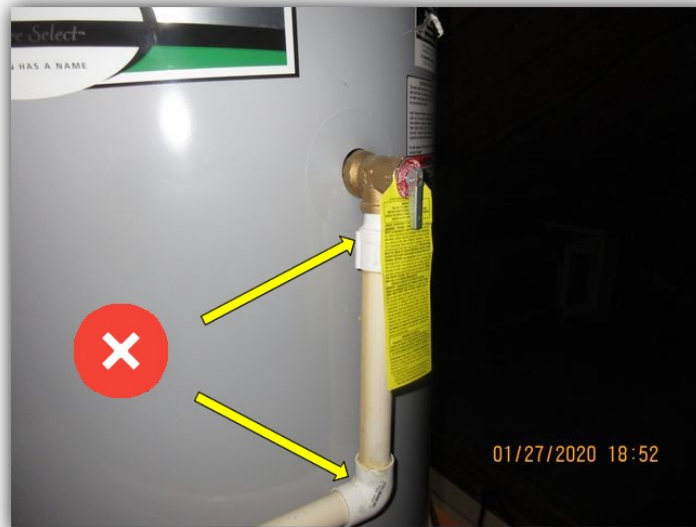
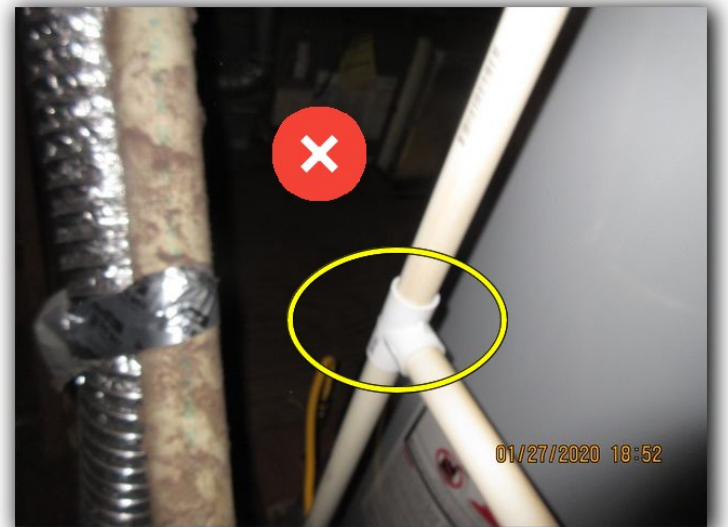
19. The drain line for the T&P valve has joints that are PVC for cold water use, must be CPVC for hot water use.

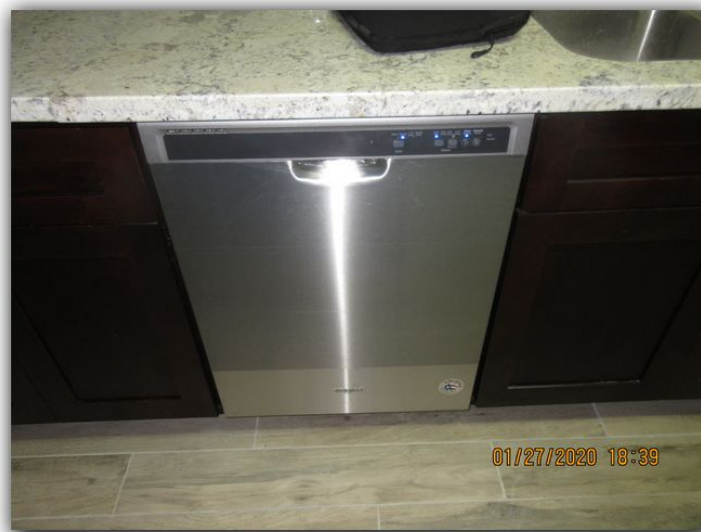
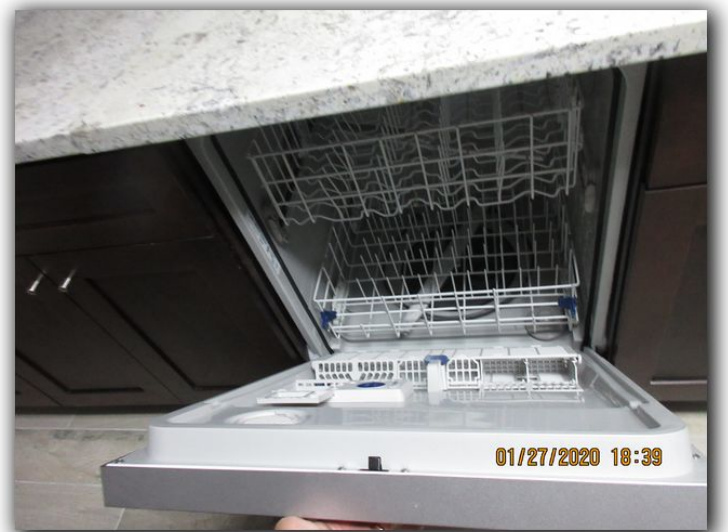
36. The dishwasher is new but not working properly at the time of the inspection, water has not been activated to unit.

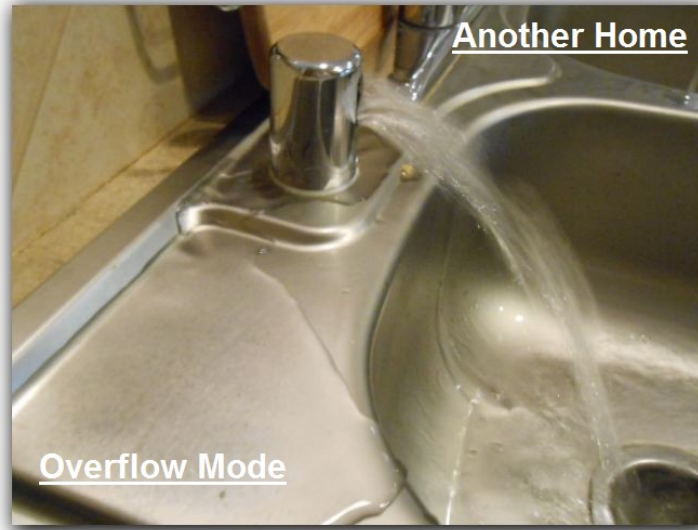
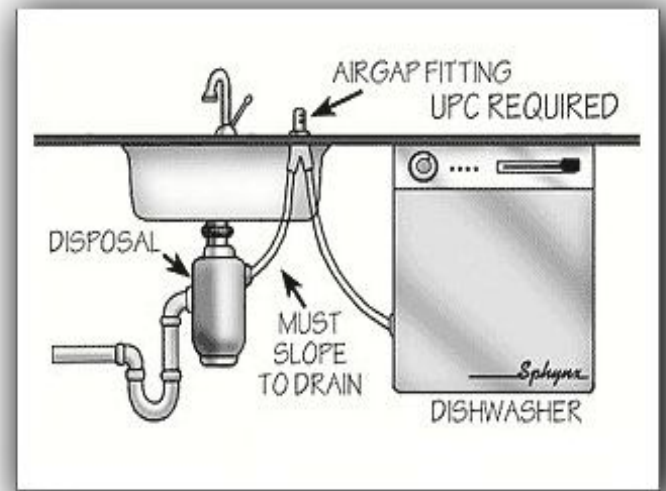
37. The drain line was not raised above the drain and looped as per code.

38. Missing an air gap valve on top of the sink as per code.

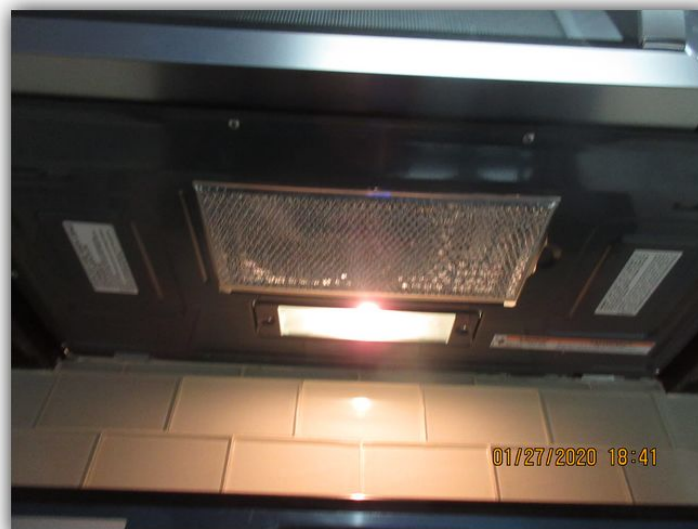
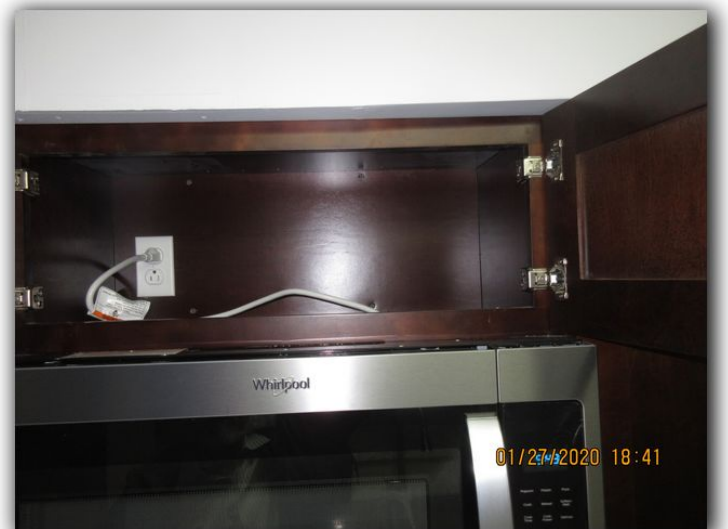
41. The vent hood was present and working properly at the time of the inspection.

42. The vent hood is a re-circulating vent hood that does not terminate to the exterior.

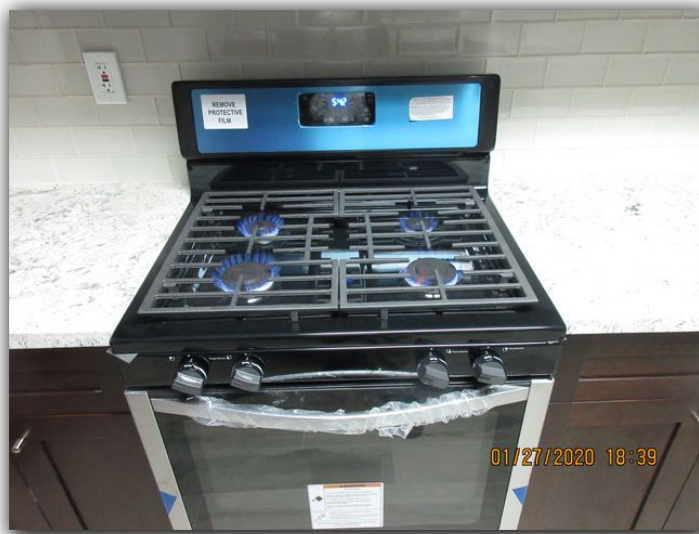
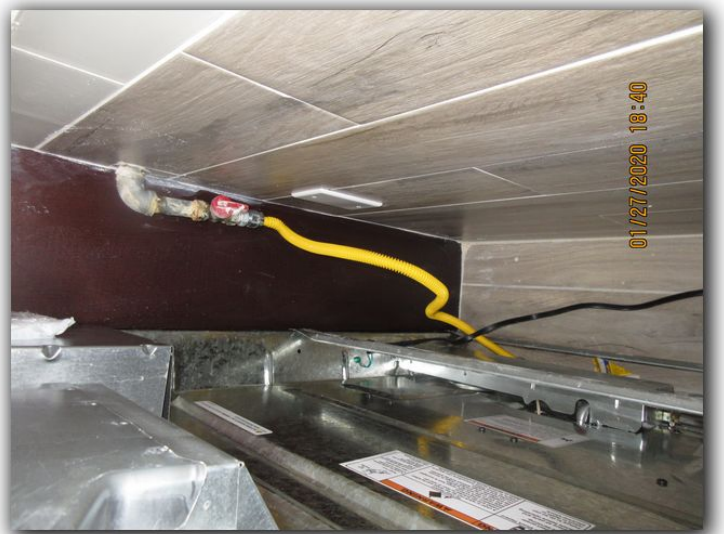
43. The home has a new working gas stove.

44. The stove has a proper gas flex and gas valve behind the unit as per code.

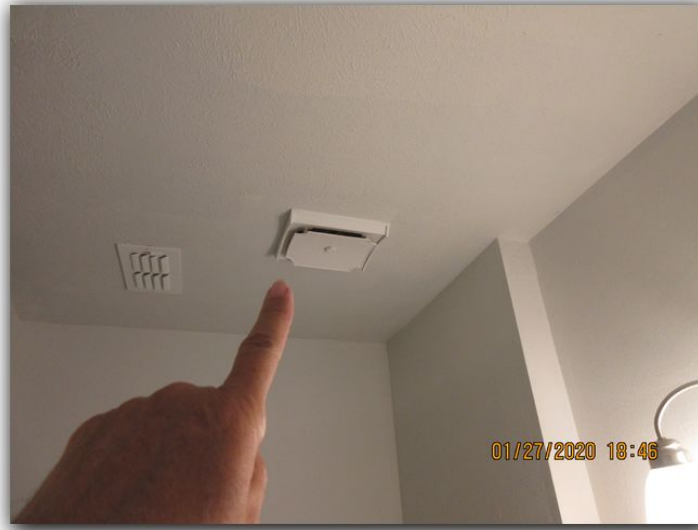
- 53. The second floor hall bathroom has a defective power exhaust vent, needs to be

replaced.

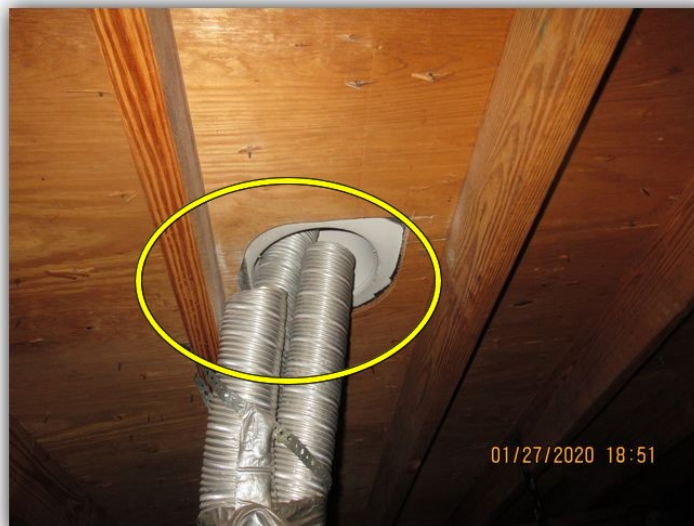
54. Improperly terminating flex vents into the attic, they must be properly fitted into the roof jack so they can terminate to the exterior as per code.

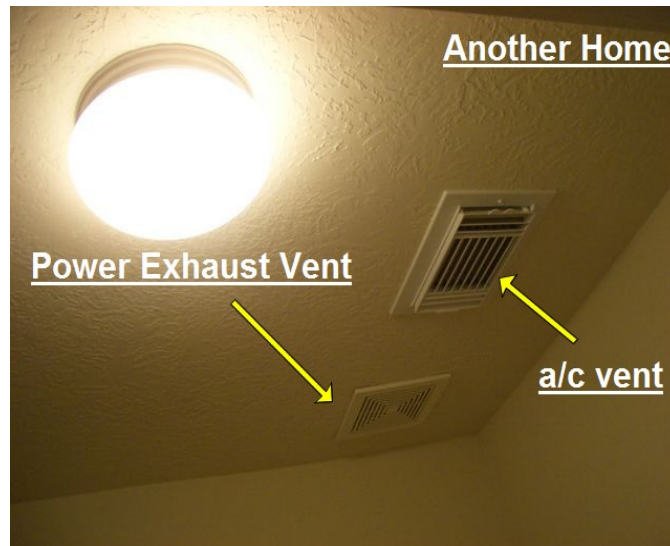
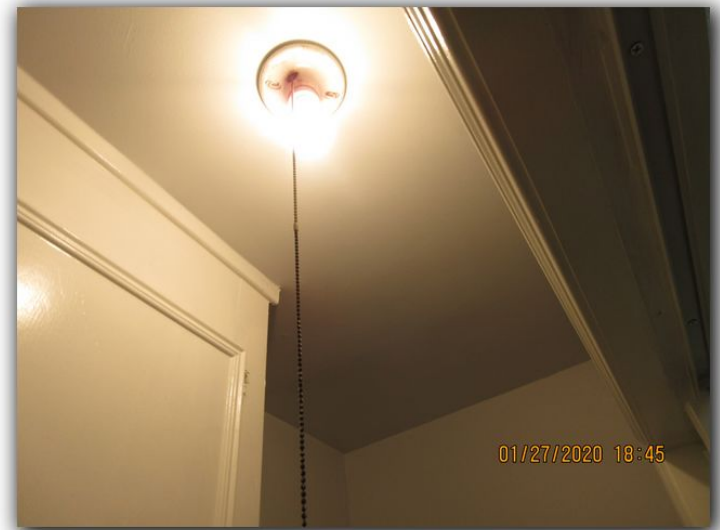
55. Missing a 50 cfm power exhaust vent at the ceiling of the utility room that has no windows as per code R-303.3x;

56. R303.3 Bathrooms. Bathrooms, water closet compartments and other similar rooms shall be provided with aggregate glazing area in windows of not less than 3 square feet (0.279 m²), one-half of which must be openable.

57. Exception: The glazed areas shall not be required where artificial light and a mechanical ventilation system are provided. The minimum ventilation rates shall be 50 cfm (23.6 L/s) for intermittent ventilation or 20 cfm (9.4 L/s) for continuous ventilation. Ventilation air from the space shall be exhausted directly to the outside.

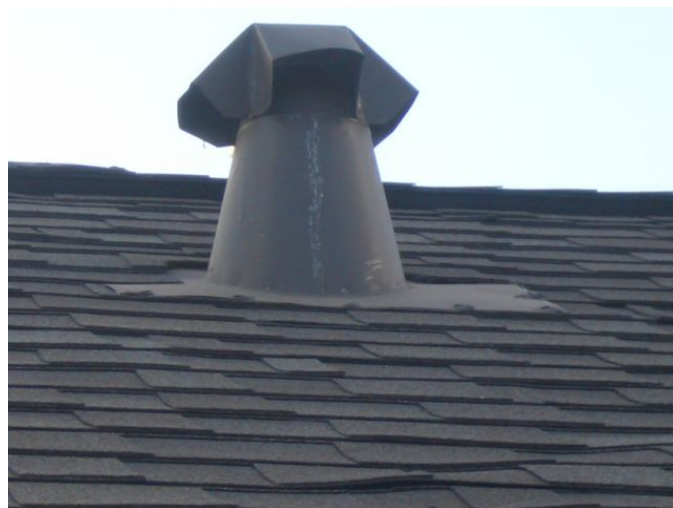
62. Missing a back draft damper at the termination of the vent as per code.

63. Improper dryer vent; Code requires that the roof jack has a back draft damper; The subject property has no back draft damper, has a type "A" roof jack that will hold lint and be a fire hazard (as per fire department); Remove existing roof jack and properly install one as required by code;

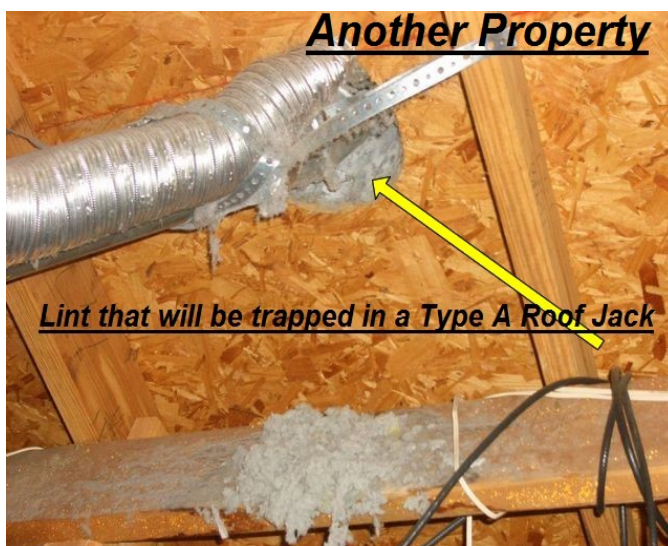
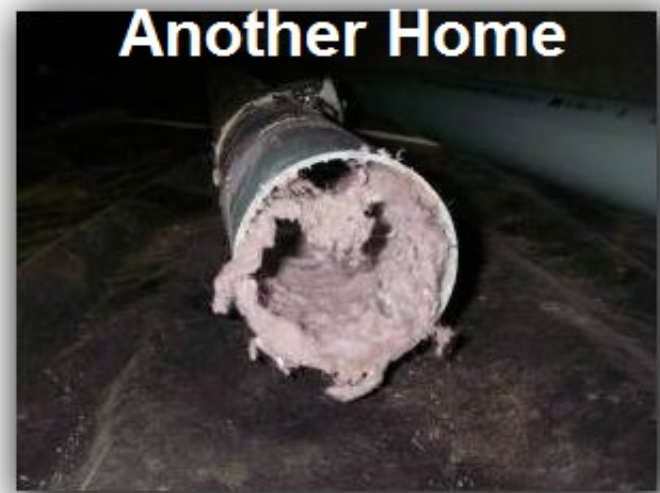
65. Improper dryer vent will cause lint to fall into the attic or accumulate in a sealed type A roof jack both of which are a fire hazard as shown on the photo below;

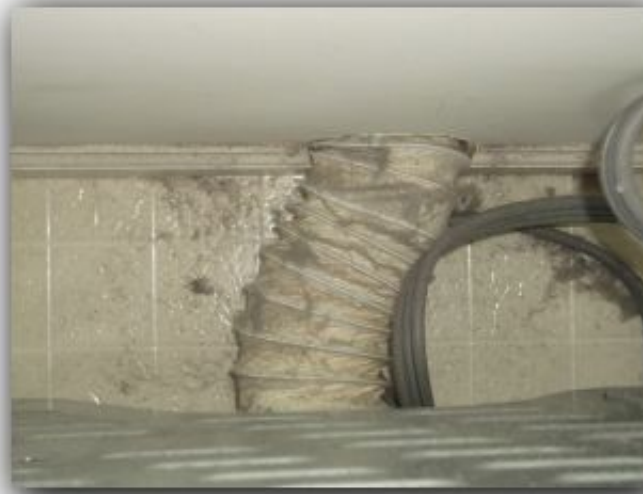
The most commonly seen improper type of dryer vent is flexible vinyl tubing. Vinyl is a type of plastic and it can easily melt and lead to a house fire. This material, most often white and ribbed, tends to allow for lint to readily accumulate. Lint is very flammable and all it takes is a small spark to ignite it leading to a house fire.

The more lint that fills a clothes dryer vent, the more energy the clothes dryer consumes to try to dry the clothes as air won't freely flow through the clogged vent material. This, in turn, causes the drying cycle to be much longer than normal and raises utility bills. The photo below shows an installation of vinyl tubing.
