PROPERTY INSPECTION REPORT

Concerning: 2823 Allyson Lane , Spring, TX 77373
(Address or Other Identification of Inspected Property)

By: Marcus Brandt Lic.#: TREC # 22244 07/02/2020
(Name and License Number of Inspector) (Date)

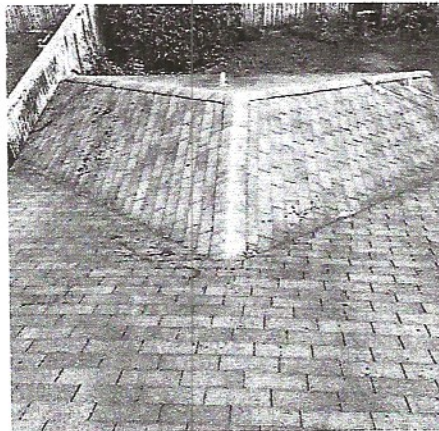
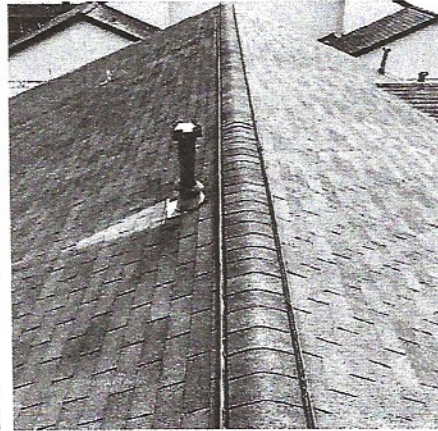
- Asphalt Composition
- On Roof Top
- Deficient

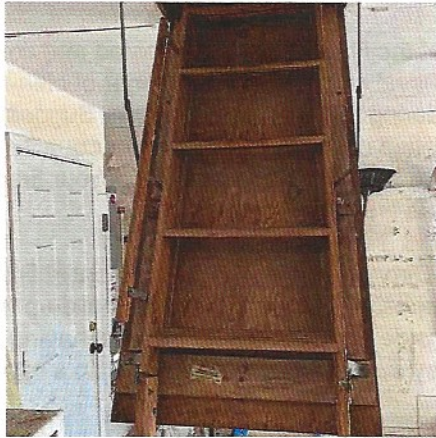
- 1. The stairs were observed to be weak when opened (see photo). This is considered a safety hazard. Recommend consulting with a qualified contractor regarding this condition.

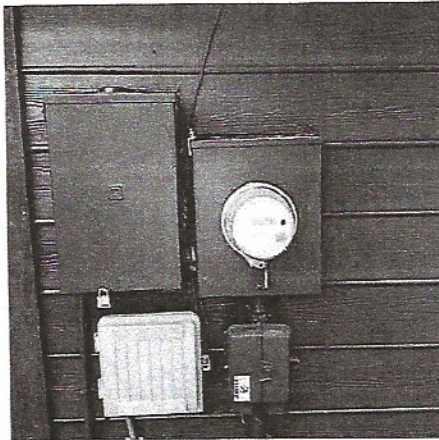
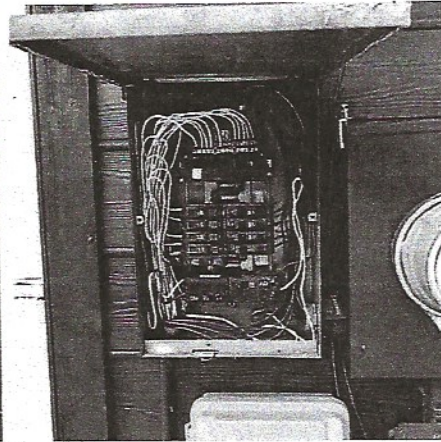
Main breaker is 150 amps (see photo).

- 1. Panel was not labeled properly at time of inspection (see photo). Recommend labeling by a qualified person or electrician.

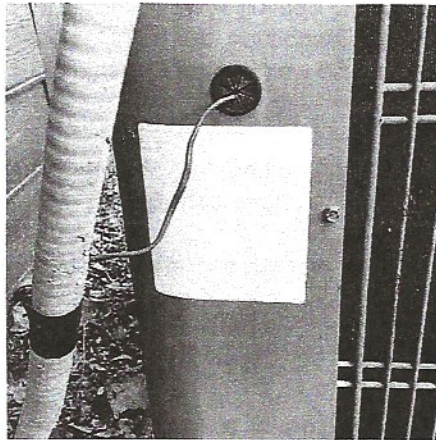
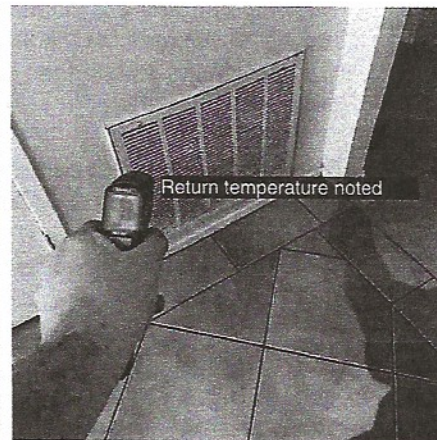
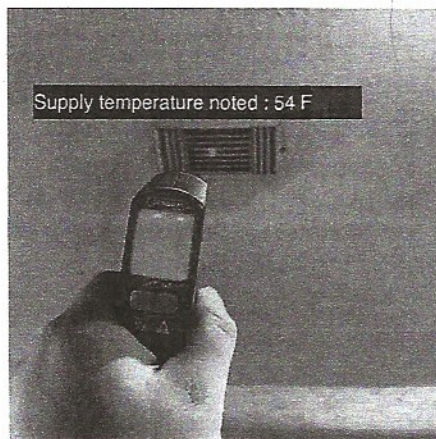
- 1. The condensing unit cage is rusted excessively (see photo). This is an indication of old age. Recommend consulting with a qualified contractor regarding this condition.

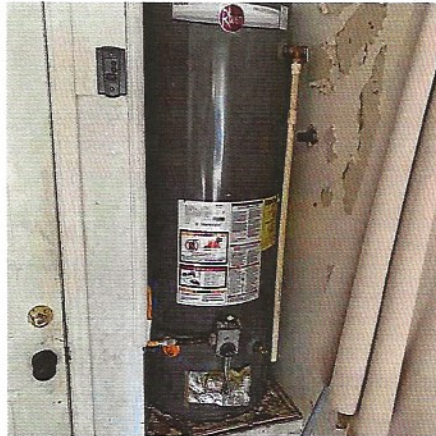
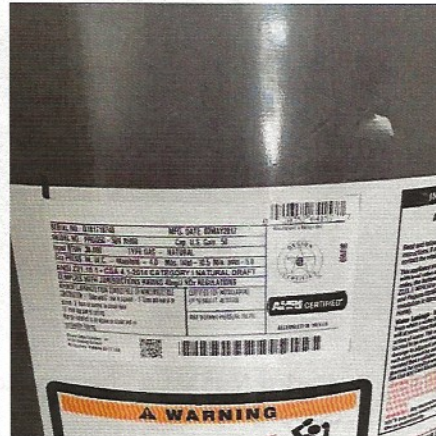
- 1. A drain pan is missing underneath the water heater (see photo). Recommend adding a safety pan.

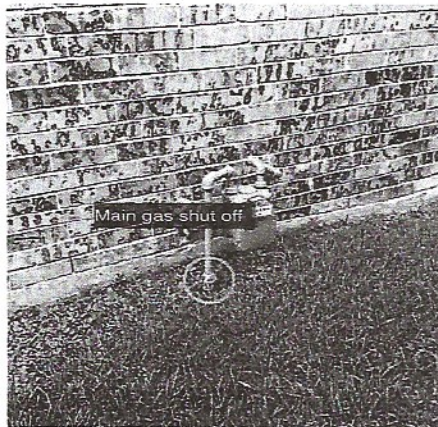
- Gas Meter located on right side. At the time of this inspection, there were deficiencies found.

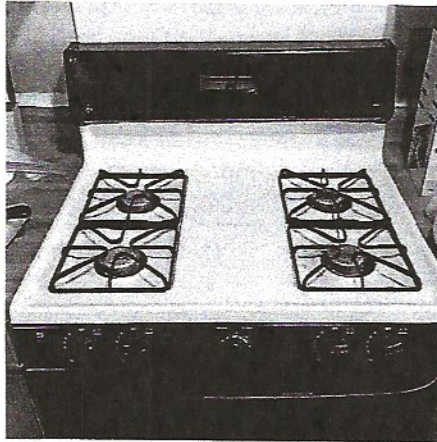
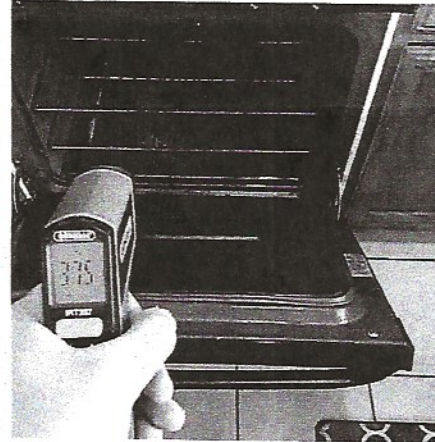
- 1. The control board is missing (see photo). Recommend consulting with a qualified contractor regarding this condition.
