RESIDENTIAL INSPECTION REPORT

6624 Merry Ln
Houston TX 77023

Juan Chavero
AUGUST 26, 2020

PROPERTY INSPECTION REPORT

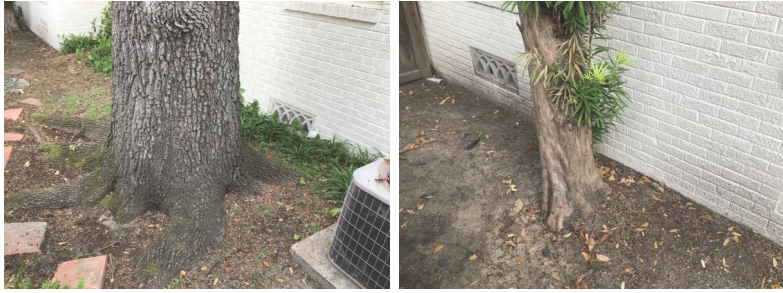
Root systems of large trees planted too close to the foundation can cause foundation problems.

Recommendation: Contact a qualified professional.

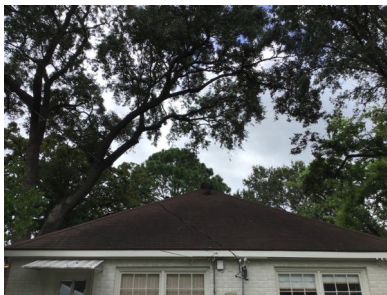
Tree limbs that are in contact with roof or hanging near roof should be trimmed to prevent damage to the roofing materials.

Recommendation: Contact a qualified tree service company.

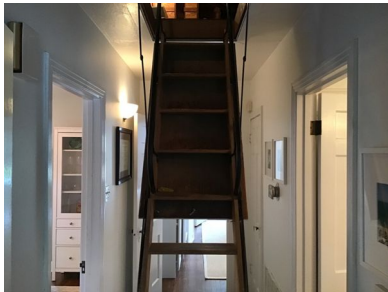
The ladder door was not insulated or weatherstripped. This can lead to increased energy loss. Remedy as needed.

Recommendation: Contact a qualified professional.

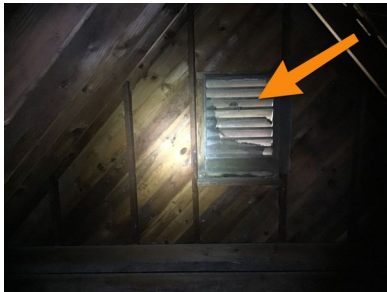
Gable vent screens were missing and/or deteriorated . Remedy as needed.

Recommendation: Contact a qualified roofing professional.

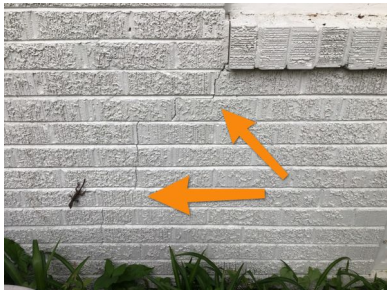
Cracked masonry or mortar may be cosmetic, but also may allow water into the wall which could damage the interior structure of the building. Cracks may grow with time at a constant (increasing or decreasing) rate and may open and close as seasons change. Remedy as needed.

Recommendation: Contact a qualified masonry professional.

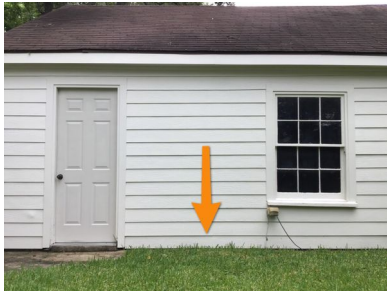
Siding should be a minimum of 6 inches above finished grade. Brick and stone should be a minimum of 4" above grade. Remedy as needed.

Recommendation: Contact a qualified professional.

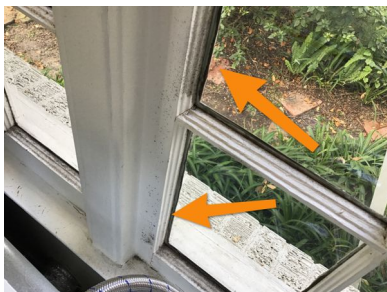
5: Interior: Possible Microbial Growth

Bryan & Bryan offers Indoor Air Quality testing. Speak with our office for further details and to see if this service might benefit you.

Recommendation: Contact a qualified professional.

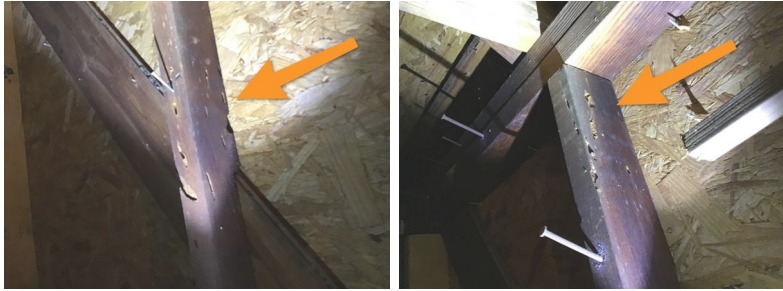
Extent of damage was not determined. Further evaluation by a qualified contractor is recommended.

Recommendation: Contact a qualified professional.

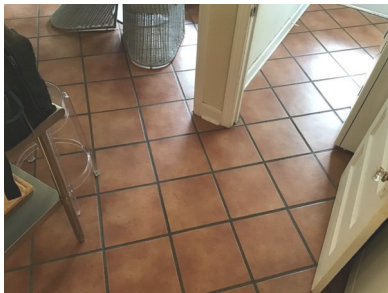
Squeaky subflooring is not uncommon and is usually caused by wood subflooring that isn't properly attached to the joists. These can generally be repaired by a flooring contractor.

Recommendation: Contact a qualified flooring contractor

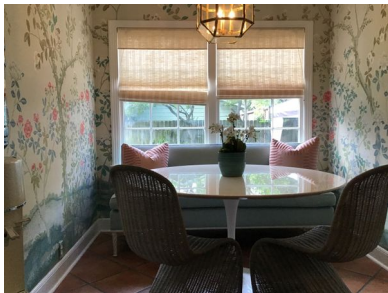
One or more windows are missing a screen or had a damaged screen. Replacement of screens is recommended.

Recommendation: Contact a qualified window repair/installation contractor.

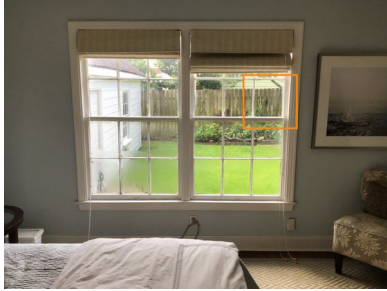
Cracked or broken glass panes were present. Remedy as needed.

Recommendation: Contact a qualified window repair/installation contractor.

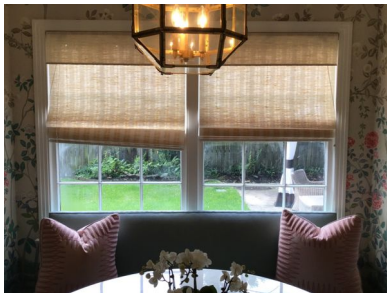
One or more windows were painted shut. Restoration of window functionality is recommended.

Recommendation: Contact a qualified window repair/installation contractor.

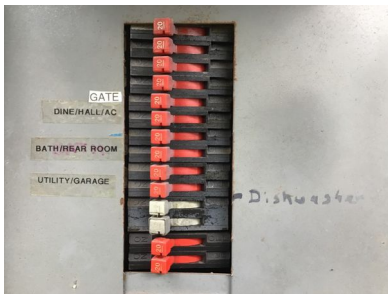
Circuits in the distribution panel were not properly labeled. Remedy as needed.

Recommendation: Contact a qualified electrical contractor.

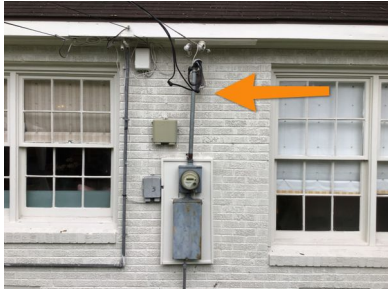
Service drop overhead wires are too low, not giving enough clearance. Contacting your local electric utility company or licensed electrician to see if they can remedy is recommended.

Recommendation: Contact a qualified electrical contractor.

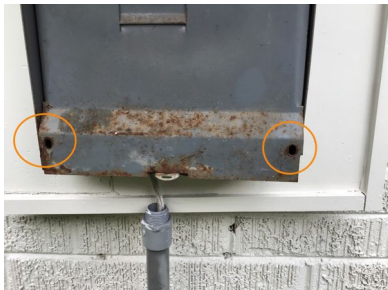
Screws that mount the cover to the electrical panel are missing. Remedy as needed.

Note: Blunt tipped screws designed for this application are recommended to prevent puncturing electrical wiring insulation.

Recommendation: Contact a qualified electrical contractor.

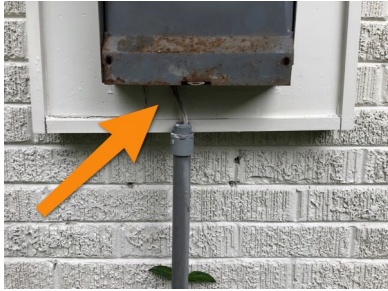
There was a gap in the conduit. Evaluation and/or remediation by a licensed electrician is recommended.

Recommendation: Contact your local utility company

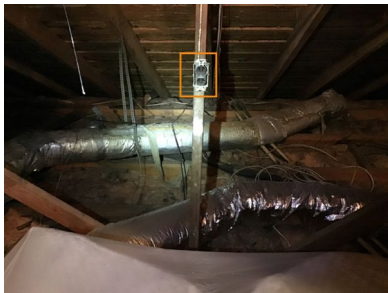
One or more receptacle/switch cover plates were missing or damaged. Replacement of cover plates is recommended for safety. Evaluation and remediation by a qualified electrical contractor is recommended.

Recommendation: Contact a qualified electrical contractor.

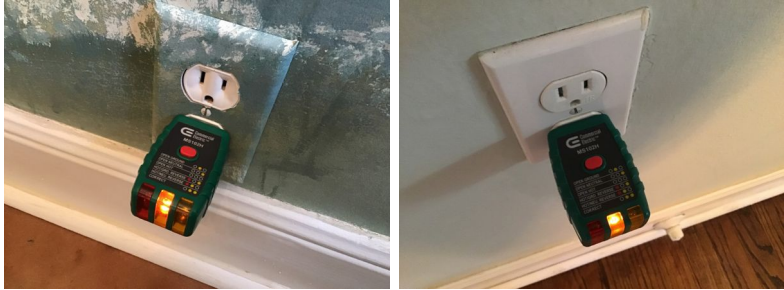
Receptacle(s) are not wired correctly. Evaluate and remedy as needed.

Recommendation: Contact a qualified electrical contractor.

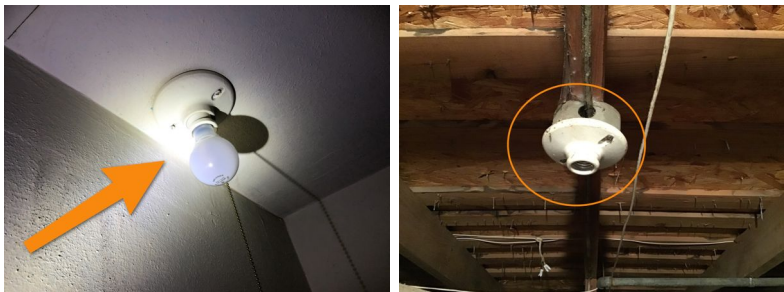
One or more light fixtures were not operating at time of inspection. Cause was not determined. Remedy as needed.

Recommendation: Contact a qualified electrical contractor.

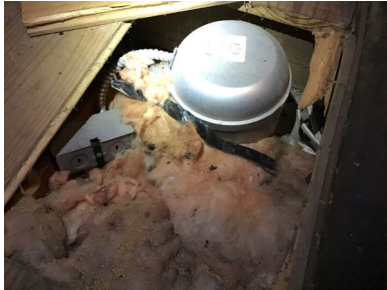
Insulation was too close or touching can lights. Insulation should be removed from can lights in attic. A 3-inch clearance is generally required for safety. Remedy as needed.

Recommendation: Contact a qualified electrical contractor.

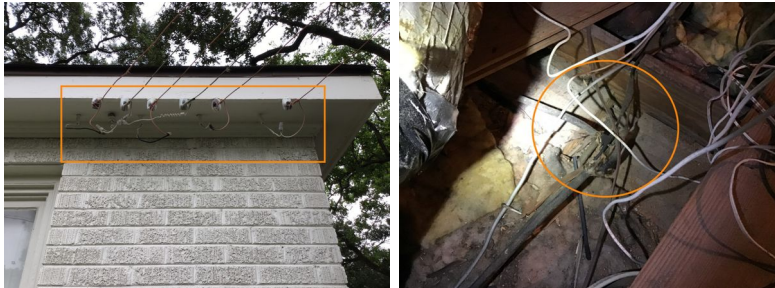
Exposed wire connections, splices, and ends were present. All wire connections and charged wires with exposed ends and splices should be covered in junction boxes for safety. Evaluation and/or remediation by a licensed electrician is recommended.

Recommendation: Contact a qualified electrical contractor.

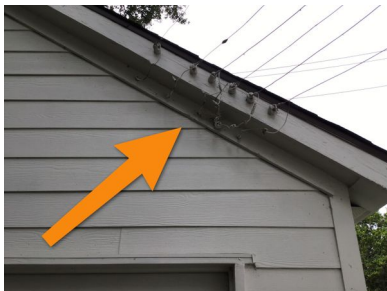
Exterior wiring is not properly installed inside wire conduit for protection from the elements. Evaluation and/or remediation by a licensed electrician is recommended.

Recommendation: Contact a qualified electrical contractor.

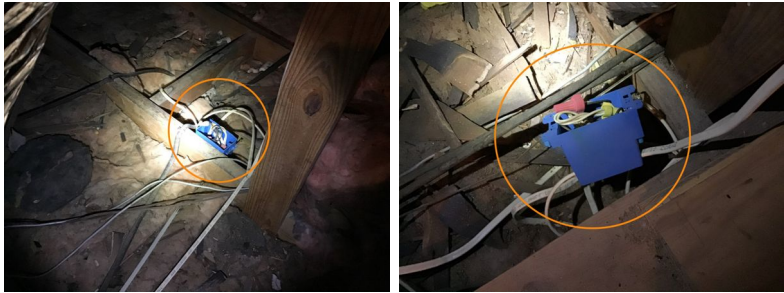
An open junction box was present. Remedy as needed.

Recommendation: Recommended DIY Project

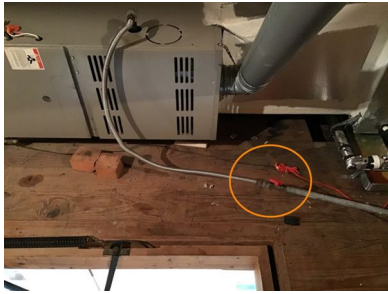
Sediment traps are installed to help prevent sediment in the gas piping from getting into the gas valve or burner area of an appliance and causing problems. Remedy as needed.

Recommendation: Contact a qualified professional.

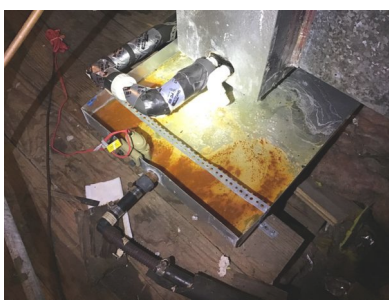
Standing water was present in the A/C emergency overflow pan. This can indicate a dirty or restricted condensate system. Servicing by a licensed HVAC contractor is recommended.

Recommendation: Contact a qualified HVAC professional.

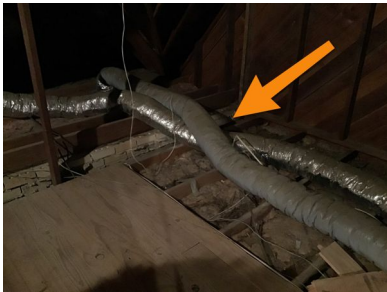
Ducts were resting on each other. This can result in condensation forming between the two sections of ductwork. Remedy as needed.

Recommendation: Contact a qualified professional.

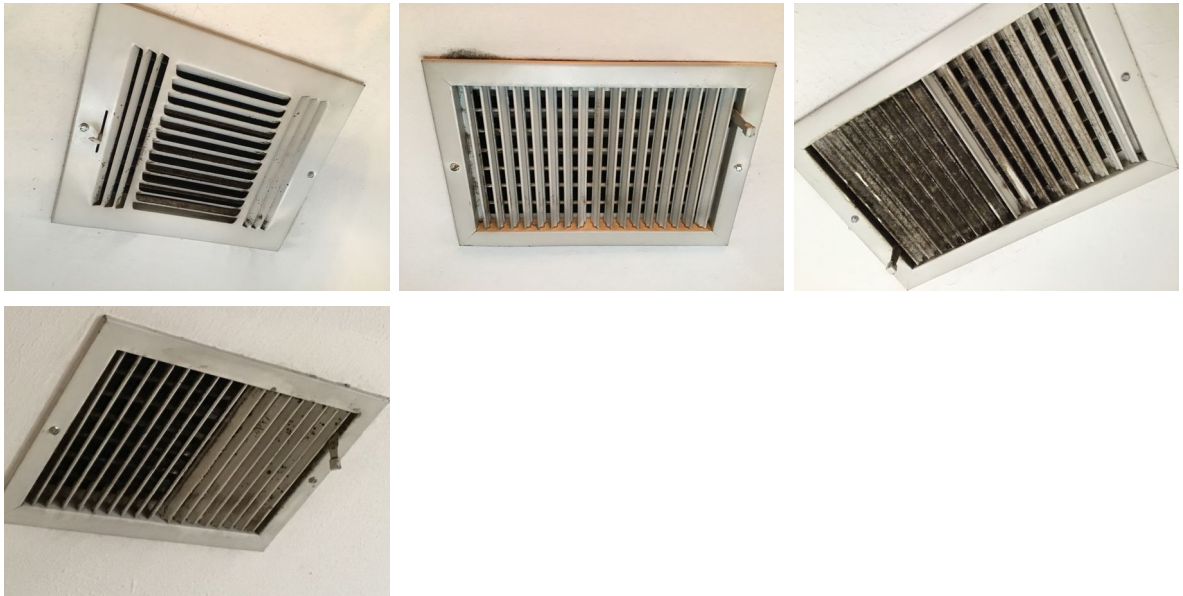
4: Visible substance observed on Supply Register

A dark substance was observed on an air supply register in the home. Servicing and cleaning of the system by a qualified HVAC contractor is recommended, as this can be a result of excessive water vapor/humidity in the conditioned air.

Recommendation: Contact a qualified HVAC professional.

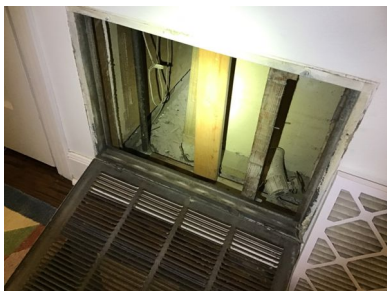
5: Return Air System: Dust or Debris In Chase

Dust particles can clog cooling coils and may lead to coil corrosion over time. Proper cleaning and evaluation of the return air shaft, ducts, and coils is recommended.

Recommendation: Contact a qualified HVAC professional.

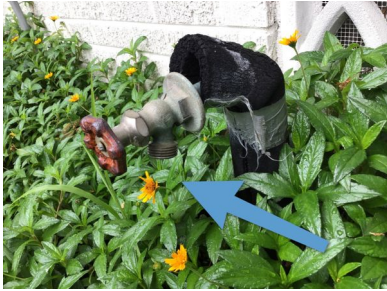
1: Hose bibb (outdoor faucet): Backflow Prevention Missing

A hose bibb was missing a backflow preventer. These devices are inexpensive and easily installed, and help to prevent contamination of potable water. Remedy as needed.

Recommendation: Contact a handyman or DIY project

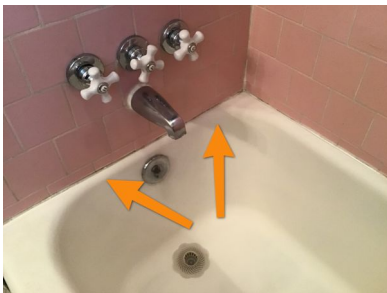
2: Shower: Missing/Deteriorated Caulking or Grout

For Example: hall bath

Recommendation: Contact a qualified professional.

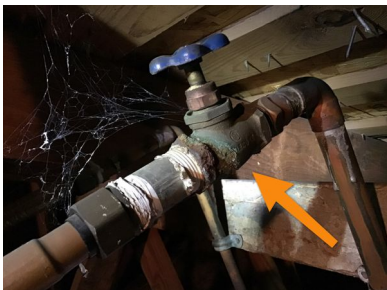
4: Supply Piping: Corroded supply valve

One or more supply valves were corroded. Remedy as needed.

Recommendation: Contact a qualified plumbing contractor.

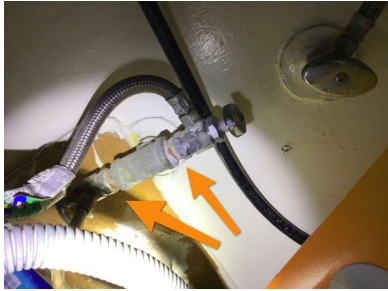
5: Supply piping: Corrosion on Galvanized Pipes

Galvanized water supply piping was corroded. The extent of rusting on the piping is not determined. Evaluation and/or remediation by a licensed plumber is recommended.

Recommendation: Contact a qualified plumbing contractor.

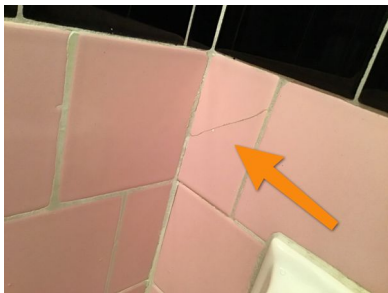
6: Cracked Tile

For Example: hall bath shower enclosure

Recommendation: Contact a qualified professional.

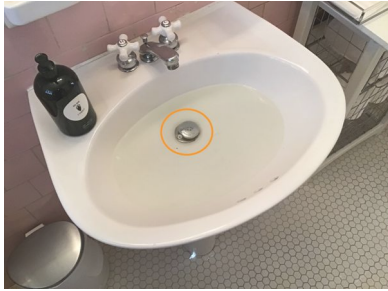
Poor/slow drainage was observed at time of inspection. Evaluation and/or remediation by a licensed plumber is recommended.

Recommendation: Contact a qualified plumbing contractor.

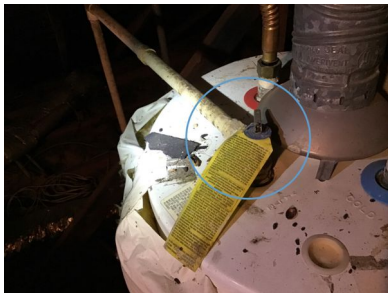
1: TPR Valve Note: Replacement may be needed

The manufacturer recommends replacement of the pressure relief valve every three years to ensure proper emergency function. The inspector does not test TPR valves due to safety hazard or possible damage to unit.

Recommendation: Contact a qualified professional.

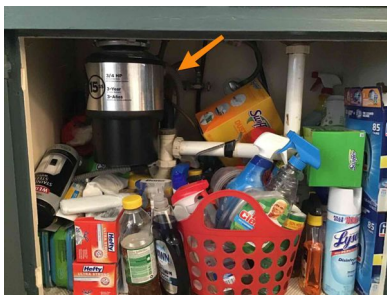
An anti-siphon loop was not installed at the drain hose under the sink. Most manufacturers specifications suggest that in the absence of an air gap, the drain be looped to prevent back washing from the sink.

Recommendation: Contact a qualified professional.

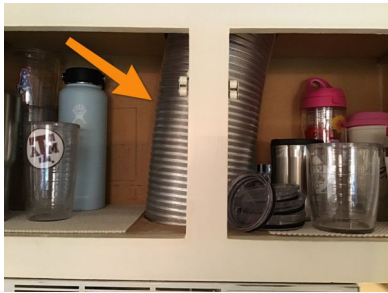
1: Flex Vent Pipe Improper

Section(s) of the kitchen exhaust vent pipe were corrugated. Smooth-walled material is recommended to prevent grease build-up inside the vent pipe.

Recommendation: Contact a qualified professional.

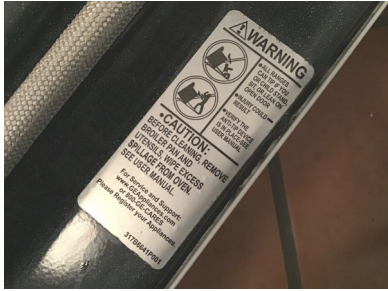
1: Missing Anti-Tip Device

There was no anti-tipping device installed on the oven/range to prevent tipping if the door is climbed on while opened. This is a possible safety hazard. Evaluate and remedy as needed.

Recommendation: Contact a qualified professional.

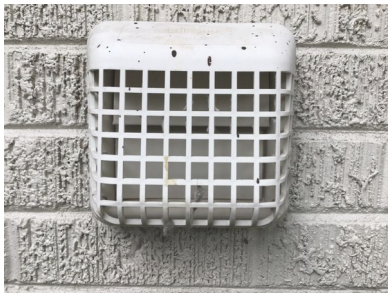
1: Cleaning Vent Recommended

Cleaning of the dryer exhaust vent is recommended as normal maintenance and to prevent excessive lint build-up in the line.

Recommendation: Contact a qualified professional.

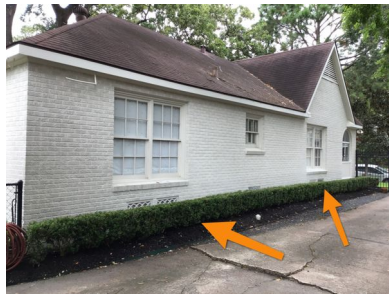
Sprinkler heads were spraying the structure. Sprinkler heads should be adjusted to spray away from the structure(s). Remedy as needed.

Recommendation: Contact a qualified professional.
