Moisture Assessment Report- Reinspection

809 Willard St.
Houston, TX 77006
07/19/18

Moisture Inspection Summary-Reinspection

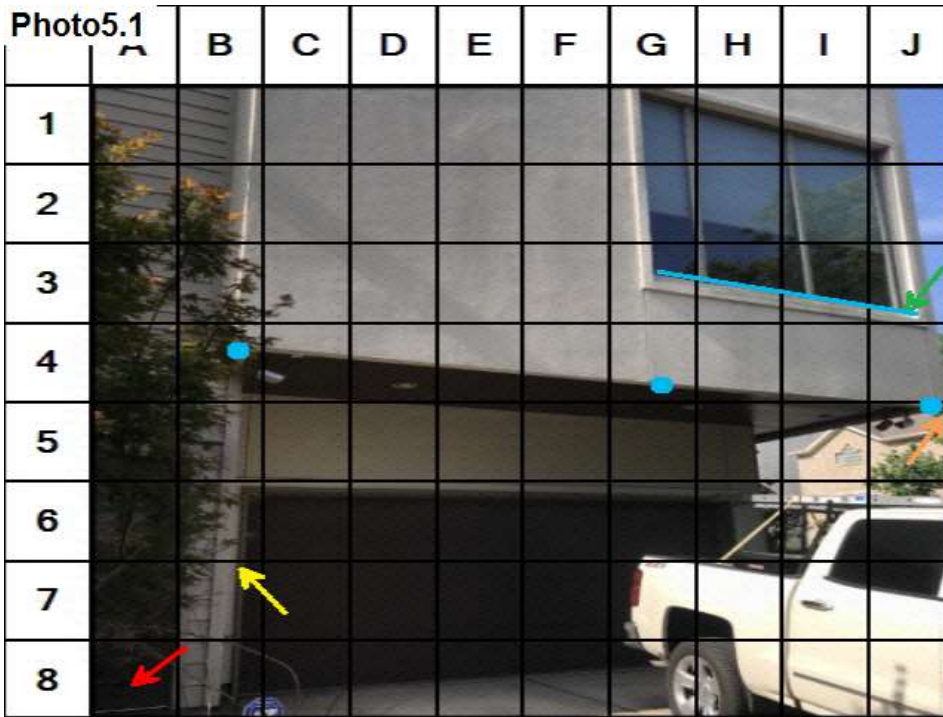
- Assess and reseal all windows, doors, flashing terminations and penetrations.
- Aged sealant joint noted at garage door. See detail #5.2. It is suggested to reseal as needed.

Reseal garage door as needed.

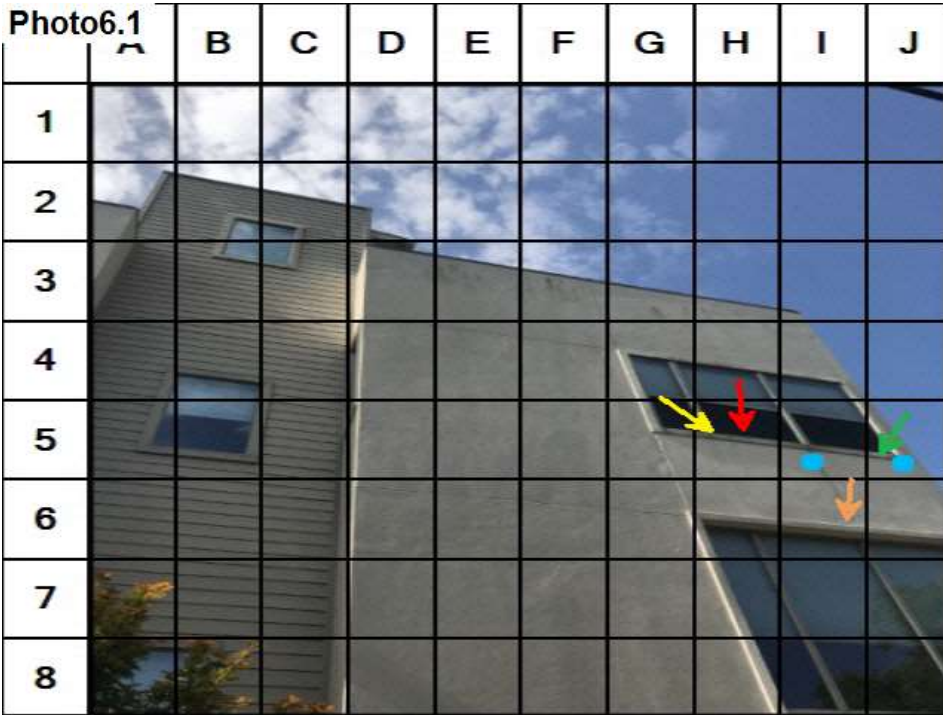
- It is suggested to apply elastomeric coating on top of semi-flat wall to minimize moisture intrusion. See detail #5.6.
- Sealant joints at windows are aged and starting to separate. See detail #5.6, 6.2 and 6.3. Assess all window frames, miters and mullions and reseal as needed.

Reseal windows as needed.

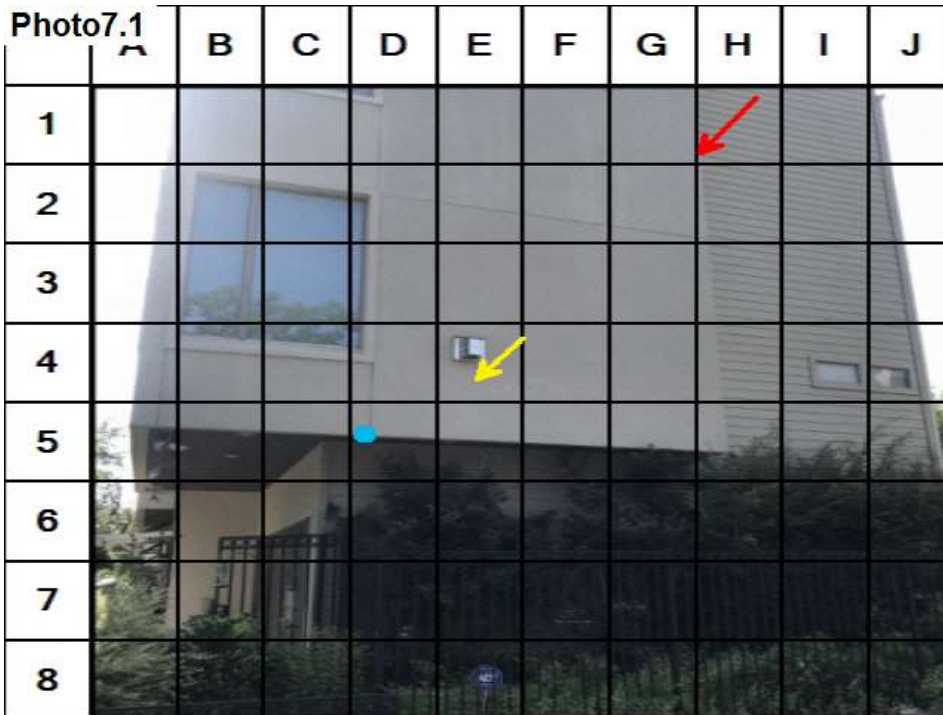
Photo7.2
 Hairline cracks are present.

- Hairline crack is present. See detail #7.2. To temporarily cover hairline cracks in the future, it is suggested to re-paint the entirety of home with an elastomeric paint.

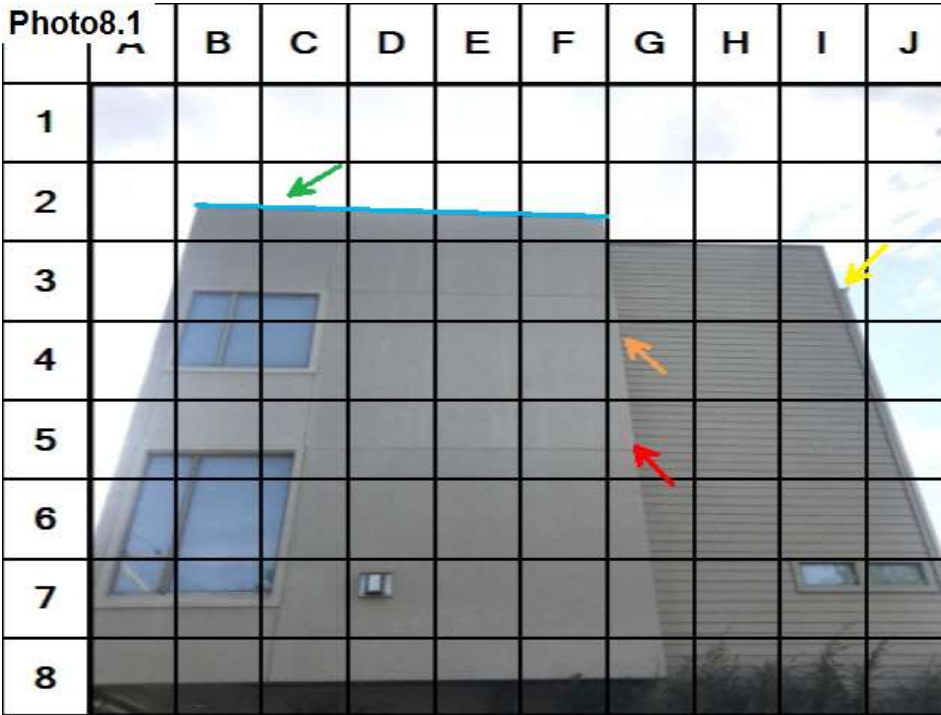
- Sealant separation noted at siding transitions. See detail #7.3. Reseal as needed.
- Crack is present at corner of wall. See detail #8.2. Seal / Repair as needed.

Seal / Repair crack as needed.
