ALLTEX HOME INSPECTIONS

PROPERTY INSPECTION REPORT

Concerning: 809 WILLARD ST., Houston, TX 77006
(Address or Other Identification of Inspected Property)

By: Stephen Perry, Lic #7854 08/31/2020
(Name and License Number of Inspector) (Date)

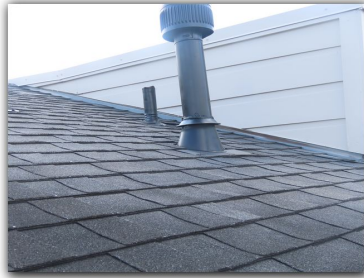
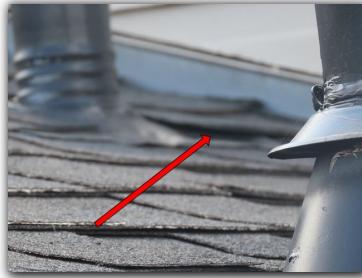
TPO ROOF BELOW THE DECKING THAT IS NOT VISIBLE AND UNABLE TO INSPECT.

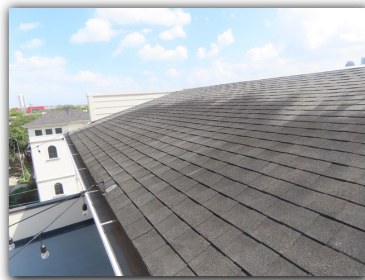
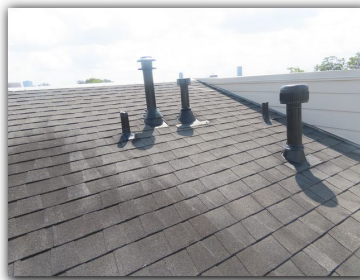
- **EXCESSIVE GRANULE LOSS IN SOME LOCATIONS DUE TO AGE THAT NEEDS EVALUATION BY A ROOFING EXPERT.**

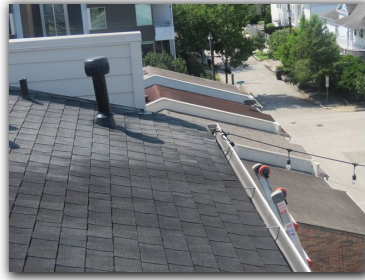
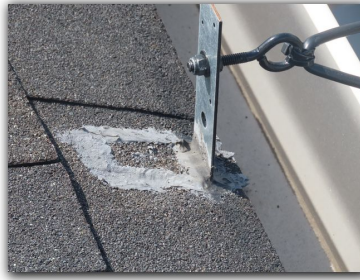
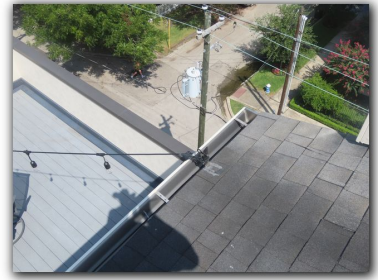
- **THE UPPER BACK RIDGE OF PITCHED ROOF NEEDS SEALANT APPLIED AT THE LAPS AND ALSO AT THE "PARAPET WALL" METAL CAPS AS WELL IN SOME LOCATIONS.**

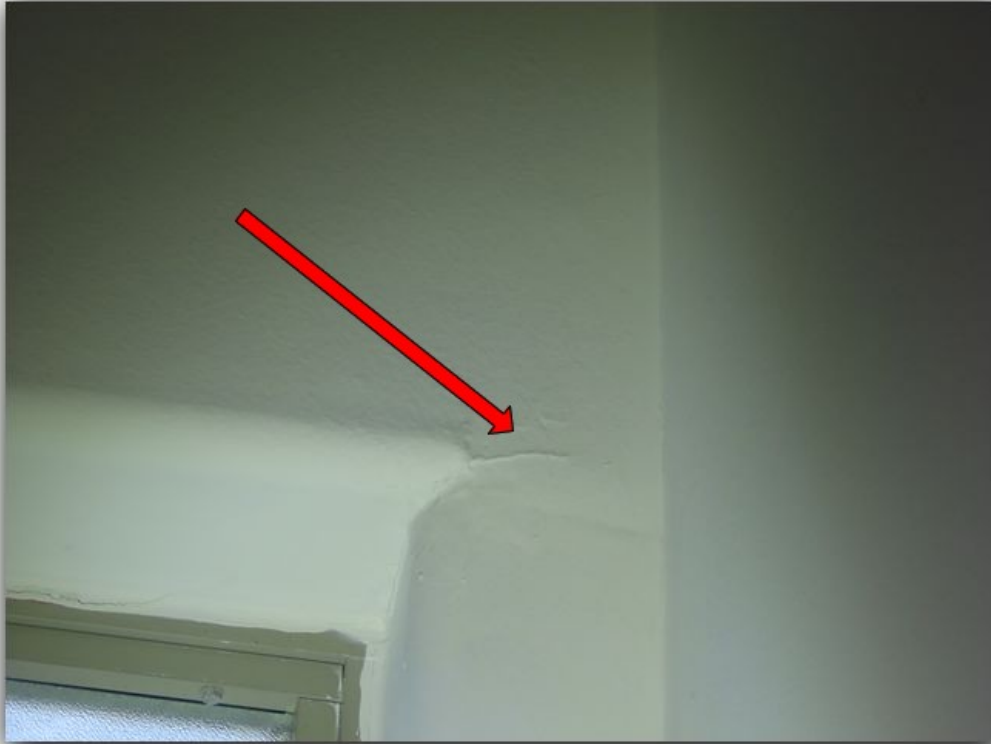
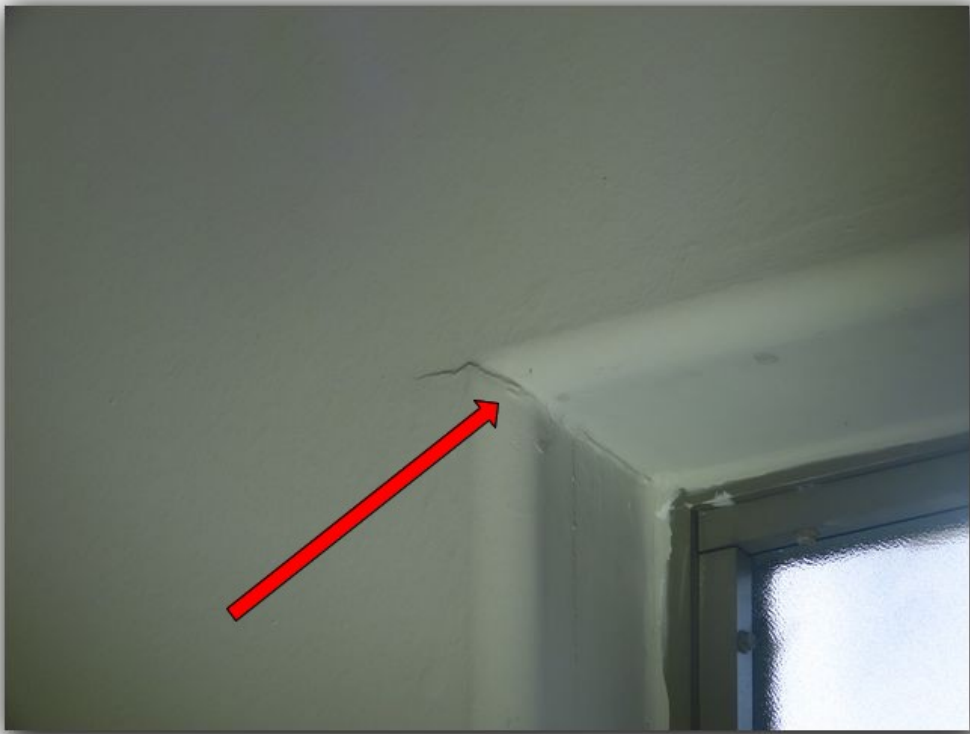
- **SOME PATCHWORK PAINTED OVER AT THE LOWER WALLS AND NEAR THE**

RIGHT CORNER WINDOW FRAME AND WALL CORNER THAT IS THE STUCCO SIDE/FRONT WALL OF THE HOME AS WELL. RECOMMEND AN INVASIVE STUCCO INSPECTION AND MOLD INSPECTION BE PERFORMED BY A LICENSED MOLD INSPECTOR AND STUCCO EXPERT TO ENSURE NO POTENTIAL FRAMING DAMAGE/WATER DAMAGE/MOLD IS PRESENT.(INFRARED CAMERA DID NOT SHOW ANY ACTIVE MOISTURE PRESENT)

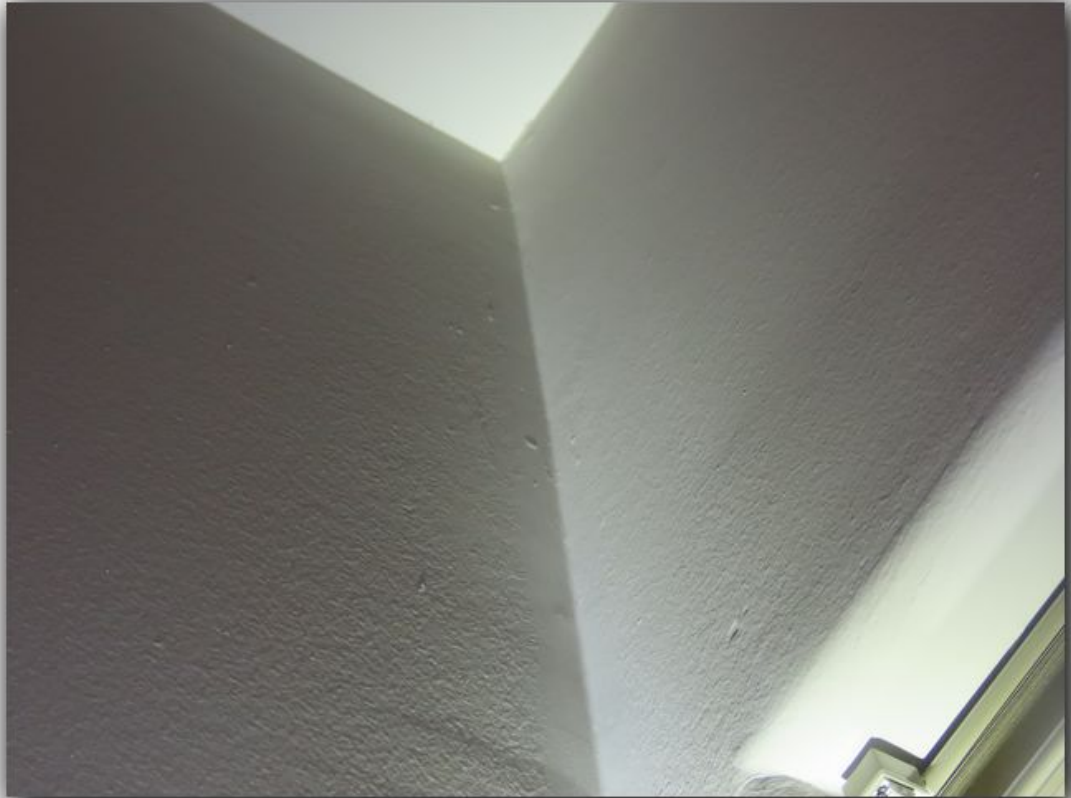
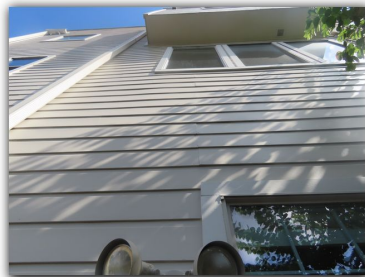
Some cracks at the Cement board siding in a few locations that can indicate some structural settlement that needs evaluation and repairs by a siding repair expert.

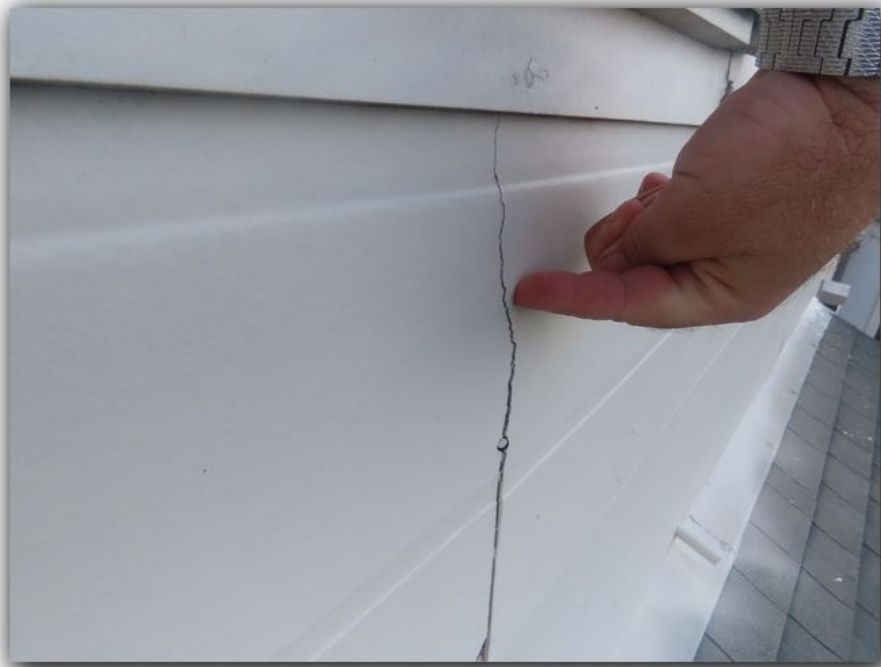
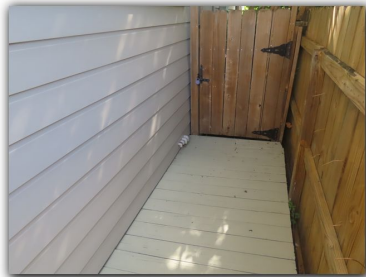
Caulking / sealant is separated or missing in some areas

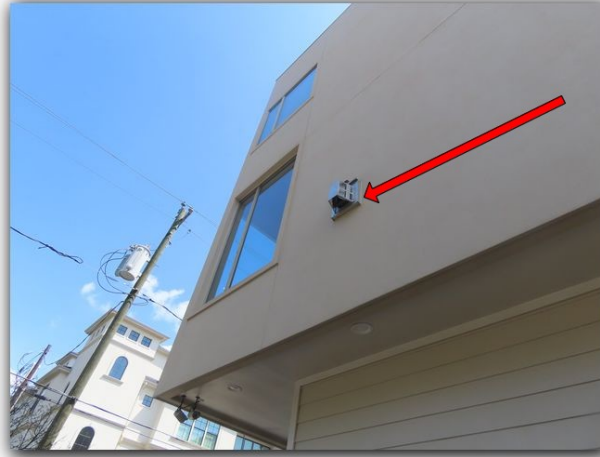
DEFICIENCY- THE FIREPLACE WALL VENT HAS SOME

AREAS THAT NEEDS ADDITIONAL CALKING APPLIED

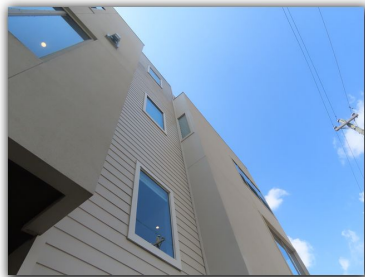
THERE IS RECENT CALKING THAT WAS APPLIED AND THE STUCCO APPEARS TO BE RECENTLY REFINISHED/PAINTED AND IN GOOD OVERALL CONDITION. THERE APPEARS TO BE SOME INTERIOR DRYWALL PATCHWORK BELOW THE DEN WINDOWS ON

THE FRONT SIDE AND ON THE MASTER BEDROOM WALL CORNER NEAR THE SIDE WINDOW; THE CONCERN IS WHAT THE STUCCO'S CONDITION WAS PRIOR TO THE RECENT WORK. TO ENSURE THERE WAS NO PREVIOUS MOISTURE PENETRATIONS OR DAMAGE INSIDE THE WALL IT WOULD BE A RECOMMENDATION ONLY TO HAVE AN INVASIVE STUCCO INSPECTION PERFORMED BY A STUCCO EXPERT TO ENSURE NO WATER RELATED DAMAGE IS PRESENT.

WINDOWS HAVE ALL BEEN RECENTLY CALKED/PAINTED AND INTERIOR WALLS RECENTLY PATCHED/PAINTED AND IT IS NOT POSSIBLE TO KNOW THE PREVIOUS CONDITIONS.THEREFORE HAVING A INVASIVE STUCCO INSPECTION CAN PROVIDE ASSURANCE THAT THERE IS NO HIDDEN DAMAGE PRESENT INSIDE THE WALL AND CAN BE VERY DIFFICULT OR SOMETIMES NOT POSSIBLE TO DETECT VISUALLY WITHOUT THE INVASIVE INSPECTION.

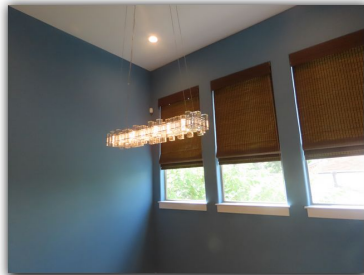
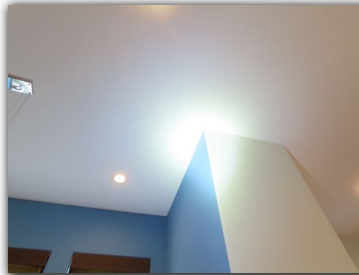
Ceiling cracks in some areas

Signs of structural settling

- **INDICATING STRUCTURAL SETTLEMENT THAT NEEDS TO BE PATCHED/FINISHED/TEXTURED AND MONITORED FOR ANY FURTHER CRACKING**

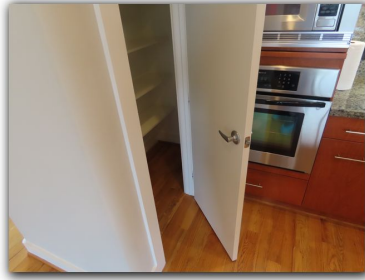
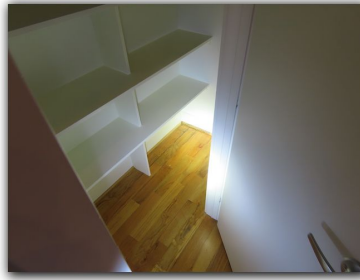
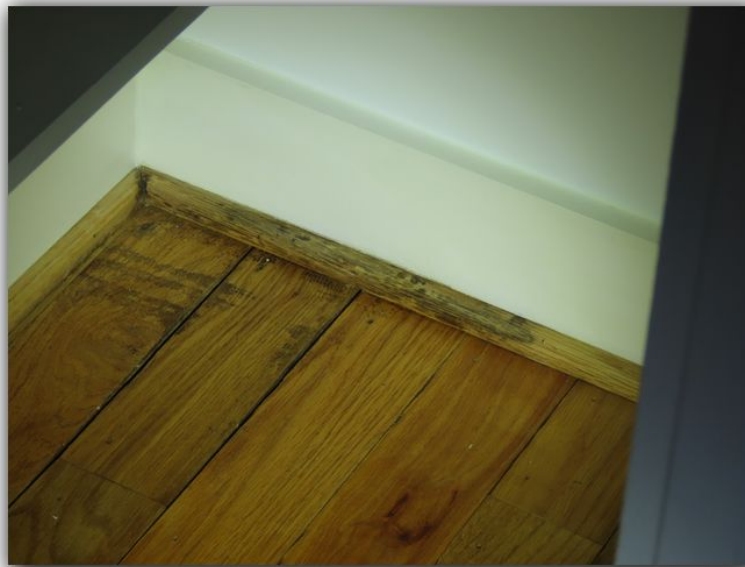
Water stains on ceiling

WATER DAMAGE ON THE HARDWOOD FLOORING IN THE PANTRY. AFTER RUNNING ALL THE PLUMBING IN THE KITCHEN AND BATHROOMS ABOVE THIS LOCATION DID NOT SHOW ANY ACTIVE MOISTURE WITH USE OF AN INFRARED CAMERA. INFRARED CAMERA DID NOT SHOW ANY ACTIVE MOISTURE IN ANY OTHER LOCATION OF THE HOME AS WELL. RECOMMEND FURTHER EVALUATION OF THE FLOORING BY A FLOORING REPAIR CONTRACTOR AND INSIDE THE WALL AS WELL. IN ADDITION. I DO RECOMMEND A MOLD INSPECTION BE PERFORMED BY A LICENSED MOLD INSPECTOR AS WELL.

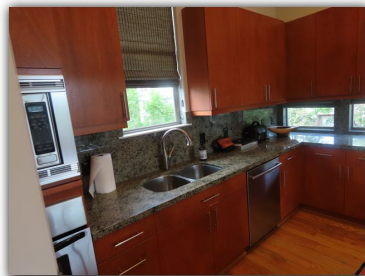
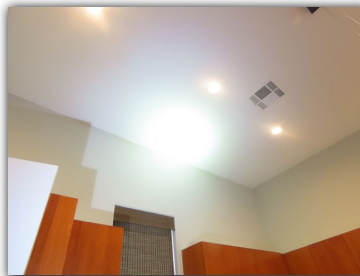
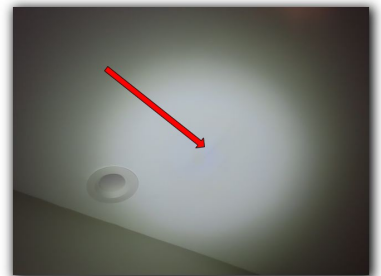
- **WATER STAINS PAINTED OVER ON THE KITCHEN CEILING THAT IS BELOW THE MASTER BATH; INFRARED CAMERA DID NOT SHOW ANY ACTIVE MOISTURE. RECOMMEND EVALUATION BY A PLUMBER TO ENSURE THERE ARE NO LEAKS PRESENT AND ALSO RECOMMEND A MOLD INSPECTION BY A LICENSED MOLD INSPECTOR.**

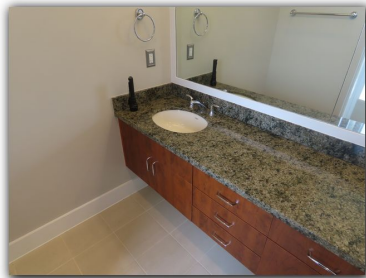
Floor cracks in some areas
SOME SEPARATIONS IN THE TILE FLOORING AND THE BASE BOARD/DOOR
FRAME TRIM AT THE MASTER BATHROOM THAT CAN INDICATE STRUCTURAL
SETTLEMENT.

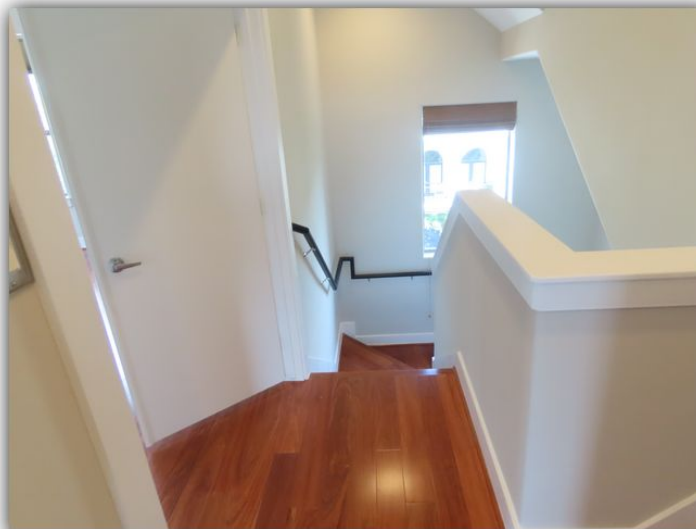
- **THE THIRD FLOOR FLOORING IS CREAKING WHEN WALKED ON MAKING EXCESSIVE NOISE THAT NEEDS EVALUATION AND REPAIRS BY A FLOORING REPAIR CONTRACTOR. THIS ALSO IS COMMON WITH STRUCTURAL SETTLEMENT.**

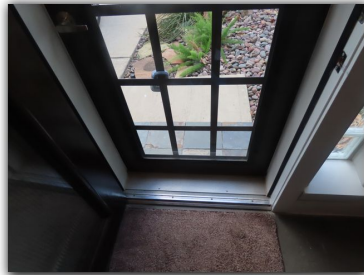
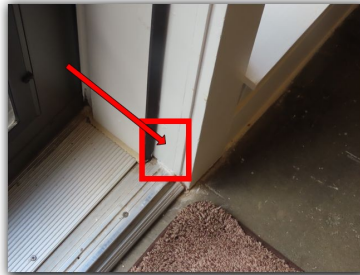
- **THE BOTTOM OF THE EXTERIOR DOOR FRAMES AT THE LOWER JAMBS NEEDS TO HAVE SMALL SQUARE FOAM RUBBER WEATHER STRIPS THAT DO PREVENT THE INSIDE JAMB FROM BECOMING ROTTED FROM WATER PENETRATIONS**

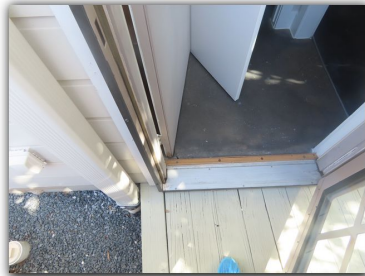
SOME DRY ROT AT THE BOTTOM OF THE BACK DOOR AND DOOR FRAME TRIM OF THE JAMB THAT NEEDS REPAIRS.

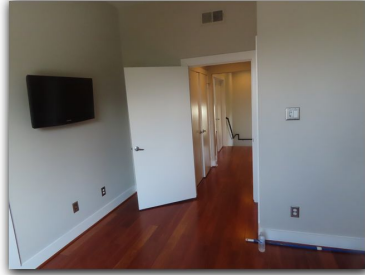
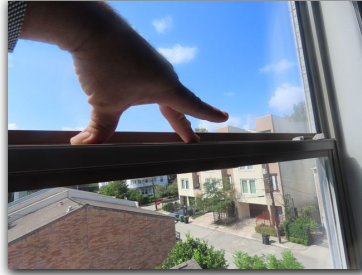
Some windows are difficult to open or close

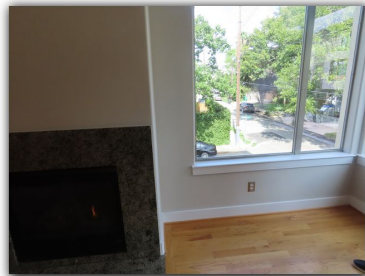
Some glass panes are loose, damaged or missing; THE DEN WINDOW ON THE RIGHT BACK SIDE WINDOW OF THE DEN HAS CHIPPED/DAMAGED GLAZING THAT NEEDS TO BE EVALUATED BY A WINDOW REPAIR EXPERT FOR REPAIRS OR POTENTIAL WINDOW REPLACEMENT.

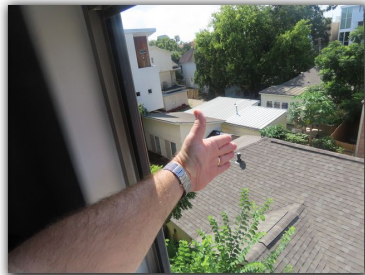
Some window / door screens are damaged or missing

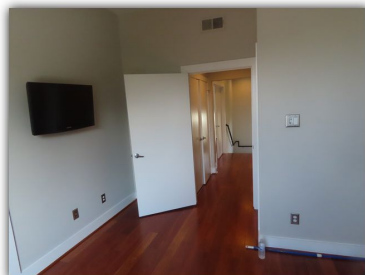
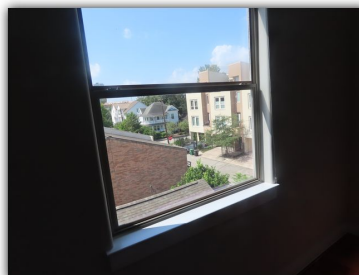
Thermal pane window seals have failed, moisture is present(THE UPSTAIRS BACK GUEST BEDROOM UPPER SASH AND THE DEN FRONT CENTER LARGE WINDOW BOTH APPEAR TO HAVE BROKEN SEALS. THIS REQUIRES WINDOW SASH REPLACEMENT WHEN THE SEALS ARE BROKEN. RECOMMEND EVALUATION BY A WINDOW REPAIR EXPERT.

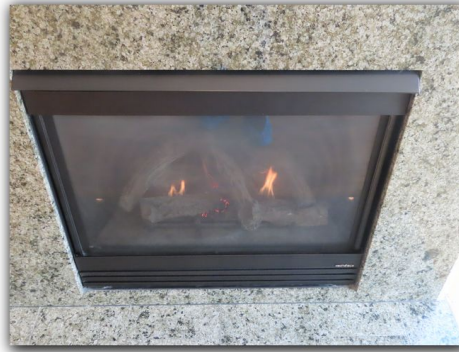
THE PRE-MANUFACTURED GAS FIREPLACE WAS TESTED AND FUNCTIONING PROPERLY

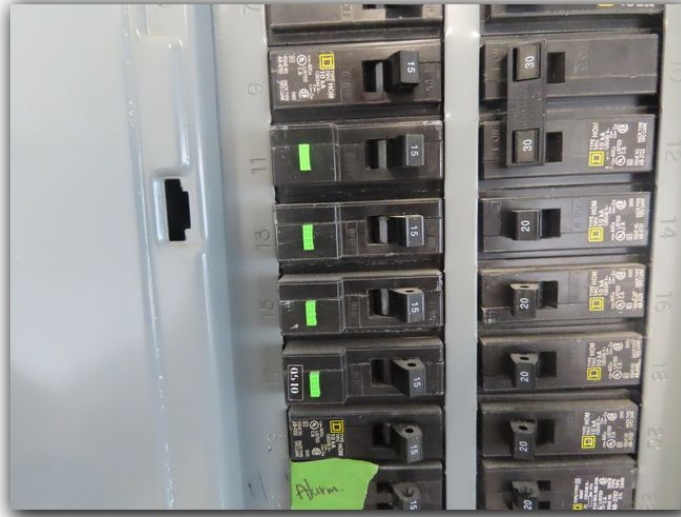
DEFICIENCY- ONE FRONT COVER SCREW IS MISSING AND NEEDS TO BE BLUNT ENDED SCREW AS REQUIRED.

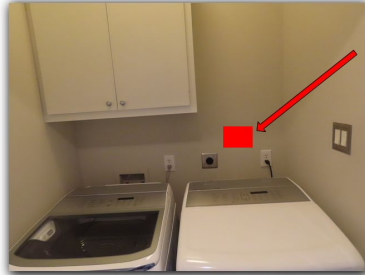
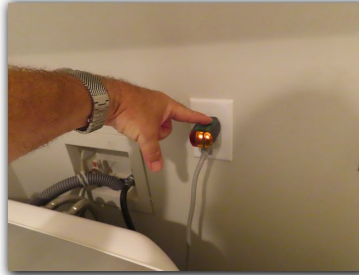
No GFCI/ARC Fault protection at one or more location. This is considered a recognized safety hazard.

NO GFCI PROTECTION FOR THE LAUNDRY ROOM OUTLETS AS IS NOW REQUIRED FOR NEW CONSTRUCTION.

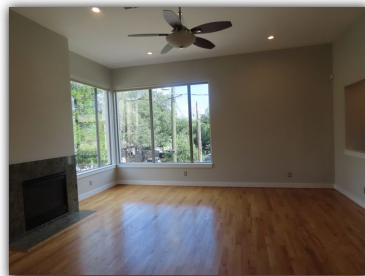
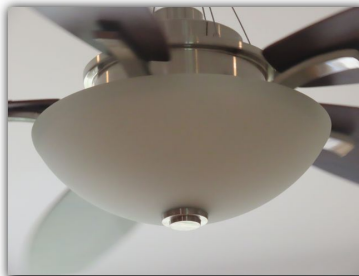
**Ceiling fans inoperable or in need of repair
THE DEN FAN LIGHT DID NOT FUNCTION.**

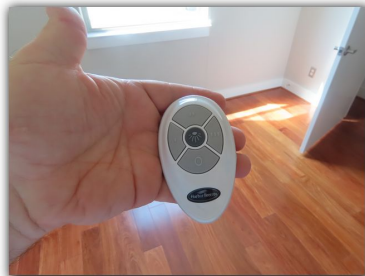
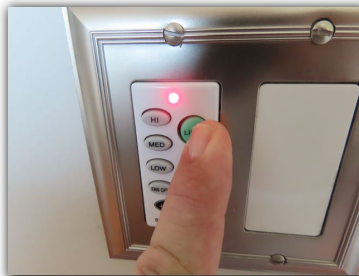
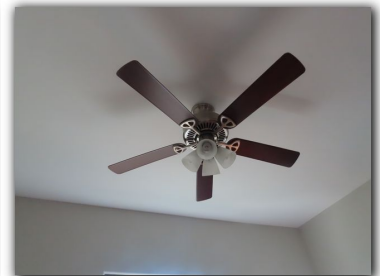
• **THE UPSTAIRS BACK GUEST BEDROOM FAN WAS NOT FUNCTIONING; IN NEED OF REPAIR BY AN ELECTRICIAN.**

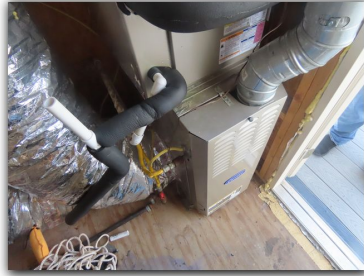
DEFICIENCY- Air handler plenum is not

**properly sealed(UPSTAIRS) WITH
CONDENSATION PRESENT; IN NEED OF REPAIR
BY A LICENSED HVAC PROFESSIONAL.**

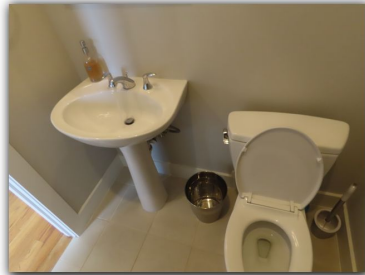
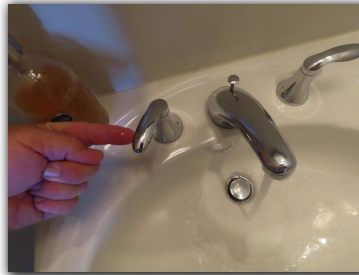
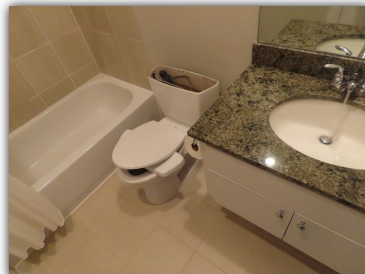
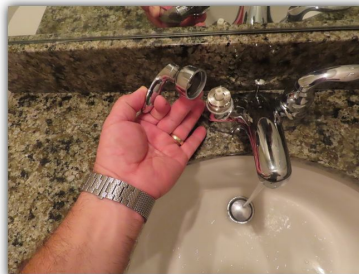
- **SEVERAL SINK FIXTURE HANDLES ARE HARD TO TURN ON AND OFF; IN NEED OF REPAIR BY A PLUMBER.**

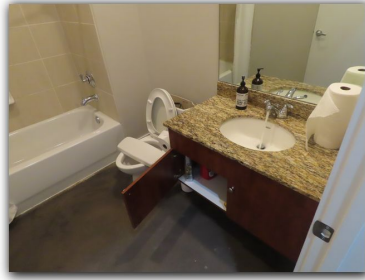
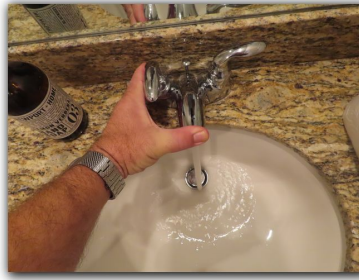
- **THE FIRST FLOOR GUEST BATH SINK FIXTURE IS LOOSE AT THE COUNTER TOP**

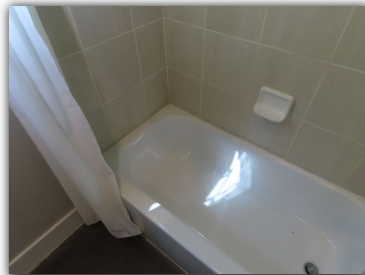
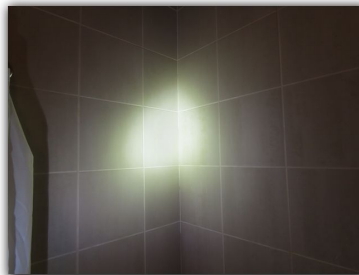
Caulking or grout missing or damaged(SEVERAL ENCLOSURES OF THE TUBS AND SHOWER, AND COMMON WITH STRUCTURAL SETTLEMENT)

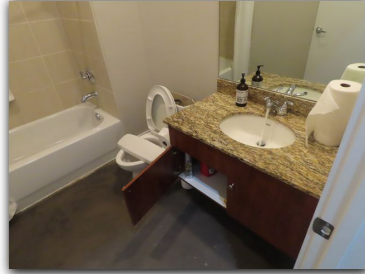
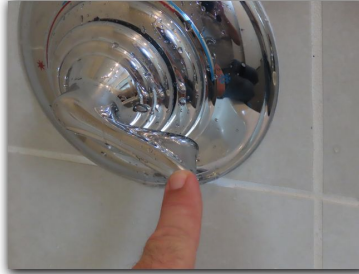
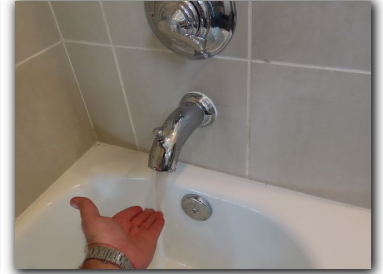
Hot and cold water reversed(FIRST FLOOR GUEST BATH)
**HOT SHOULD BE ON THE LEFT SIDE NOT THE RIGHT;
IN NEED OF REPAIR BY A PLUMBER.**

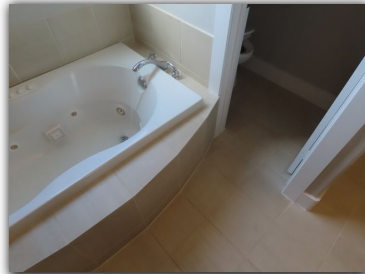
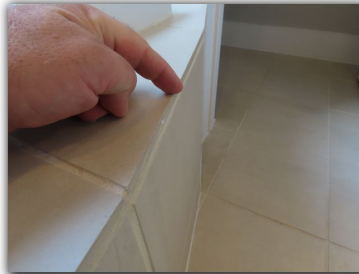
- **THE TILE ON THE MASTER TUB ENCLOSURE ON THE OUTER EDGE IS VERY SHARP AND A SAFETY HAZARD.**

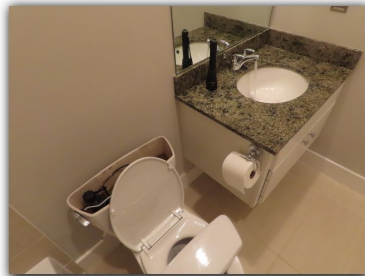
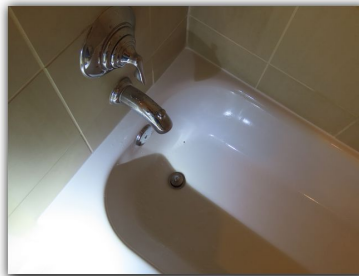
- **BATHTUBS UPSTAIRS GUEST ROOM AND GROUND FLOOR GUEST BATH HAVE CHIPPED ENAMEL**

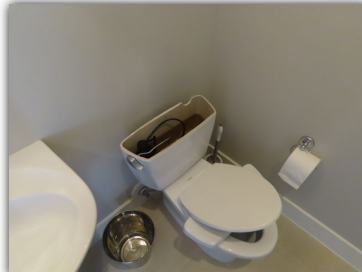
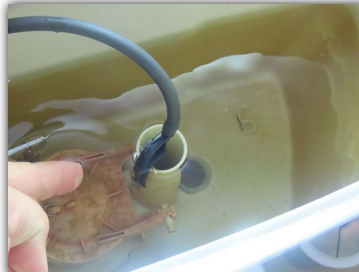
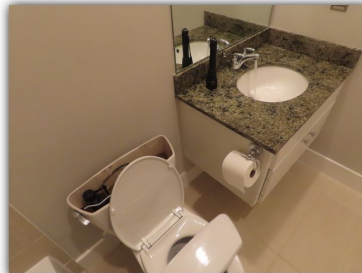
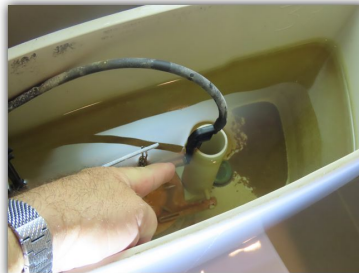
Tank water level is too high(SEVERAL LOCATIONS)

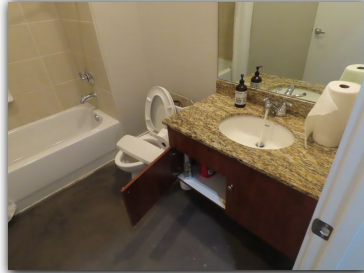
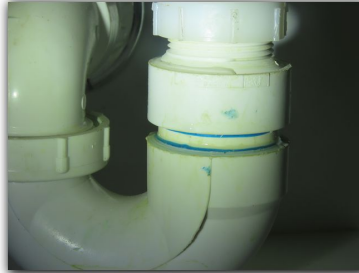
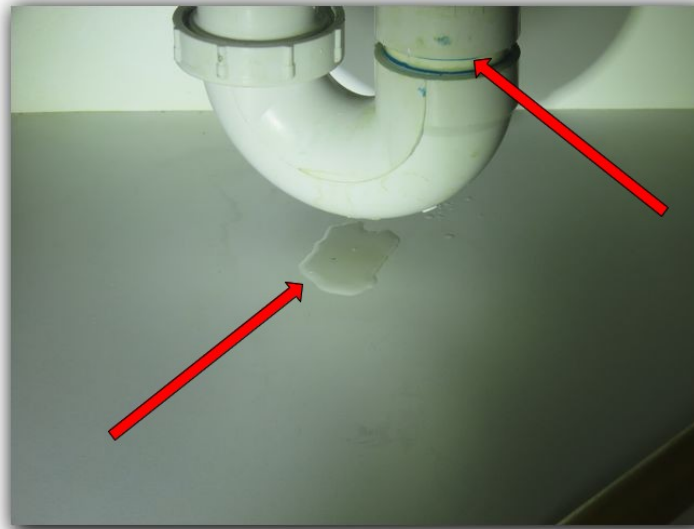
P-TRAP DRAIN LEAKS FROM THE GROUND LEVEL GUEST BATH SINK THAT NEEDS REPAIRS BY A PLUMBER.

IT IS RECOMMENDED TO HAVE A DRAIN INSPECTION PERFORMED BY A LICENSED PLUMBER/DRAIN INSPECTOR THAT INCLUDES A HYDROSTATIC TEST AND CAMERA INSPECTION THAT CAN DETERMINE IF THERE IS ANY POSSIBLE LEAKS IN THE DRAIN SYSTEM AND UNDER GROUND AND SLAB OUT TOWARDS THE MAIN DRAIN TO THE SEWER AS WELL. THIS IS OUTSIDE THE SCOPE OF THE INSPECTION AND CAN ONLY BE PROPERLY DETERMINED BY A SPECIALIZED TEST DONE BY A PLUMBER.

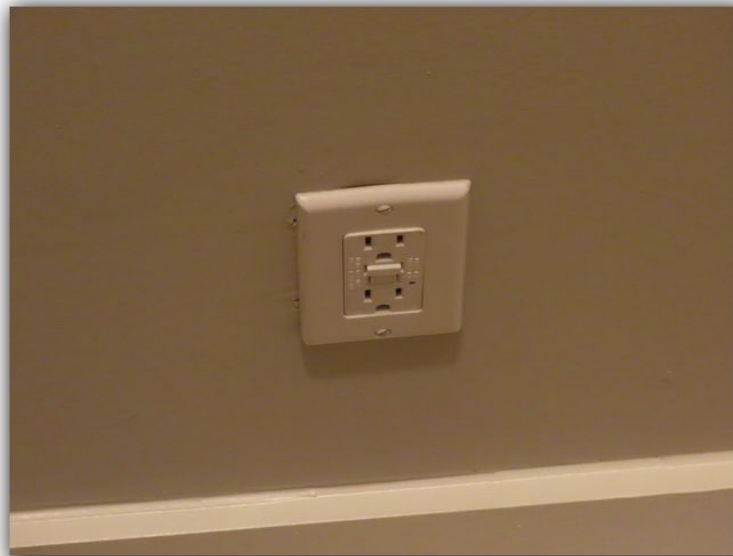
Deficiency- Vacuum switch does not operate/ THE SWITCH WILL NOT TURN THE TUB OFF AND WAS PREVIOUSLY BEING TURNED OFF AT THE GFCI OUTLET IN THE POWDER ROOM. IN NEED OF REPAIR.

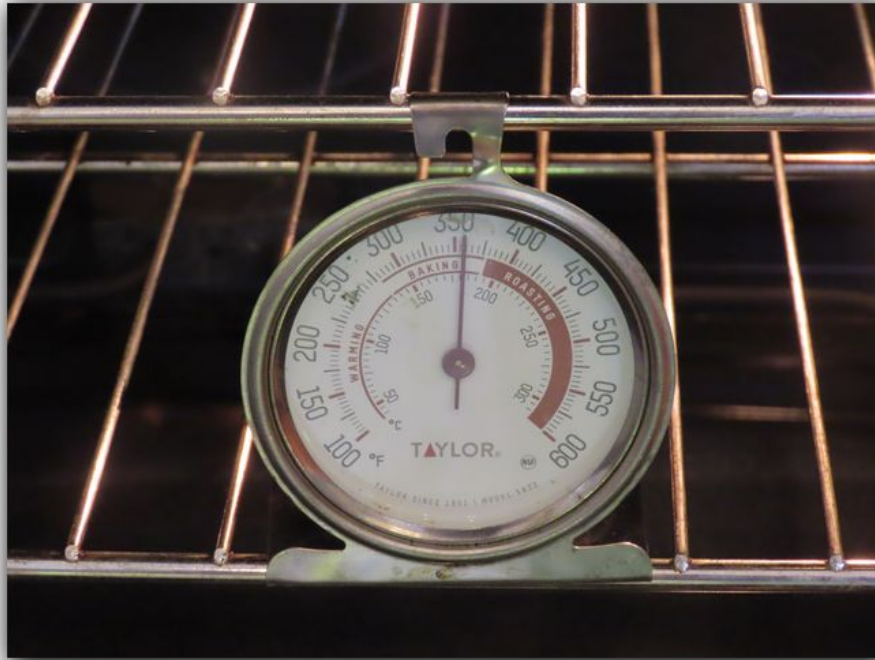
THE OVEN IS LOOSE INSIDE THE WALL AND NEEDS TO BE SECURED AND THE DIGITAL DISPLAY FOR SETTING THE OVEN TEMP. DID NOT FUNCTION FOR THE "ZERO" DIGIT ALL OTHER DIGITS DID FUNCTION FINE BUT NOT ZERO. HAD TO SET THE TEMP TO 351 RATHER THAN 350 FOR TESTING THE OVEN. IN NEED OF EVALAUTION AND REPAIRS BY AN APPLIANCE REPAIR PERSON.
