**Better Residential Home Inspections, Inc.**

## PROPERTY INSPECTION REPORT

**Concerning:** 15831 Chimney Rock Rd, Missouri City, 77489  
(Address or Other Identification of Inspected Property)

**Report Identification: 181004A**

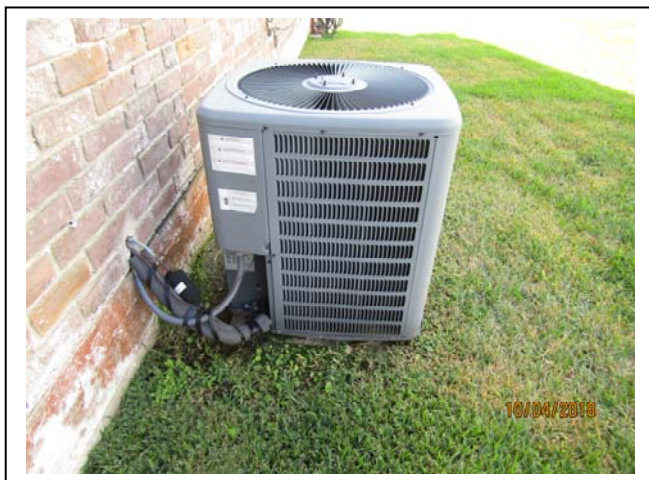
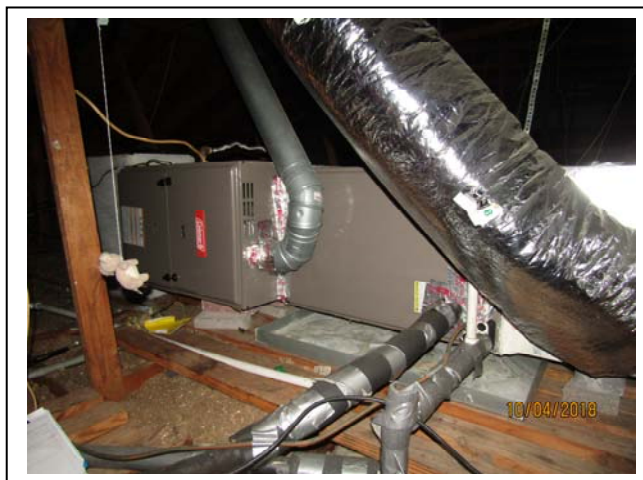
**NOTE:** The temperature drop measured across the evaporator coil of air conditioning system should be between approximately 15 and 22 degrees. This test is minimal and only design to determine if the system is cooling within a normal set of temperature ranges (*temperature ranges may vary with different temperature gauges, personnel, or manufacturer's recommendations*).

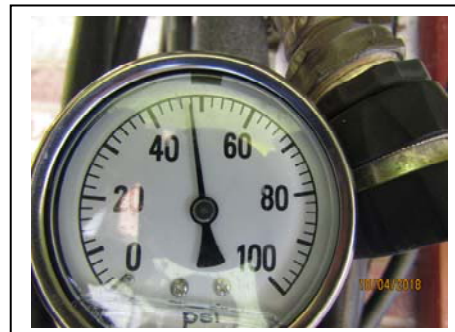
Static water pressure reading: **Approximately 48 psi**

Comments: **OPERATIONAL**
