Special Consult

1516868-SCI-1-TDF

Address: 23434 Dukes Run Drive, Harris County
Project: Breckenridge Forest Section 10
Lot/Blk: 3/2 Plan: 1650 v4 B R
Client: Express Homes Houston North Strand: 1516868R2
Complete: Mar 18, 2019 4:30 PM PO: PO 241074
Structure: Main House
Notified:

Owner is concerned that the cracks in the hall bath tile relates to foundation performance. Some recent repairs in the walls were not able to be photographed , but current defects are attached. Also elevations were taken of the floor surface.

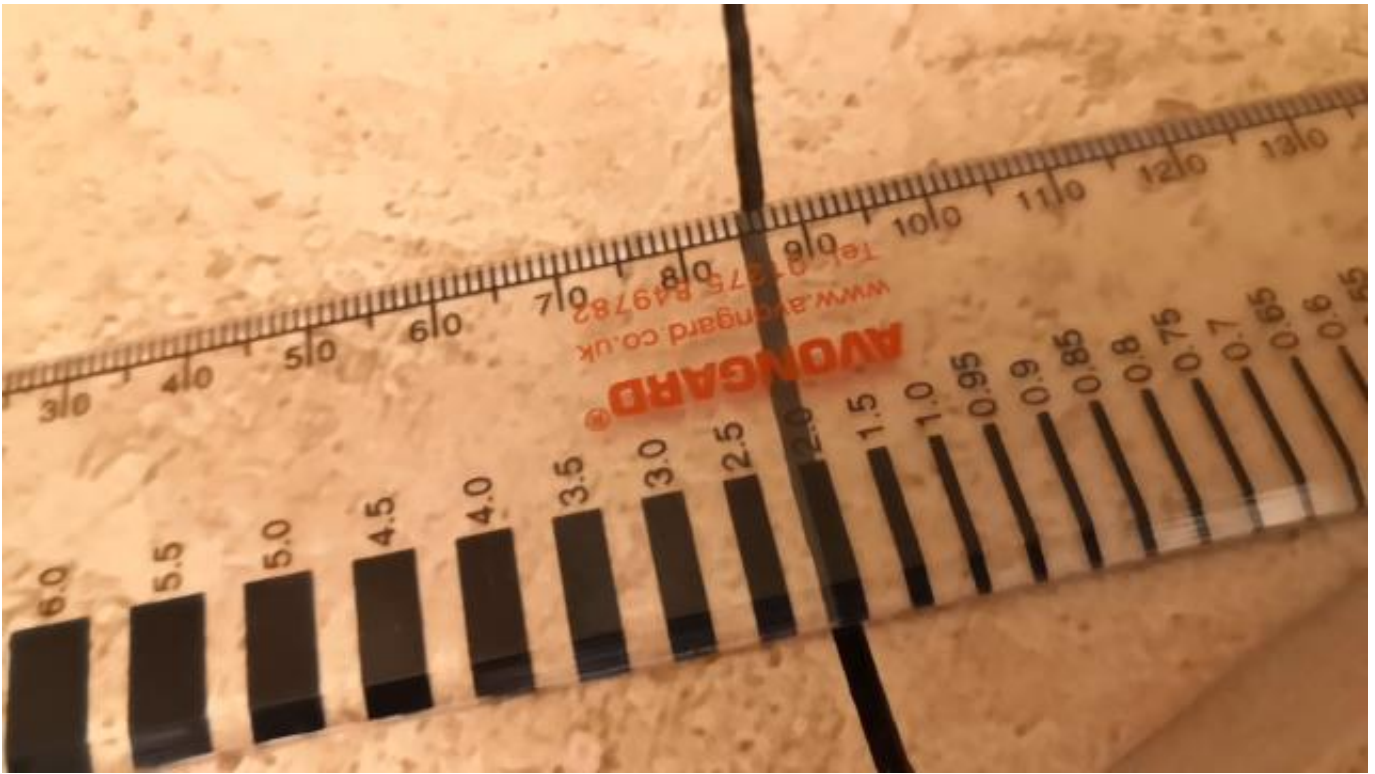
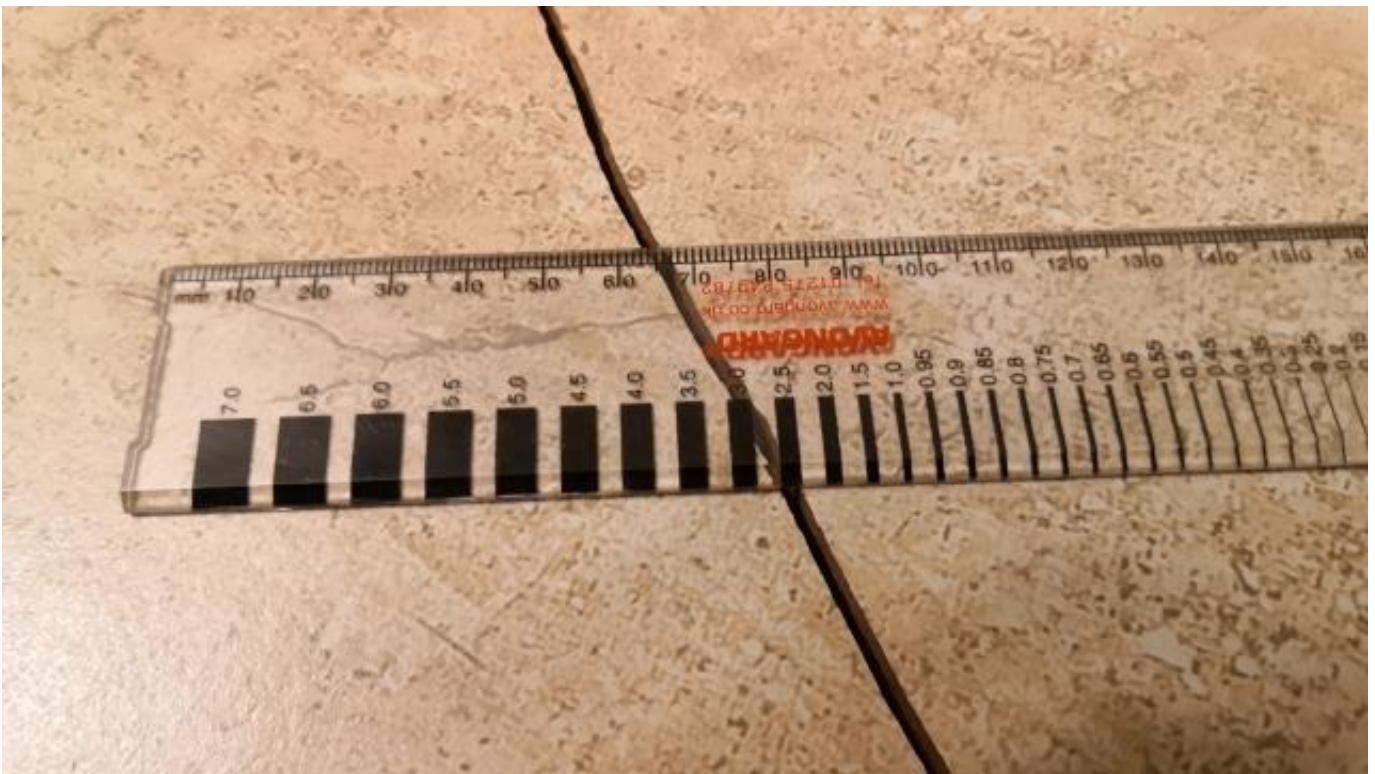
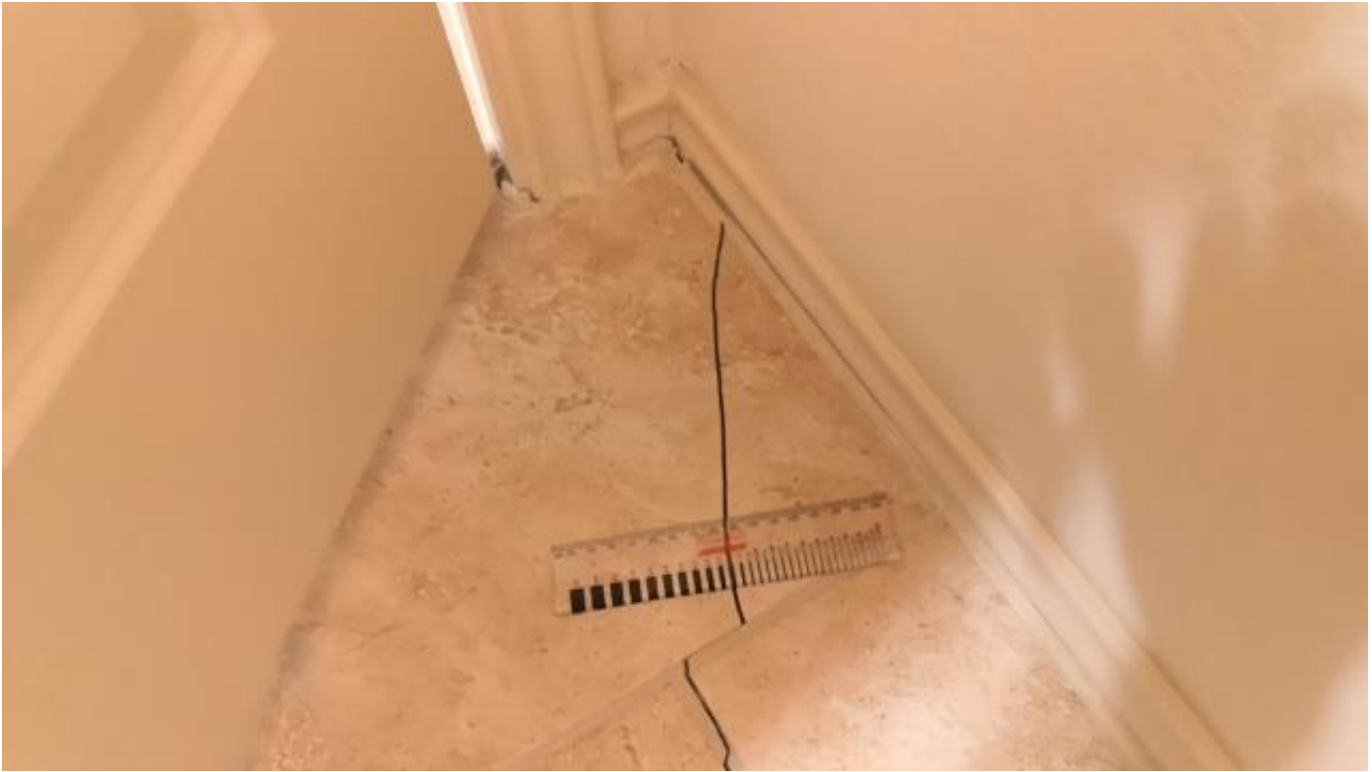
PIC 1 - main concern is this tile crack

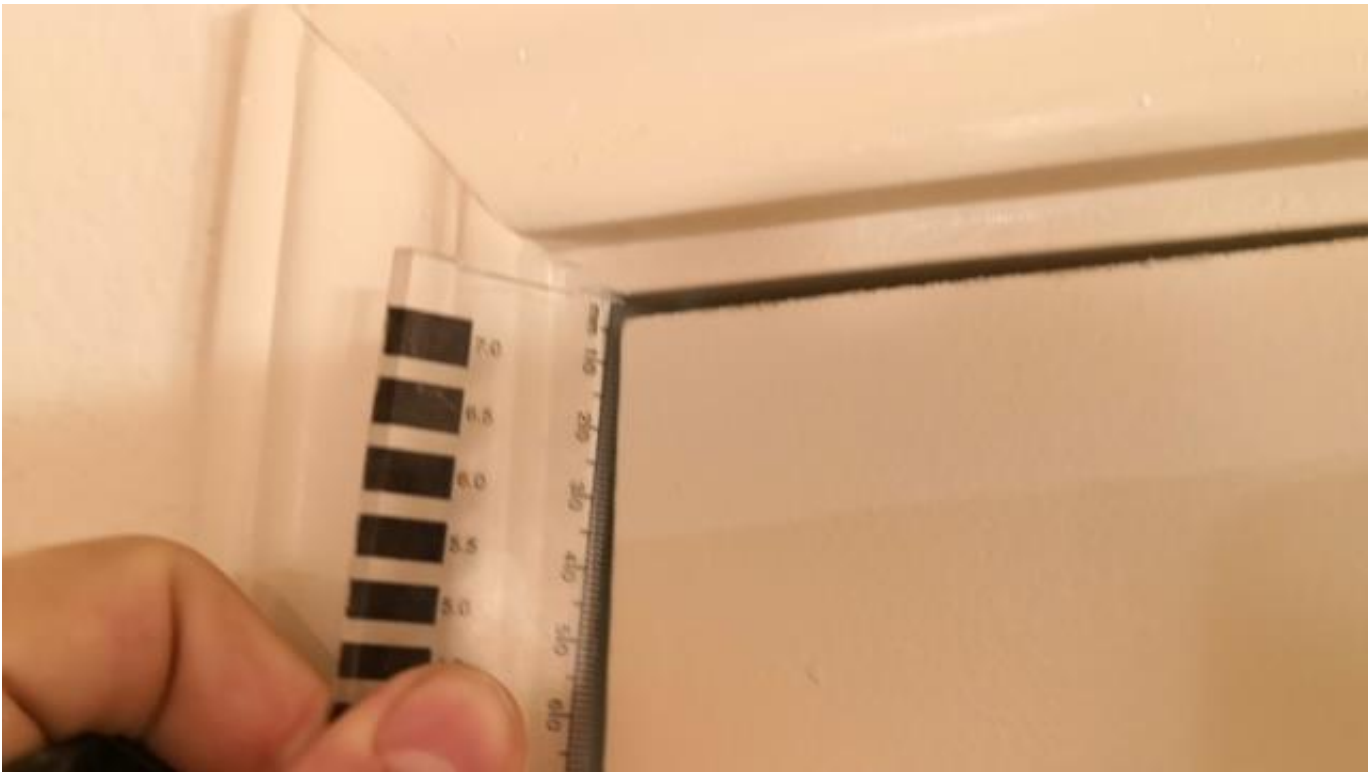
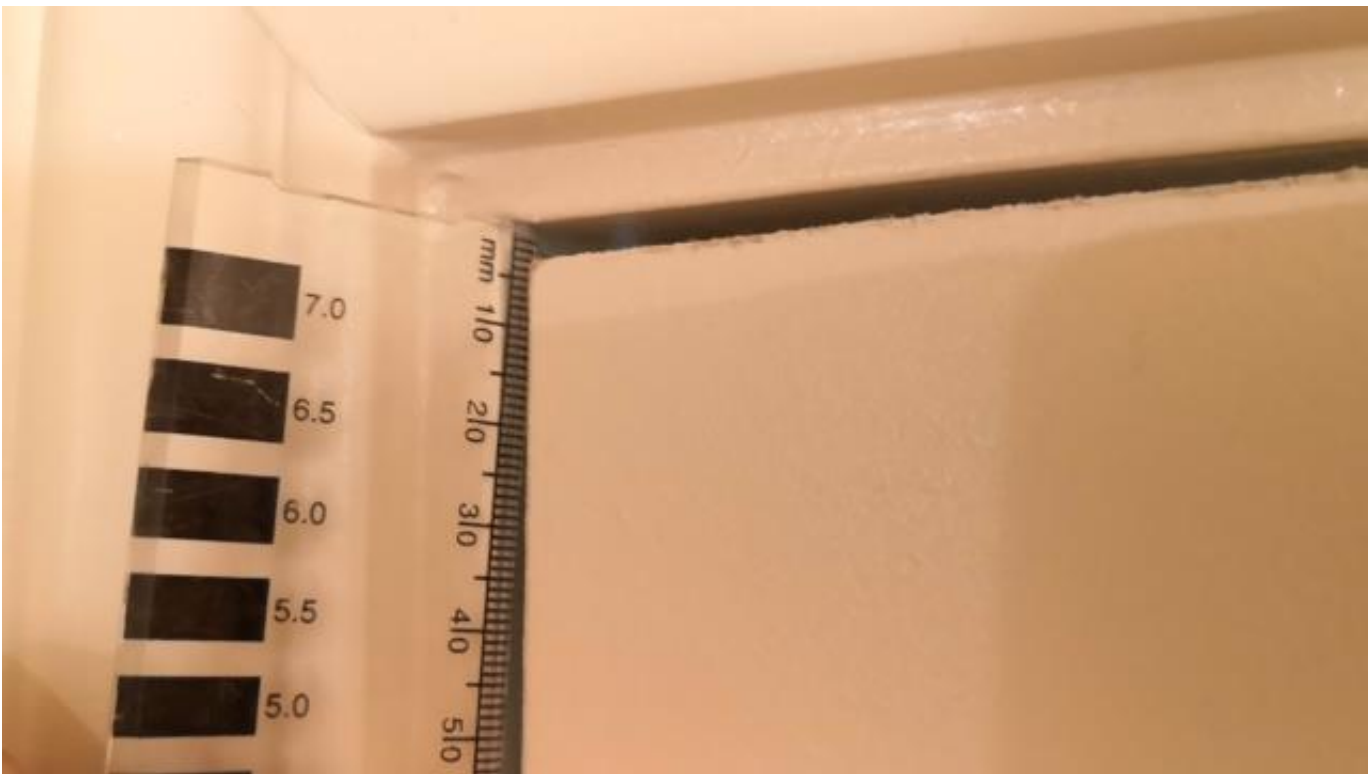
PIC 4 - master bath door is racked and rubs. Does not close any more.

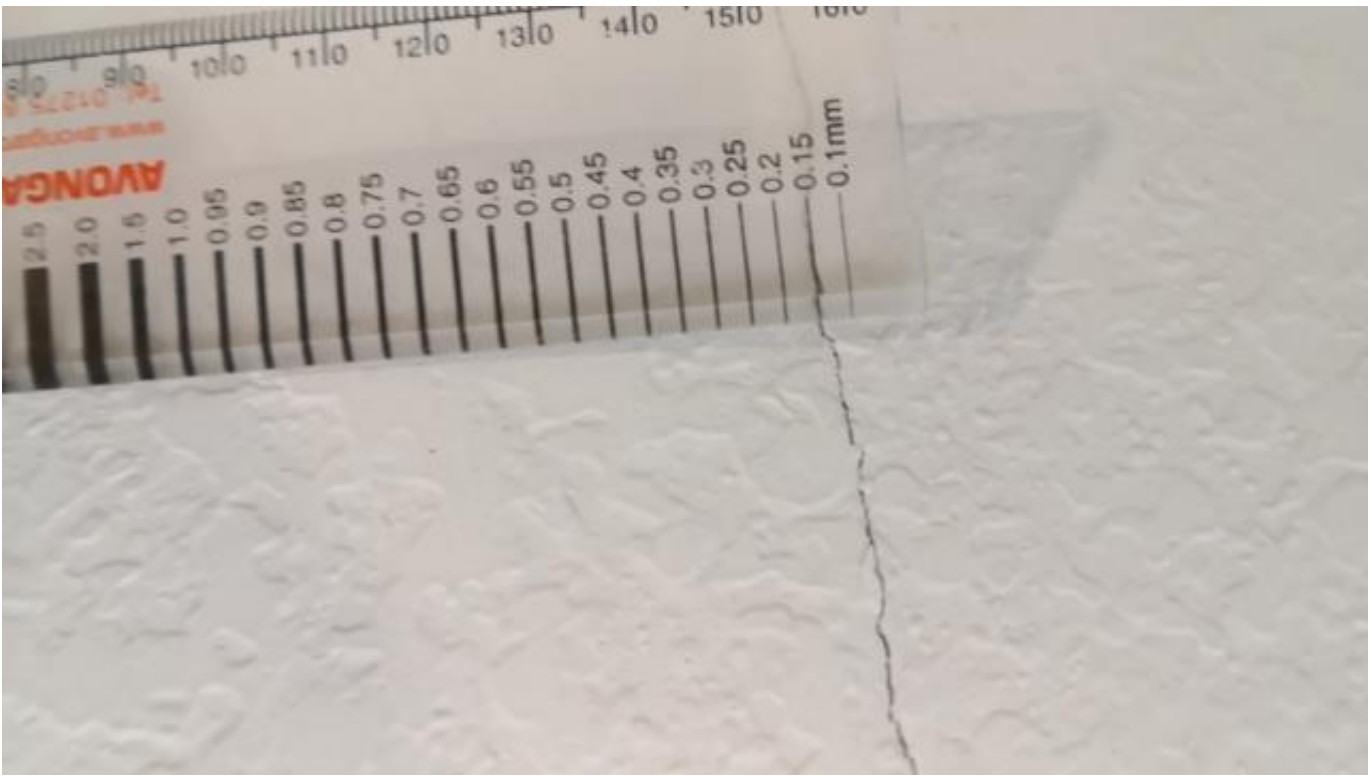
PIC 7 - header of window has crack

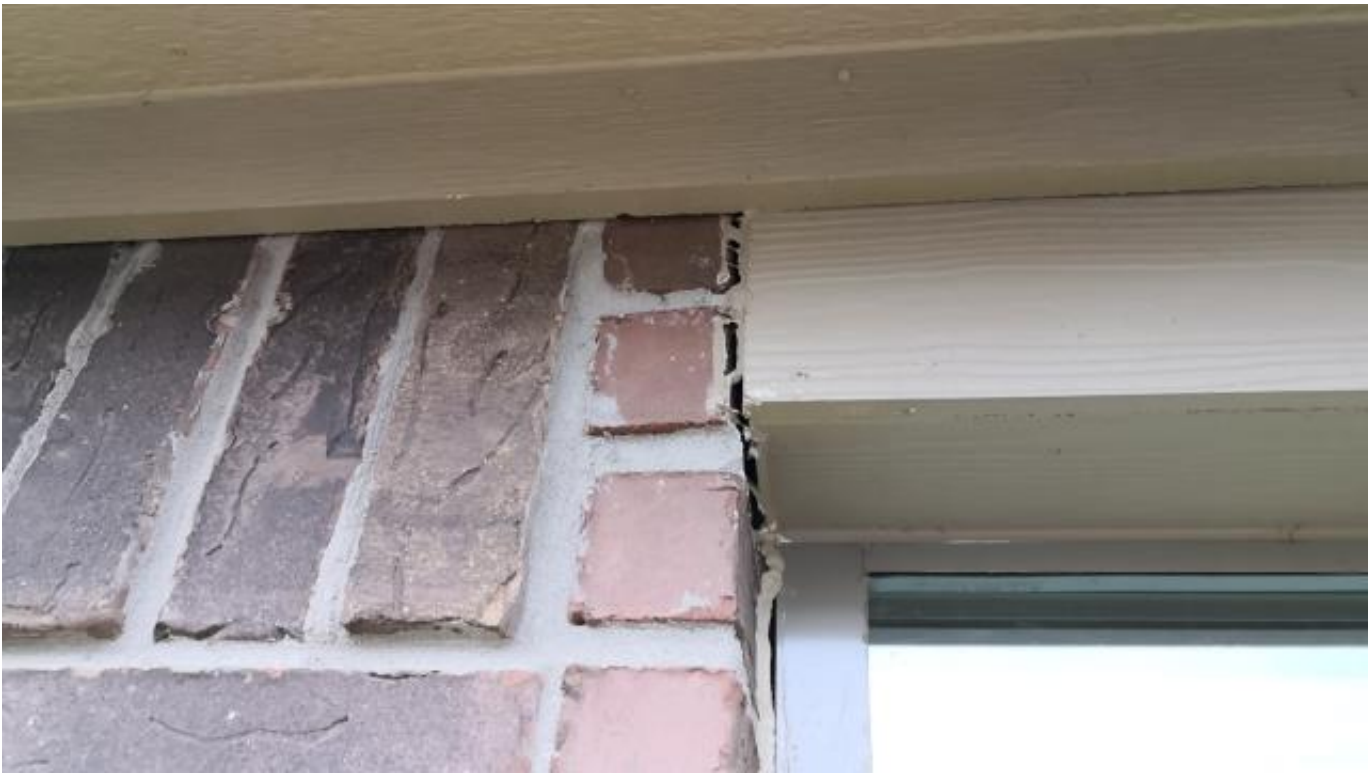
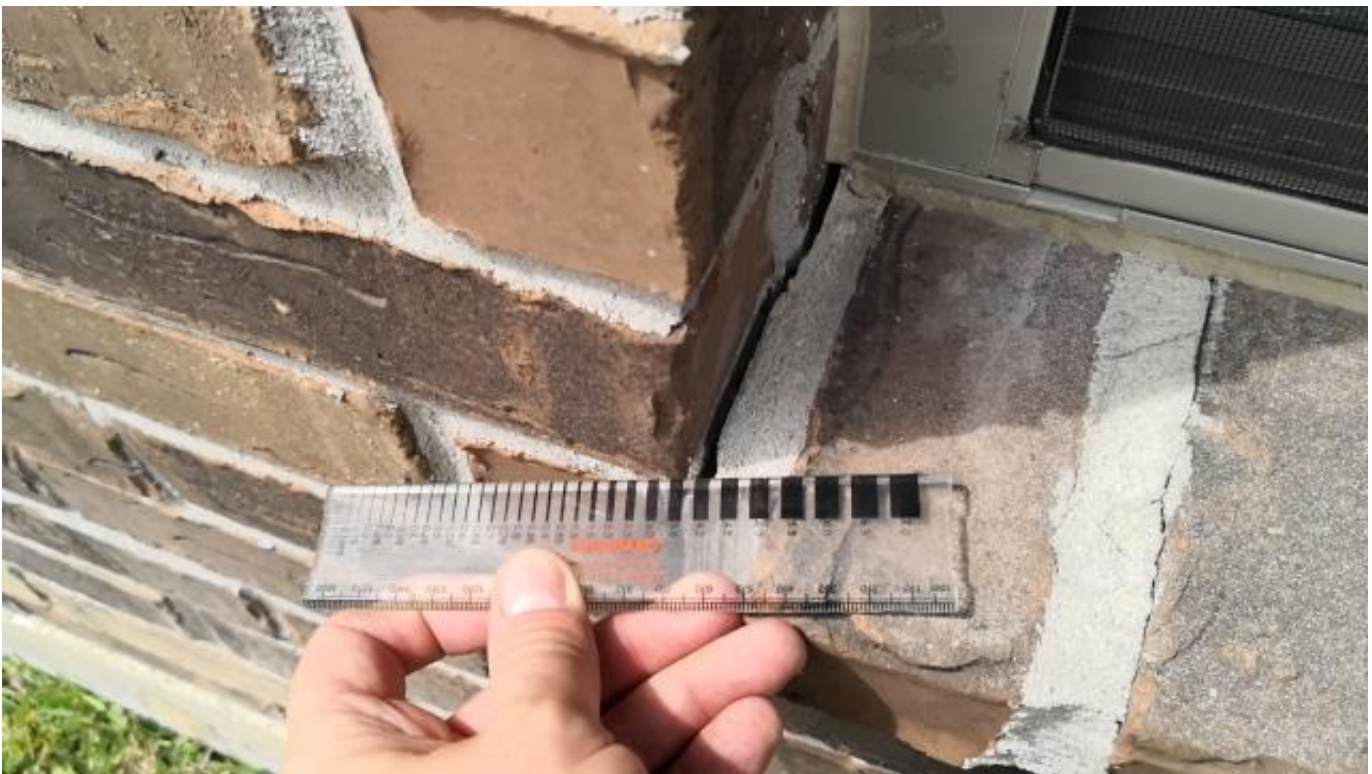
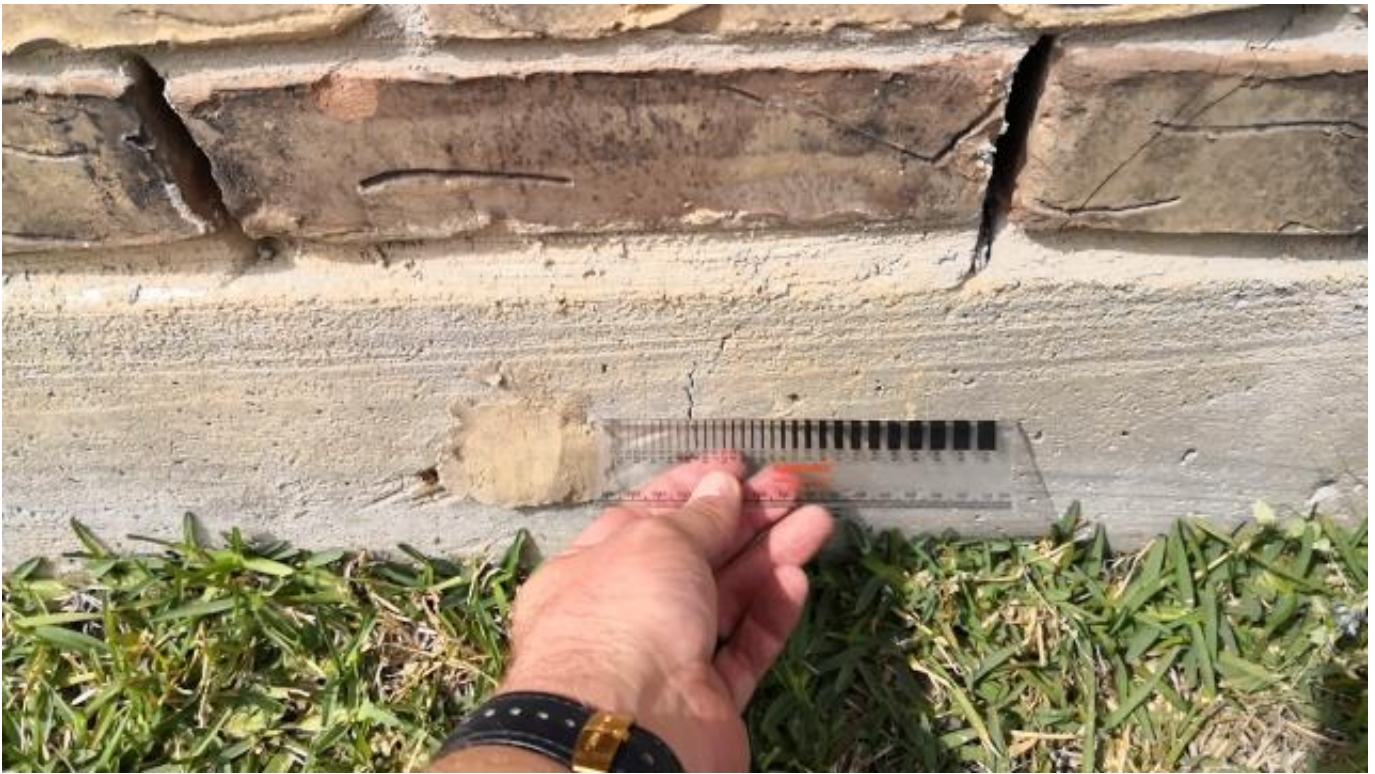
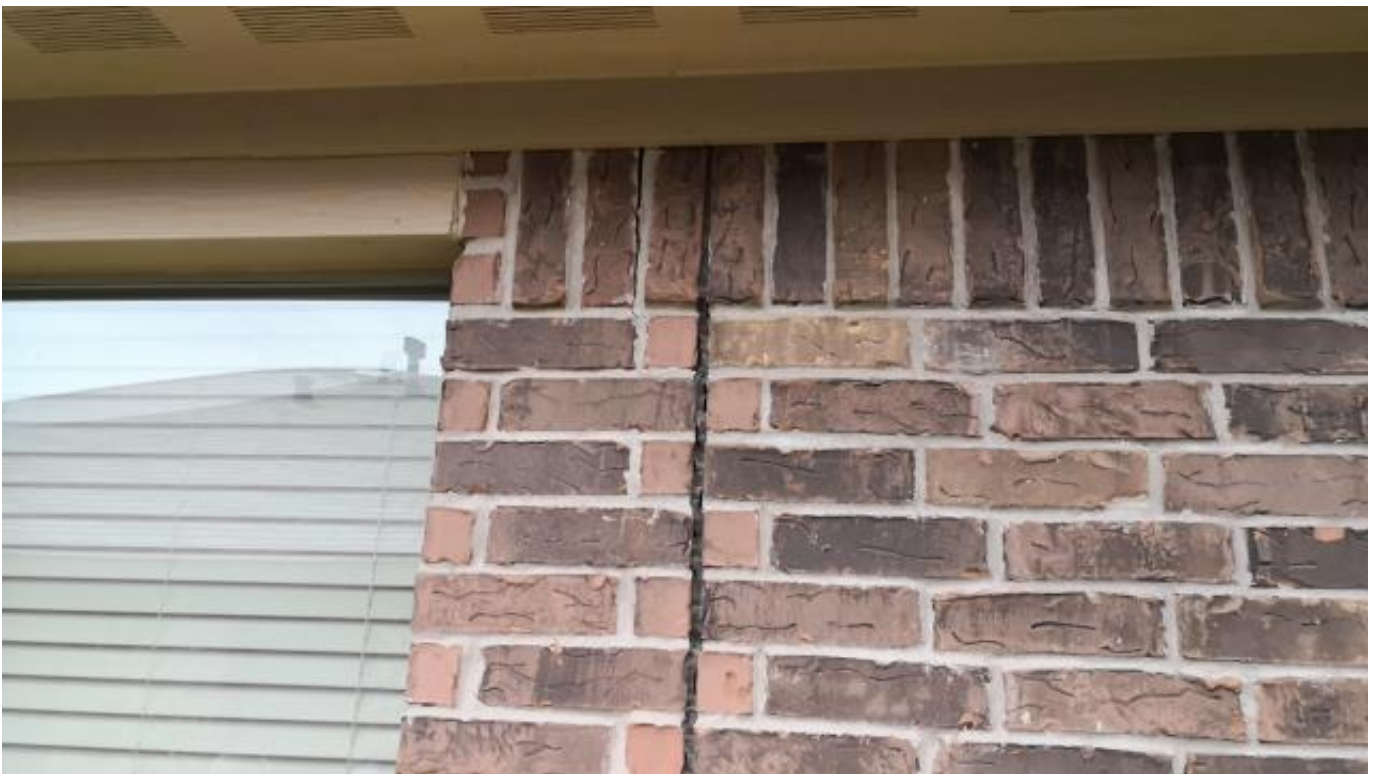
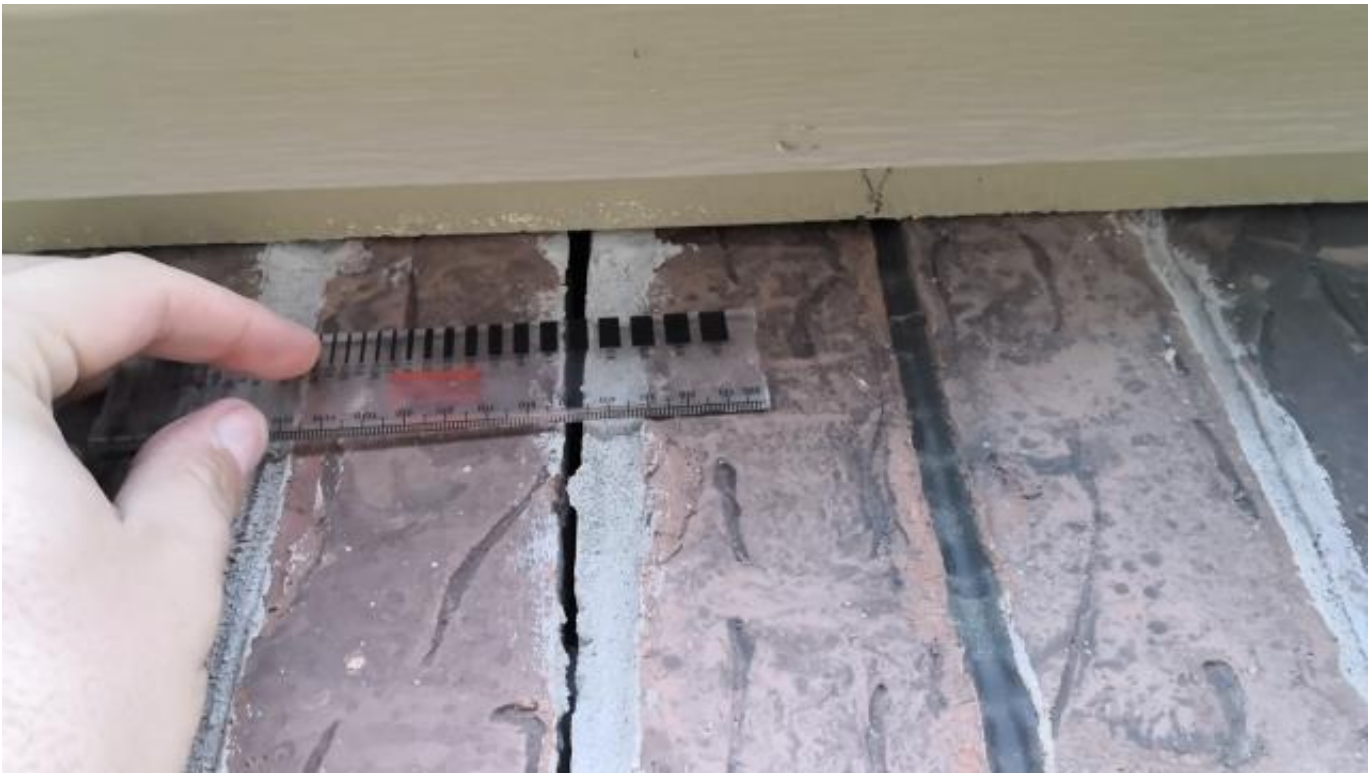
PIC 11 - this window has defects at wood lintel and sill. Also a pattern of cracks extending toward a slab crack below. Adjacent is a brick expansion joint that widens as it extends upwards.

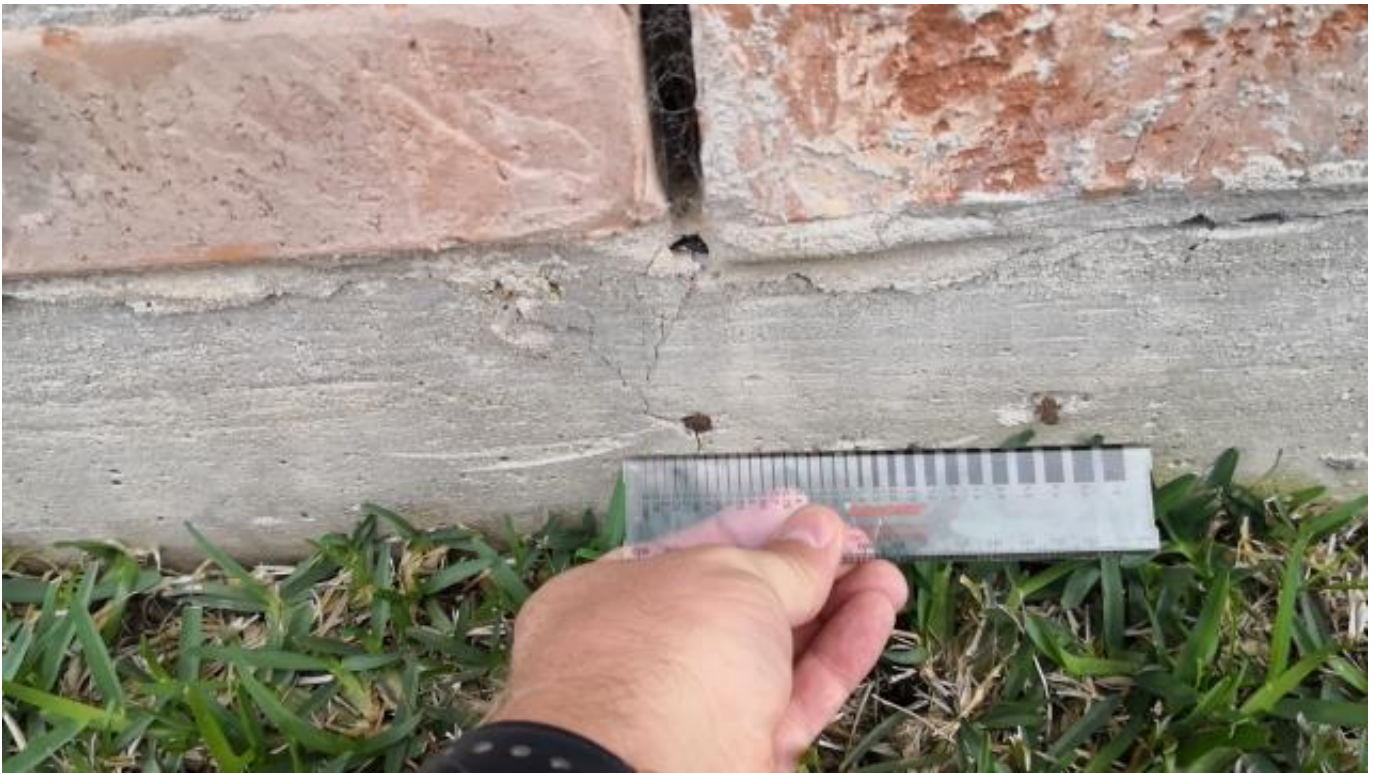
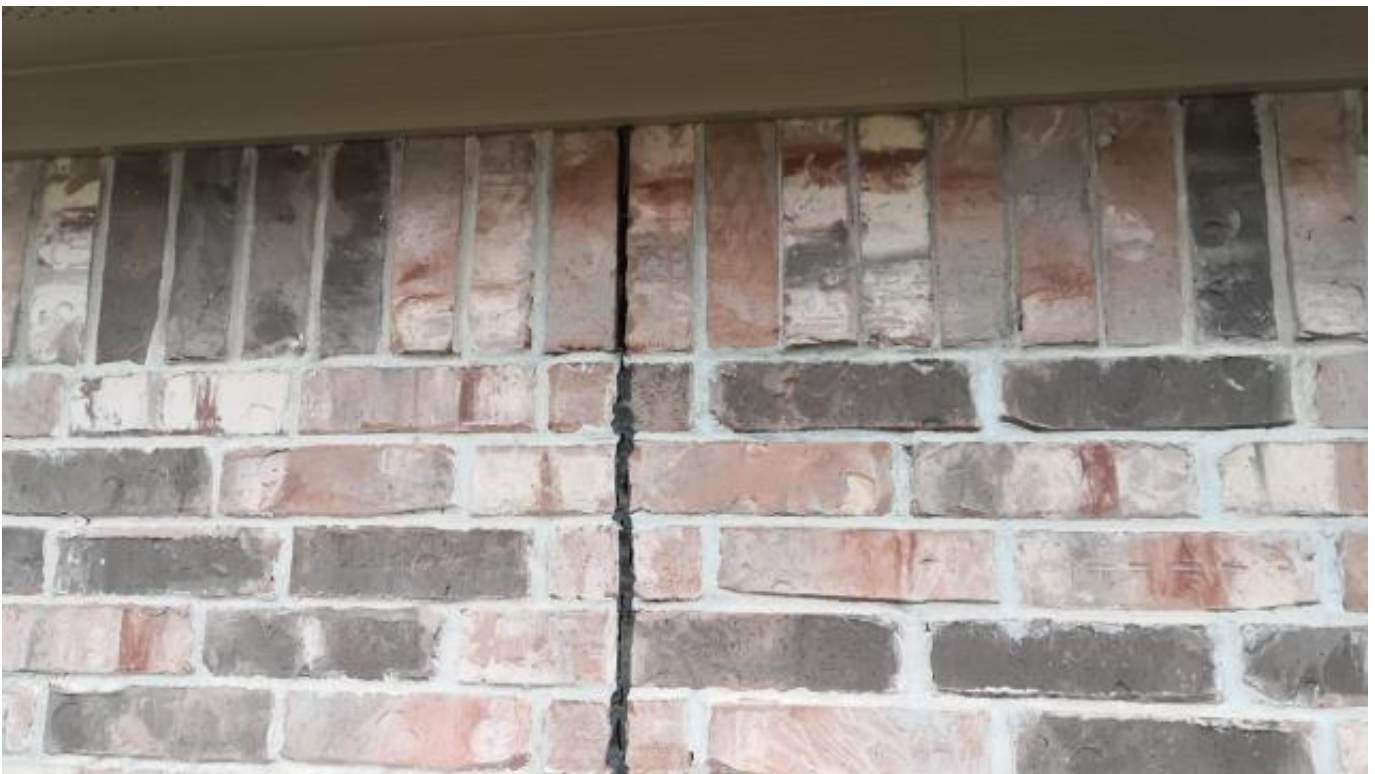
PIC 12 - Neighboring home has similar but not as pronounced defect in roughly the same location (not to open a can of worms)

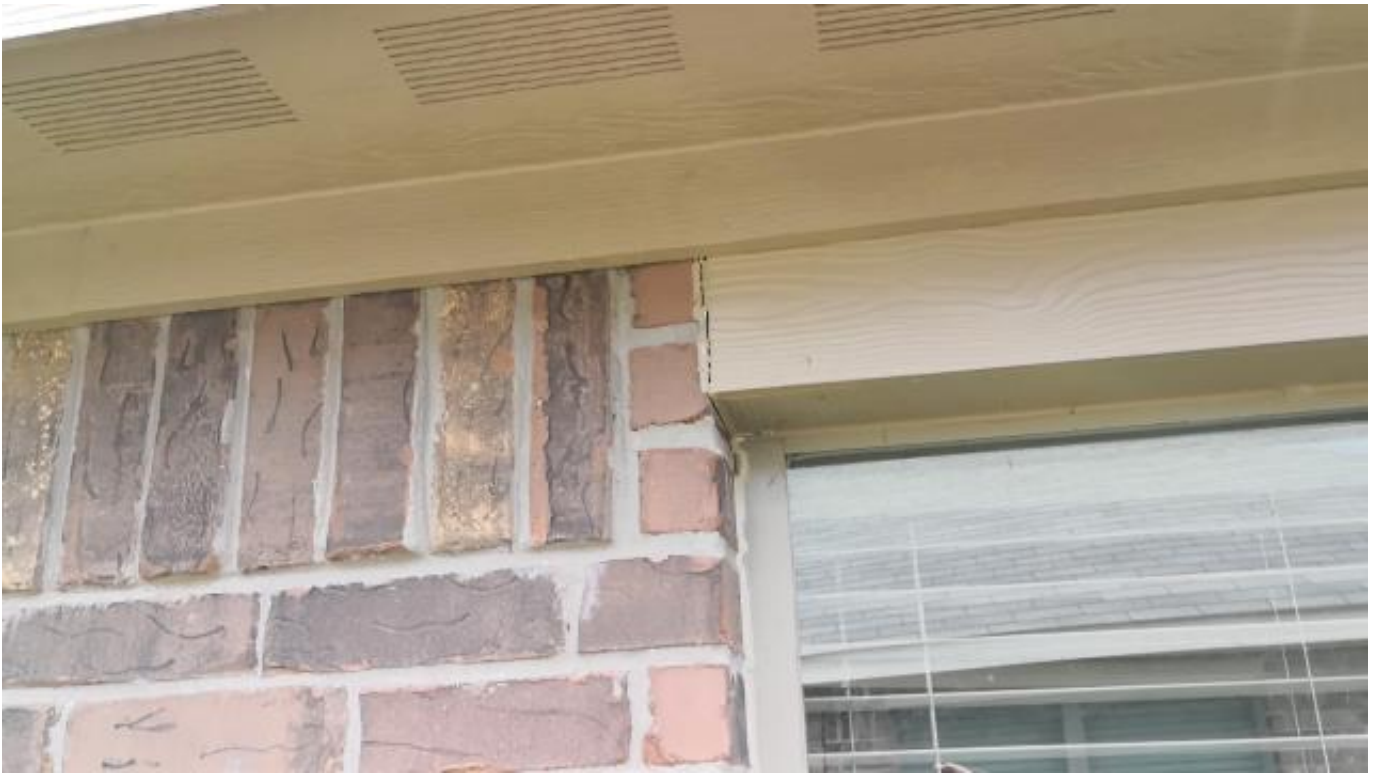
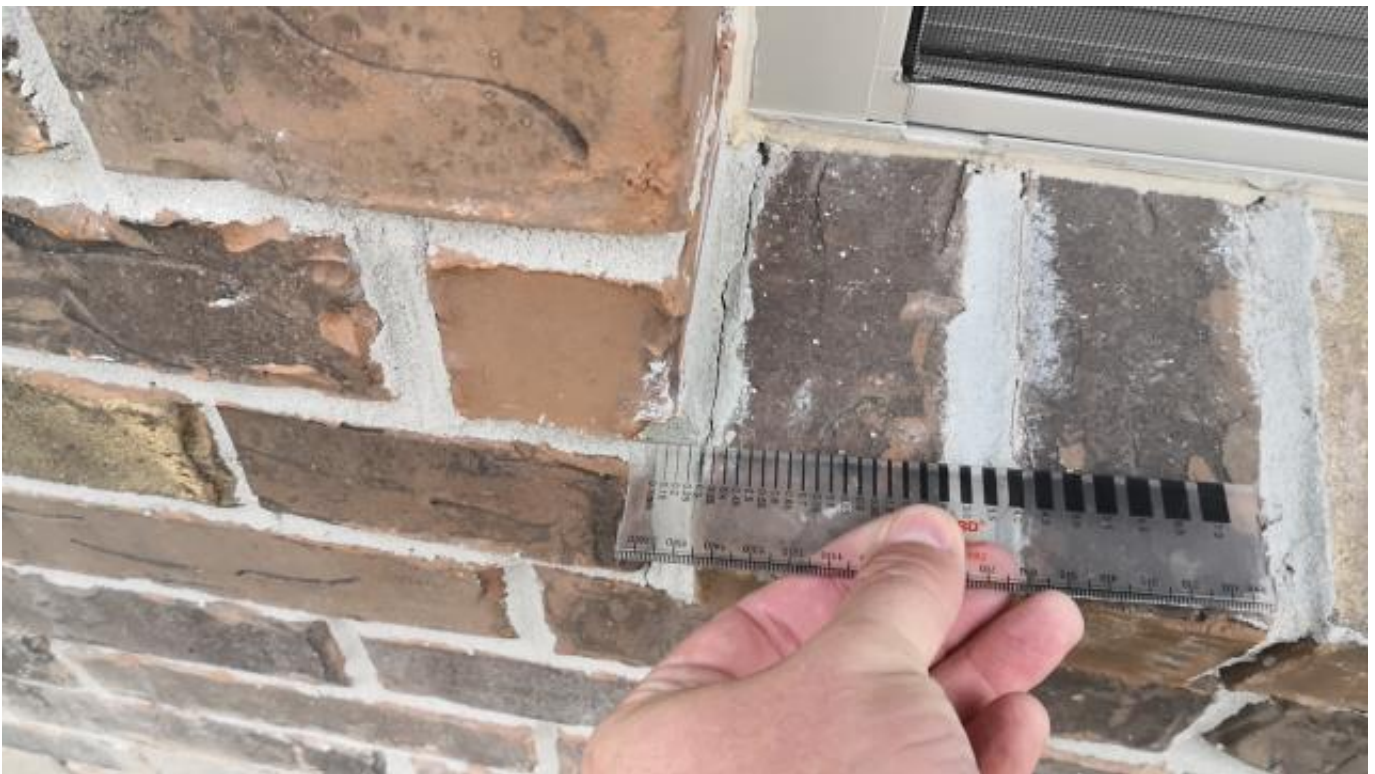
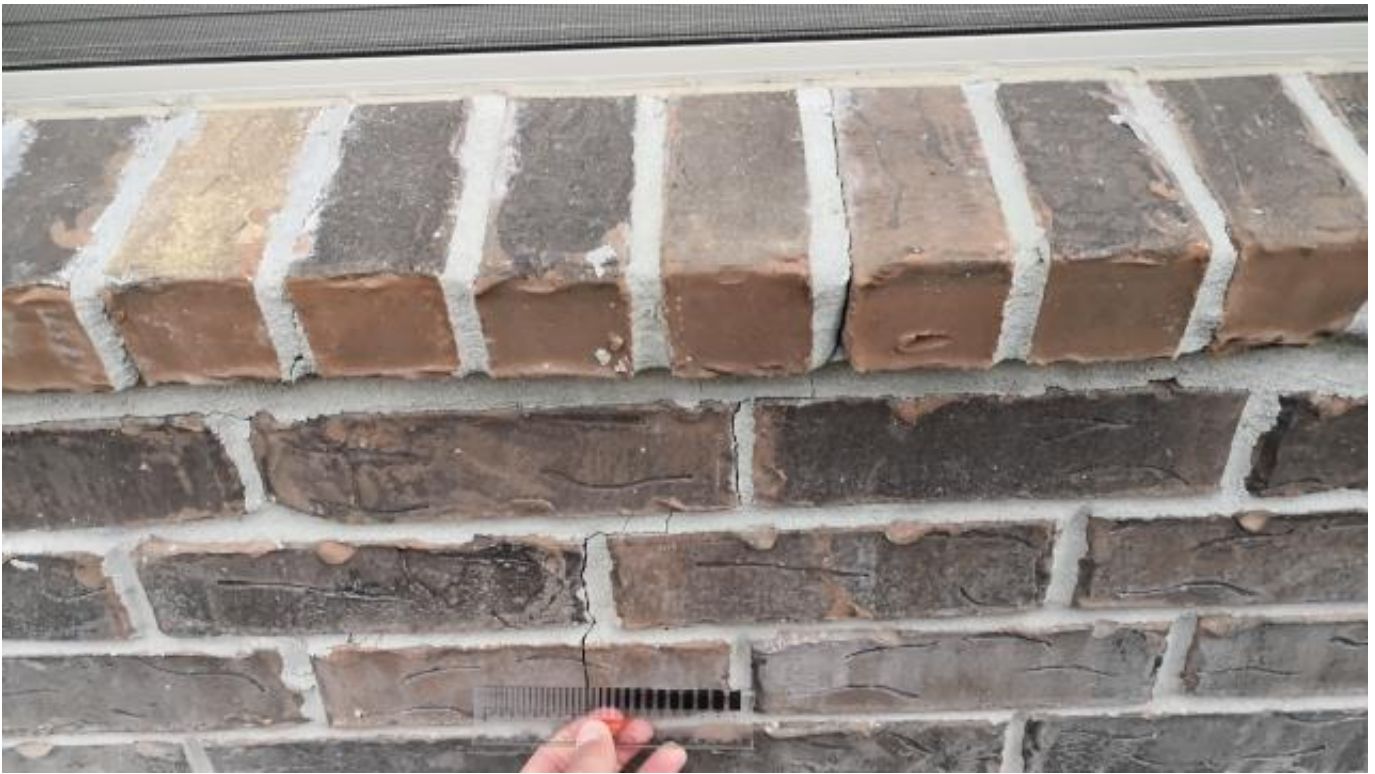
PIC 13 - this window has defects at wood lintel and sill. Also a pattern of cracks extending toward a slab crack below. Adjacent is a brick expansion joint that widens as it extends upwards.

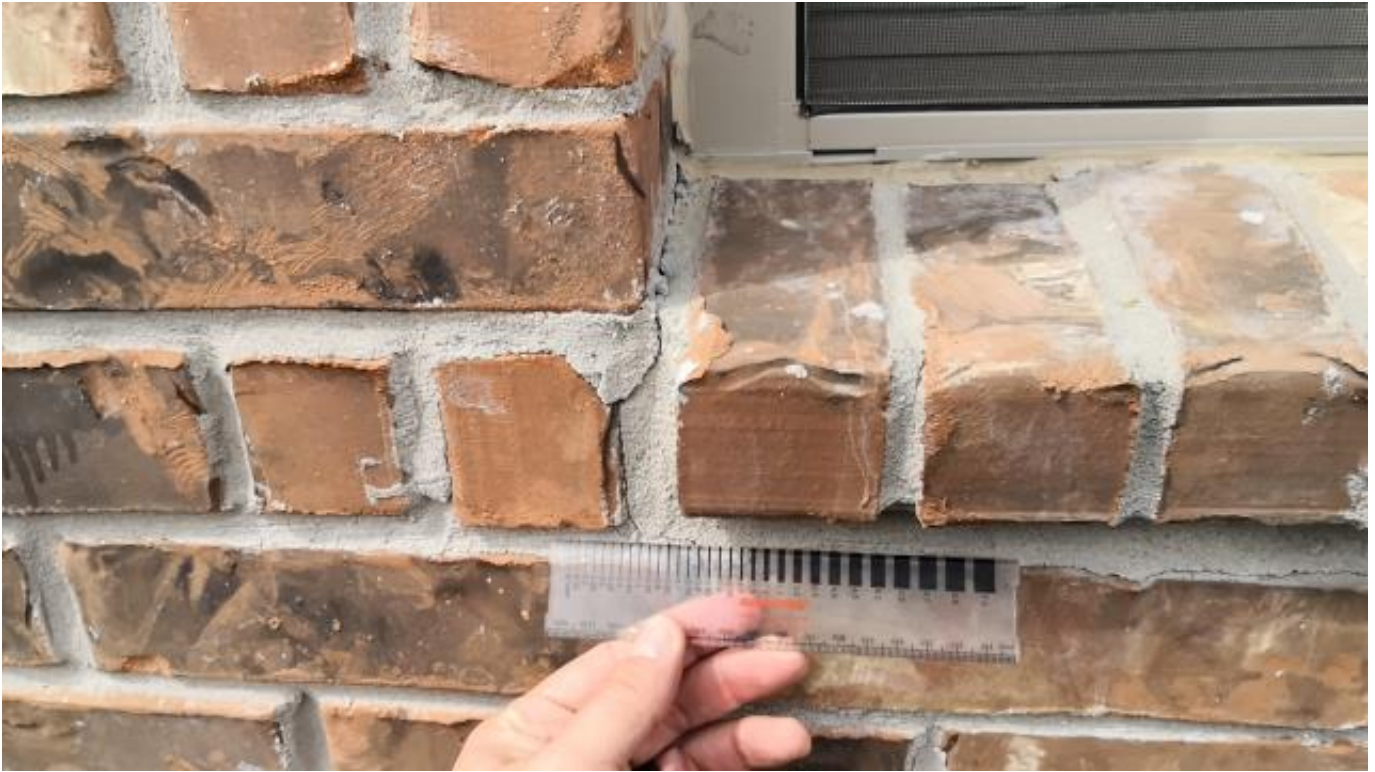
PIC 142 - Neighboring home has similar but not as pronounced defect in roughly the same location (not to open a can of worms)
