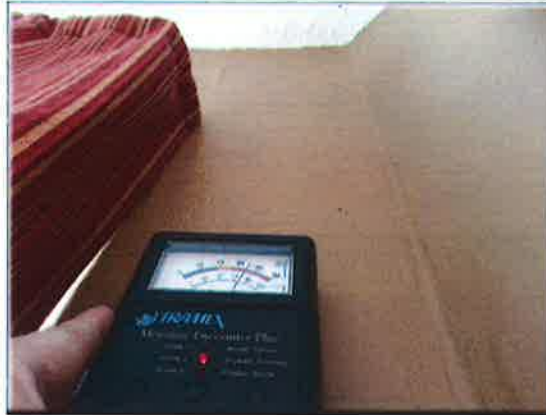
Elevated readings from an electronic moisture meter were observed at the Left and middle of the dining room. 4-29-2017 UPDATE: HIGH READINGS FOUND AGAIN WITH THE NON-DESTRUCTIVE METER. PIN TYPE METER USED TO VERIFY AND DID APPEAR TO HAVE ELEVATED MOISTURE READINGS IN THIS AREA COMPARED TO THE DRY AREA COMPARISION OF .3.

PIN METER READING WAS .7 AND .8

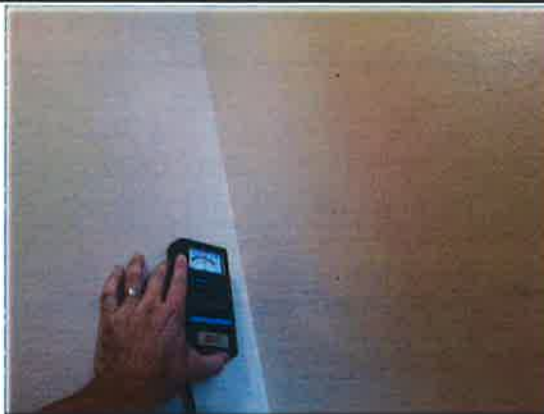
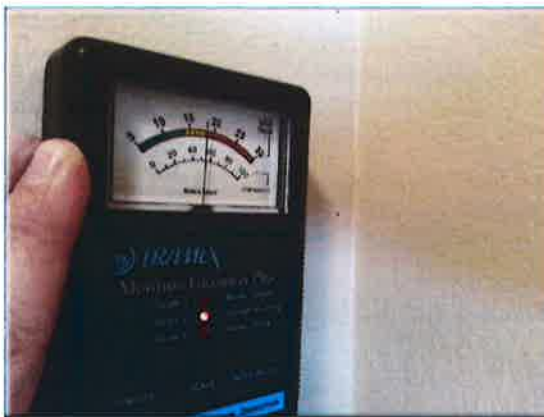
Elevated readings from an electronic moisture meter were observed at the Right and middle of the stairs window sill.

4-29-2017 UPDATE: HIGH READINGS FOUND AGAIN WITH THE NON-DESTRUCTIVE METER. PIN TYPE METER USED TO VERIFY AND DID APPEAR TO HAVE HIGH MOISTURE READINGS IN THIS AREA.

HIGH MOISTURE READINGS ABOVE 20% (WOOD SETTINGS MODE IN THE WINDOW SILL)

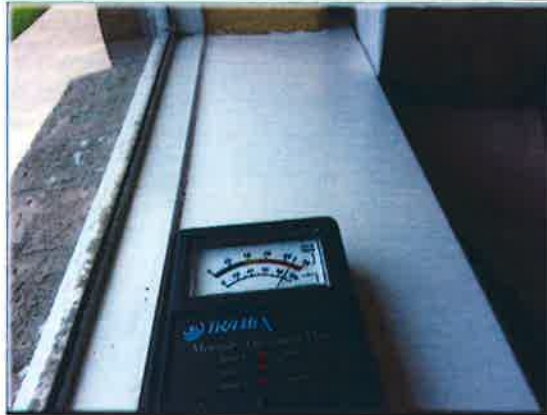
Elevated readings from an electronic moisture meter were observed at the Front of the upstairs front center bedroom. 4-29-2017 UPDATE: HIGH READINGS FOUND AGAIN WITH THE NON-DESTRUCTIVE METER. PIN TYPE METER USED TO VERIFY AND DID APPEAR TO HAVE HIGH MOISTURE READINGS IN THIS AREA. READINGS OBSERVED OVER 20%. Suspect cause of moisture is leaks around these upstairs windows.

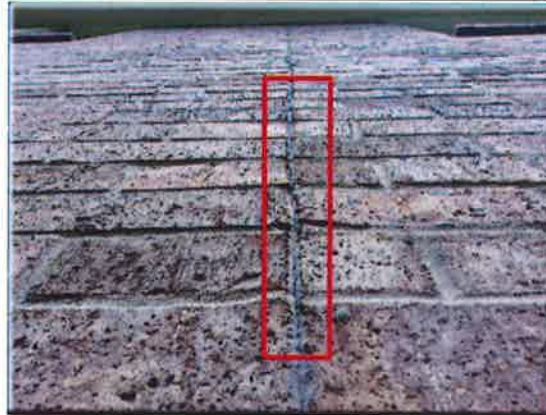
Small cracks were observed in the brick veneer wall on the home - Location: Each Side of the exterior. This is an indication that previous deflection or thermo-expansion has occurred, possibly due to slight framing settling, mortar deficiency or slight foundation movement or other. The cracks did not appear to be structurally significant in the inspectors opinion at the time of inspection; recommend re-pointing (repairing) mortar to prevent moisture intrusion. Example photos below for visual clarification. (note the largest crack was observed at the entry arch-way)

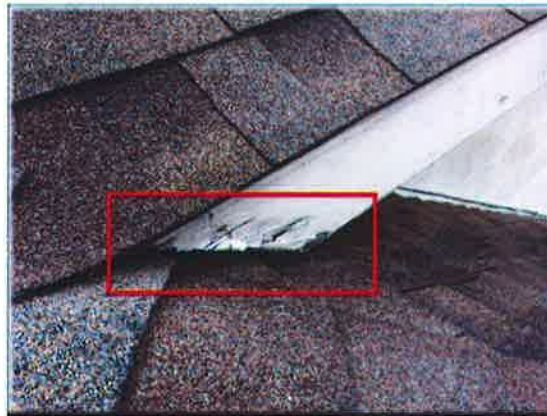
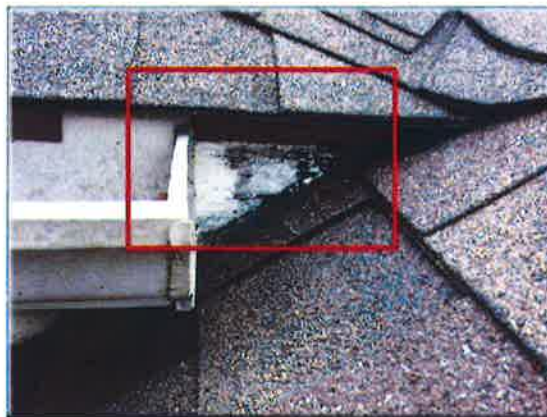
Rainwater running down the roof surface can saturate siding that is too close to the roofing. Siding and stucco should start 2" above roof line to help prevent water damage to the siding.
