BRYAN & BRYAN INSPECTIONS

Inspection Report For:
1727 Ball St, Galveston, TX 77550

Inspection Date: 4/15/2017

Prepared By: Chance Phillips TREC # 3899

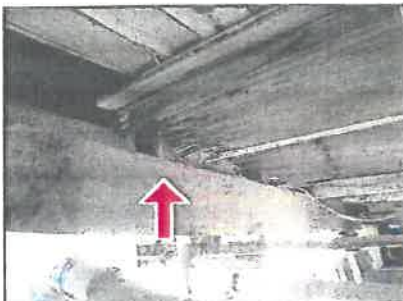
A. Item 2(Picture)

(2) Wood rot/deterioration was observed to the beam member(s) under the home. The inspector cannot determine the integrity of the wood. If further evaluation is desired, consult with a qualified contractor or structural engineer to determine the best method of remedy.

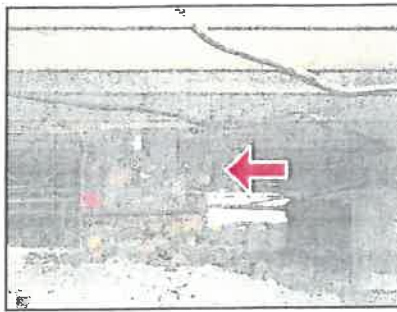
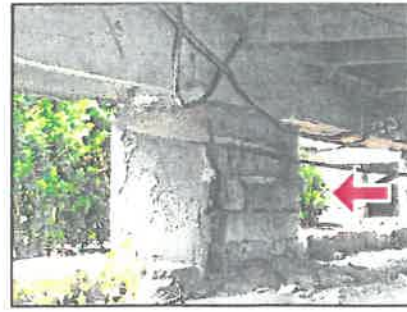
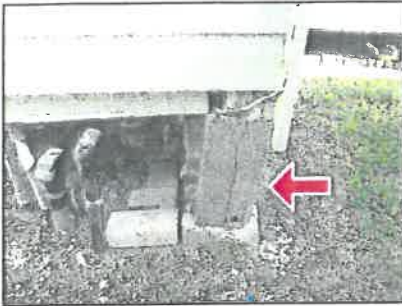
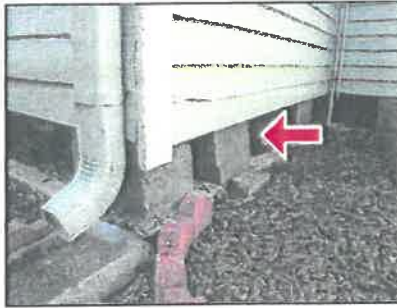
(3) Deterioration or leaning of masonry piers was observed. If further evaluation is desired, consult with a qualified contractor or structural engineer to determine the best method of remedy.

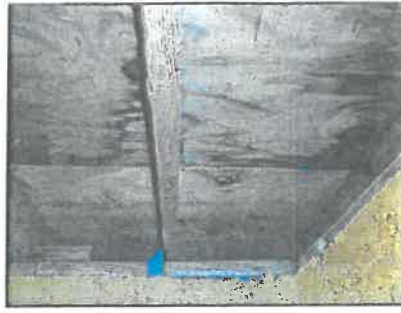
C. Item 10(Picture)

(5) Evidence of prior moisture intrusion is observed indicating a possible active or prior breach in the roof covering. Evaluate and remedy as needed.

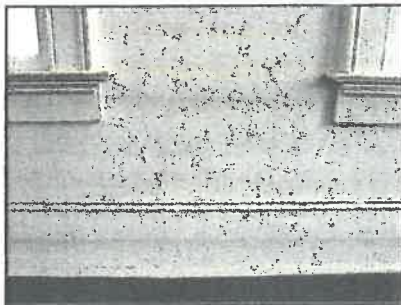
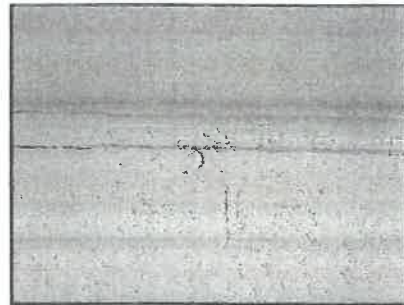
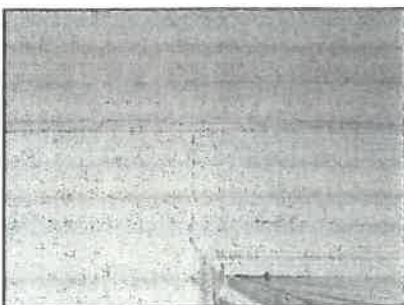
(3) Stress cracks are observed on the interior drywall. This is consistent with the structural movement of the home.

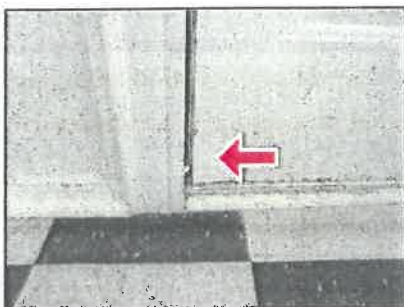
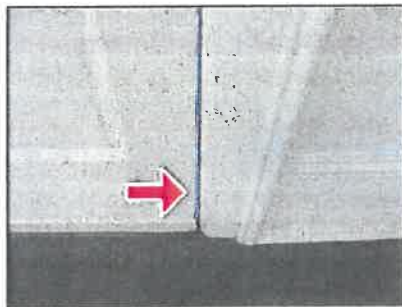
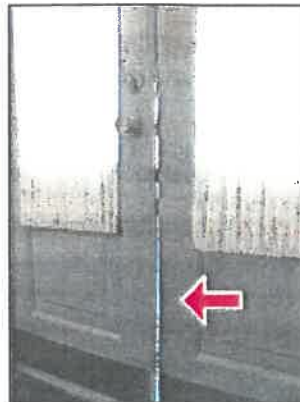
(2) Door does not make proper seal: adjust as needed.

Location(s): Front door, rear door of unit 3, front door of unit 4

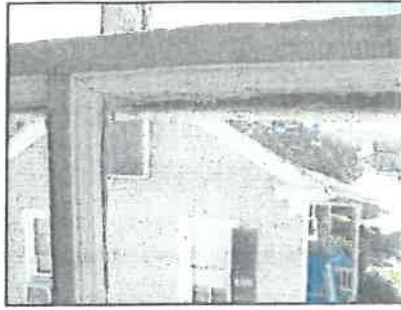
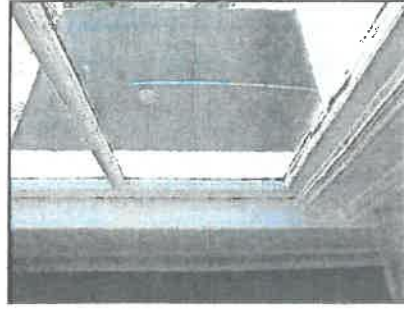
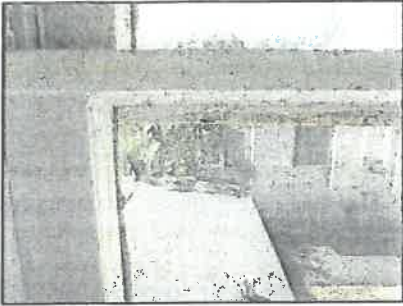
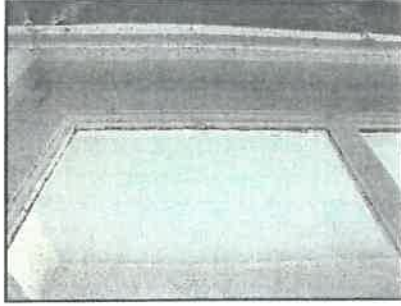
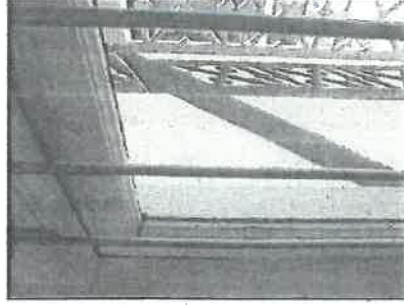
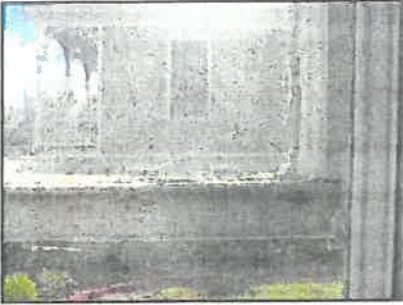
(3) Cracked window glass was observed.

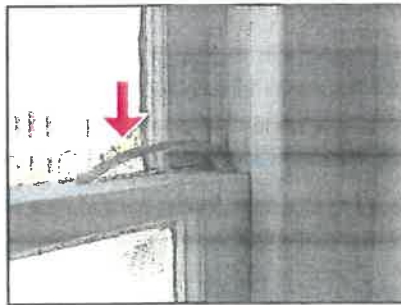
H. Item 13(Picture)

(5) Window(s) do not stay open properly due to lack of support/missing guide springs or counter weights. Location(s): Unit 2

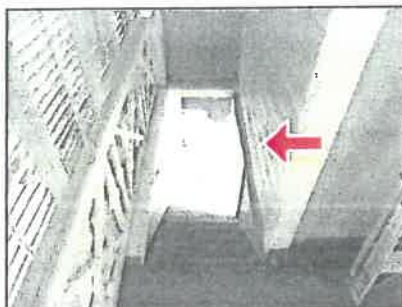
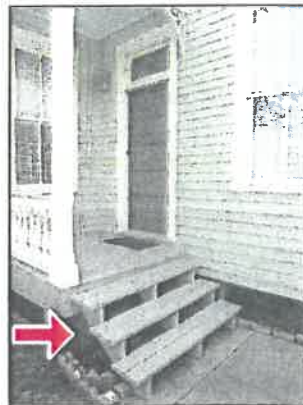
(1) There is a missing handrail/guardrail at the rear exterior stairs: Installation is recommended for safety. Multiple locations

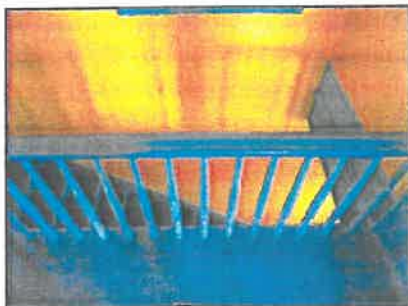
I. Item 5(Picture)

(3) The guard rail appears to be too short. Current building standards require a 36 inch guardrail for safety.

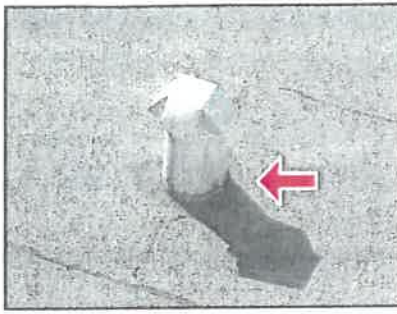
C. Item 8(Picture)

(4) Noted heavy tar around vent flashing. These are typically temporary repair measures. Tar may deteriorate over time. Monitor as needed.

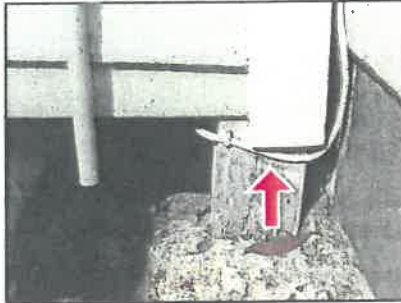
B. Item 3(Picture)

(2) Noted exterior wiring that has not been contained in protective conduit. For safety purposes, exterior wiring should be protected per the manufacturers specifications.

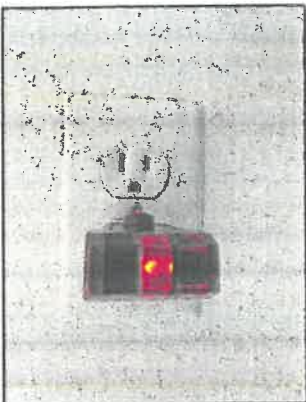
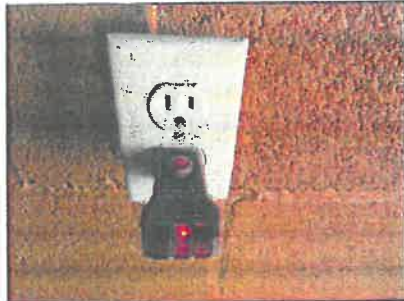
(4) Receptacle(s) are not properly grounded (as designed).

Location(s): Multiple Locations in unit 1, unit 2, garage/laundry area

** garage wiring*

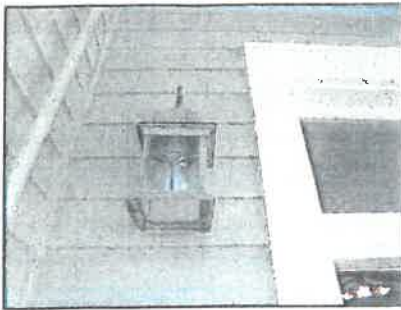
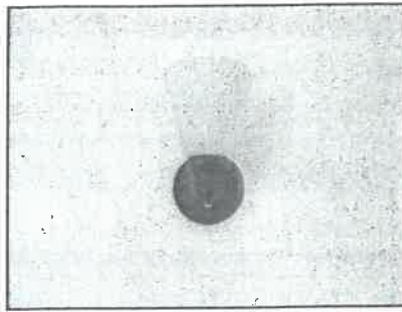
(7) Lights are not functioning. This may be a result of a bad bulb: test with new bulb and remedy if needed.

Location(s): Exterior, Unit 4

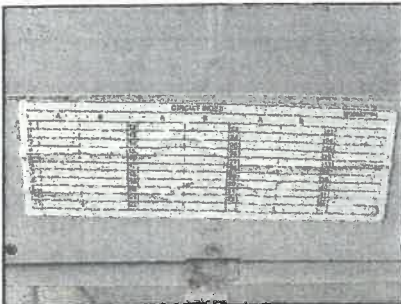
A. Item 11(Picture)

(8) The distribution panel is not properly labeled to identify circuit locations.

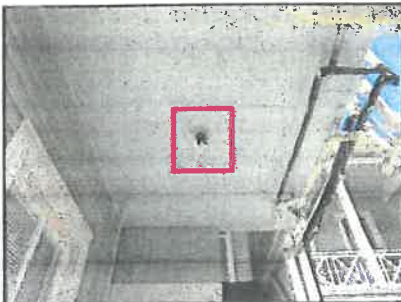
B. Item 1(Picture)

(1) Missing/damaged light globe(s) were observed. Recommend repairing or replacing globes.
Location(s): Rear exterior

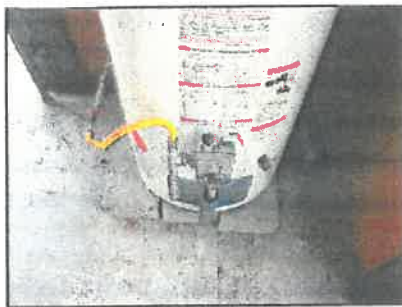
C. Item 8(Picture)

(4) Water heaters are not raised the recommended 18 inches above garage floor. Possible fire hazard.

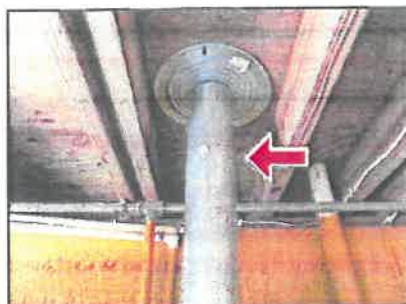
C. Item 9(Picture)

(5) The rear water heater vent pipe is not properly strapped. Strapping is needed to prevent movement.

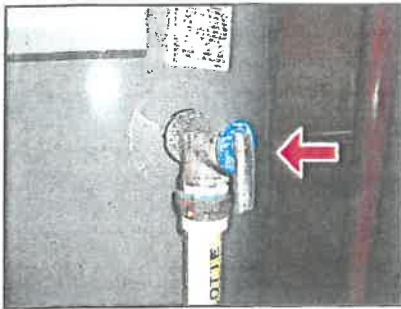
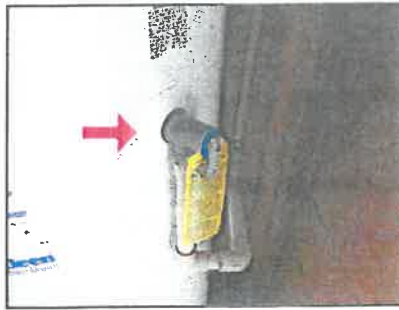
(3) **Note:** The manufacturer recommends replacement of the TPR valves every three years to ensure proper emergency function. Inspection company does not test TPR valves due to safety hazard or possible damage to unit.

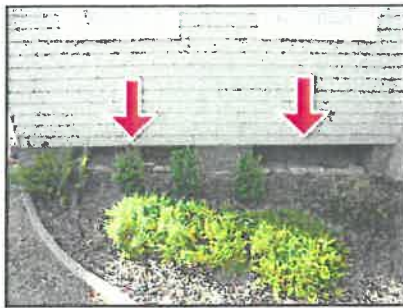
A. Item 1(Picture)

(1) The crawl space access appears to be open. This leaves access to rodents or other pest that may do damage to crawl space components.

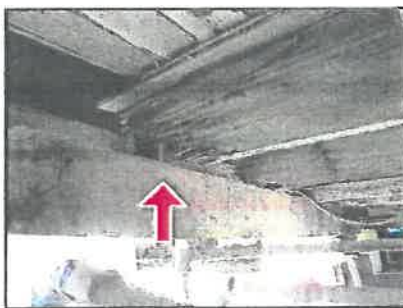
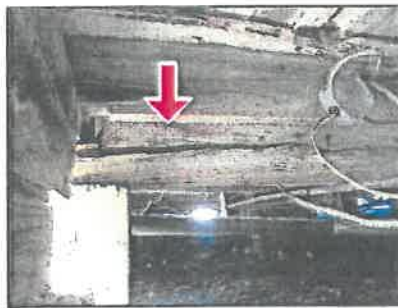
(2) Wood rot/deterioration was observed to the beam member(s) under the home. The inspector cannot determine the integrity of the wood. If further evaluation is desired, consult with a qualified contractor or structural engineer to determine the best method of remedy.

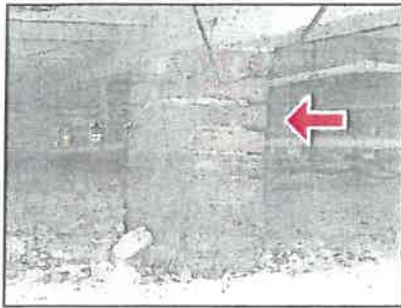
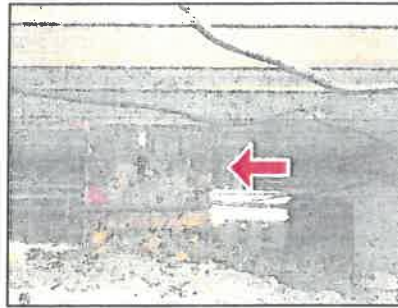
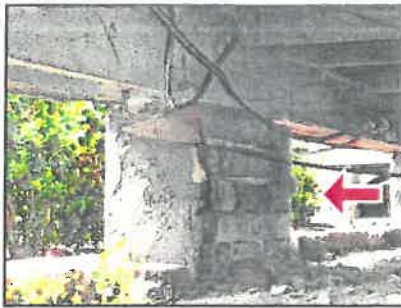
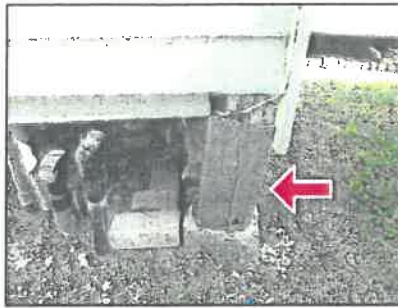
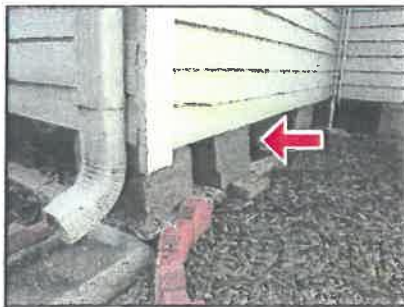
(3) Deterioration or leaning of masonry piers was observed. If further evaluation is desired, consult with a qualified contractor or structural engineer to determine the best method of remedy.

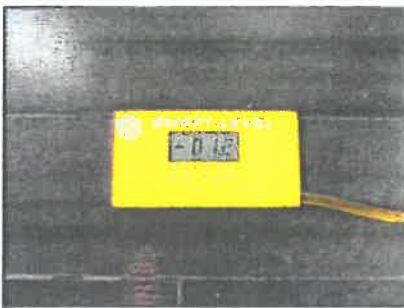
A. Item 9(Picture)

(4) Further evaluation of the foundation is recommended. There is evidence of structural movement that, in the inspector's **OPINION**, should be further evaluated by a structural engineer and/or qualified foundation company.

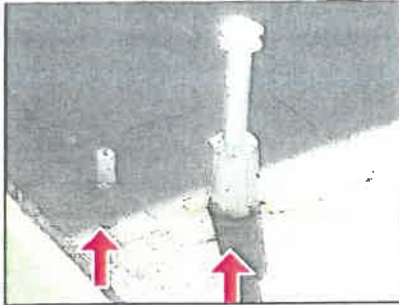
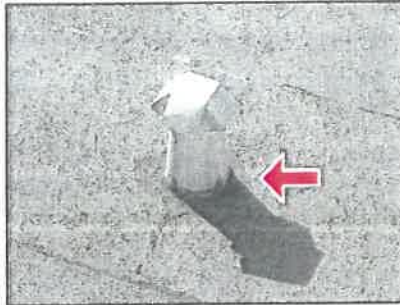
(4) Noted heavy tar around vent flashing. These are typically temporary repair measures. Tar may deteriorate over time. Monitor as needed.

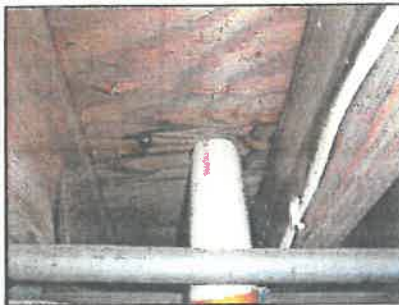
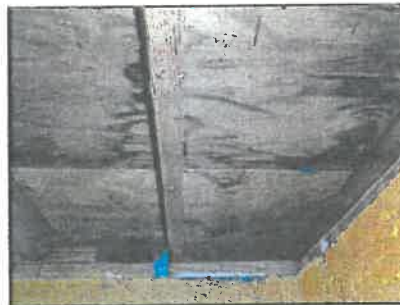
(5) Evidence of prior moisture intrusion is observed indicating a possible active or prior breach in the roof covering. Evaluate and remedy as needed.

Location: Garage/laundry

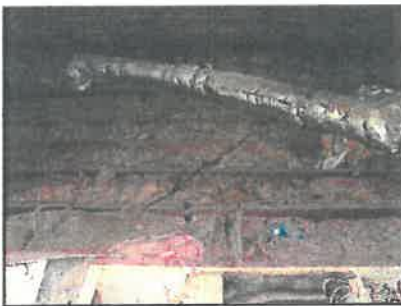
D. Item 4(Picture)

(2) Attic ventilation appears to be lacking or inadequate to provide for proper air flow and performance of the roof attic system: Consultation with a qualified contractor is recommended to calculate the adequate venting that is needed.

(3) The attic insulation coverage in the attic appears inadequate. Additional insulation should be considered for optimal insulating barrier.

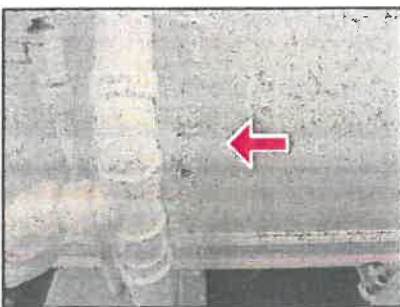
Location(s): Unit 4 bath

(4) Water damage was observed. No moisture was detected at the time of inspection using a surface moisture meter.

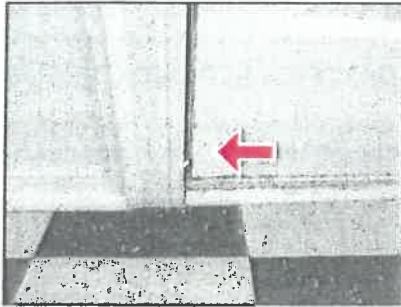
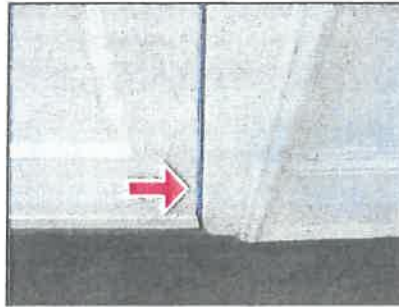
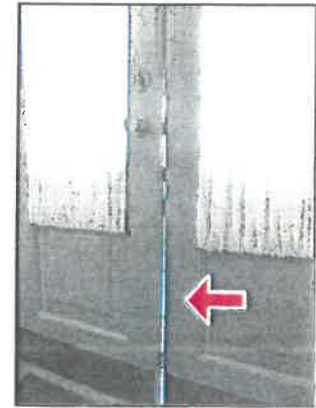
(1) Door stops are missing/need adjustment to prevent doors from hitting other interior components.

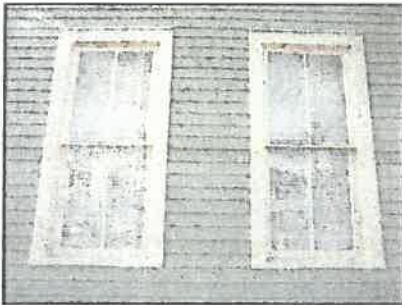
Location(s): Multiple Locations

(1) Screens were observed damaged/missing.

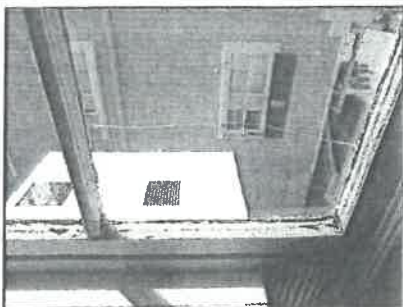
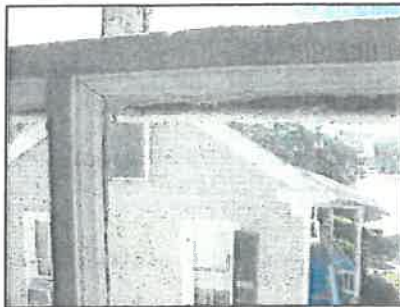
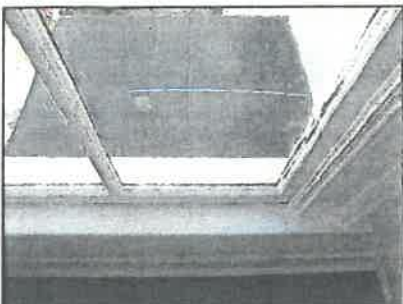
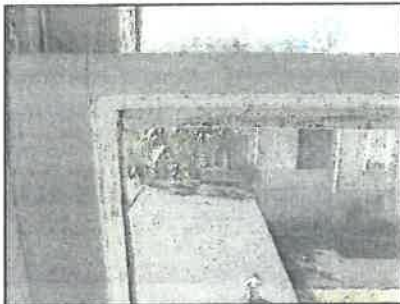
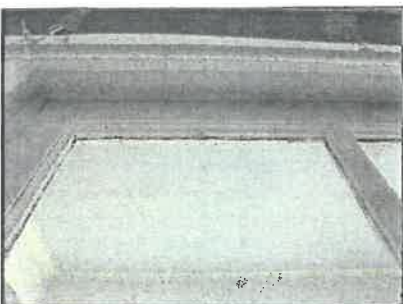
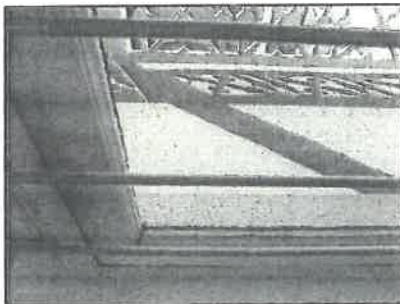
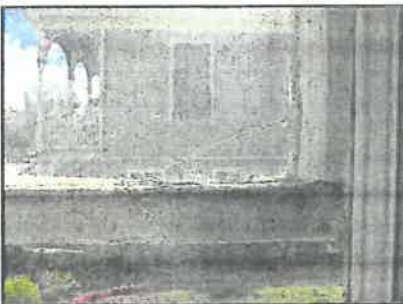
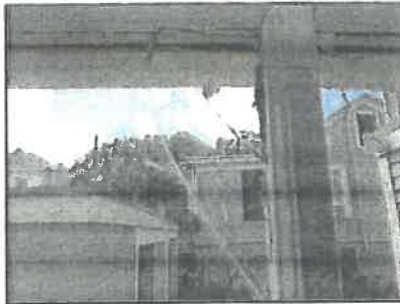
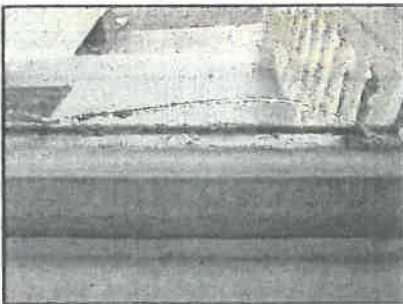
(3) Cracked window glass was observed.

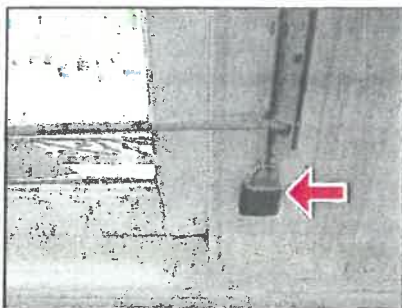
(4) Window metal bars have no apparent release mechanism. (Pad locks are improper) Safety hazard.

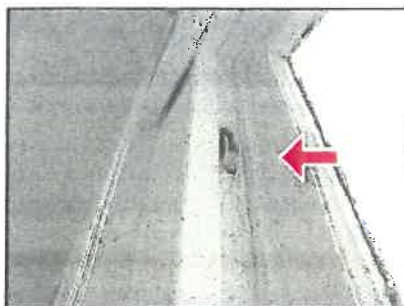
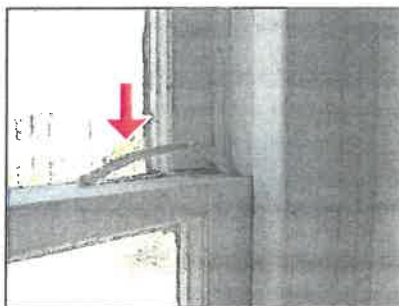
Location(s): Unit 2

(5) Window(s) do not stay open properly due to lack of support/missing guide springs or counter weights.

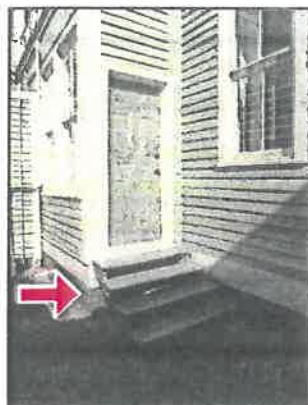
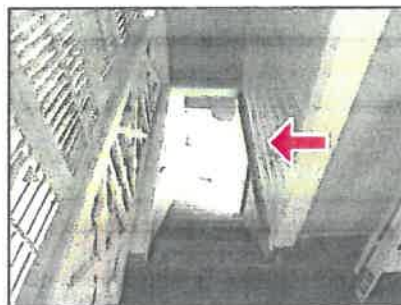
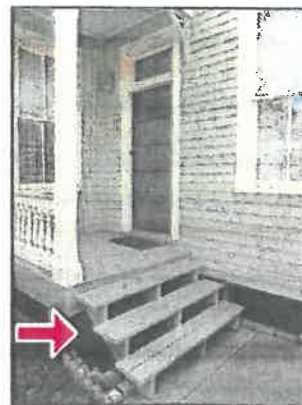
Multiple locations

(1) There is a missing handrail/guardrail at the rear exterior stairs: Installation is recommended for safety.

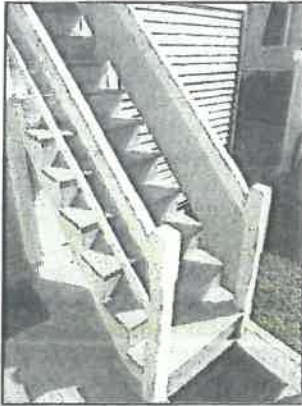
(2) The railing/guard balusters are installed horizontally which could allow them to be climbed on. Building standards recommend that balusters be installed vertical so that they cannot be climbed on.

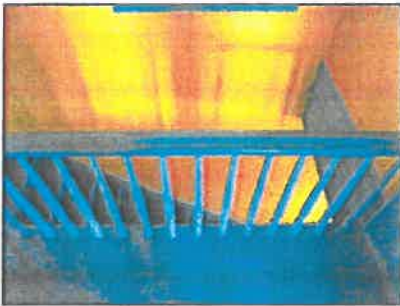
(3) The guard rail appears to be too short. Current building standards require a 36 inch guardrail for safety.

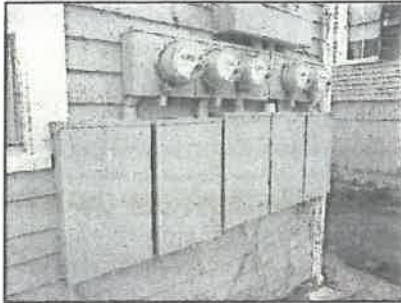
(1) General Photo of the Distribution Panel

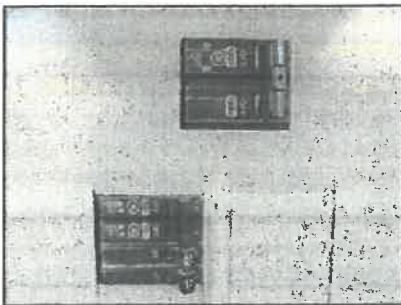
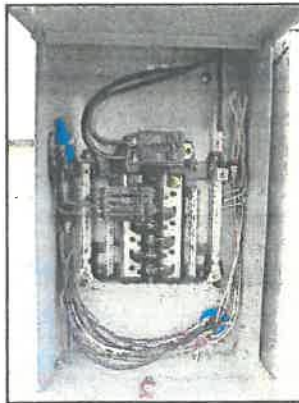
(2) General Photo of Sub-Panel

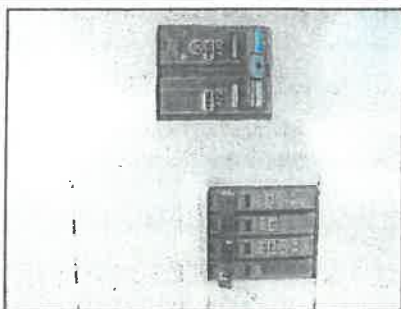
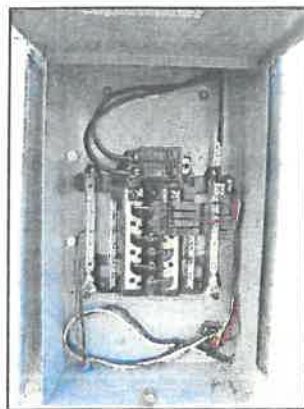
(3) General Photo of Sub-Panel

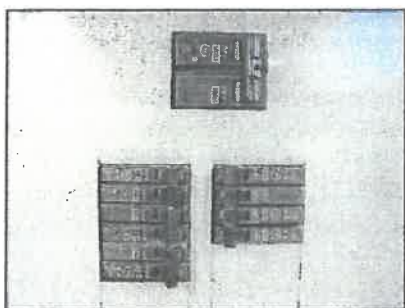
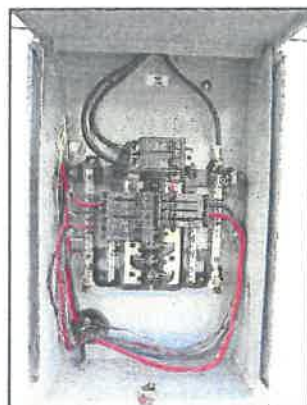
(4) General Photo of Sub-Panel

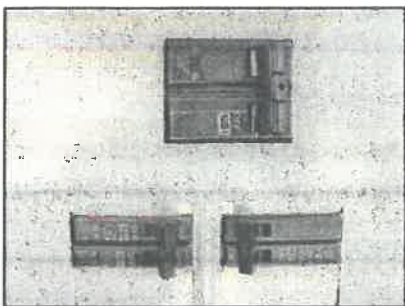
A. Item 7(Picture)

(5) General Photo of Sub-Panel

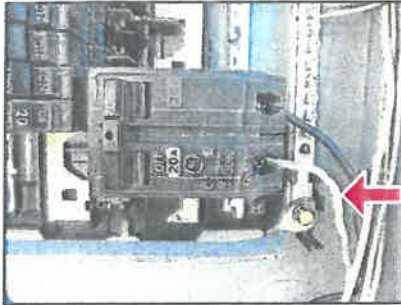
A. Item 10(Picture)

(6) Arc-fault safety protection is not installed for all of the living and bedroom areas. This protection was required by the National Electric code for homes built after 2008. The Texas Real Estate Commission requires inspectors to list as "deficient" any arc-fault protection not installed in these areas; regardless of the homes age.

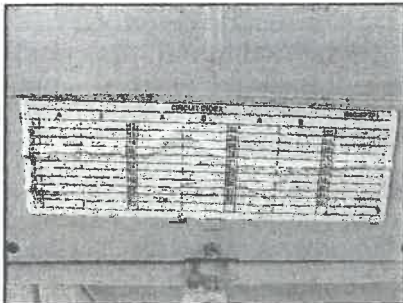
A. Item 11(Picture)

(8) The distribution panel is not properly labeled to identify circuit locations.

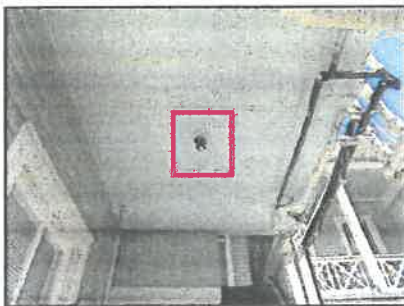
B. Item 1(Picture)

(1) Missing/damaged light globe(s) were observed. Recommend repairing or replacing globes.

Location(s): Rear exterior

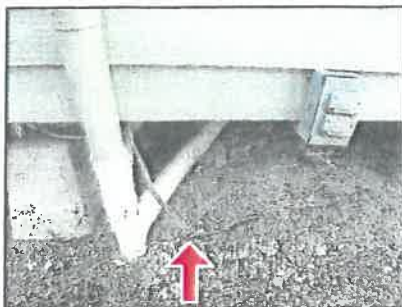
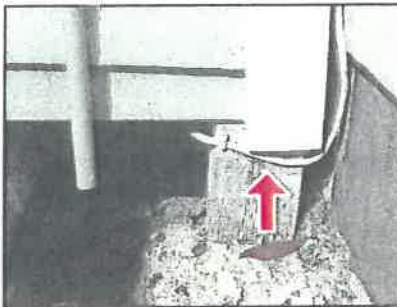
(2) Noted exterior wiring that has not been contained in protective conduit. For safety purposes, exterior wiring should be protected per the manufacturers specifications.

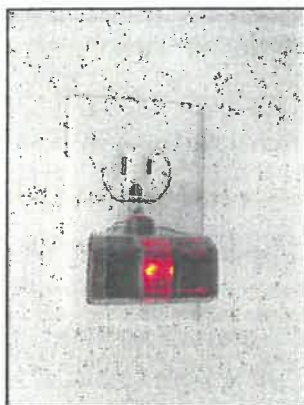
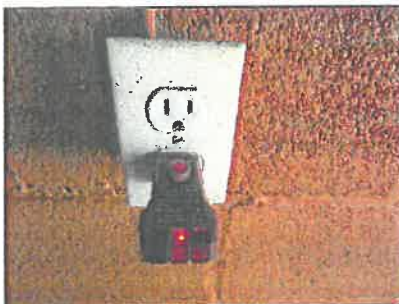
(4) Receptacle(s) are not properly grounded (as designed).

Location(s): Multiple Locations in unit 1, unit 2, garage/laundry area

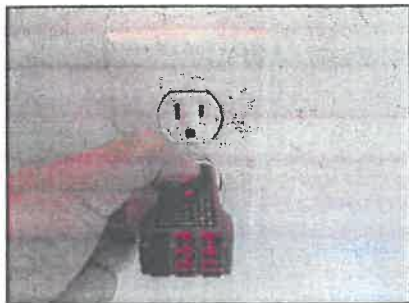
B. Item 6(Picture)

(5) Not all receptacles at locations in kitchens, bathrooms, garages, and the exterior are currently ground fault (GFCI) protected for safety, which is consistent with the age of the home. Current building standards now require all receptacles in these locations to be GFCI protected. If further evaluation or replacement is desired, contact a qualified electrician.

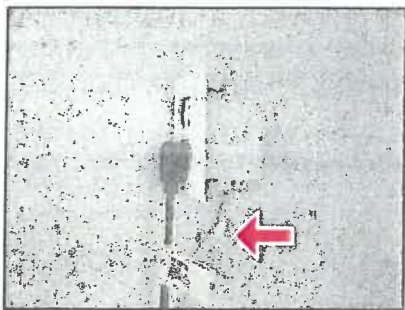
B. Item 7(Picture)

(6) Romex is exposed and subject to physical damage. Install behind walls or enclose in conduit for safety.

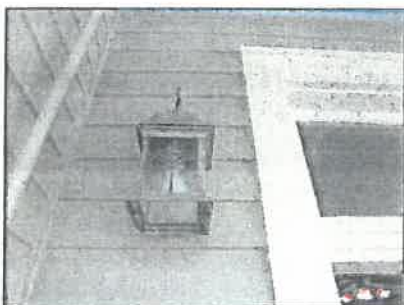
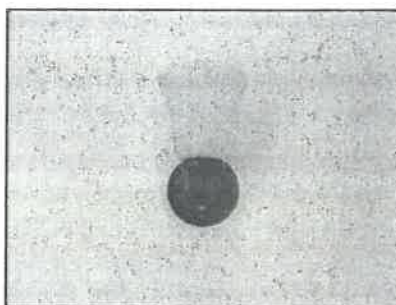
(7) Lights are not functioning. This may be a result of a bad bulb: test with new bulb and remedy if needed.

Location(s): Exterior, Unit 4

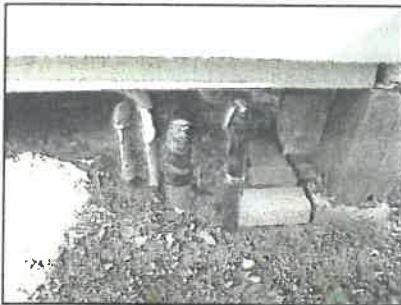
A. Item 1(Picture)

(1) General Photo of Main Shut-Off Valve

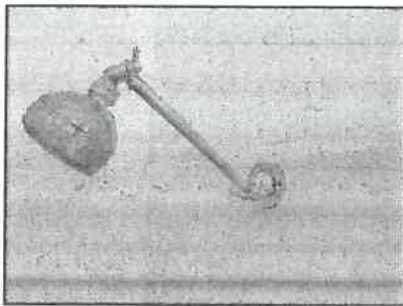
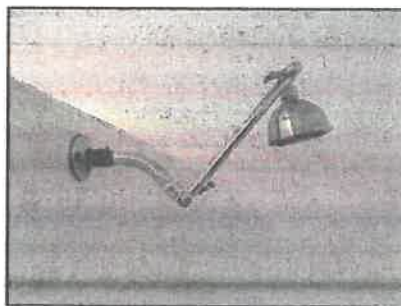
(3) Water lines appear to be unsecured or improperly secured behind the shower wall. Faucet handles move excessively when operated. Evaluate and remedy as needed.

Location(s): Unit 2, unit 4

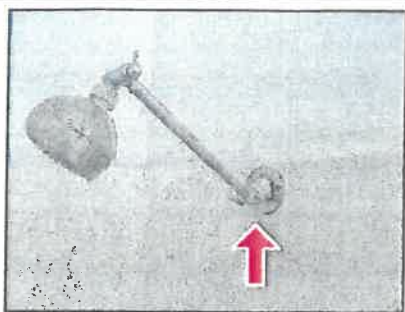
A. Item 4(Picture)

(4) Water leaks/sprays around the showerhead during operation; remedy as needed.

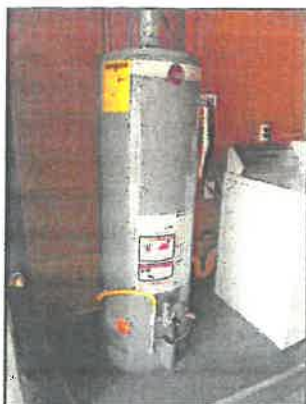
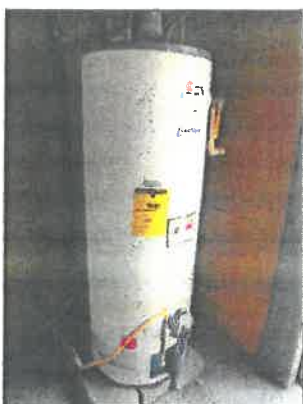
(1) General Photo of the Water Heaters

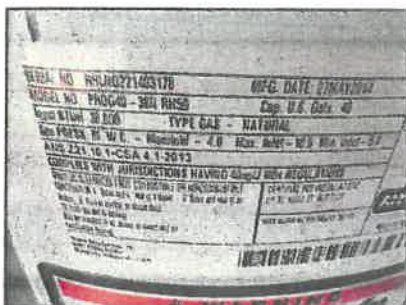
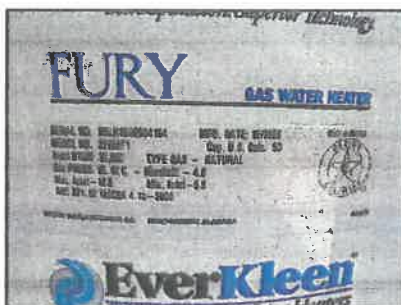
(2) Photo of Data Plate for Water Heaters

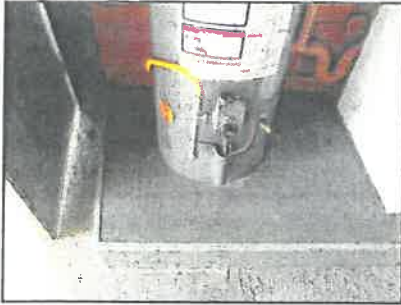
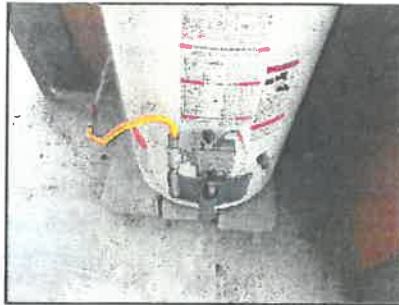
(4) Water heaters are not raised the recommended 18 inches above garage floor. Possible fire hazard.

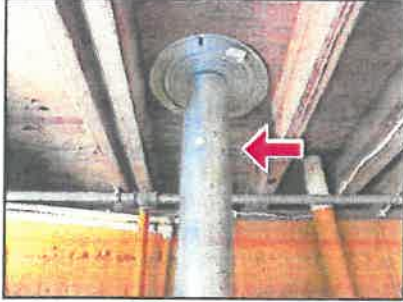
C. Item 9(Picture)

(5) The rear water heater vent pipe is not properly strapped. Strapping is needed to prevent movement.

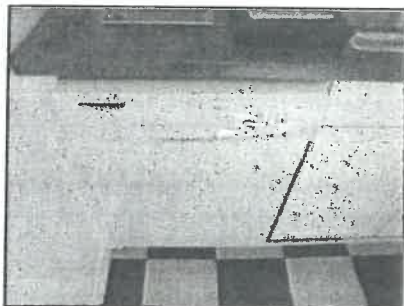
A. Item 1(Picture)

(1) The dishwasher did not operate properly when tested. Unit 3 (No water used)

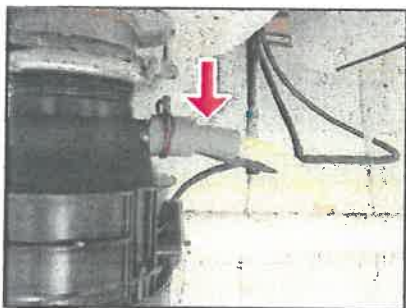
A. Item 2(Picture)

(2) Anti-siphon loop is not installed at the drain hose under the sink: the drain hose must be lifted at some point where it is higher than the hose connection to the drain (or disposal) to prevent water from back flowing from the drain (or disposal) back into the dishwasher. Unit 3, unit 4

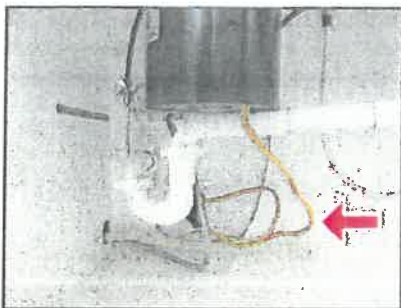
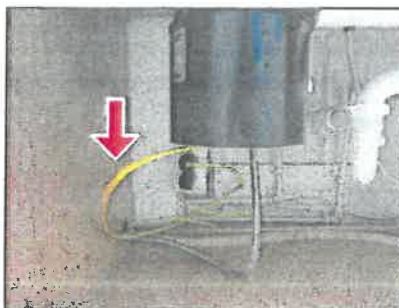
(2) Romex wiring is not properly secured in conduit under the kitchen sink at the disposal. Unit 3, unit 4

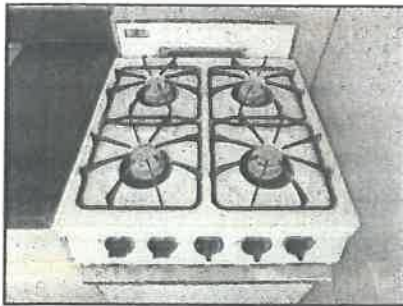
D. Item 3(Picture)

(2) **Note:** The cooktop is functioning as intended. Unit 1, unit 3, unit 4

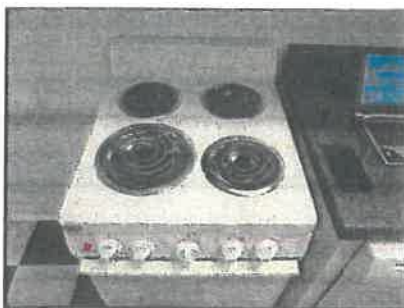
D. Item 6(Picture)

(3) There is no anti-tipping device installed on the oven/range to prevent tipping if the door is climbed on while opened. This is a possible safety hazard. Evaluate and remedy as needed. Unit 1, unit 2, unit 3, unit 4

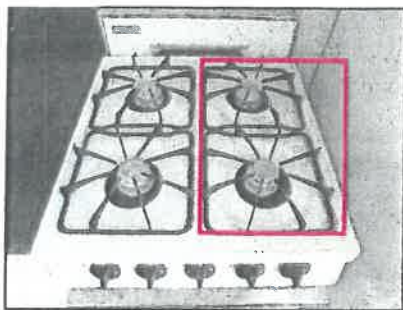
D. Item 7(Picture)

(4) The right burners were inoperative at the time of inspection. Evaluate and remedy as needed. Unit 2

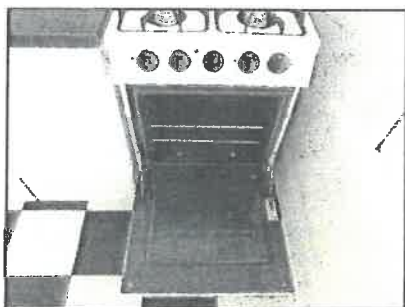
D. Item 8(Picture)

(5) Oven was inoperative at time of inspection. Unit 2

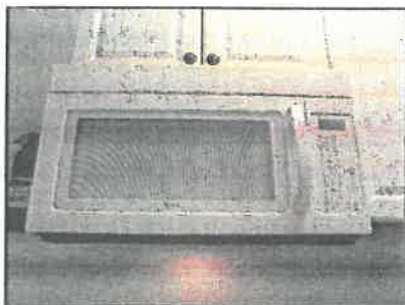
E. Item 1(Picture)

Note: The microwave is functioning as intended. Timers are not operated. Unit is tested for heating only on the "high" temperature setting. Unit 4

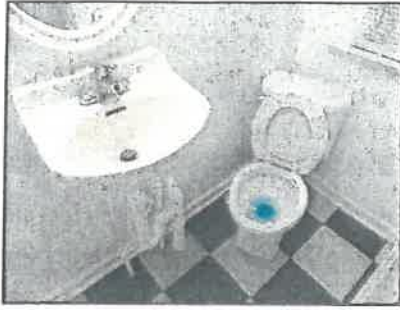
F. Item 1(Picture)

Current building standards recommend exhaust fans be installed if no openable windows are present in the bathroom. No bathroom exhaust fans were noted at the time of inspection. Unit 4
