MECHANICAL INSPECTION

4547 Bermuda Dr
Sugar Land TX 77479

Gary Turner & Debra Turner
SEPTEMBER 2, 2020

PROPERTY INSPECTION REPORT

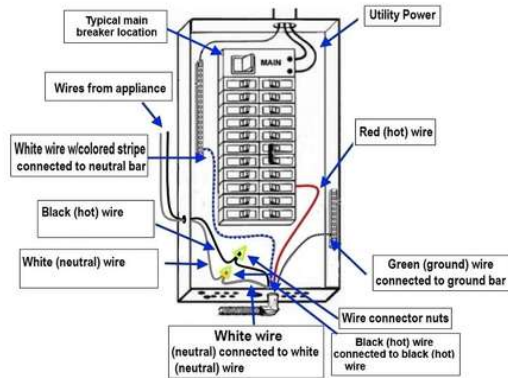
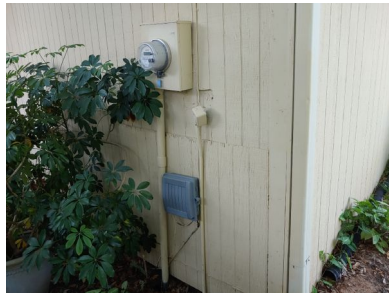
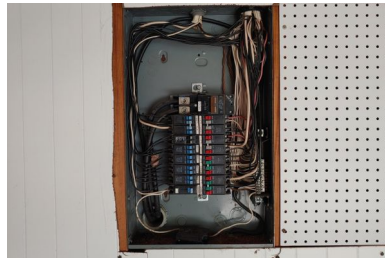
Breaker Panel Equipment - Acceptable :

The interior of the breaker panel equipment was inspected and the breakers were all properly sized for the circuits they were protecting, the grounding and bonding were properly connected, no knockout clips were missing, and the wiring appeared to be in acceptable condition at the time of the inspection.

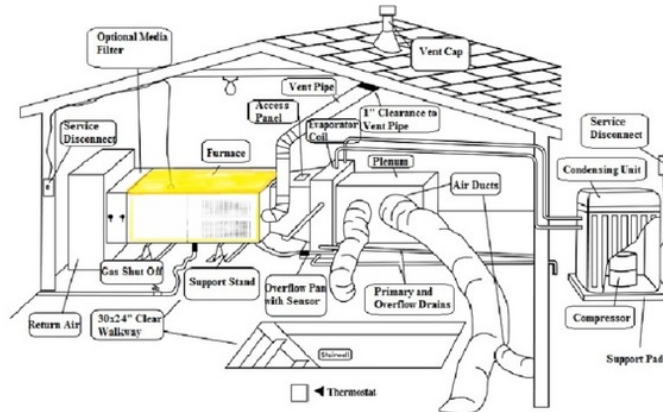
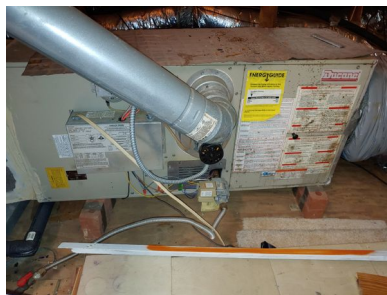
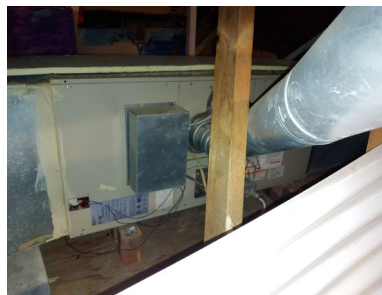
Heating Equipment - Functional:

The heating equipment was observed to be operating and functional at the time of the inspection. The heating equipment responded to the thermostat and the equipment appeared to be heating the air adequately.

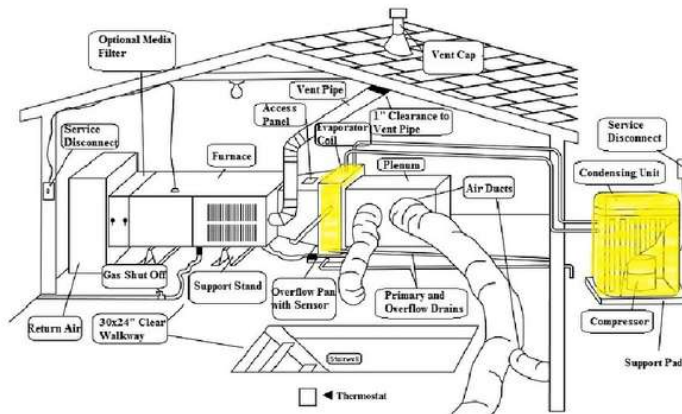
2nd

Condensing Unit Equipment - Functional:

The condensing unit equipment was functional at the time of the inspection. The equipment responded to the corresponding thermostat, and the compressor components and fan motor components were operating.

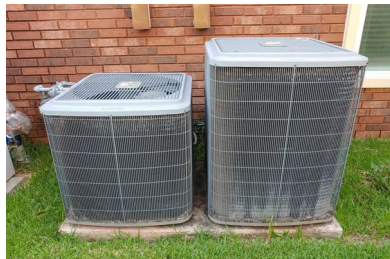
South Side

Condensing Unit Equipment - Limited Life:

Due to the age and/or condition of the equipment, it is our opinion that the equipment has only a limited amount of life remaining. It would be prudent to have the equipment thoroughly checked by a licensed air conditioning service company and further investigation is recommended.

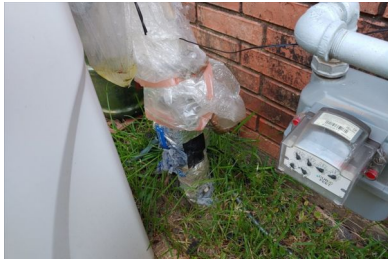
Shut Off Valve - Exterior location:

The shut-off valve for the main inlet water line was located at the exterior South Side of the house upstream of the water treatment system.

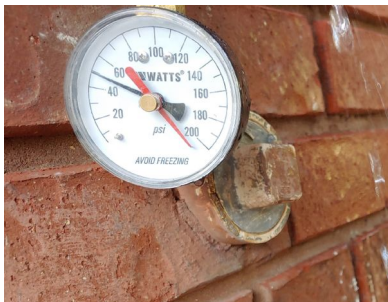
Static Water Pressure :

The static water pressure to the house at the time of the inspection was measured with a pressure gauge at the hose bibb nearest the shut off valve, and the static pressure was observed to be 50 PSI.

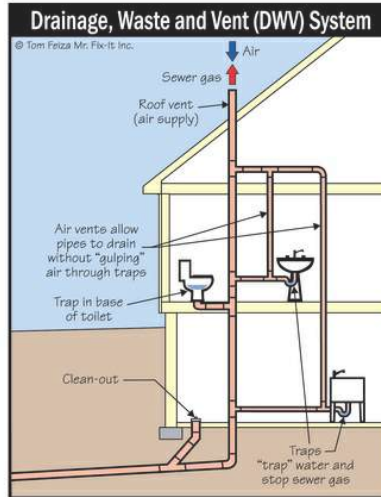
Sewer Clean Out - Present :

A sewer clean out was present. The clean out is needed in the event of a stoppage in the main sewer drain line, and the clean out is where a sewer snake would be utilized to remove a clog in the sewer line.

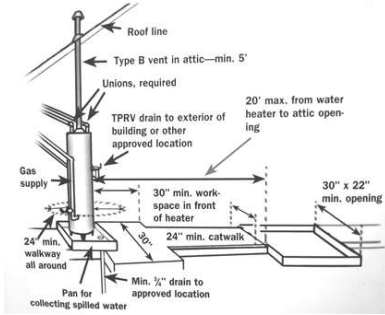
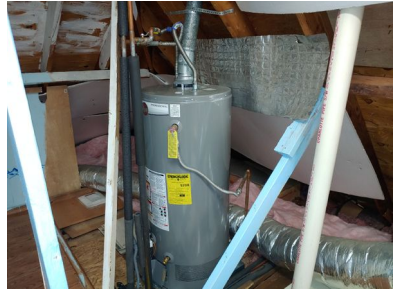
Water Heater Equipment - Functional:

The water heater equipment was functional at the time of the inspection and providing hot water to the applicable plumbing fixtures.

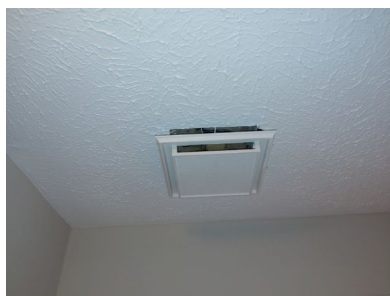
The exhaust vent was loose in the ceiling it needs to be secured.

Obtain Cost Estimate

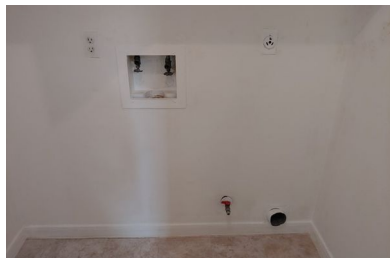
Dryer Connections - Electric 3 Prong and Gas:

The 240-volt outlet for the electric dryer connections was observed to be the older style 3-prong outlet rather than the newer 4-prong outlet. You may want to check your clothes dryer to determine if you have the correct power cord for this outlet. A gas connection was installed. It is pointed out that the gas valve was not operationally checked.
