## **PROPERTY INSPECTION REPORT**

**Concerning:** 17219 Park Lodge Drive, Spring, TX 77379  
(Address or Other Identification of Inspected Property)

**By:** Michael Barnes, Lic #22055 NACHI 17010801 10/16/2020  
(Name and License Number of Inspector) (Date)

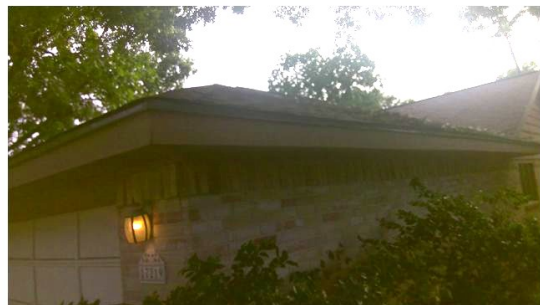
**REPAIR ITEMS:** Adding gutters to the perimeter of the home will aid drainage and erosion control

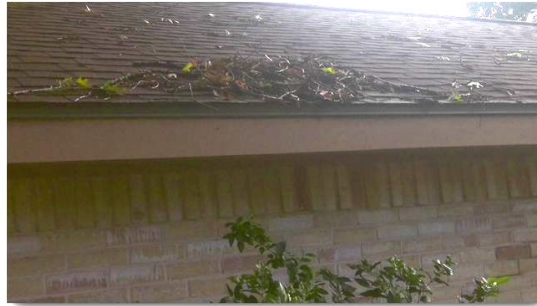
**REPAIR ITEM:** I recommend keeping the roof clear of debris. Pine straw, leaves, etc. will trap moisture, cause the roof to deteriorate prematurely, and may allow water damage to occur in the attic and on interior surfaces.

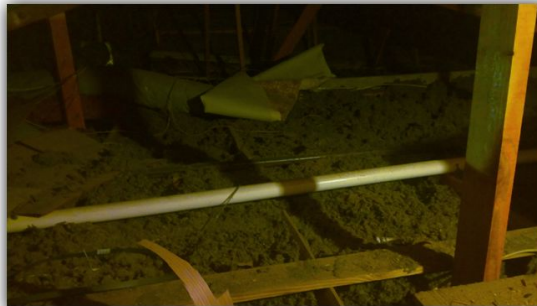
**REPAIR ITEM:** The insulation was missing/thin in several locations. There were also some wall insulation that had fallen. I recommend evaluation by an insulation professional.

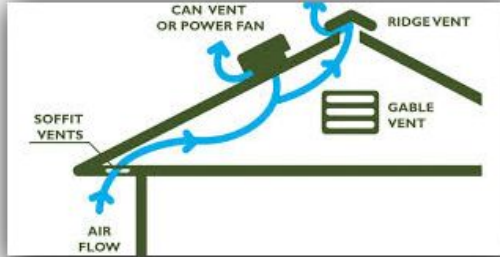
**REPAIR ITEM:** The attic ventilation was inadequate at the time of the inspection. Poor ventilation increases heat in the attic and living space in addition to decreasing the life of the roof covering and any appliances located in the attic such as HVAC equipment and water heaters.

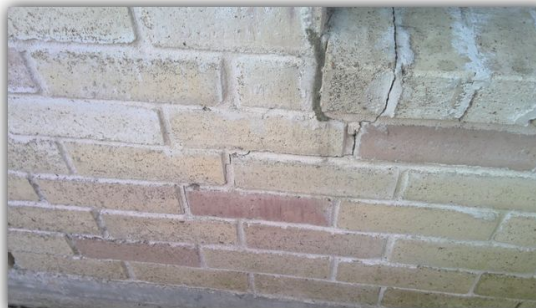
**REPAIR ITEM:** There were cracks in the brick and/or mortar. This may have been the result of a foundation or structural issue. I recommend sealing the cracks to prevent possible water and/or pest intrusion that could eventually damage the components behind the brick.

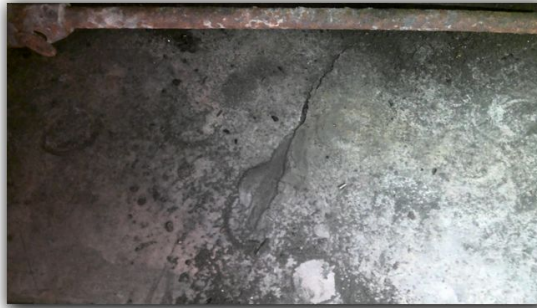
**SAFETY CONCERN:** The inside of the firebox was cracked and the gas line was damaged. I repairing the damage firebox and repair/replacement of the gas line.

**NOTE:** I recommend a professional contractor evaluate and repair the system as needed.

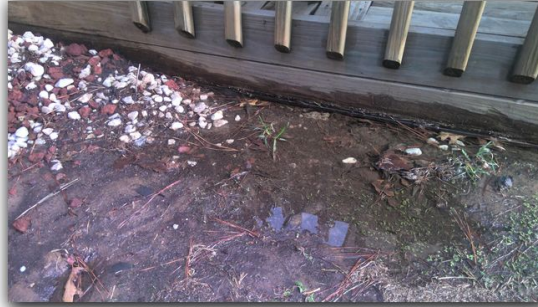
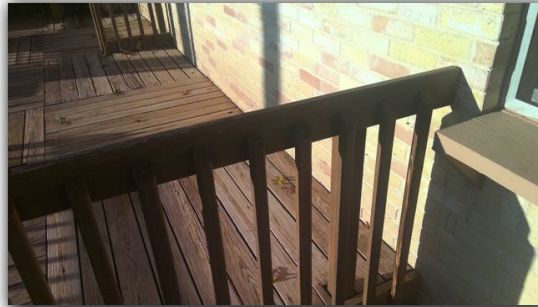
**REPAIR ITEM/SAFETY CONCERN:** The deck on the rear of the home had several issues. There was wood to ground contact, wood rot, loose rails, exposed nails, etc. I recommend repair/replacement.

**NOTE:** I recommend a professional contractor evaluate and repair the system as needed.

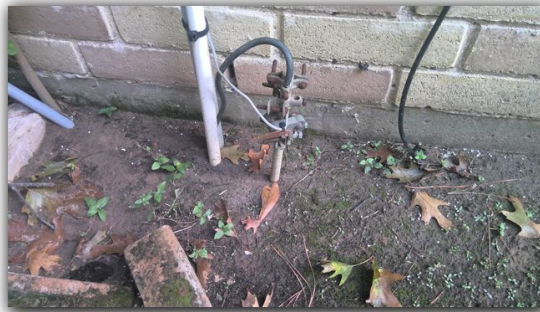
**SAFETY CONCERN:** The ground rod should be driven completely into the ground and the ground wire should be secured with an acorn type fastener.

The electrical system should be investigated by a licensed, professional electrician. Some of the issues discovered were as follows:

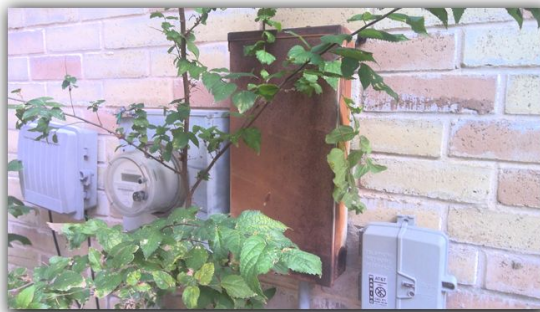
**SAFETY CONCERN:** I was unable to safely remove the panel cover because owner belongings were blocking access. There should be a minimum of 36" clearance on the front and sides of the service panel.

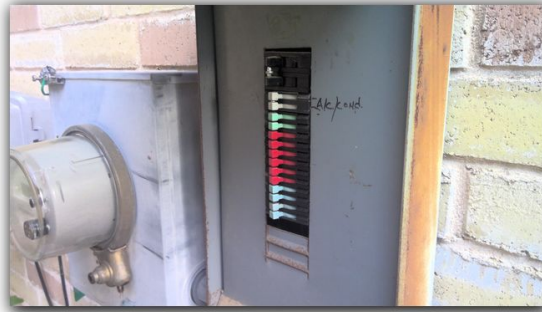
**SAFETY CONCERN:** The service entrance panel was not properly labeled.

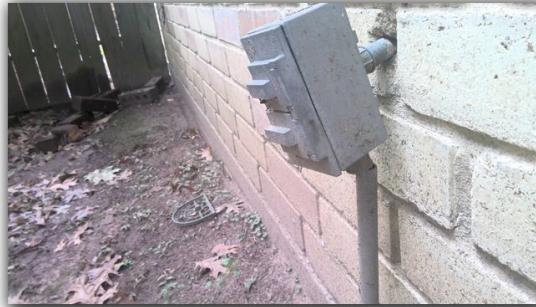
**REPAIR ITEM:** There was an outlet on the left side of the home that was not properly installed and not functional at the time of the inspection.

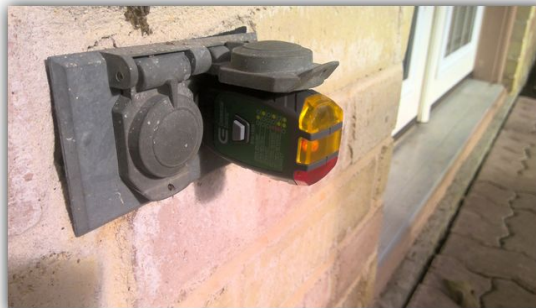
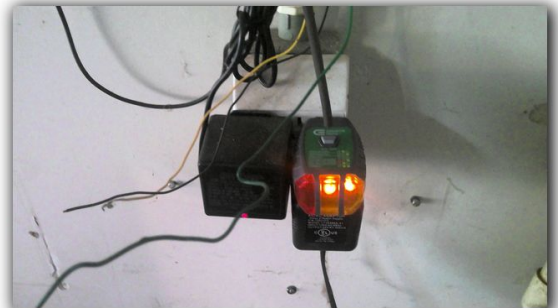
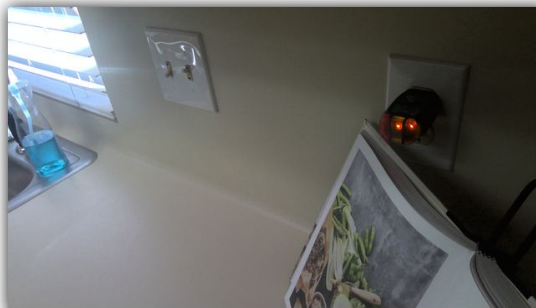
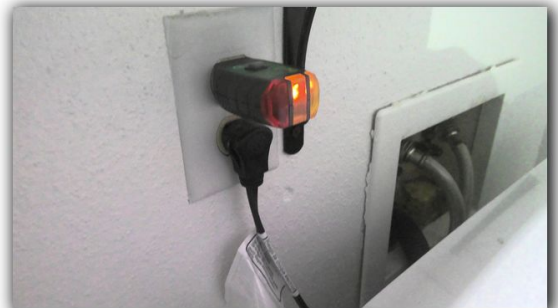
**SAFETY CONCERN:** Many of the outlets in "wet areas" in the home were not protected by GFCI's such as the kitchen, exterior, garage, and laundry room.

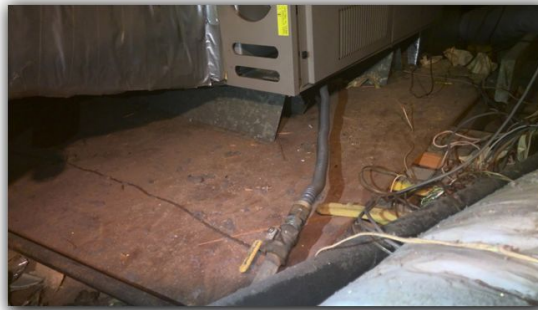
**SAFETY CONCERN:** Drip leg/sediment traps need to be installed on the furnace gas line by a licensed plumber.

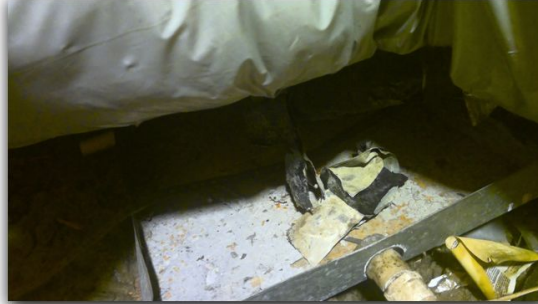
**REPAIR ITEM:** The secondary drain pan had debris that should be removed and was not installed correctly.

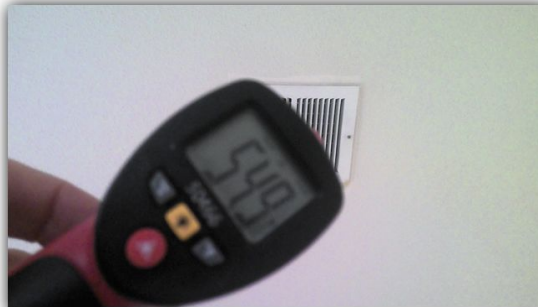
**REPAIR ITEM:** According to TREC standards A/C units should have a minimum of a 14 degree differential between supply. I recommend evaluation and repair by a licensed HVAC technician.

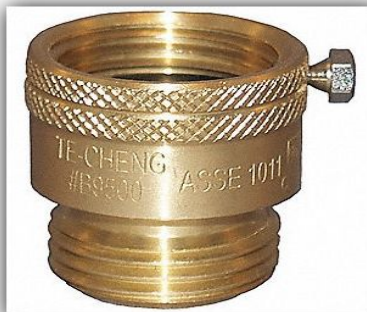
**REPAIR ITEM:** An anti-siphon device was missing on hose bibs.

**NOTE:** I recommend a licensed plumber evaluate and repair the system as needed.

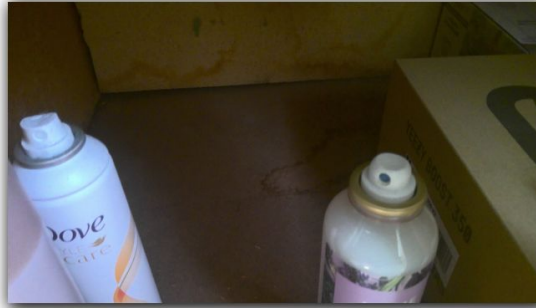
**REPAIR ITEM:** There was evidence of prior water damage and organic growth under sinks.
