PROPERTY INSPECTION REPORT

Concerning: 10834 Olympia Dr. Houston, TX 77042

By: Gabe Fitzpatrick #21417

1/28/2020

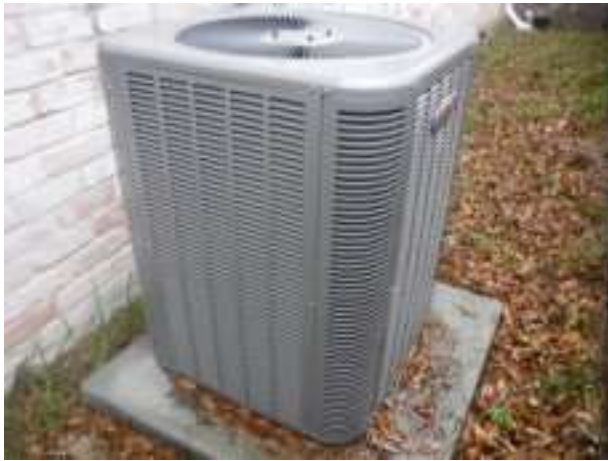
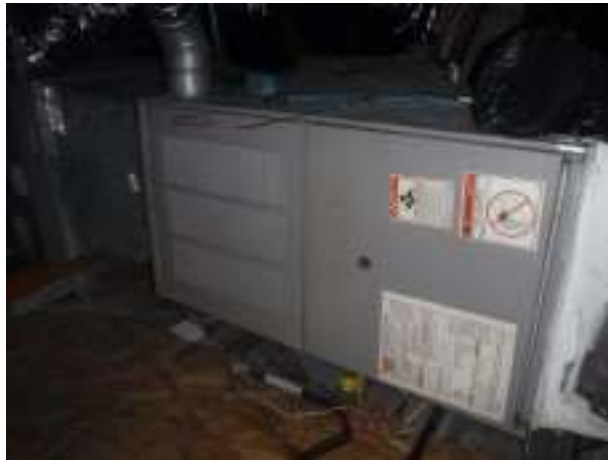
Type of Systems: Forced Air
Energy Sources: Natural Gas
Comments:

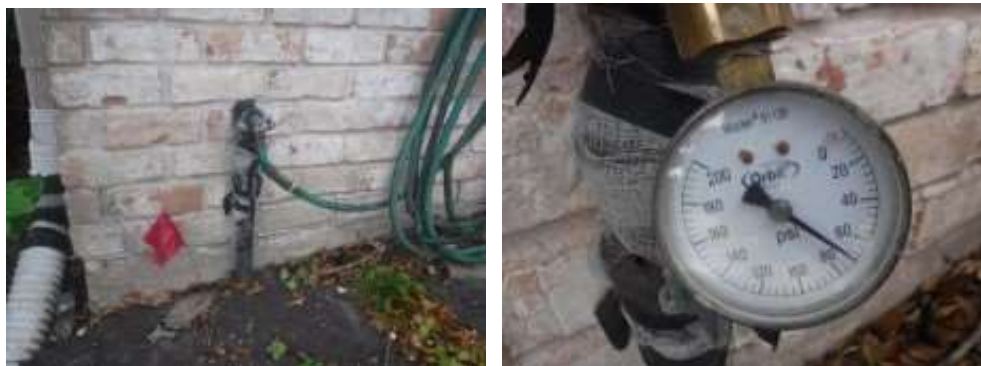
The shut-off valve for the main inlet water line was located at the exterior at the east side of the house. The water meter was located at the street. (Information)

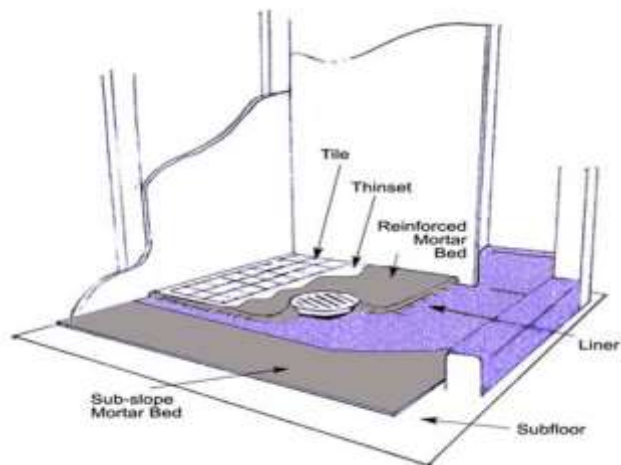
Access was not provided to the trap areas at the back of the tubs, therefore the plumbing behind the tubs was not viewed. (Information)

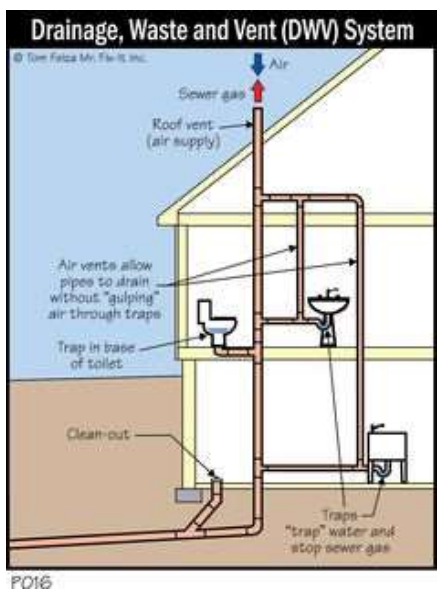
The water in the house was run for approximately 30 minutes at the sinks and tubs. In addition, the toilets were flushed three or four times each, and the sinks and tubs were filled, and allowed to drain. No evidence of slow drains were visible. If you desire a hydrostatic test to determine if the underground piping is leaking or clogged, then it is recommended that you contact a plumber. (Information)

The sewer piping appeared to be the original cast iron piping. It can be anticipated that the underground cast iron piping will rust out at some point, and will need to be replaced at that time. Due to the corrosive nature of the cast iron sewer piping, it is recommended that an underground sewer line inspection be performed by a service company to determine if any repairs are needed and to provide cost estimates. It is pointed out that underground sewer leaks can cause differential foundation settlement and lead to drainage problems.

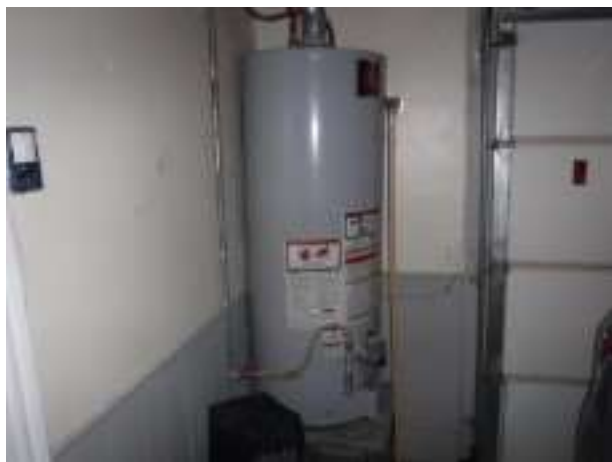
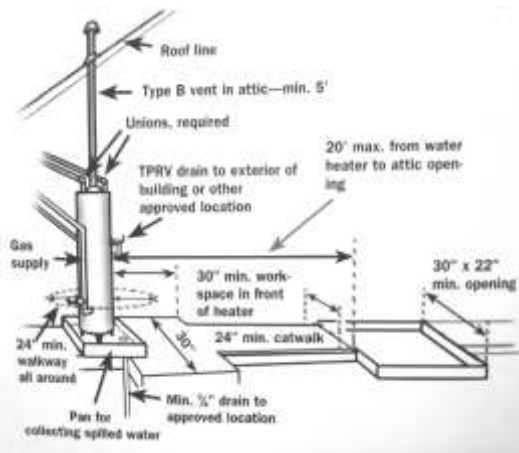
The hot water for the house was provided by a 50-gallon natural gas fired water heater manufactured by State Select in 2016 and is located in the garage. The water piping from the water heater was observed to be galvanized steel. (Information)

No items requiring repair were visible at the time of the inspection to the operation of the water heater. The water heater was functional at the time of the inspection, and providing hot water to the house.

The temperature of the hot water was measured to be 131 degrees at the kitchen sink at the time of the inspection. Normally, 120-125 degrees is the recommended maximum temperature of hot water to prevent accidental scalding. See the chart below for more information about hot water burns, as taken from the International Residential Code, 2012.

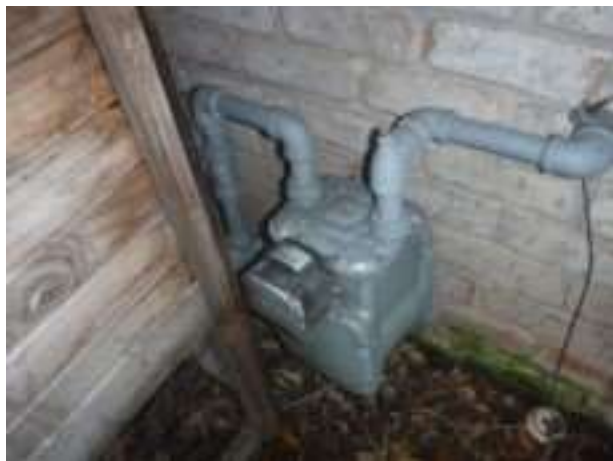
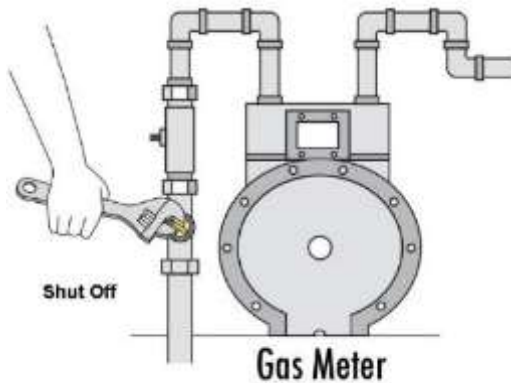
The gas meter, with the main shut off valve for the gas to the house, was located at the side of the house.

The gas supply lines were not equipped with sediment traps on the gas line. Have a plumber make the needed repairs.
