HEDDERMAN ENGINEERING, INC.

REF: CONDITION OF PROPERTY SURVEY

At your request, a visual survey of the house located at 10834 Olympia Drive, Houston, Texas, was made by Mr. Tim Hedderman and Mr. Gabe Fitzpatrick.

10834 Olympia Drive

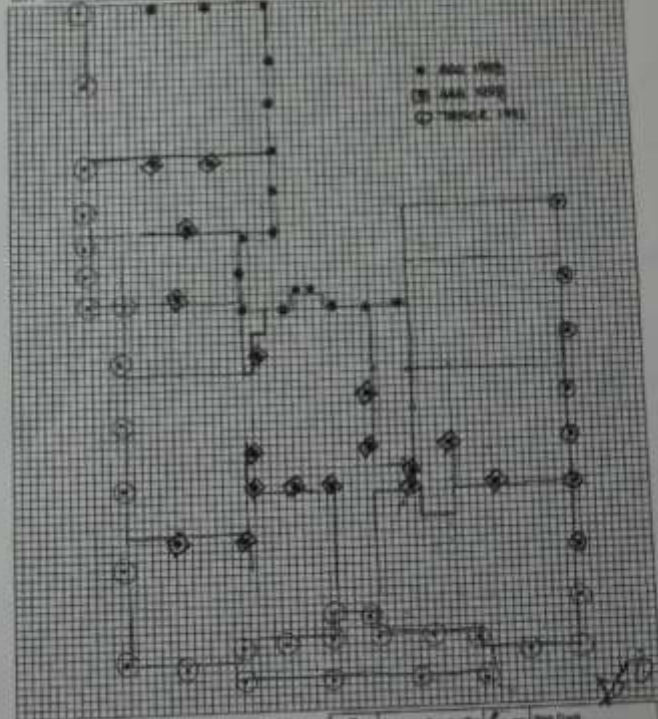
It was disclosed that the foundation of this house has been repaired previously as shown in the two sketches below. It is pointed out that HEDDERMAN ENGINEERING, INC. cannot and does not take any responsibility for the adequacy and/or future performance of the repair work. Any opinions given in this report concerning the levelness of the house are for the day of the inspection only, and are not a warranty against future foundation movement of the house. It is recommended that you obtain all available information and warranties from the homeowner relating to the foundation repair(s).

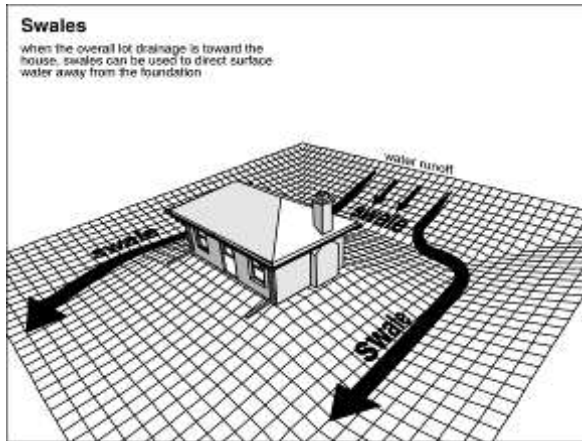
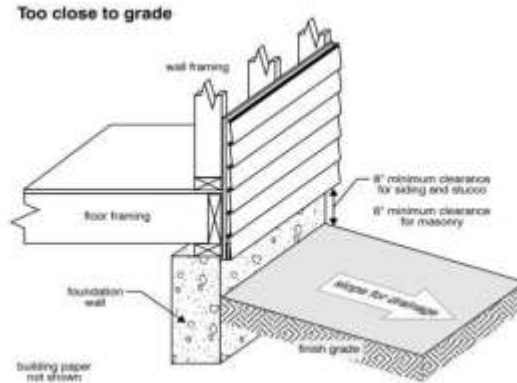
Perimeter Grading/Drainage

The perimeter drainage around the property appeared to generally be adequate. It could not be determined with certainty if water would pool at any localized low areas around the property. Further investigation with the homeowner is recommended to determine if there are any drainage problems or standing water after a rain.

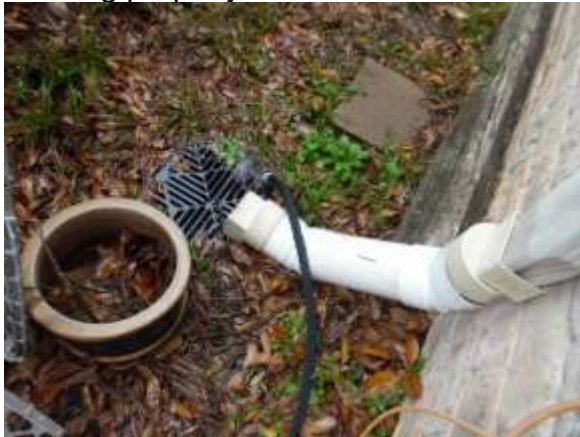
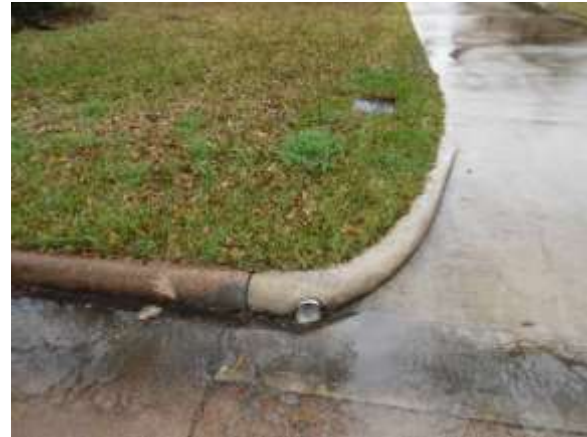
Underground Drainage

The underground drainage system at the rear of the house was checked by running water into the drain for approximately 15 minutes, and the system was observed to be draining properly to the street.

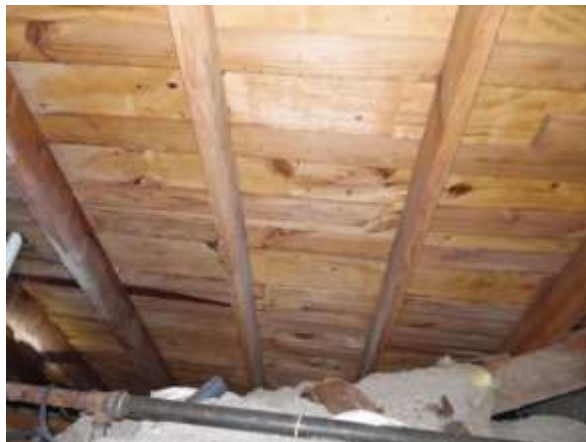
It was observed that the old wood shingles were removed, and the roof has been redecked.

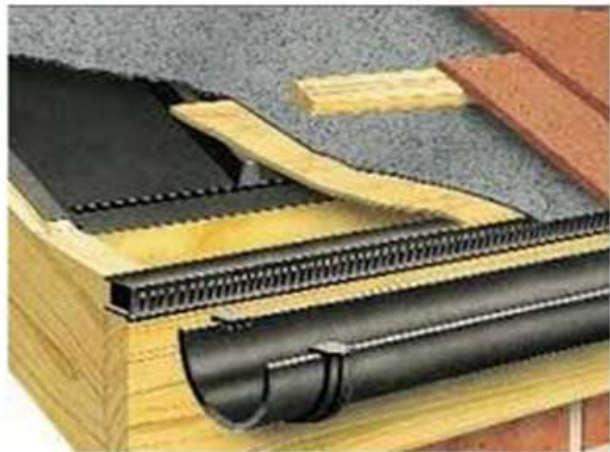
The ventilation for the upper portion of the attic consisted of vents in the roof, including continuous ridge vents and screened soffit vents.

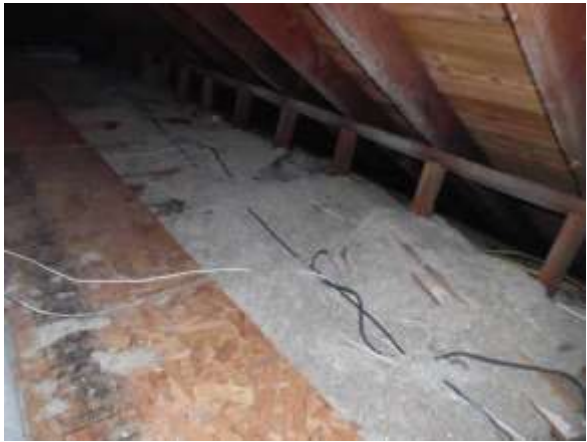
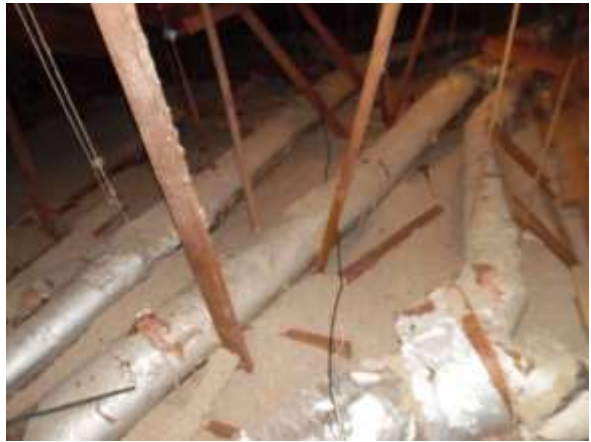
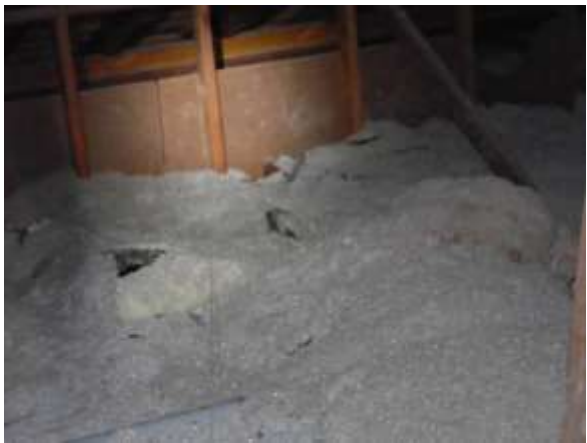
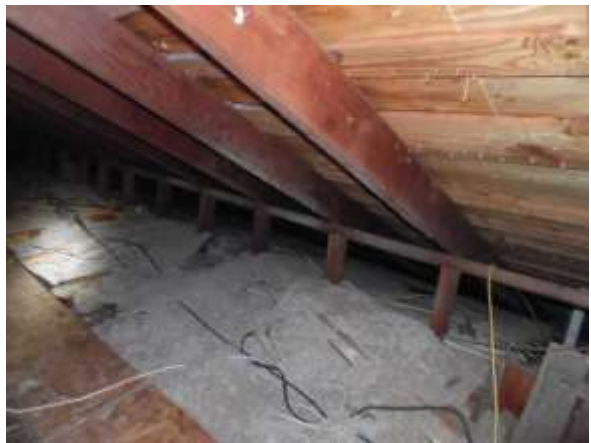
Insulation Description

The insulation in the attic has been upgraded and appeared to be approximately an R30 installation.

The access ladder into the attic appeared to be the original installation ladder, and, therefore, does not meet current code requirements for ladders into attics. Consideration should be given to replacing the ladder with a ladder that meets current code requirements.

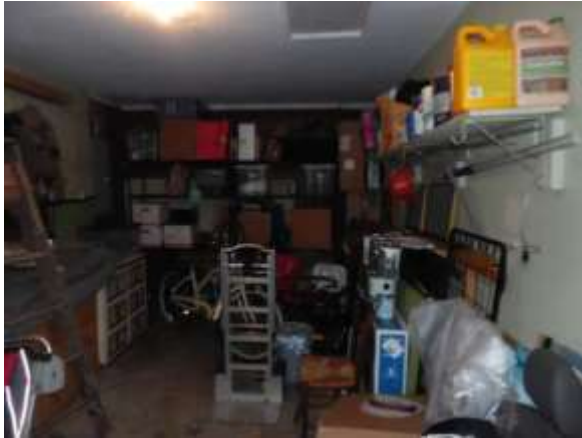
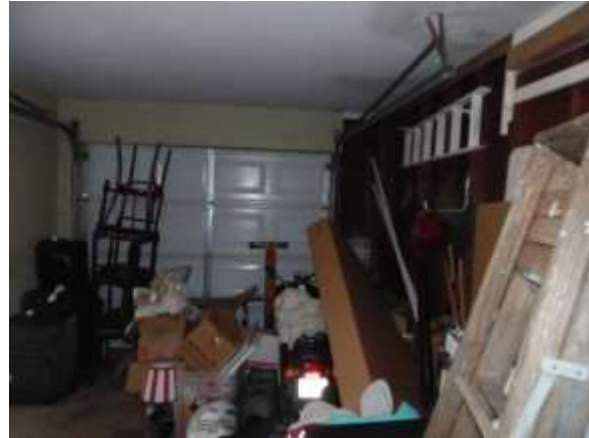
Garage

The garage had stored items in the garage, and access was limited inside the garage. We did not move any item in the garage, and not all of the garage was viewed at the time of the inspection.
