PROPERTY INSPECTION REPORT

Concerning: 1028 E 14TH STREET, Houston, TX 77009
(Address or Other Identification of Inspected Property)

By: Stephen Perry, Lic #7854 06/19/2018
(Name and License Number of Inspector) (Date)

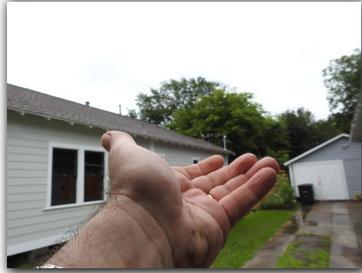
☑ Roof decking deflection and / or sagging
ON THE FRONT RIGHT AND BACK RIGHT SIDES OF THE
HOME DUE TO A LACK OF RAFTER/HIP JACK MID SPAN
SUPPORT COMMON WITH OLD HOMES THAT DOES NEED
EVALUATION AND REPAIRS TO THE ROOF STRUCTURE IN
THE ATTIC.

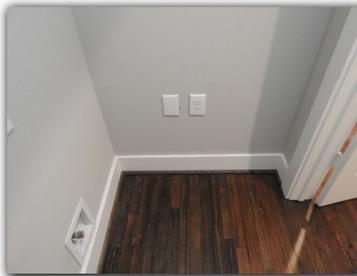
- **SOME DRYWALL DAMAGE IN THE LAUNDRY ROOM/FINISHING WORK NEEDED**

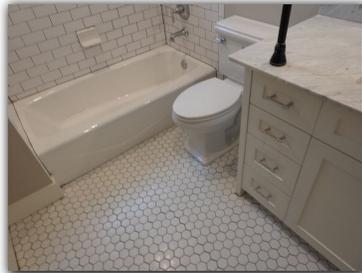
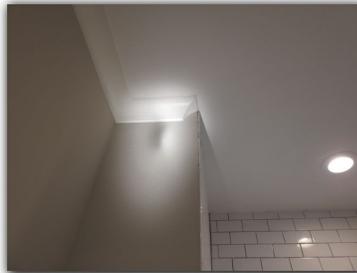
- **CALKING/GROUT AND SOME PAINT DEFICIENCIES IN THE BATHROOMS, DOOR FRAME/BASE BOARDS TRIM, AND THE CLOSET HANGER RODS NEED PAINTING**

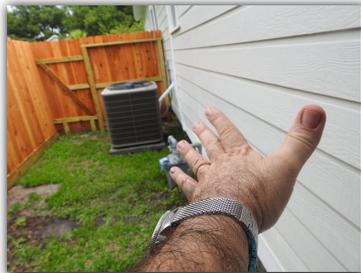
- **THERE IS A CONCAVE WARPED AREA OF THE LOWER EXTERIOR WALL ON THE RIGHT SIDE OF THE HOME THAT NEEDS EVALUATION AND REPAIRS. POTENTIAL ROTTED FRAMING MAY HAVE BEEN COVERED OVER WITH CEMENT BOARD SIDING OR JUST IMPROPERLY INSTALLED.**

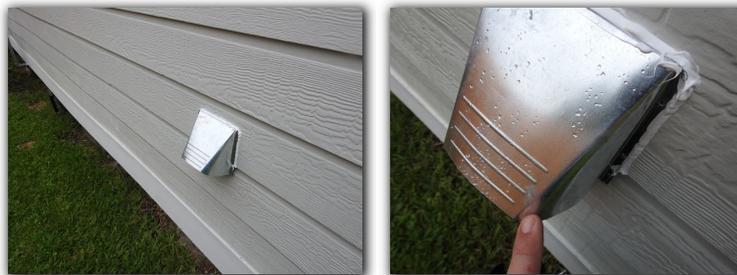
- **THE CLOTHES DRYER DUCT VENT COVER NEEDS TO BE PAINTED AND TEMPORARY SEALED OFF TO PREVENT A DRAFT AND ALSO VERMIN FROM ENTERING INTO THE HOME UNTIL A DRYER IS INSTALLED.**

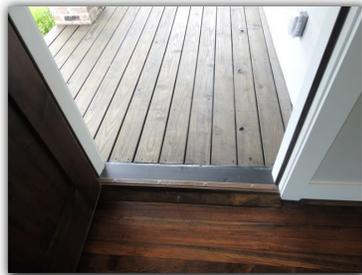
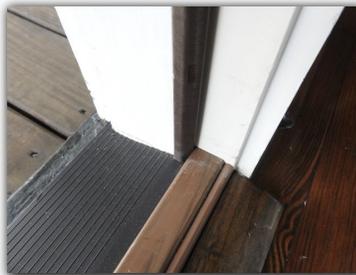
- **THE BOTTOM OF THE EXTERIOR DOOR FRAMES AT THE LOWER JAMBS NEEDS TO HAVE SMALL SQUARE FOAM RUBBER WEATHER STRIPS THAT DO PREVENT THE INSIDE JAMB FROM BECOMING ROTTED FROM WATER PENETRATIONS**
- **CALKING NEEDED AT THE EXTERIOR DOOR FRAME TRIM/THRESHOLD/FLOOR PLATE AND TRIM**

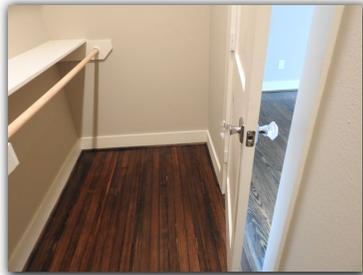
- **THE MASTER CLOSET DOOR KNOB ASSEMBLY IS MISSING A LATCH THAT NEEDS TO BE INSTALLED**

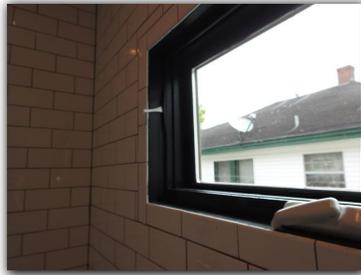
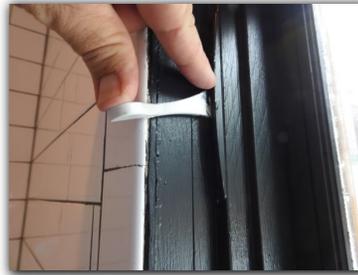
- **THE MASTER BATH CASEMENT WINDOW HAS A LOCK ON THE LEFT SIDE HARD TO LOCK AND IN NEED OF EVALUATION AND REPAIR**

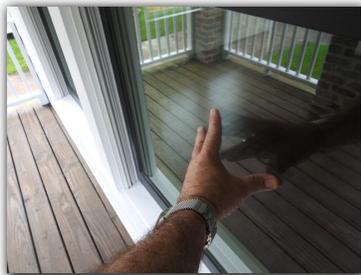
- window screens are all missing**

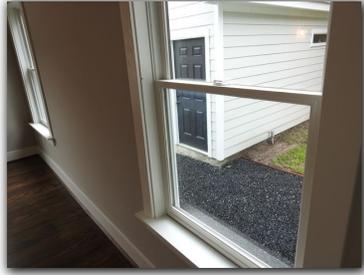
- Thermal pane window seals have failed, moisture is present**
- There appears to be a broken seal with a foggy appearance on the master bedroom window on the back right side that may require replacement on the lower sash of the double hung window. recommend evaluation by a window repair expert.**

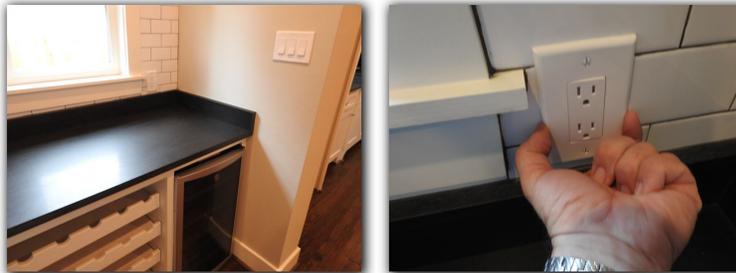
Loose, damaged, missing outlets / switches / covers

**•INFRARED CAMERA DID SHOW ONE OUTLET IN THE DEN WITH EXCESSIVE HEAT;
RECOMMEND EVALUATION BY AN ELECTRICIAN**

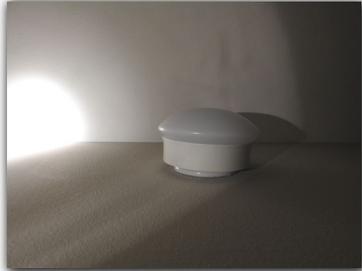
- Light fixtures inoperable or in need of repair**
BACK PORCH HALL CLOSET LIGHT IS OUT

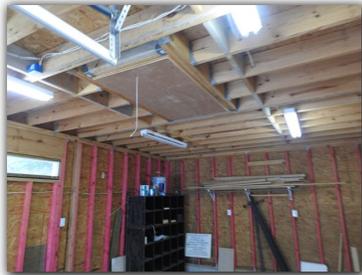
- **ONE FLORESCENT LIGHT IS OUT IN THE GARAGE THAT NEEDS TO BE REPAIRED.**

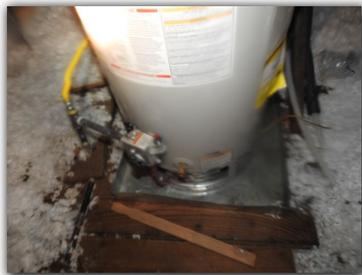
Water heater Temperature and Pressure Relief Valve

- **MISSING FLAME PLATE THAT NEEDS TO BE REPLACED**

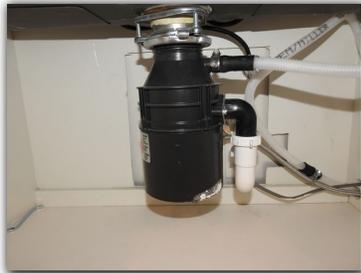
B. Food Waste Disposers

Excessive Vibration; may have dirt or debris from during construction. recommend service/cleaning

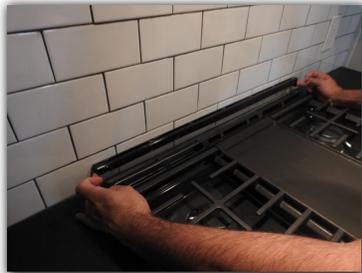
- **LOOSE TRIM PIECE ON THE BACK OF THE OVEN/RANGE THAT NEEDS REPAIRS**
