Home Inspection Report

3117 Indiana, Baytown, TX 77520

Inspection Date:
Wednesday, December 30, 2020

Prepared For:
Bruce Cassidy

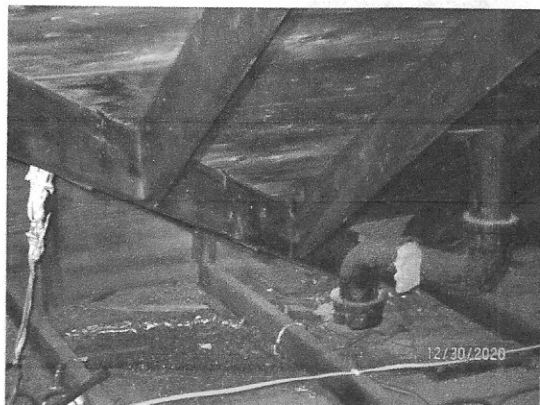
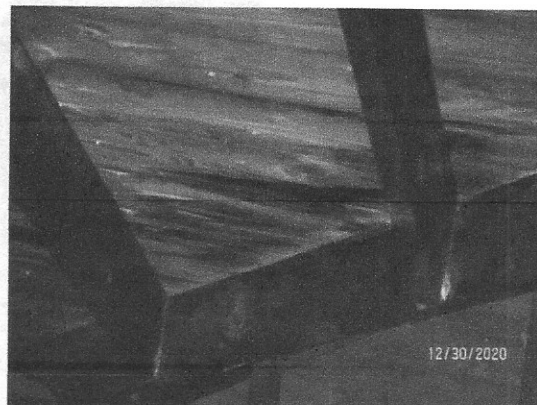
Some missing purlin supports at Various Locations. Although this does not appear to have caused any structural defects the area should be monitored for possible future repairs.

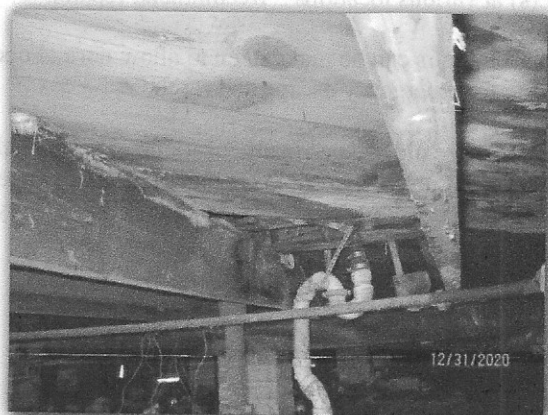
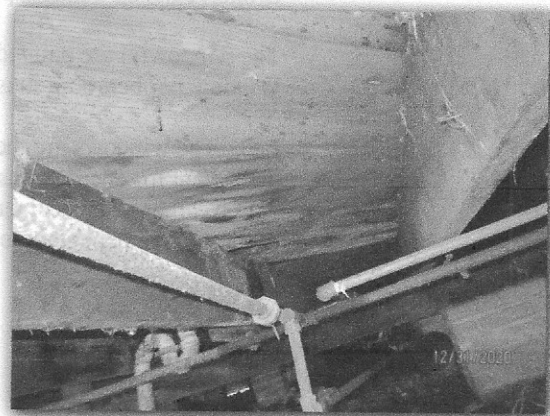
Some termite damaged sub floor/ wood flooring/trim East side. Recommend repair/replacement of the damaged flooring and further examination to determine if there is an active termite infestation or additional structural damage.

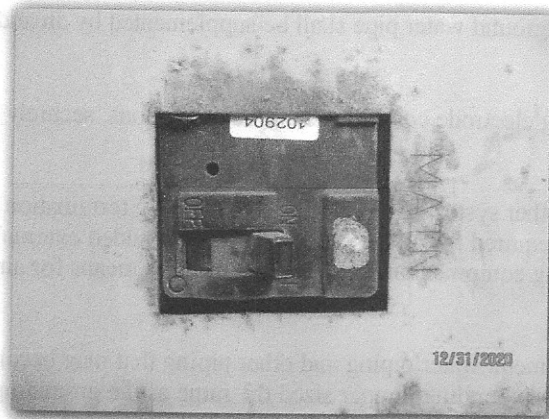
Box Rating and/or Main Disconnect Rating: Rating Not Determined / Box Not Properly Labeled
Box Location: Rear Exterior

Comments:
Visual inspection only, power not connected.

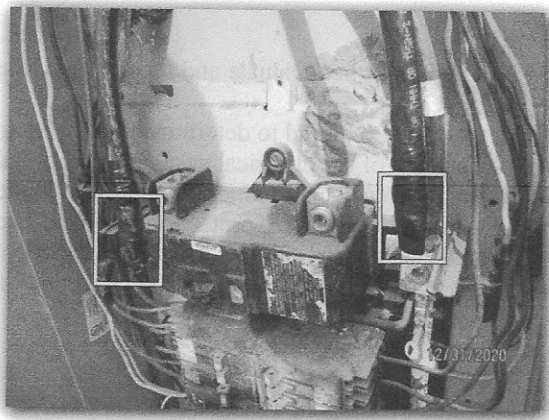
FYI. The 2008 National Electric Code now requires No-Arc or No-Fault protection (AFCI) be installed for family rooms, dining rooms, living rooms, parlors, libraries, dens, bedrooms, sun rooms, recreations rooms, closets, hallways, or similar rooms or areas.

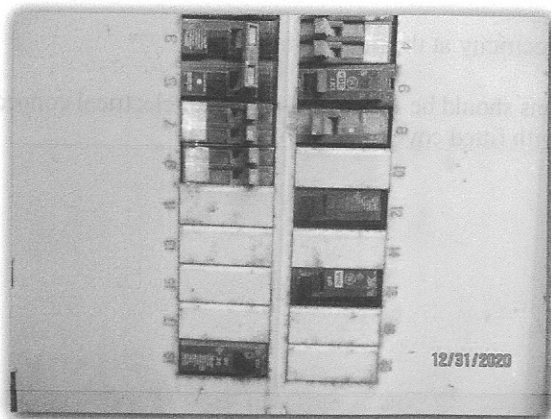
N.E.C. - 250.50 Grounding Electrode System.
All grounding electrodes as described in 250.52(A)(1) through (A)(7) that are present at each building or structure served shall be bonded together to form the grounding electrode system. Where none of these
