## RESIDENTIAL INSPECTION REPORT

2402 Gerol Dr  
Galveston TX 77551

Margaret Martinez & John Martinez  
FEBRUARY 2, 2021

Inspector  
**Chance Phillips**  
TREC #3899  
(281) 484-8318  
[office@inspectorteam.com](mailto:office@inspectorteam.com)

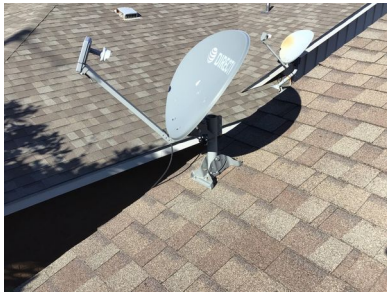
**1: Tree limbs on/near roof**

Tree limbs that are in contact with roof or hanging near roof should be trimmed to prevent damage to the roofing materials.

Recommendation: Contact a qualified tree service company.

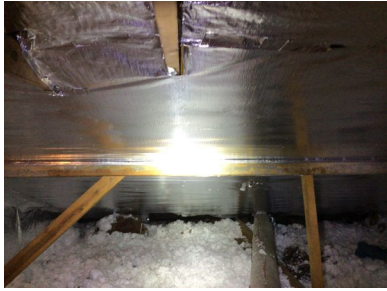
**1: Sheathing: Wavy or Sagging**

**Note:** A radiant barrier was installed on the roof decking. This may conceal possible evidence of water penetration and limit evaluation of the decking material.

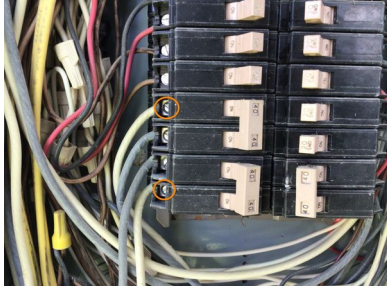
**1: White Wires Not Marked**

White wires connected to breakers are not marked with black or red electrical tape to indicate that they are "hot". Remedy as needed.

Recommendation: Contact a qualified electrical contractor.

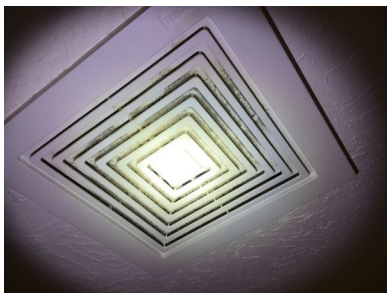
Cleaning of the exhaust vent cover is needed to ensure unrestricted air flow.

Recommendation: Contact a qualified professional.
