Henson Home Inspections

Property Inspection Report

22257 Round Valley Drive, Katy, Texas 77450

Date of Inspection: 5/9/2020 Time: 9am

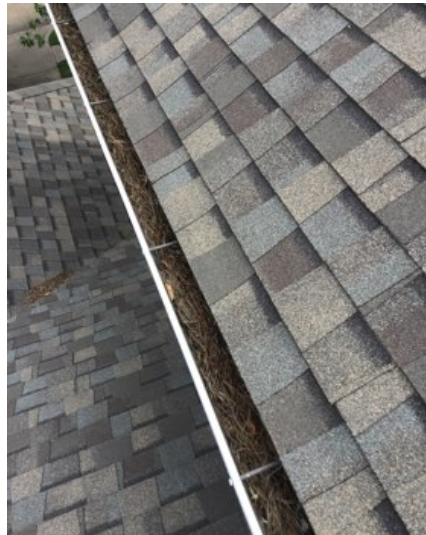
Debris in the gutter on rear of home

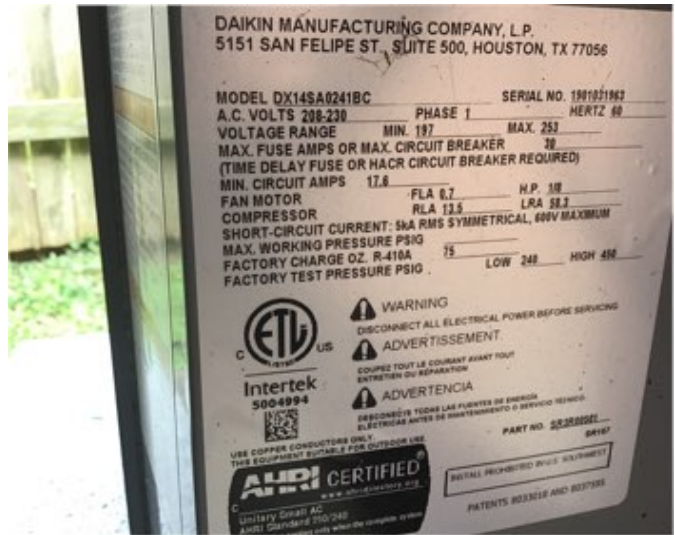
Downstairs unit R410

The area where the refrigerant lines enter the dwelling needs to be sealed to prevent insects and rodents from entering the premises
