PROPERTY INSPECTION REPORT

Report I.D. # 111620-A

Concerning: 3510 Stratford Plaza Lane
Sugar Land, Texas 77498

Lee Fasbinder, T.R.E.C. #7507

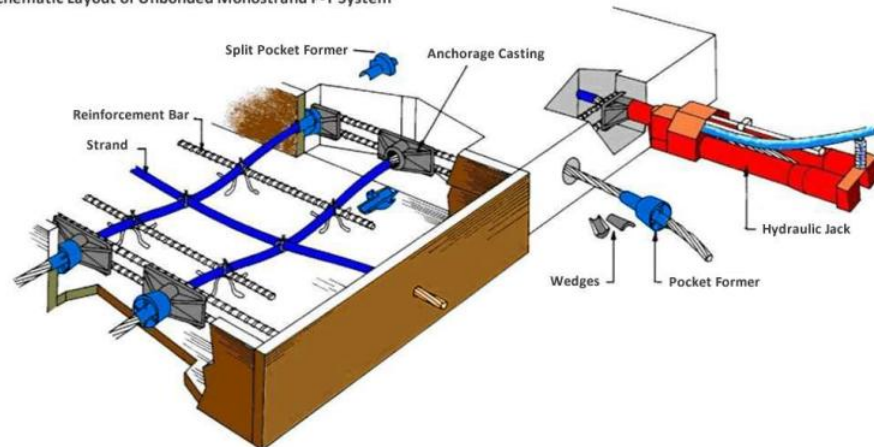
Schematic Layout of Unbonded Monostrand P-T System

Post tension cables are added to the foundation with tension to increase the integrity of the slab. The tension cables are cut off at the sides of the foundation wall (right and left side of the home) and the ends of the cables are sealed with exterior caulking or epoxy to prevent the tension ends from corrosion (rusting).

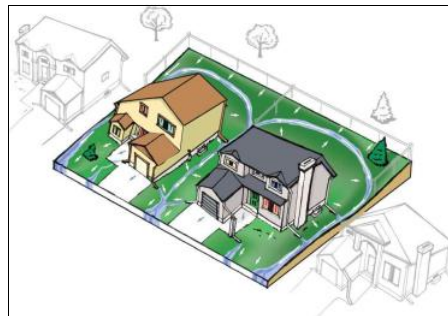
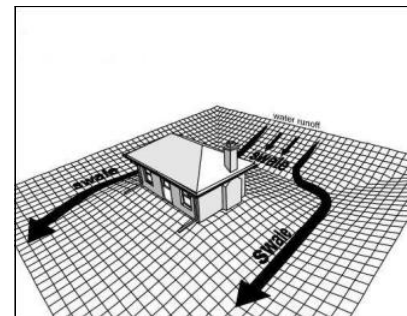
All grading leads away from the home. The grading at the front of the home leads to the street. The grading at the back of the home is directed to the right and left side of the home and then directed to the street.

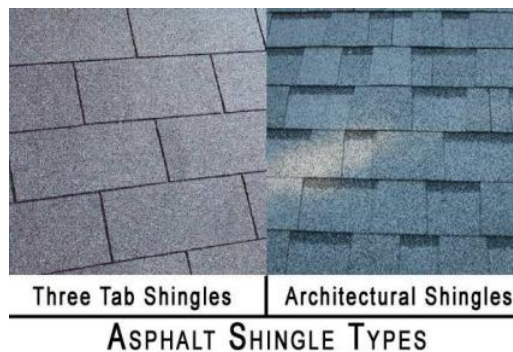
There are two types of shingles on the home:

- architectural (back patio overhang)
- 3-tab (home)

The composition shingles, single layer, is on top of underlayment (vapor barrier) with metal drip edge guards (this keeps the water from going under the shingles at the edge of the roof). This was properly installed.

The shingles are showing normal wear for its age. Pitting, topical granular loss and fiberglass frayed edging is just starting to occur. Minor repairs were noted. At the time of this inspection, the covering is functioning as intended.

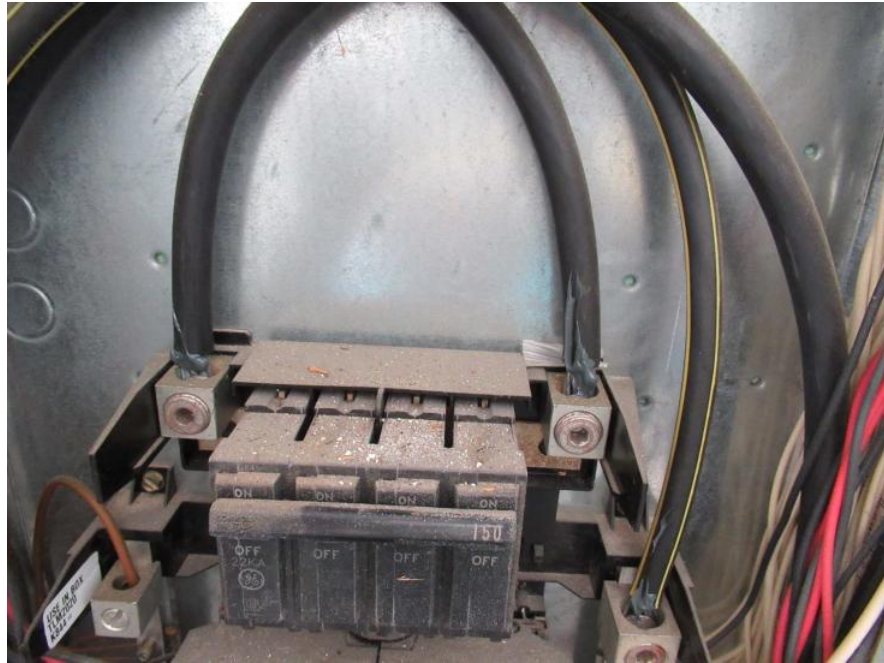
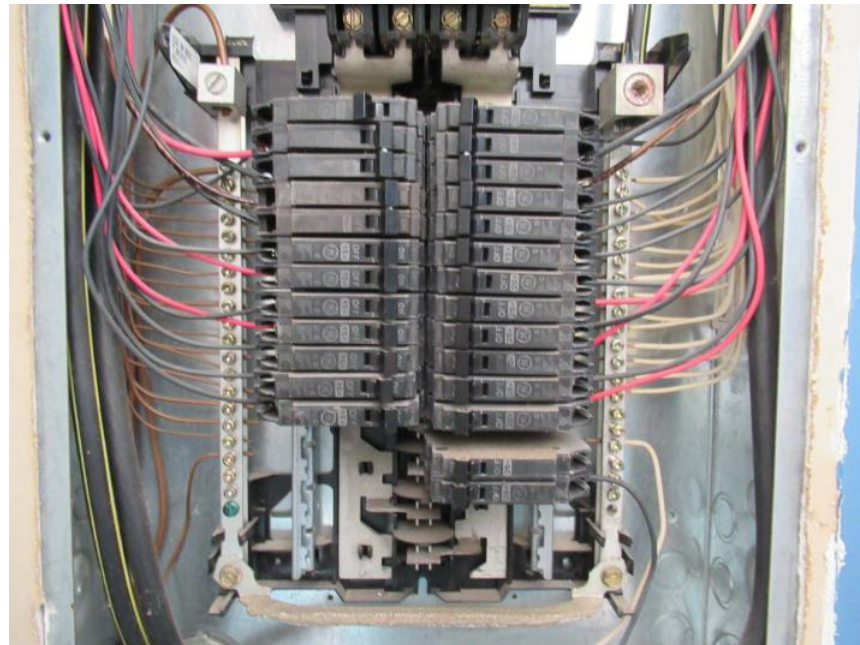
All remaining accessible components of the service panel were examined and found to be installed correctly per original age of construction.
