HOUSTON INSPECTIONS

Chad & Taylor McCoy
313 Eado Park Circle
Houston, TX 77020

November 9, 2018

PROPERTY INSPECTION REPORT

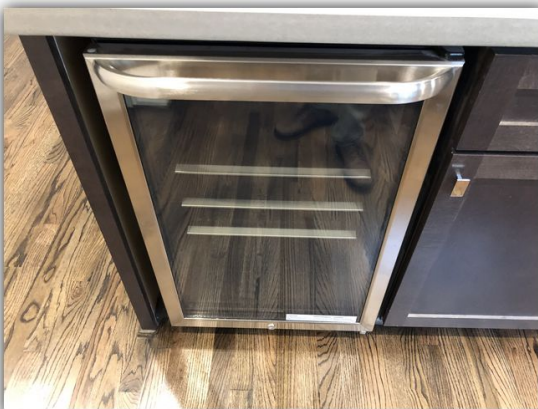
1. Wine Fridge

These systems are beyond the scope of this inspection and were not inspected. The client is urged to have the system(s) along with associated components evaluated prior to closing to insure proper installation and performance.

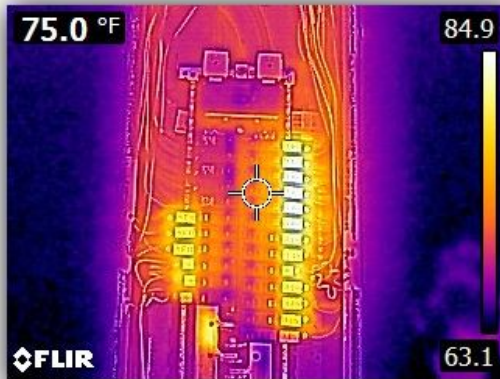
During the inspection of the electrical panel with a infrared camera no significant abnormalities were noted. The picture(s) below are a sampling of some image(s) taken during the inspection.
