# Inspection Report

**Property Address:**  
9336 Old River Ct.  
Montgomery TX 77356

**JASE Home Inspections**

<b>Date:</b> 10/11/2020	<b>Time:</b> 09:55 AM	<b>Report ID:</b>
<b>Property:</b> 9336 Old River Ct. Montgomery TX 77356	<b>Customer:</b> Monte Gibbs	<b>Real Estate Professional:</b> Jeff Deutschmann

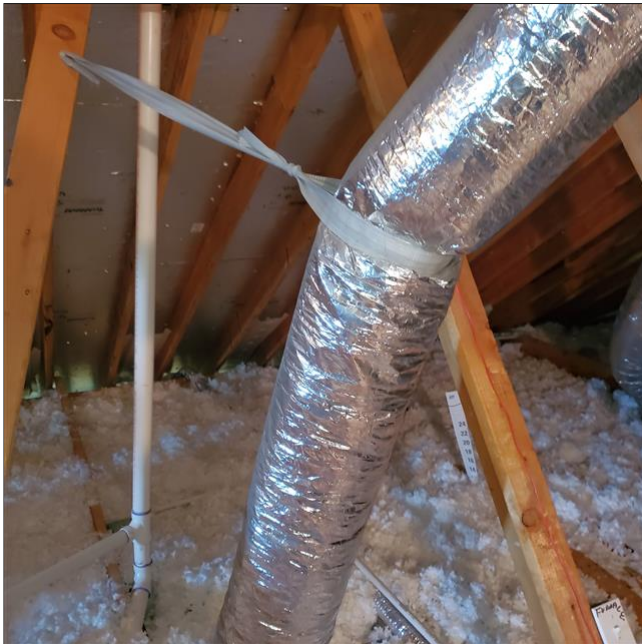
F. Item 3(Picture) There was no visibly damaged insulation.

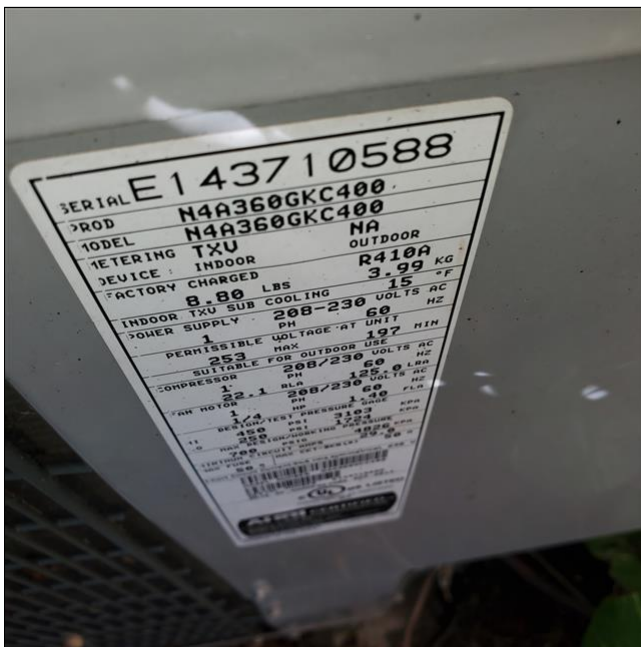
B. Item 1(Picture) AC was manufactured in 2014.

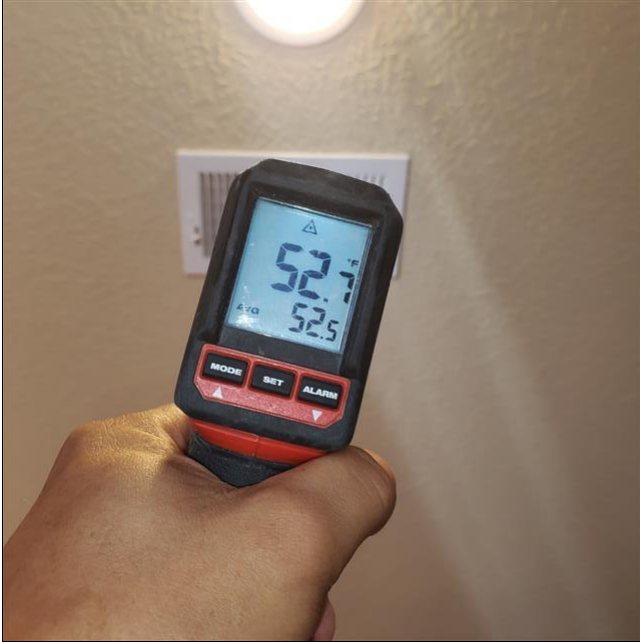
B. Item 5(Picture) 52.7 degree supply air.

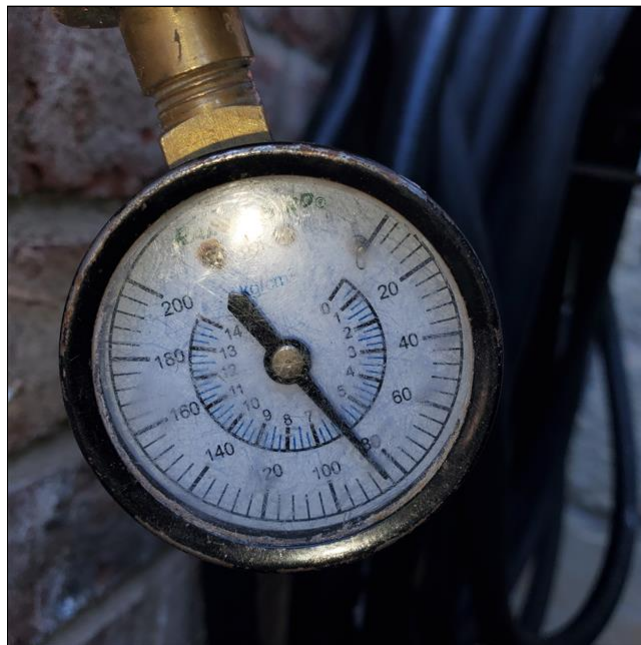
Water pressure was 84 psi (slightly high)

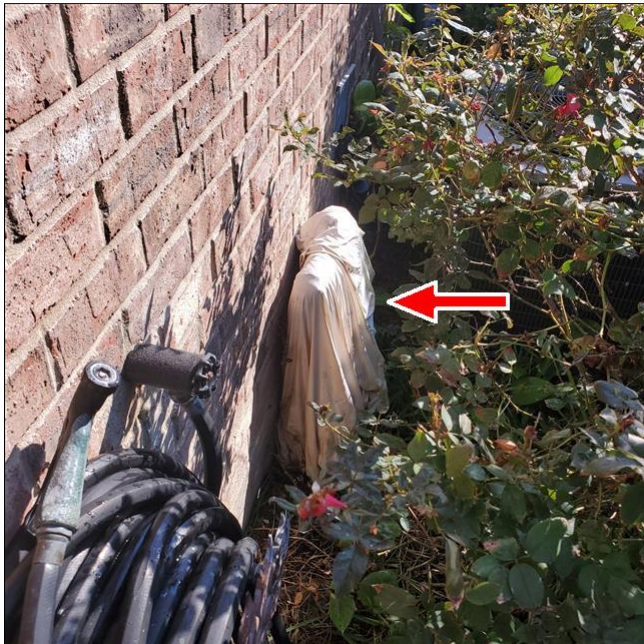
(2) The backflow irrigation device and shut off valves for the irrigation system were completely covered and were not accessible for the inspector to view at the time of the inspection.

A. Item 2(Picture) Pipes were covered.
