Professional Inspection Report

**Vicky Philips
402 Shirlington Rd
Montgomery, TX 77316**

February 1, 2021

ProVantage Inspections, PLLC

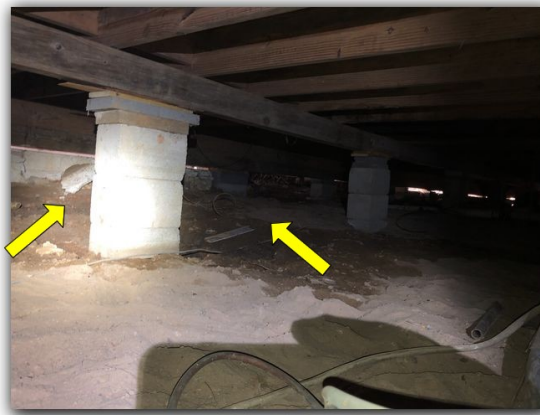
Foundation Performance Opinion:

For a structure of this type construction and age, it is not uncommon to observe uneven slopes in the interior floors. While there was some unevenness in the floor observed, it was understood that the piers / stacked blocks and beams had been recently professionally repaired and corrected for stability. The structure appeared to be satisfactorily support by the piers / stacked blocks and shims installed. Recommend consulting with the current homeowner regarding any possible warranties that may be valid and transferable to the new owner.

There was no apparent evidence, in my opinion, that would indicate the presence of major foundation deformities, excessive settlement distress conditions, or significant deficiencies in the foundation. Interior and exterior stress indicators showed little effects of adverse performance. The foundation appeared to be performing at the time of the inspection without the obvious need of immediate remedial leveling and was providing adequate support for the structure.

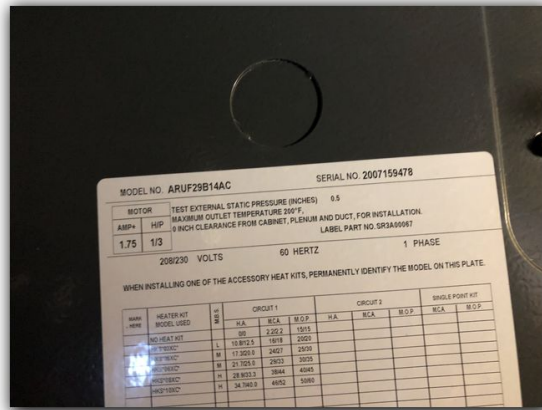
Central Heating System

Manufacturer Name: Goodman
Model # ARUF29B14AC
Serial # 2007159478
Approximate System Age: 7/2020

- Given the condition of the excessively broken and/or separated plenum / ductwork connections in the attic space that was observed, it is recommended that a full evaluation of the HVAC system components, plenums, and ductwork be fully evaluated by a licensed HVAC technician for service and repairs needed.

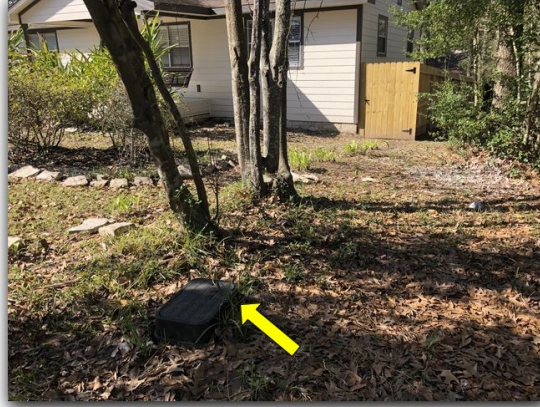
Location of water meter: *Front of the yard*

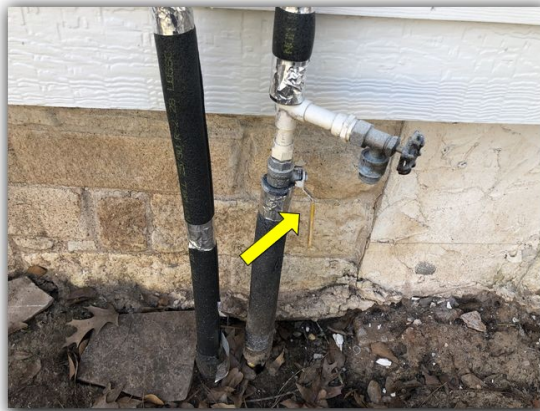
Location of main water supply valve: *There was a valve on a water pipe on the rear of the house. It was unknown if this was a main shut-off valve for the house.*

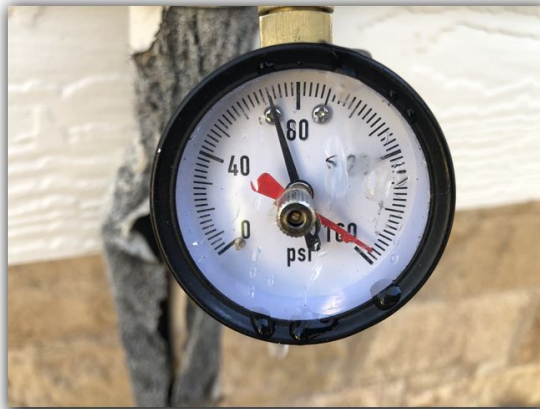
Static water pressure reading: *70 psi*

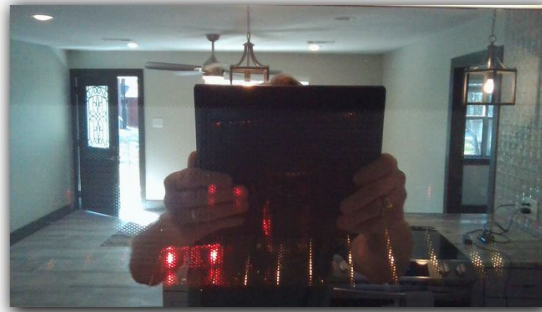
E. Microwave Ovens

- The microwave appeared to function satisfactorily at the time of the inspection. Built-in microwaves are tested, using normal operating controls.
