RESIDENTIAL INSPECTION REPORT

4023 Addicks Clodine Rd
Houston TX 77082

Orlando McCuin
JANUARY 12, 2021

Inspector
Charles Pyle
TREC 20638
713-885-6000
alltex@alltexinspections.net

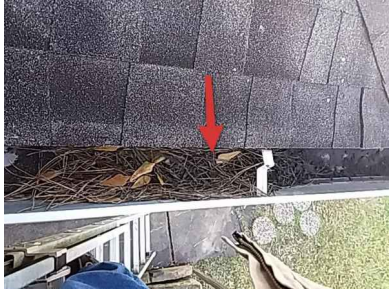
Debris noted at gutters and/or downspouts. The gutters may clog causing water to overflow and run down fascia board, potentially wearing wood before its time. Consider routine maintenance consisting of clearing leaves from the gutters and downspouts to improve water runoff and reduce moisture related damage.

Recommendation: Contact a handyman or DIY project

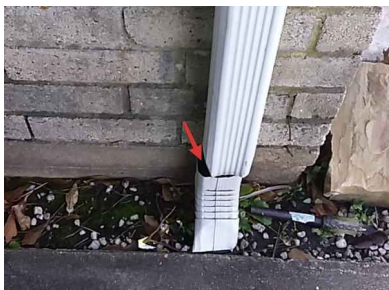
West side elbow loose

Downspout elbows loose.

Recommendation: Contact a qualified professional.

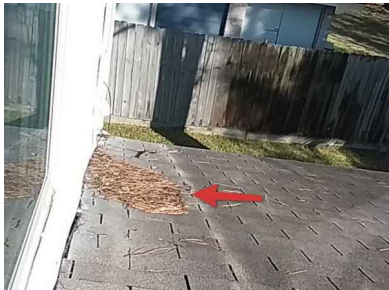
Debris was noted at roof coverings and/or valleys. Consider routine maintenance to ensure proper roof drainage.

Recommendation: Contact a handyman or DIY project

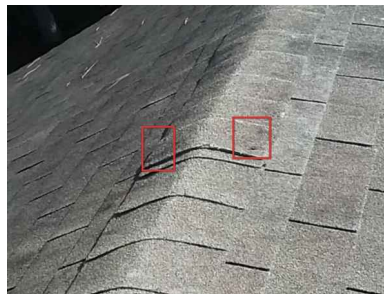
Exposed fasteners observed in shingle or flashing. One or more nails and/or staples observed. Consider sealing all exposed fasteners with an approved sealant to prevent further deterioration.

Recommendation: Contact a handyman or DIY project

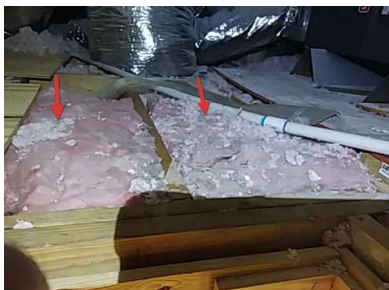
Insulation R value is below current standards. Consider evaluating the cost of increasing the R value levels in comparison to the energy savings. The current standard for this climate zone is R-38 (14 inches).

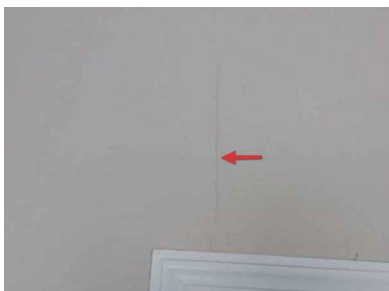
Bedroom 1

Common cracks (seam tape separation, cracks along joints) observed at interior wall coverings. Due to construction in areas where known expansive soils exist, cracks are considered typical and consistent with the age of the structure.

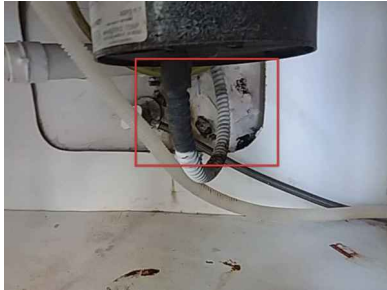
Kitchen

Inspector observed what could be organic, fungal or bacterial growth. Microbial growth can cause issues for those with sensitive allergies. Consider cleaning the area with an approved sanitizer. For those who may be sensitive, consider contacting a licensed hygienist to evaluate and suggest repairs.

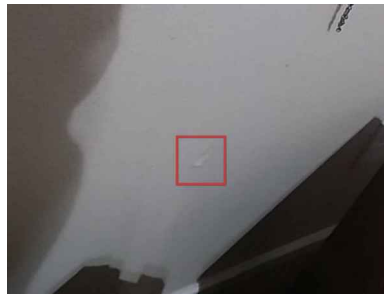
Bedroom 2, bedroom 3

Wall coverings are damaged and/or improperly sealed.

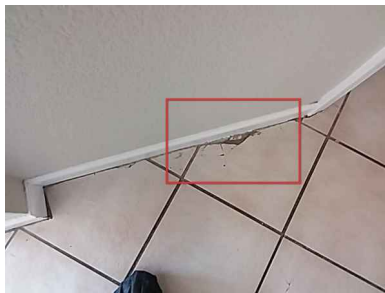
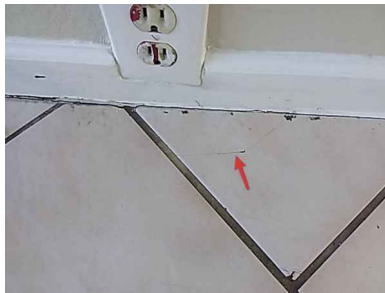
Down stairs hall, entry, breakfast nook, den, living room
Loose, cracked or damaged tiles observed.

Recommendation: Contact a qualified professional.

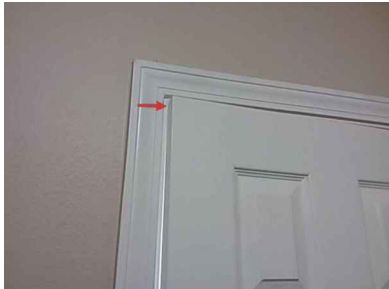
Door may be difficult to open or close. When not severe, typical repair consists of sanding down offending sides or hinge adjustments..

Recommendation: Contact a handyman or DIY project

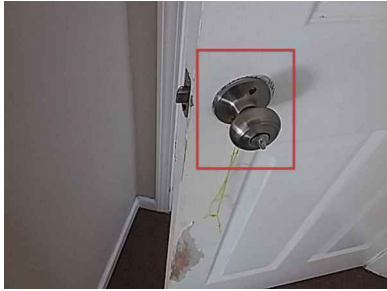
Door hardware (hinges, latches, locks or pulls) are missing, damaged and/or not operating as intended.

Recommendation: Contact a handyman or DIY project

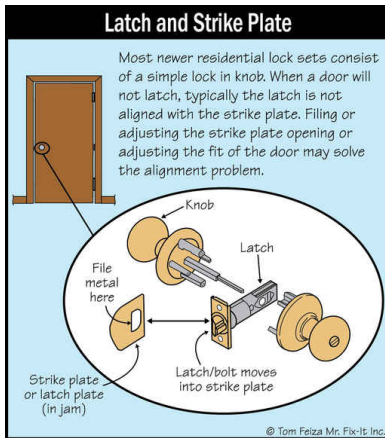
Door doesn't latch properly. Typical repair includes adjustment of the strike plate or latch.

Recommendation: Contact a handyman or DIY project

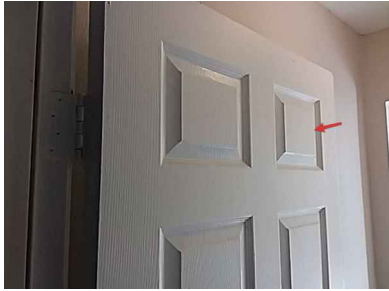
The recessed areas of the door reduce the overall thickness below the minimum requirements. Current standards require the service door between the home and the garage to be a minimum of 1 3/8 solid core lumber or a steel door with a solid core or a labeled door that has a fire rating of 20 minutes. Verify the door meets current standards or consider upgrading.

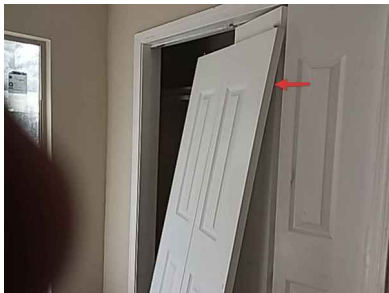
Bedroom 4 closet
Doors not installed.

Recommendation: Contact a qualified professional.

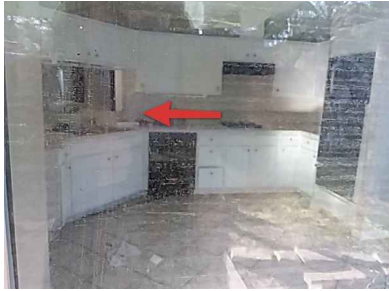
Observed condensation between the window panes. This typically indicates failure of the seal. Failed seals result in loss of energy efficiency and a condensate that form between the dual panes. Consider replacing the glass unit to improve energy efficiency and cosmetic appeal. Due to the high number of failed units observed at the time of this inspection, it is recommended that all windows be tested and replaced as needed.

Recommendation: Contact a qualified window repair/installation contractor.

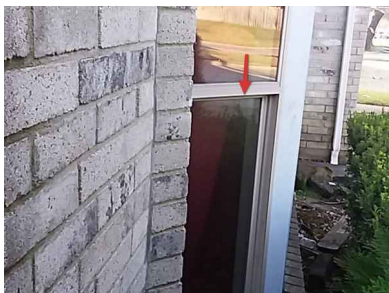
Window screens are missing, improperly installed and/or damaged at one or more locations.

Recommendation: Contact a handyman or DIY project

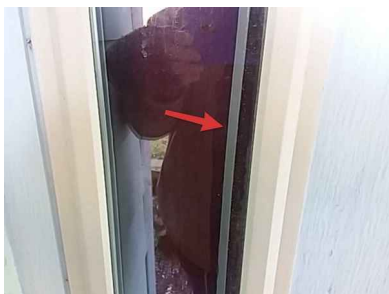
Inner gaskets warped, no evidence of seal leakage.

Recommendation: Contact a qualified professional.

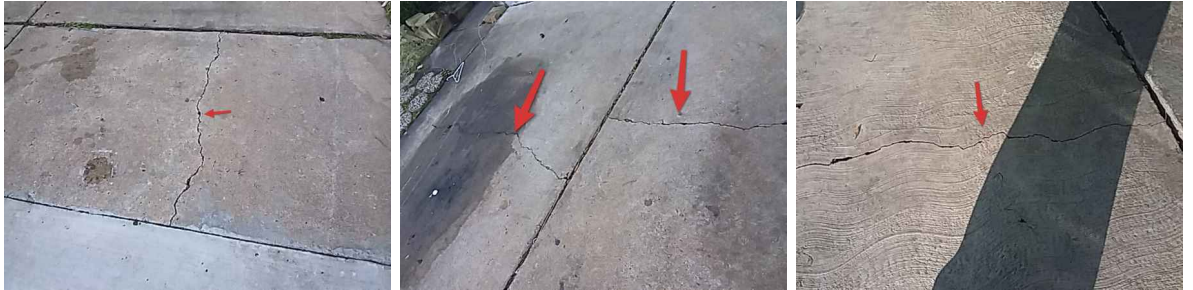
Driveway, back porch

Surface cracks observed at concrete flat works. Cracks are considered typical due to construction type and expansive soils. Seal cracks and monitor cracks. Example: driveway, walkways and/or garage floor.

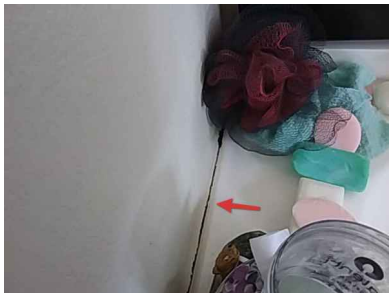
Counter top is not properly sealed at wall or cabinet intersection. Without a seal, water can seep behind the cabinet causing damage to the wall or cabinet. Consider sealing as needed to prevent moisture intrusion or related damage.

Recommendation: Contact a handyman or DIY project

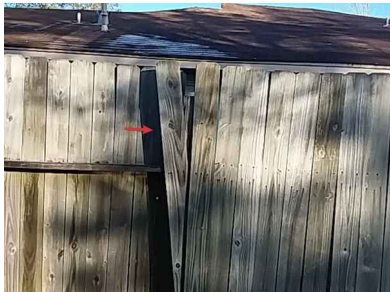
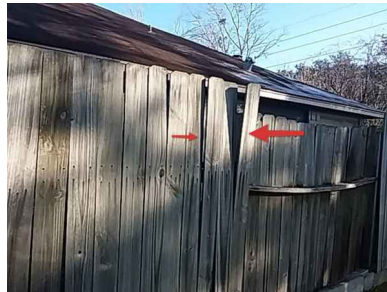
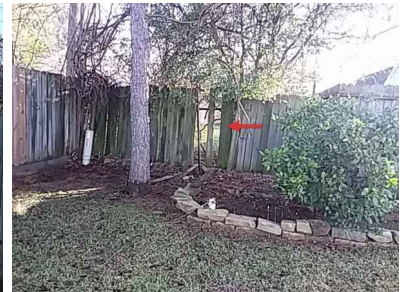
Loose, damaged or improperly secured pickets noted.

Recommendation: Contact a handyman or DIY project

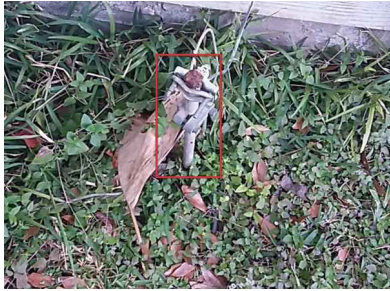
Ground rod partially visible, could not determine rod length.

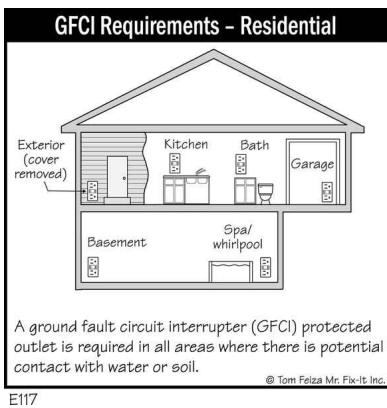
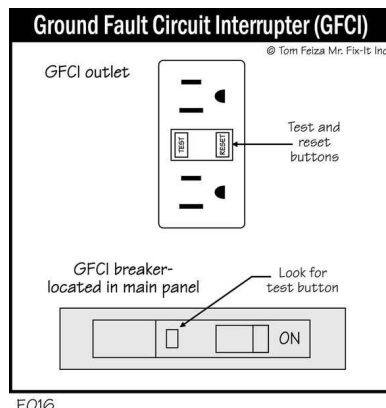
GFCI protection devices are missing, damaged or improperly installed. Current standards require GFCI protection devices at any accessible outlets located in the garage, at the exterior, near a pool/spa, all food preparation areas in the kitchen or food service area, wet bar, bathroom, or any outlet within six foot of water for occupant safety.

Recommendation: Contact a qualified electrical contractor.

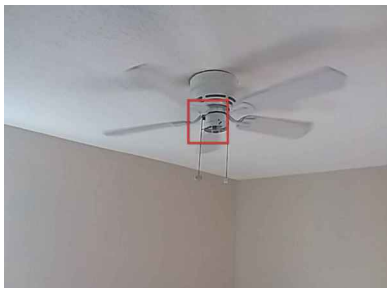
Electrical lighting cover is missing, damaged or deteriorated. Consider replacement to prevent accidental contact with the lighting element or energized conductors.

Recommendation: Contact a handyman or DIY project

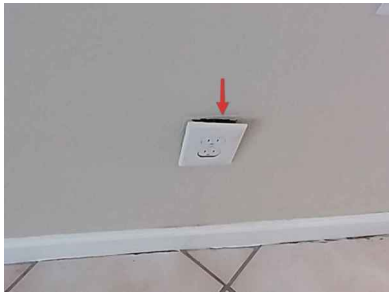
Electrical outlets were not properly secured within the junction box as required by current building standards. All outlets energized and ungrounded conductors and components should be concealed within a non combustible junction box for occupant safety.

Recommendation: Contact a handyman or DIY project

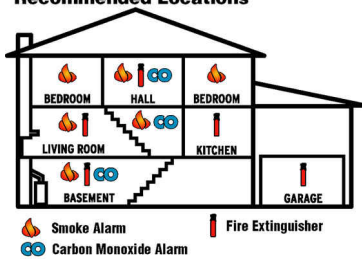
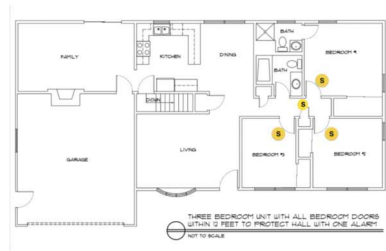
Recommended Locations

Smoke detection equipment is missing and/or not properly installed. Current building practices require that smoke detection equipment be installed in all sleeping rooms and in the adjoining hall in the immediate vicinity. Detection equipment should be hardwired with a battery back-up and be interconnected so that all units are activated simultaneously.

Recommendation: Contact a handyman or DIY project

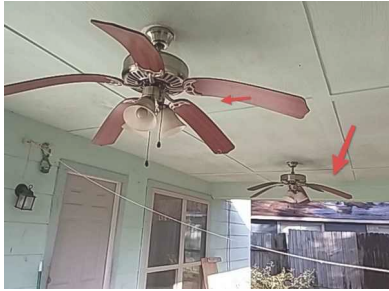
Warped fan blades observed.

Recommendation: Contact a qualified professional.

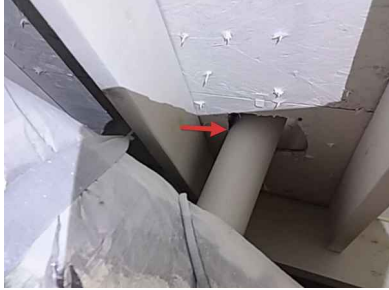
Gas fired appliance exhaust flue has improper clearance to combustibile materials. Vents with improper clearance to combustibile materials may generate too much heat for the material. Current standards require a minimum 1 inch clearance shall be maintained.

Recommendation: Contact a handyman or DIY project

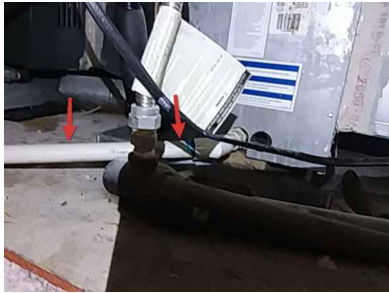
Insulation was damaged and/or missing at the condensate waste line. Current standards require that the condensate line be insulated within 10 foot of the HVAC unit. The warmer attic air will cause condensate to form and possibly leak into surrounding building materials.

Recommendation: Contact a qualified professional.

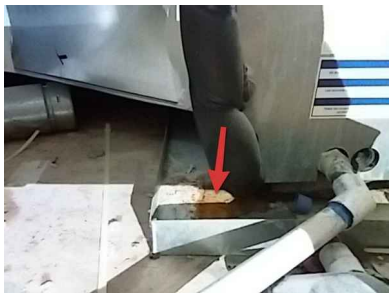
2: Drain Pan - Corrosion

Corrosion observed in the emergency overflow pan. Consider pan replacement to ensure future performance.

Recommendation: Contact a qualified HVAC professional.

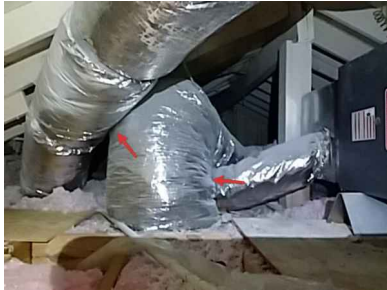
The flexible ducts are improperly supported. Current building practices require that the ducts be hung from the attic framing and supported at 4.5 maximum intervals. Ducts in contact with other ducts and at potentially different temperatures may cause condensate to form (internal or external) on the duct. Consider separating ducts with batt insulation or equivalent.

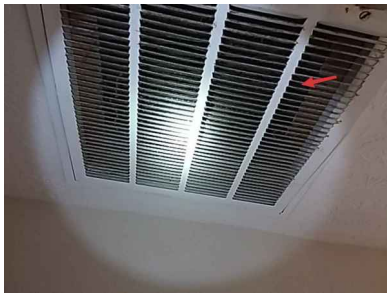
2: Filter

HVAC filters were excessively dirty at the time of this inspection. Filters should be replaced at regular intervals to ensure proper system performance.

Recommendation: Contact a handyman or DIY project

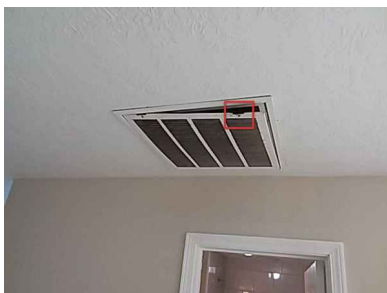
3: Return - Cover

The return air cover was missing, damaged and/or improper. Consider repairs to ensure proper air flow and filtration.

Recommendation: Contact a handyman or DIY project

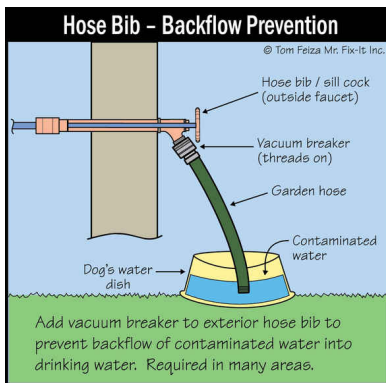
Anti siphon devices not present or improperly installed. Anti siphon / backflow prevention devices are vacuum breakers that prevent contaminated water from entering the potable water system. Items may be purchased at any hardware store and screwed in place before installing a hose.

Recommendation: Contact a handyman or DIY project

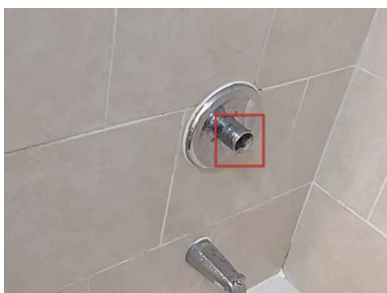
2: Faucet - Handle

Control handle/knob is missing, damaged or not operating as intended. Consider repair and/or replacement to ensure proper operation.

Recommendation: Contact a handyman or DIY project

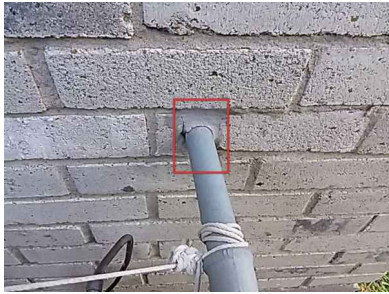
3: Pipe - Gas Protection

The gas line is not protected where it passes through the exterior wall coverings. Current standards require that the gas line be protected by a corrosion resistant material or use a plastic sleeve when passing through masonry.

Recommendation: Contact a qualified plumbing contractor.

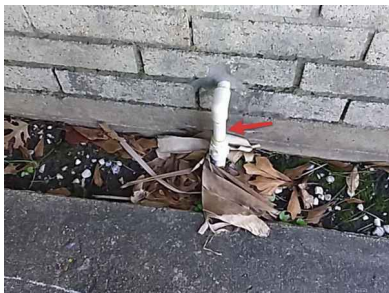
4: Pipe - Insulation

Insulation missing or damaged. Insulation is needed at attic or exterior plumbing supply piping. All supply pipe should be protected from freezing.

Recommendation: Contact a handyman or DIY project

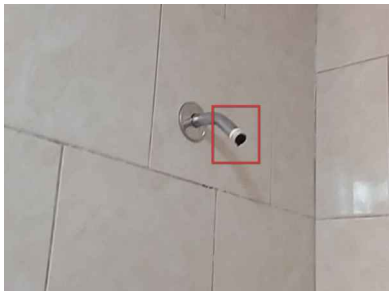
5: Shower Head

Shower head missing.

Recommendation: Contact a handyman or DIY project

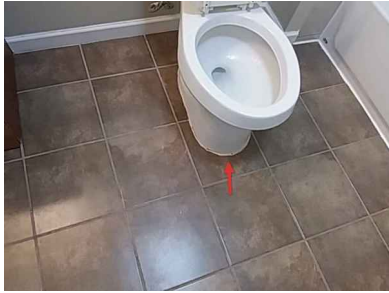
6: Toilet - Improperly Secured

Loose or improperly secured toilet bowl. A loose toilet may damage the wax ring and no longer provide

a proper seal. Remove, replace wax ring and reinstall the toilet.

Recommendation: Contact a qualified plumbing contractor.

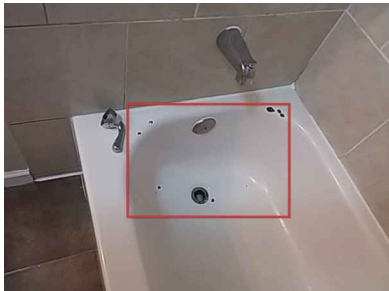
8: Tub - Enamel Damage

Upstairs hall bath

Damage observed to tub enamel. The area may rust or deteriorate. Consider repair prior to use to prevent further damage caused by corrosion.

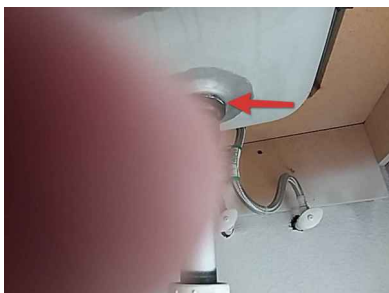
2: Waste - Leak

Waste lines were leaking at the time of this inspection. Repair is needed to prevent moisture related damage to building components.

Recommendation: Contact a qualified plumbing contractor.

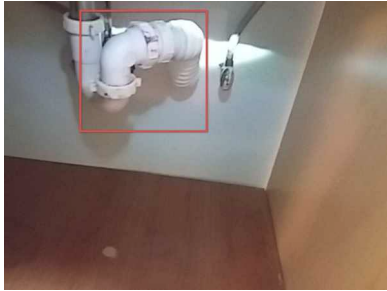
Improper trap (aka: S Trap due to its shape) observed. S traps have a tendency to dry out due to potential siphoning. Current standards prohibit the installation of a S trap.

Recommendation: Contact a qualified plumbing contractor.

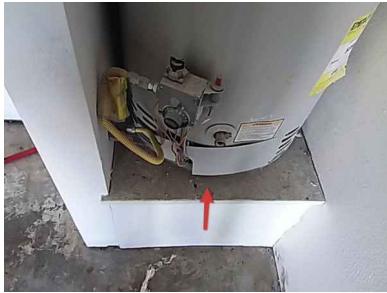
Drain pan and/or piping not installed at garage. Although not required for a garage installation, a drain pan (and its discharge line) would prevent water from accidentally entering the dwelling if a leak occurred. Consider adding drain piping to the lower level of the floor to prevent accidental moisture damage.

Recommendation: Contact a qualified plumbing contractor.

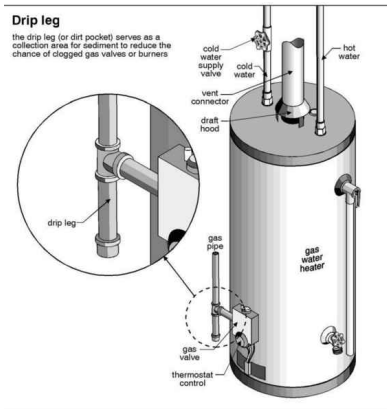
2: Gas - Sediment Trap

Sediment traps missing or improperly installed at appliance gas supply piping. To prevent sediment (trash or condensate) from entering the appliance, traps must be installed in such a manner that the gas must change directions at the trap. See illustration.

Recommendation: Contact a handyman or DIY project

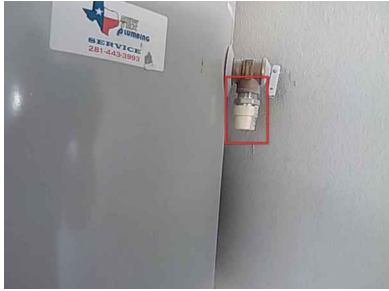
3: TPRV - Guideline

Missing

The TPRV (temperature pressure relief valve) is a safety mechanism designed to open and release excessive pressures or temperatures that could rupture the tank. TPRV drain lines must not be reduced in size, must terminate no more than 6" above grade in an area that will not cause damage, must not be threaded at the outlet, must not run uphill and discharge line must be made of a corrosion resistant metal or CPVC.

Recommendation: Contact a qualified plumbing contractor.

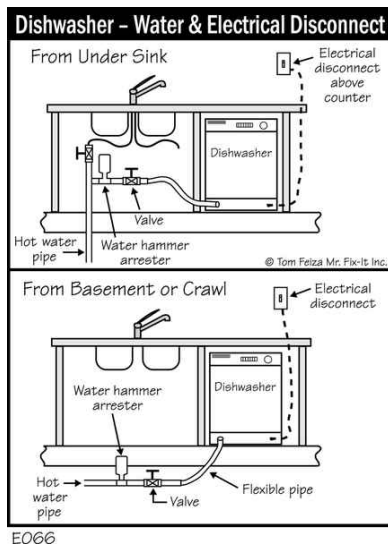
2: Service Disconnect

Service disconnect not present or not located. Current building practices require that a service disconnect be provided for this appliance. This may be an accessible, removable cord or a switch located at counter top.

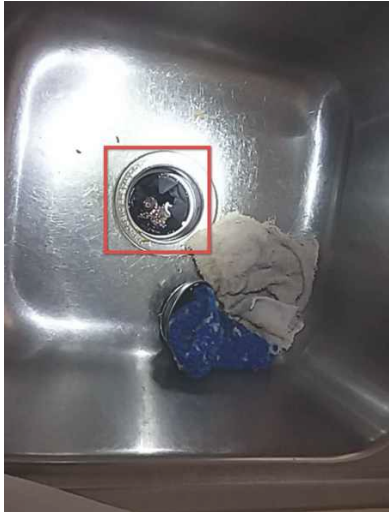
Splash guard is missing, damaged and/or not operating as intended. A splash guard is positioned in the disposal sink flange to reduce noise and to protect against accidental projectile discharge.

Recommendation: Contact a handyman or DIY project

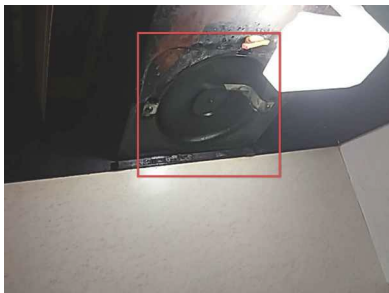
1: Filter missing

Filter missing.

Recommendation: Contact a qualified professional.

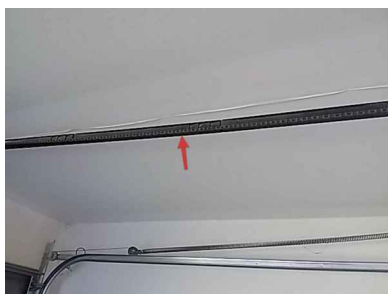
The drive chain appeared to be loose, damaged and/or improperly secured. Consider repairs to ensure proper operation.

Recommendation: Contact a qualified garage door contractor.

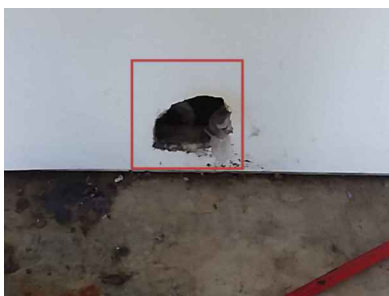
The dryer exhaust flue is damaged, deteriorated or disconnected. Lint debris can be flammable. Repair is needed to ensure proper discharge to the exterior and/or prevent improper discharge of lint debris within the building envelope.

Recommendation: Contact a qualified HVAC professional.
