## STRUCTURAL INSPECTION

907 Blue Willow Dr  
Houston TX 77042

Steve Gordon & Cynthia Mattice

DECEMBER 29, 2020

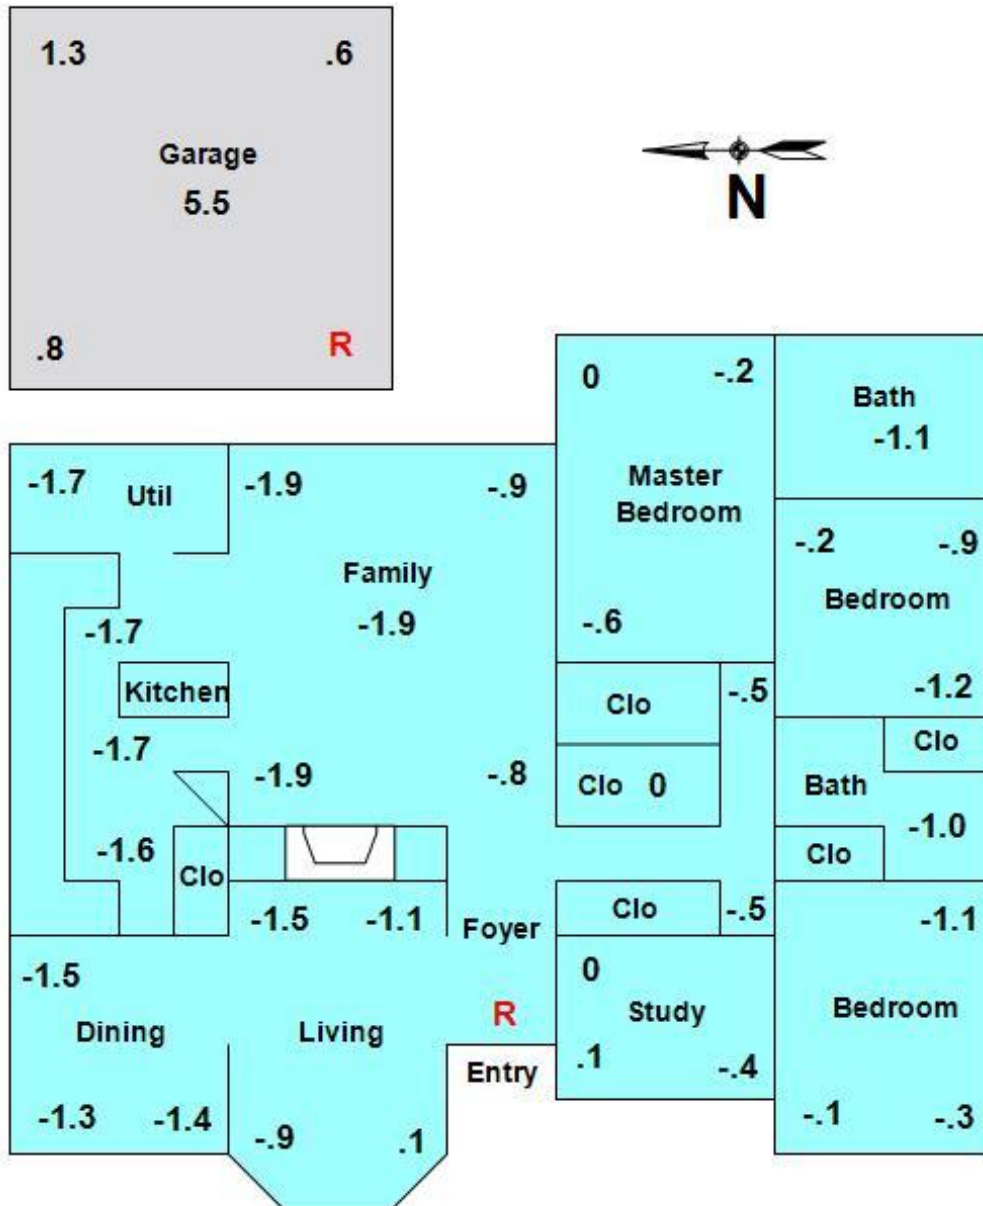
### Elevation Readings 907 Blue Willow Drive

The floors were checked with an electronic level, and were observed to be sloping from the center towards the perimeter of the house. The difference in elevation between the high point and low point was 2.0 inches. The high point was located at the living room, and the low point was located at the family room. The unlevelness takes place over a horizontal distance of approximately 25 feet.

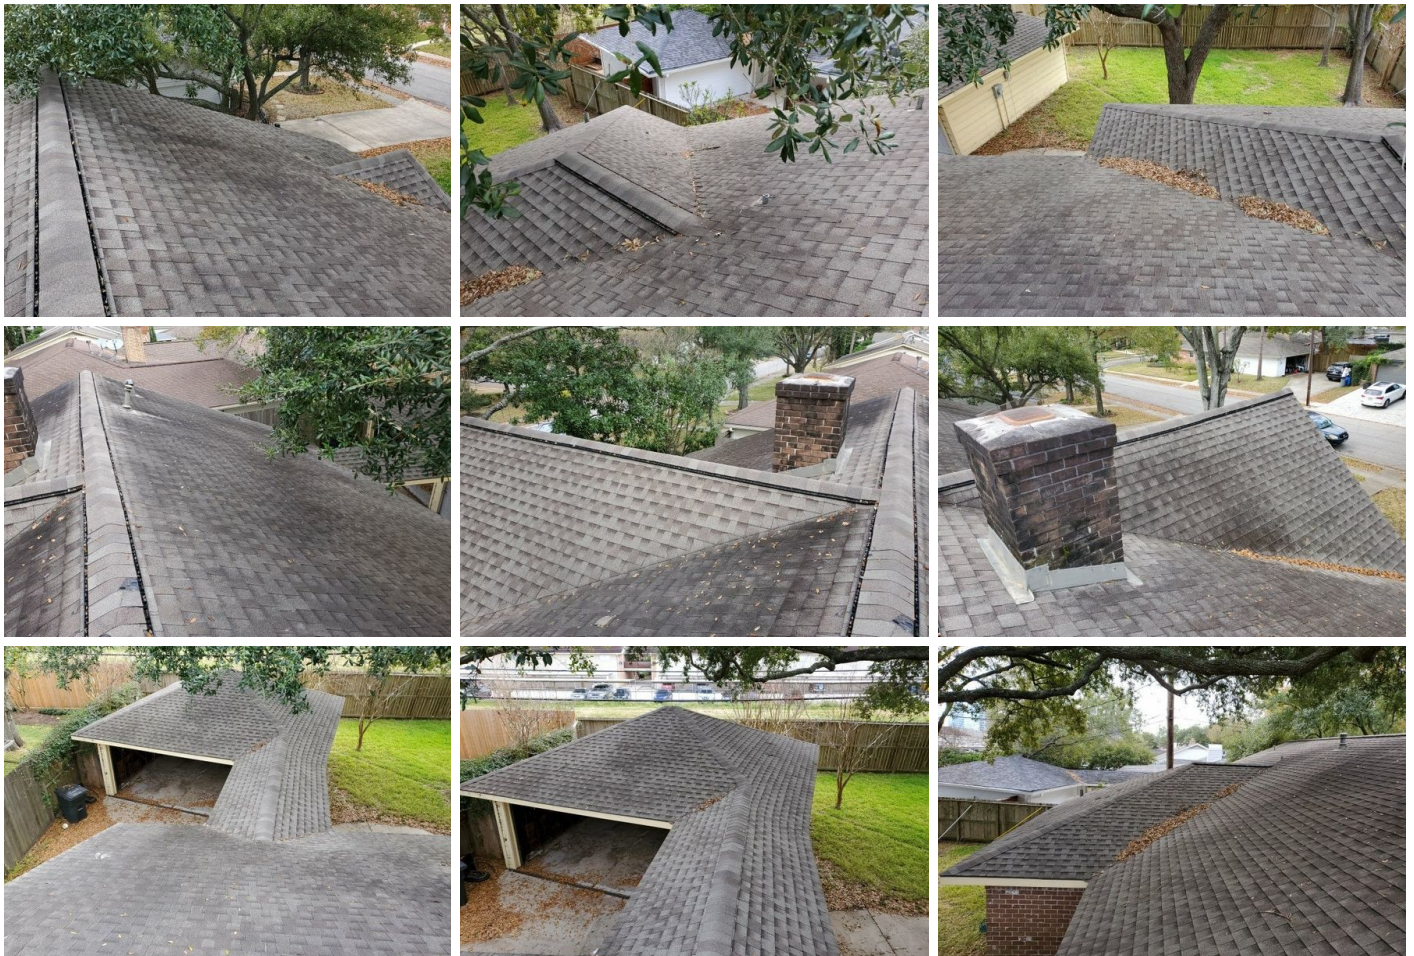
The pitched roof surface was constructed of composition shingles. The life expectancy of a composition shingle roof has been observed to vary from 15 to 20 years, with most requiring replacement at about 17-20 years.

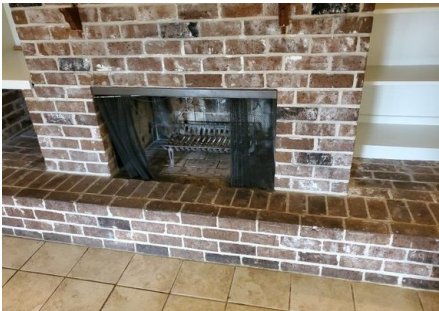
A gas log lighter was present and was functioning properly.

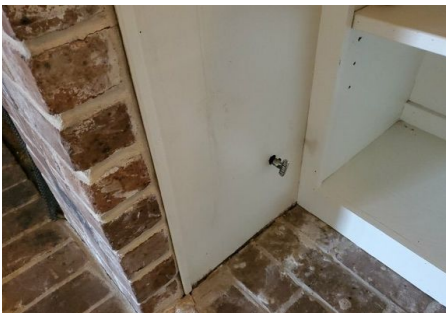
The gas to ignite the burner in the fireplace was controlled as shown above.

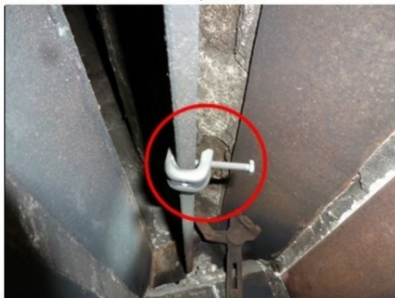
The fireplace was equipped with a ceramic gas log. The smoke chamber and flue pipe were free from built-up soot, the damper was operational, and the firebox was properly sealed. While the draw of the chimney was not able to be checked, no evidences of poor draw were visible, and no repairs were needed to the fireplace. It is pointed out that the damper was not equipped with a spacer device to prevent the damper from closing completely. This device keeps the damper open slightly, even when it is in the closed position, to prevent combustion gases from building up in the living space should the gas log be operated when the damper is closed. It is recommended that the clamp be installed for safety purposes.

HEI file photo showing c-clamp in masonry fireplace

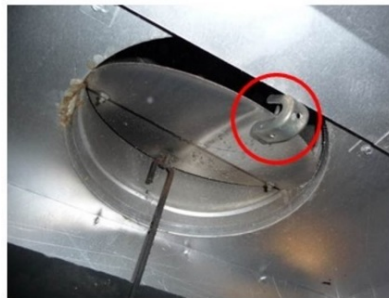
HEI file photo showing c-clamp in metal fireplace

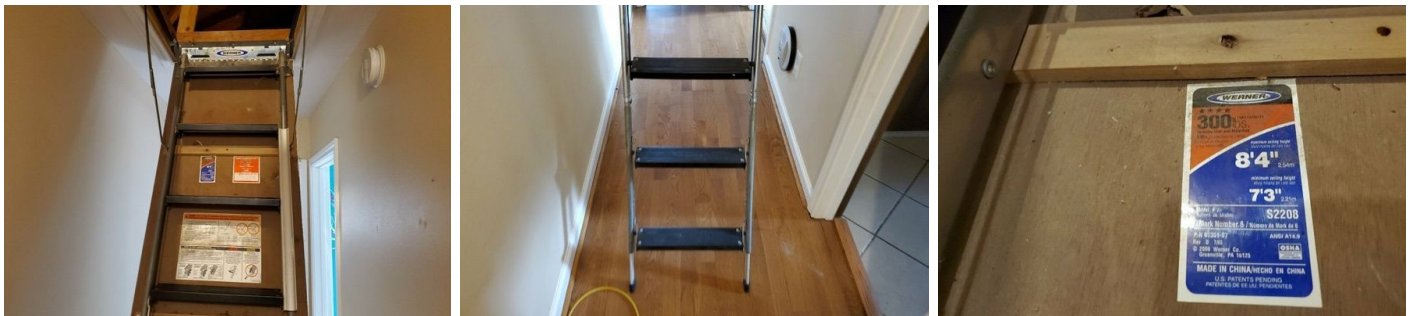
The access ladder into the attic appeared to be the original installation ladder, and the ladder was labeled to indicate the rated capacity of the ladder is 300 pounds. The ladder does not meet current code requirements for ladders into attics. Consideration should be given to replacing the ladder with a ladder that meets current code requirements.

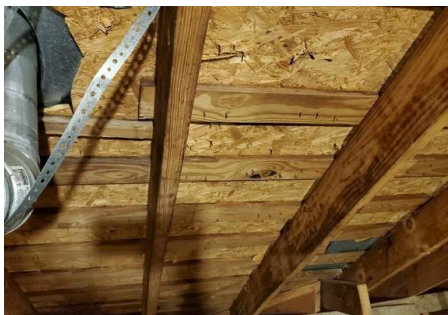
The roof decking was observed from the attic space to be as described above.

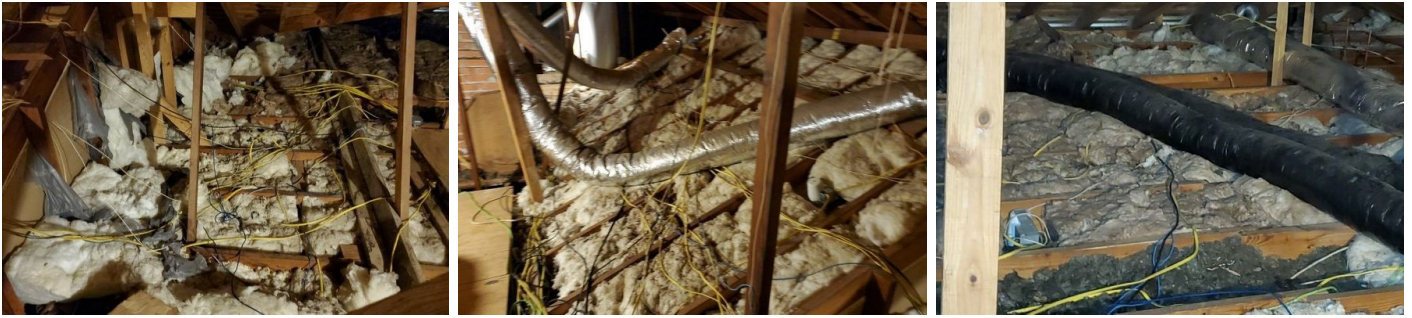
The insulation in the attic was average by today's standards. The normal amount of insulation for attics in this area is an R38 energy rating. This attic had approximately 9-10 inches of fiberglass batt insulation in the ceiling, which was marked as being an R30. It is pointed out that the insulation requirements according to the latest standard for new houses in this area is an R38 energy rating.

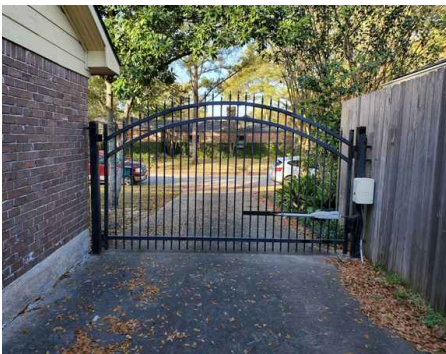
The flatwork concrete listed above was in generally good condition at the time of the inspection with no significant repairs needed. Note that there may be some small cracks in the concrete, but in the opinion of the inspector, the concrete is still functional.

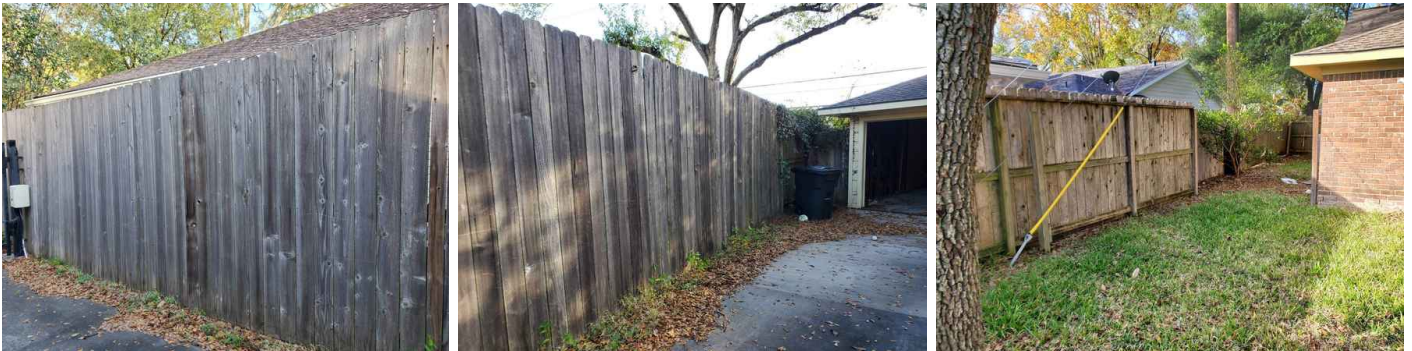
The gates and fences were in generally good condition at the time of the inspection with some repairs observed to be needed as shown below under Recommendations/Repairs.

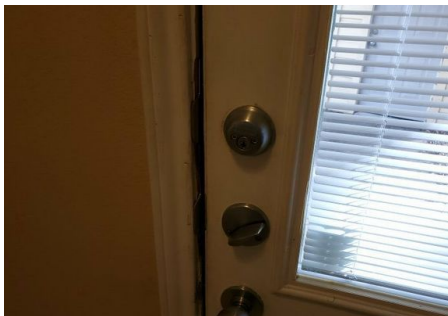
##### R311.4.4

We observed exterior doors that were equipped with keyed deadbolts, rather than thumbed deadbolts. In case of emergency, you would have to find a key to unlock the door, which could be hazardous. It is recommended that the keyed deadbolts be replaced with thumbed deadbolts. It is pointed out for informational purposes that current code requirements prohibit the use of keyed deadbolts.
