## MECHANICAL INSPECTION

907 Blue Willow Dr  
Houston TX 77042

DECEMBER 29, 2020

# PROPERTY INSPECTION REPORT

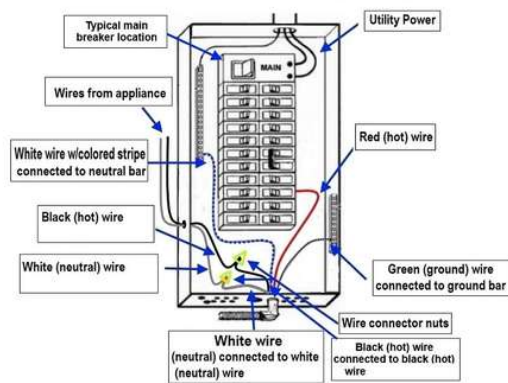
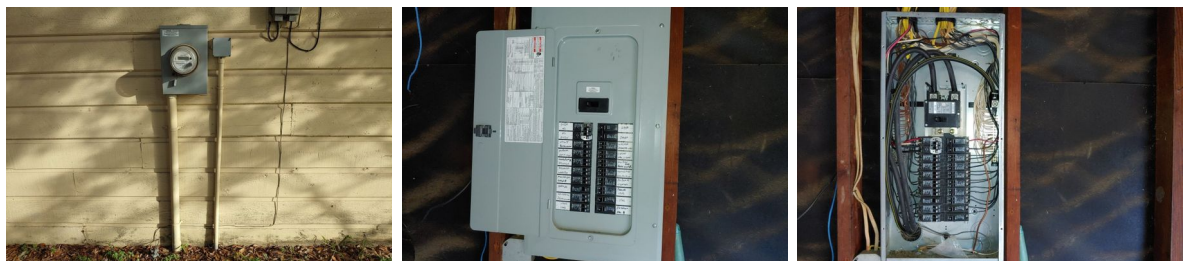
Circuit Breaker Wiring Diagram

*Breaker Panel Equipment - Acceptable :*

The interior of the breaker panel equipment was inspected and the breakers were all properly sized for the circuits they were protecting, the grounding and bonding were properly connected, no knockout clips were missing, and the wiring appeared to be in acceptable condition at the time of the inspection.

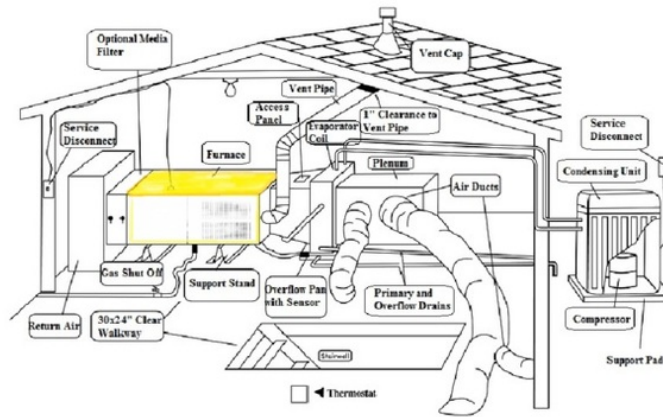
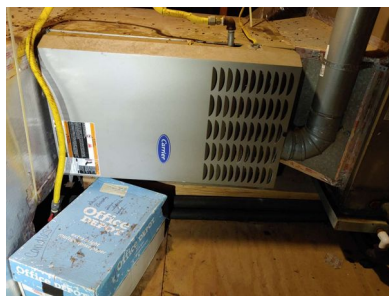
*Heating Equipment - Functional:*

The heating equipment was observed to be operating and functional at the time of the inspection. The heating equipment responded to the thermostat and the equipment appeared to be heating the air adequately.

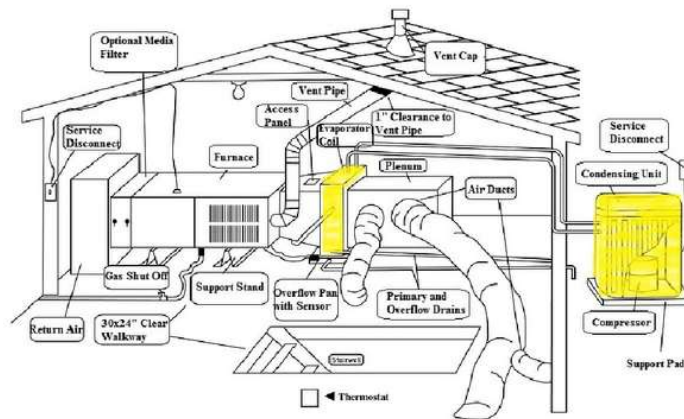
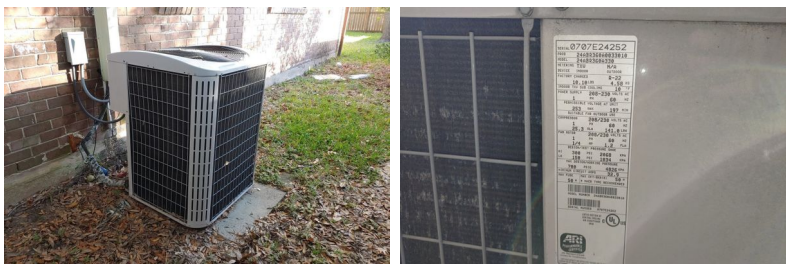
**Condensing Unit Equipment - Functional:**

The condensing unit equipment was functional at the time of the inspection. The equipment responded to the corresponding thermostat, and the compressor components and fan motor components were operating.

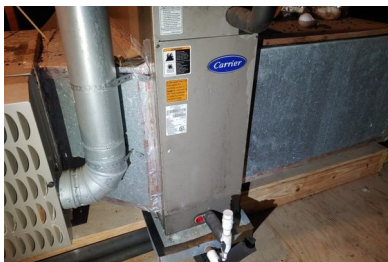
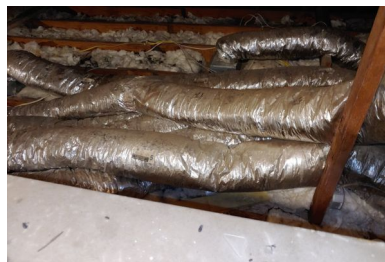
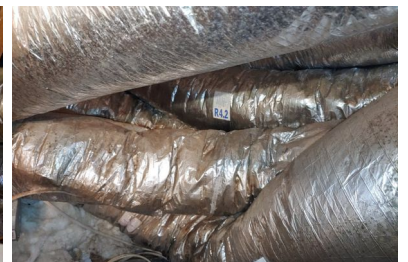
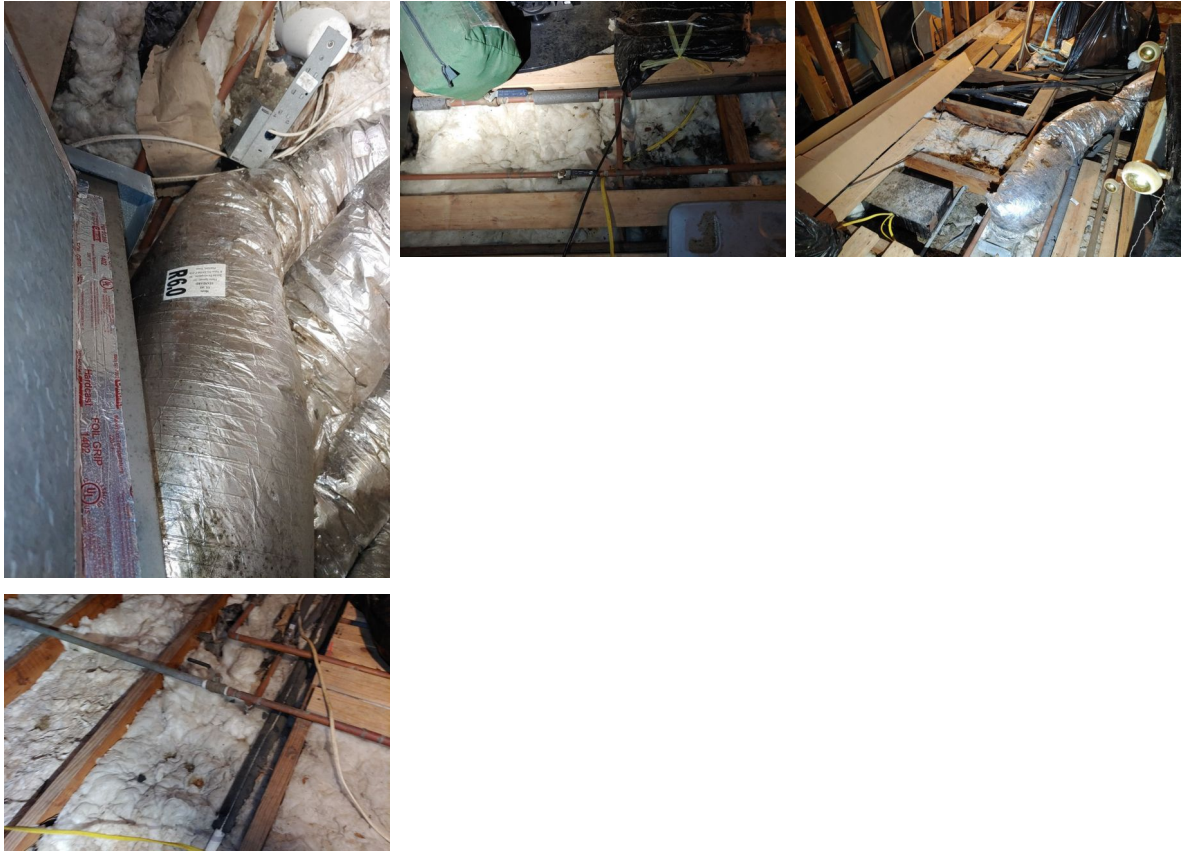
**2: Ducts - Not supported properly**

The ducts were laying on the insulation and ceiling joints and are not supported properly. The ducts should be supported in accordance with the manufacturer's installation instructions, which typically includes hanging the ducts from the rafters supported by 1 1/2 inch straps spaced approximately every four feet. Have a service company make the necessary repairs.

**Obtain Cost Estimate**

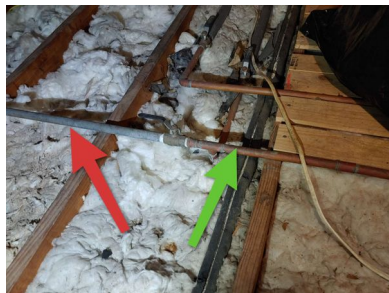
Galvanized inlet water supply connected to copper pipe.

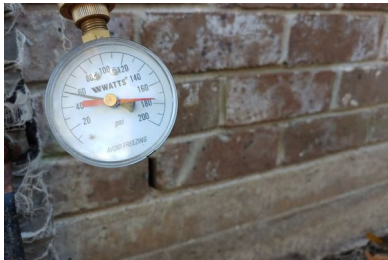
The static water pressure to the house at the time of the inspection was measured with a pressure gauge at the hose bibb nearest the shut off valve, and the static pressure was observed to be 54 PSI.

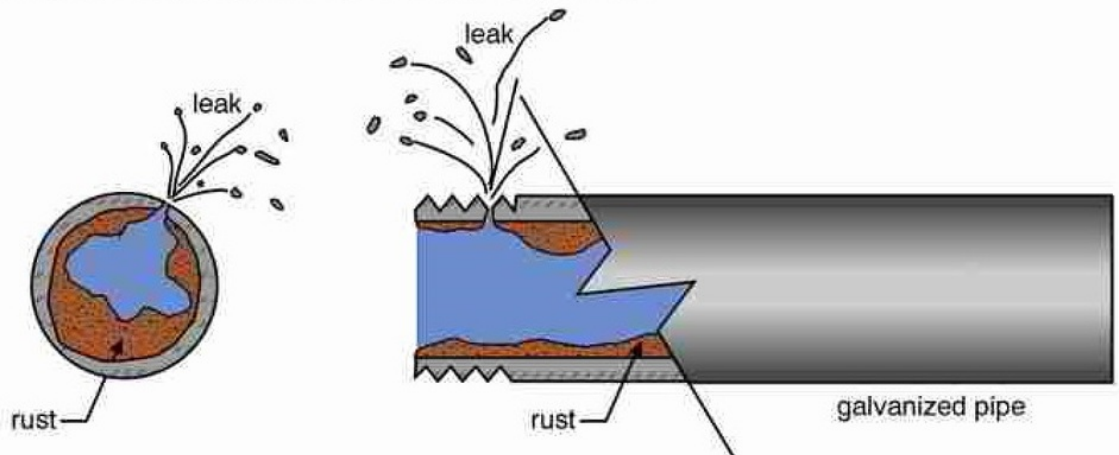
All or portions of the water piping for the property was observed to be the original galvanized piping. It is pointed out that the galvanized piping will deteriorate with time, and will corrode on the inside of the piping, thereby reducing the inside diameter of the pipe, and restricting the flow of the water through the pipe. In addition, the piping will corrode through to the outside of the pipe and will eventually deteriorate to where the pipe will start leaking. It can be anticipated that the galvanized water piping throughout the house will need to be replaced when it is causing reduced water pressure or is corroded enough to start leaking.

rusting of galvanized pipe can greatly reduce water pressure and will eventually cause leaks as rust creates holes in the pipe walls

problems are likely to occur soonest on pipes carrying hot water, horizontal pipes and at threaded (thinner) sections

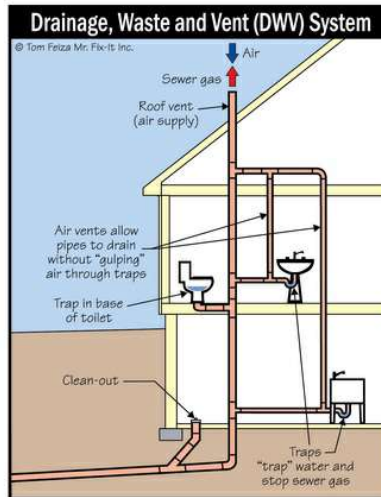
*Sewer Clean Out - Present :*

A sewer clean out was present. The clean out is needed in the event of a stoppage in the main sewer drain line, and the clean out is where a sewer snake would be utilized to remove a clog in the sewer line.

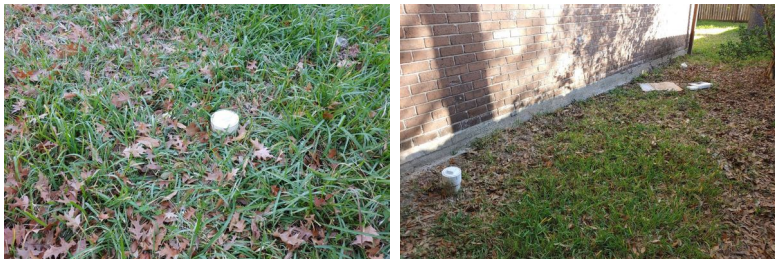
Front of house, two at south side,

*Sewer Piping - Evidence of repairs observed:* PVC clean out present, PVC drain(s) extended through wall and rerouted -

Evidences of sewer line repairs and/or replacement were observed. It is noted that we could not determine the extent of the repairs to the sewer system or if any of the original cast iron piping is still active. Further investigation is recommended with the owner and/or a service company to determine the extent of the repairs and to determine if any further repairs are needed. A sewer inspection with a plumber to verify the extent of the repairs and the condition of the sewer piping and repairs is recommended.

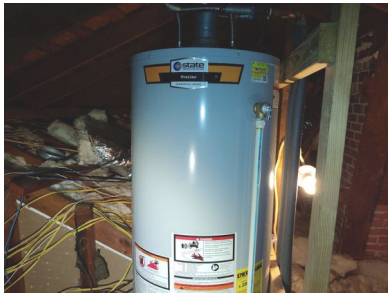
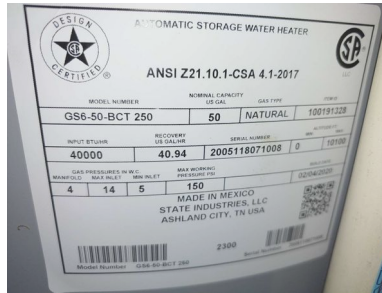
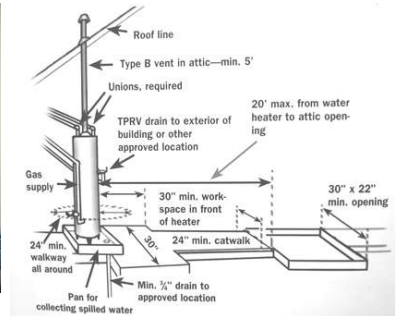
*Water Heater Equipment - Functional:*

The water heater equipment was functional at the time of the inspection and providing hot water to the applicable plumbing fixtures.

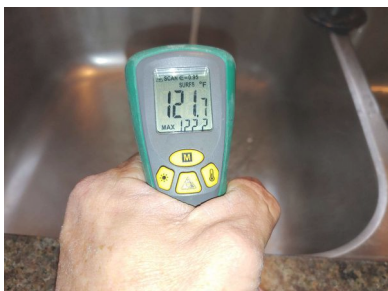
The temperature of the hot water at the kitchen sink was 121 degrees.

The generally recommended maximum temperature setting for a hot water heater, to prevent accidental scalding, is 120-125 degrees. It is recommended that the water heater thermostat be adjusted to and maintained in this temperature range.

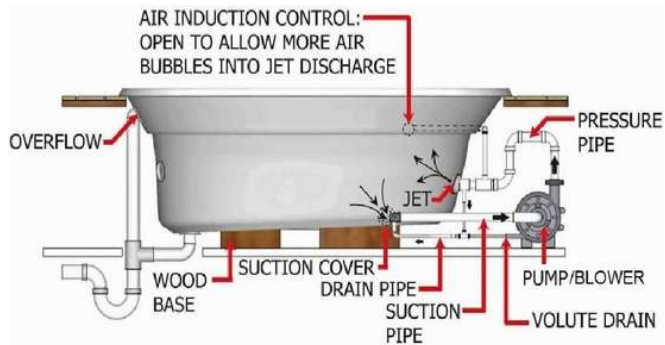
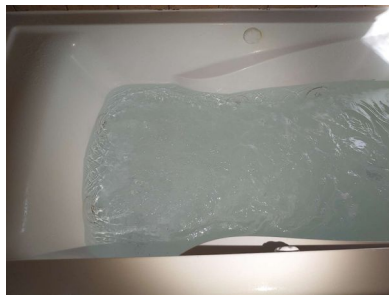
*No access to plumbing supply and drain trap:*

Access to the plumbing supply and drain piping was not provided at the time of the inspection, therefore the plumbing under the tub was not visually checked. If further investigation is desired, it is recommended that access to the underside of the tub be made. It is pointed out, if repairs become necessary, an access opening will need to be installed.

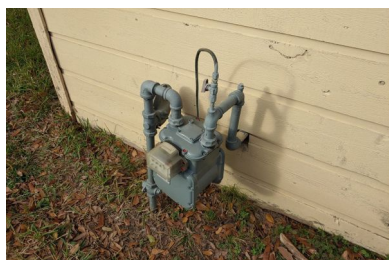
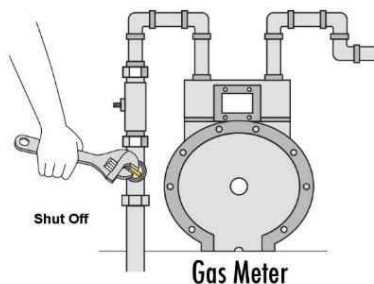
Rear of garage

The main gas shut off valve was located at the inlet side of the gas service meter.

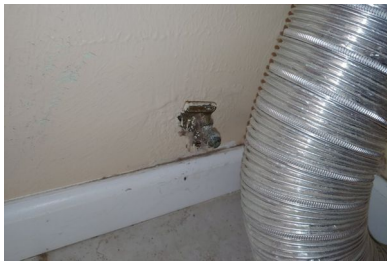
An unused gas valve that was not capped was observed. The unused gas valve needs to be properly capped to prevent accidental gas leaks.

**Obtain Cost Estimate**

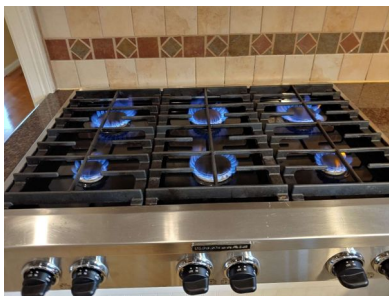
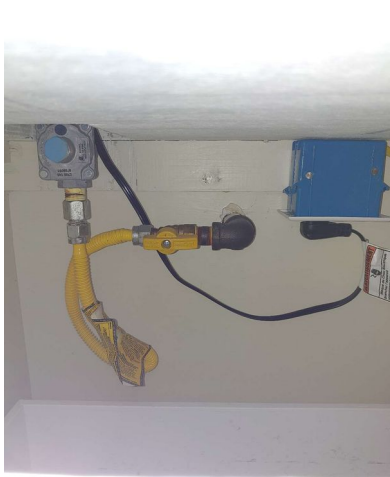
Gas shut off valve in cabinet below cooktop
