**This Professional Inspection Report Has Been Prepared Exclusively For:**

**Christopher Noland  
31525 Timber Grove Ln Lot 3206  
Spring, TX 77386  
May 10, 2018**

## PROPERTY INSPECTION REPORT

By: Alfonso Ulloa, Lic #21313 05/10/2018  
(Name and License Number of Inspector) (Date)

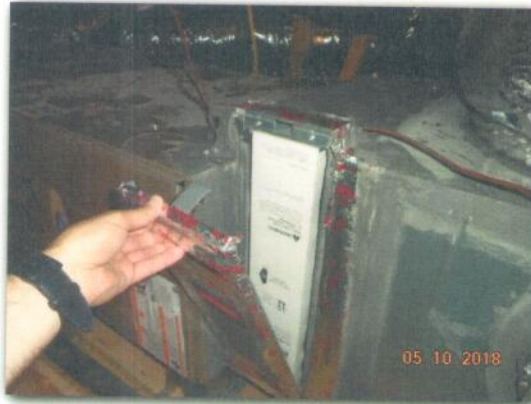
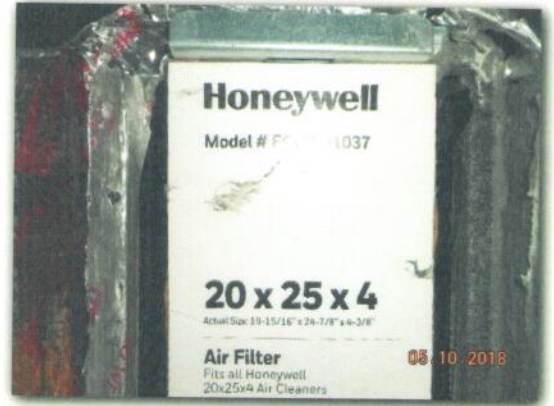
**X:** Dirty media filter was noted in line with the air handler in the attic. It should be changed regularly for an efficient operation of the cooling/heating equipment. Dirty media filters can cause dirty coils at the evaporator which can have a negative effect on the performance of the A/C system.
