Inspection Report

Property Address:
34518 Lake Side Dr
Brookshire TX 77423

PROPERTY INSPECTION REPORT

By: S. Brad Williams TREC# 23549 / Sunbelt Inspections 1/23/2021

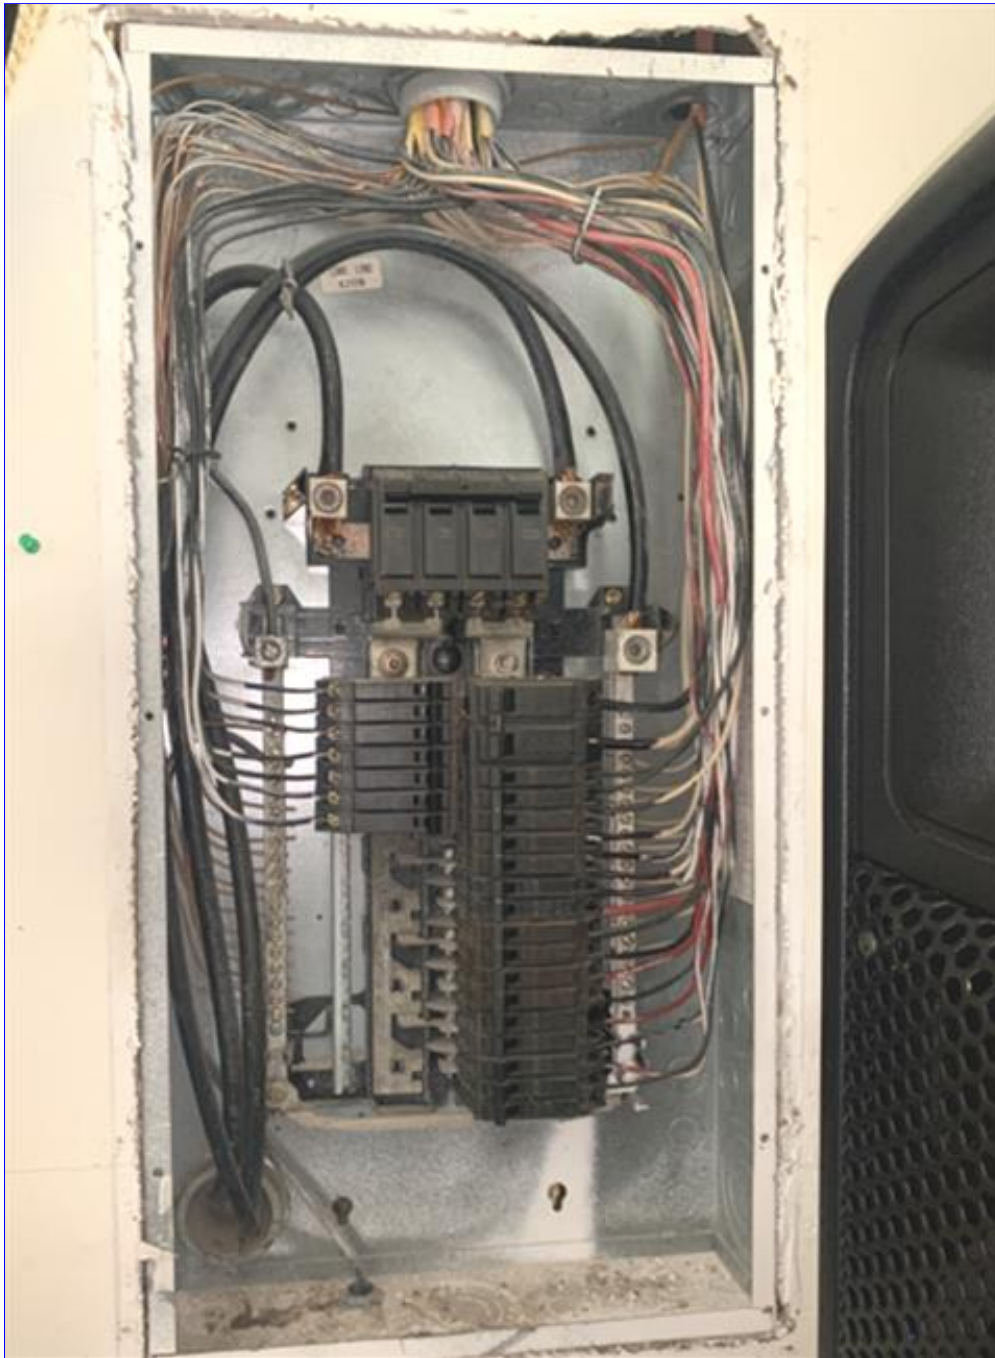
A. Photo 1(Picture) The main electrical service panel, shown with dead front cover removed for inspection purposes.

(2) Some labels are present, but are illegible or confusing. I recommend correcting for safety reasons.

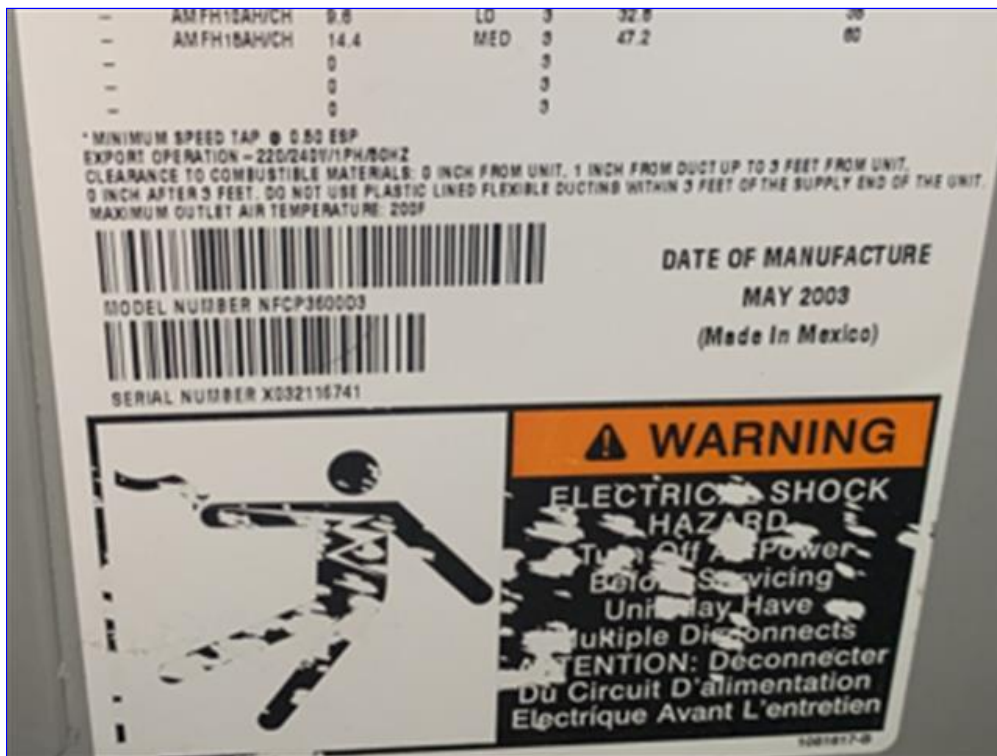
Manufacture date 2003.

A. Photo 1(Picture) Furnace service tag(s).
