PROPERTY INSPECTION REPORT

Prepared for: Hollie McKenzie
(Name of Client)

Concerning: 19415 Tocanatins Dr., Porter, Texas, 77365
(Address or Other Identification of Inspected Property)

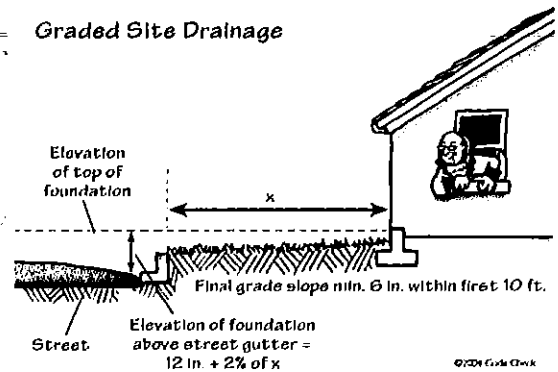
Drainage ditches along the street appeared to have almost filled the culverts under the driveways, which could be preventing water to drain properly away from the property.

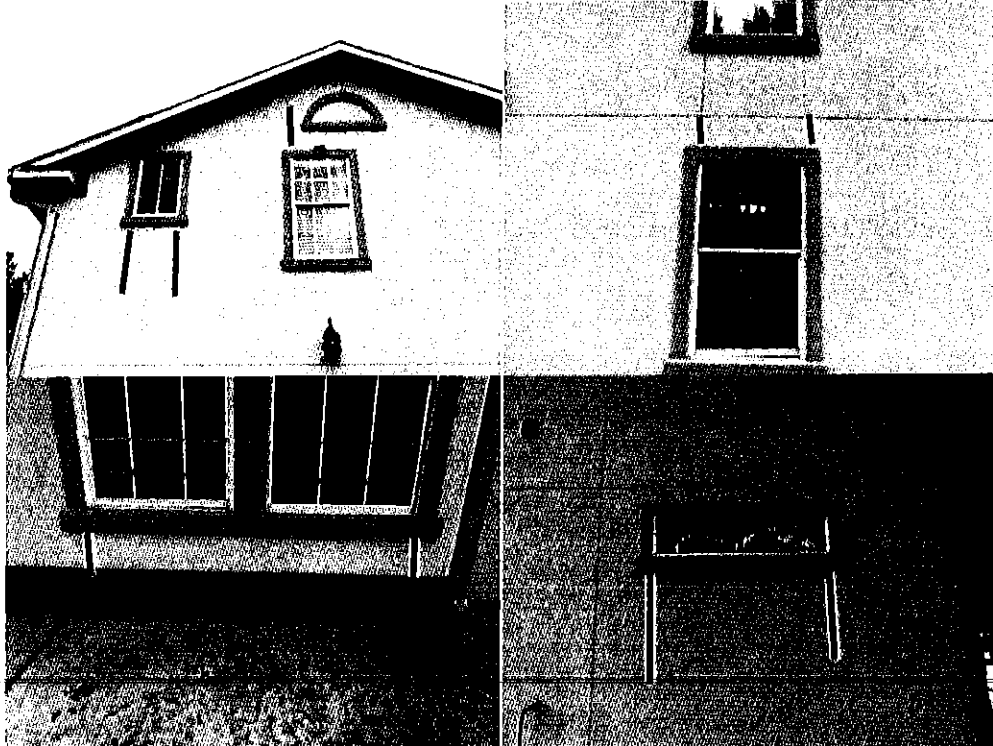
Observed one or more locations where expansion joints appeared to be missing or improperly installed. Expansion joints (sometimes known as control joints) are required horizontally at each floor level, vertically above and below windows and above doors with the vertical joints running uninterrupted, not more than 18' apart with no total area to not exceed 144 sq."

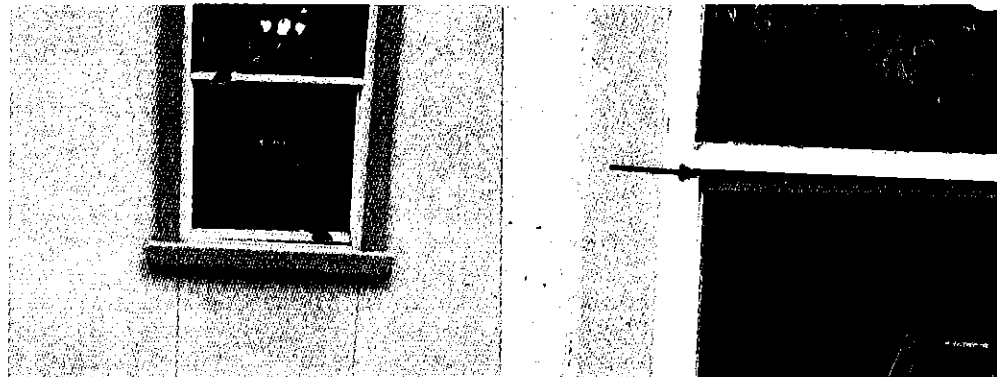
Observed window that appeared to be out of alignment, preventing the window from closing properly.

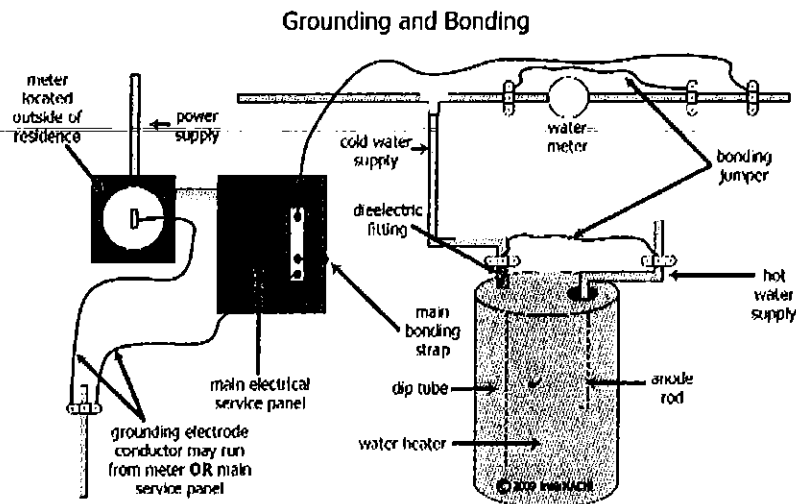
Proper bonding was not observed or identified in all required locations. Bonding may or may not have been observed at the water heater with connections at the hot and cold-water pipes as well as to the gas pipes; however, they were missing at all locations where flex pipe was used to connect appliances to the gas supply pipe. Bonding ensures electrical continuity and provides a path to mother earth. It is required on all interior piping system capable of becoming energized. Since there are so many areas within a house not visible or accessible, and since I did not test the system, I can't verify that the system was properly bonded. I suggest having a licensed electrician verify the system is properly bonded.

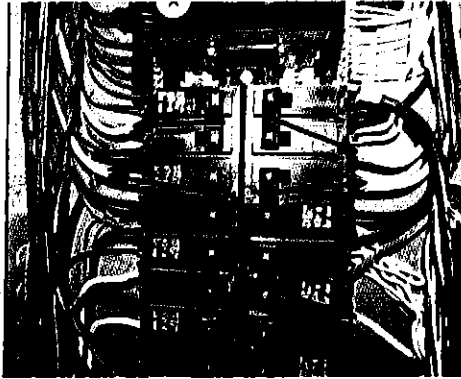
I observed grounded conductors (white neutral wires) being used as non-grounded conductors (black, "hot" wires) that were not properly identified with black or red paint or tape.

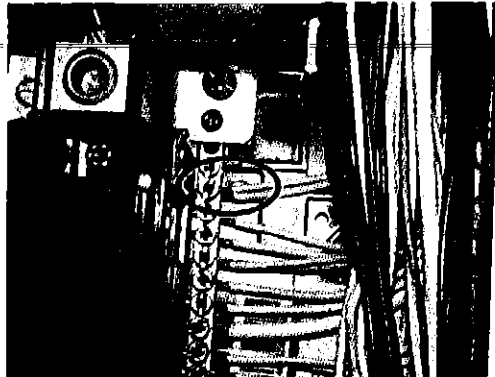
Termination on bus bar was not approved for grounded conductors (white, neutral wires) to be double tapped in single lugs at bus bar. These wires are improperly installed and when screwed into the same terminal, they may not make proper contact. Wiring should be evenly distributing on the bus with a single wire attached to each separate terminal. AFCI and/or GFCI protection may not function properly if neutral wires are double tapped at the panel.

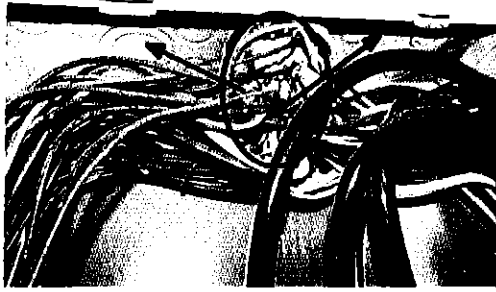
The wiring exiting the service panel was grouped together, not allowing individual wiring to exit the panel, each through its own punch-out. Passing a group of wires through the panel does not properly secure the wiring as required by code.

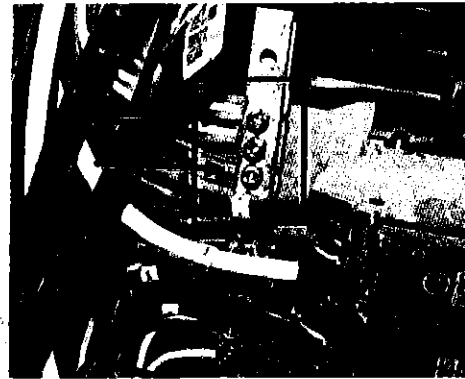
It appeared that the sub-panel had been installed as a main service panel. There can only be one Main Service Panel and it has that main shut-off switch and is connected to the ground rod. Also, the sub-panel the neutral bar and the ground bar must be isolated. Bonding these conductors in a sub-panel is considered to be hazardous.

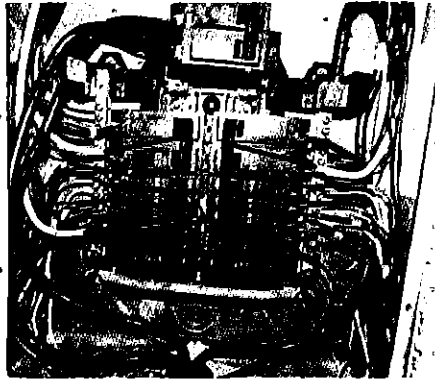
I observed grounded conductors (white neutral wires) being used as non-grounded conductors (black, "hot" wires) that were not properly identified with black or red paint or tape.

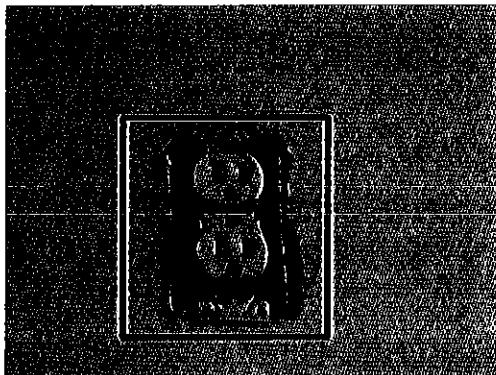
Observed a receptacle or switch box missing the protective faceplate.

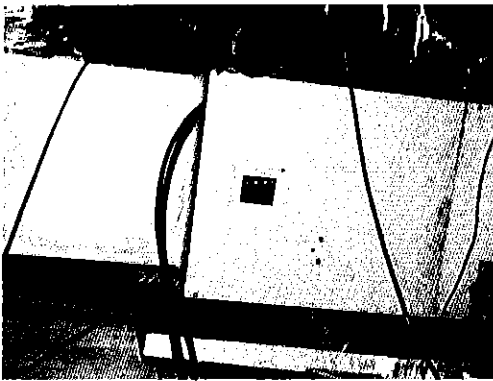
There did not appear to be an electrical disconnect within sight of any of the units.

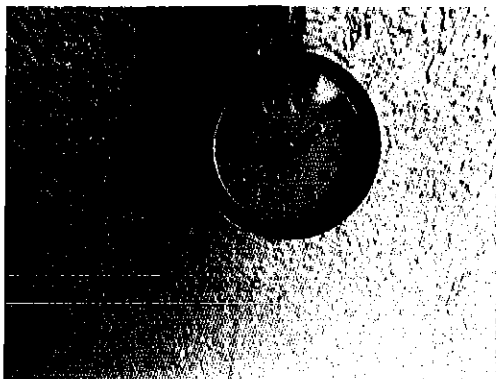
Static Water Pressure Reading: 70 PSI

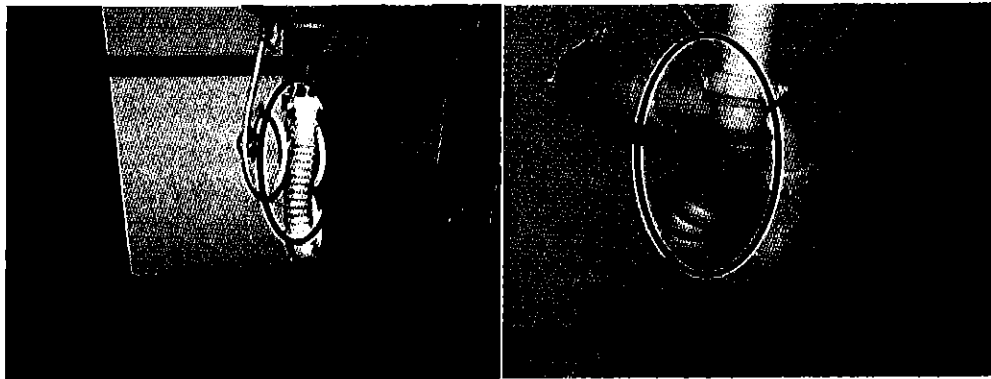
Observed improper material being used as part of the drain system under one or more sinks. The Standard requires a smooth surface and the expandable pipes don't meet this requirement.

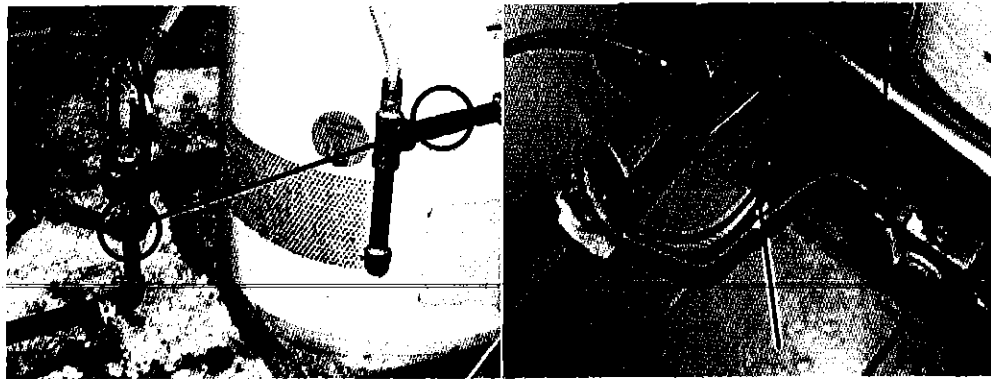
Proper bonding was not observed or identified around GAC/CSST (gas flex line) where attached to either gas appliance. Bonding ensures electrical continuity and provides a path to clear faults. It is required on all interior piping systems capable of becoming energized. I suggest having a licensed electrician verify the system is properly bonded. For more information go to:

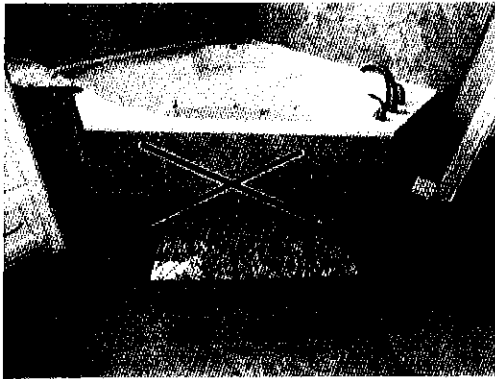
Access to tub drain line, plumbing and motor are not accessible, which limits my inspection. Building codes require a readily access opening to these areas for service and repairs to this fixture and its components.

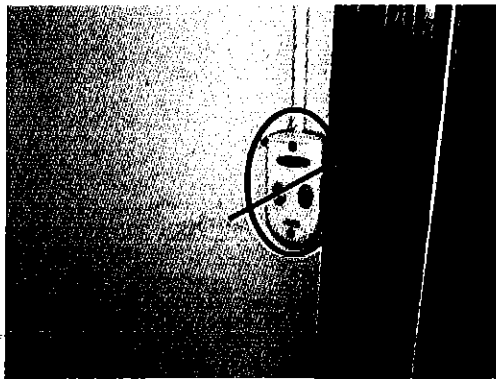
Was not functioning at the time of this inspection.

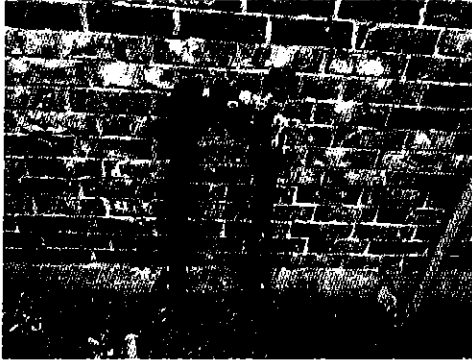
There did not appear to be an anti-siphon device installed with this system.
