PROPERTY INSPECTION REPORT

Concerning: 5841 Darling Street B, Houston, TX 77007
(Address or Other Identification of Inspected Property)

By: Erick Scheuermann Lic.#: 21458 03/19/2021
(Name and License Number of Inspector) (Date)

Home Inspection Report

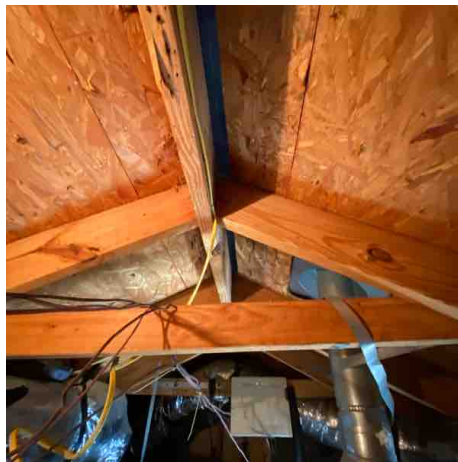
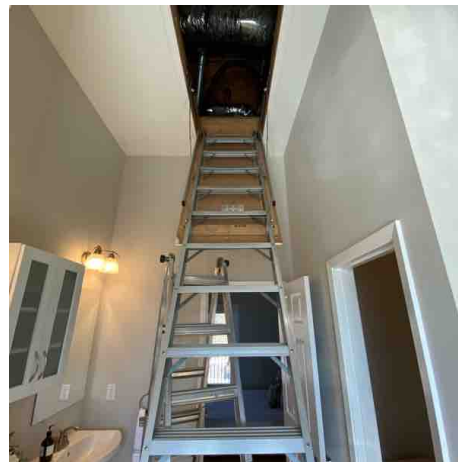
- Roof structure is conventional wood framed rafter system. The roof framing is supported by interior and exterior bearing walls and beams. This is a standard method of construction. Ventilation is roof vents and soffit vents and appears to be adequate, and there is no evidence of excessive moisture in the attic. Insulation in the attic is blown-in type and appears to be adequate.

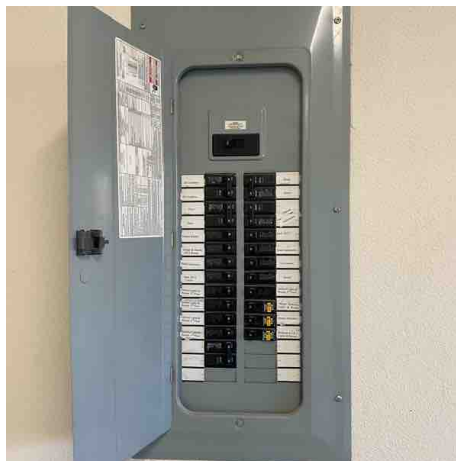
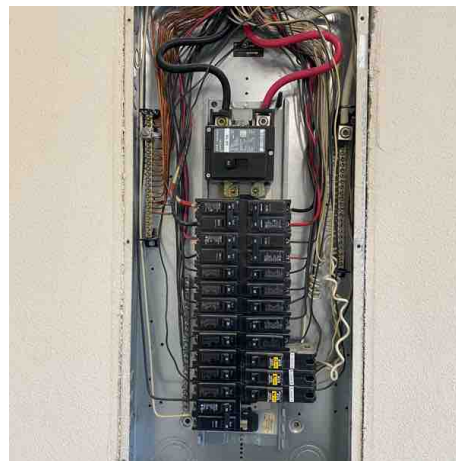
A typical electrical system consists of two distinct components: (1) The electric service entrance, and (2) The electric circuits. The service entrance determines the capacity of the electric power available to the home. The electric circuits distribute the power throughout the home. Electrical devices in a home typically use either 120 or 240 voltage electricity. The major appliances, such as clothes dryers, kitchen ranges, water heaters, air conditioners and electric heating units require 240 volts. General purpose circuits (lighting, outlets, ect.) require 120 volts. At the time of inspection, there were no signs of arcing, sparking or overheating present.

All electrical panels were scanned with a Flir I7 infrared camera and no abnormalities were noted.

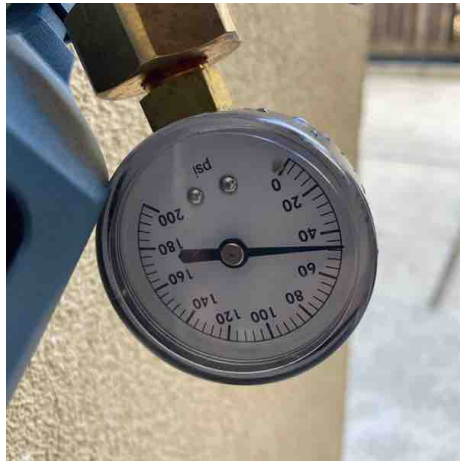
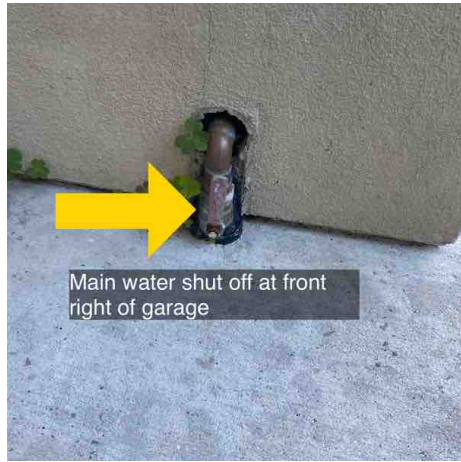
All accessible plumbing fixtures were scanned with a Flir I7 infrared camera and no abnormalities were noted.

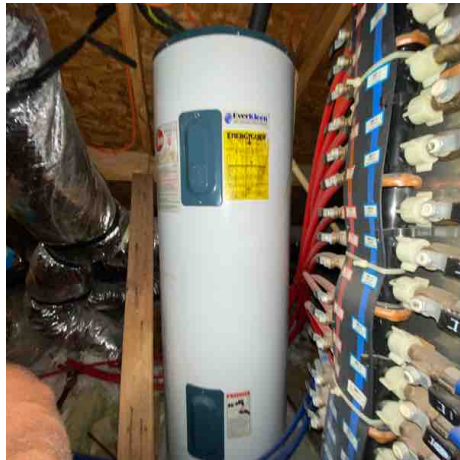
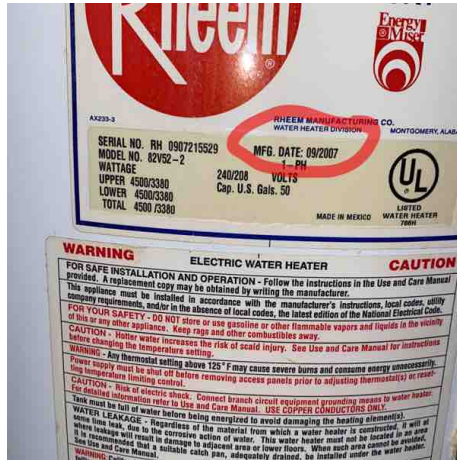
• A electric water heater, located in the attic, provides domestic hot water to the home and was in operation at the time of inspection. According to the data plate, the water heater has a capacity of 50 gallons and was manufactured in September 2007. The capacity of the hot water system appears adequate for the normal needs of this size house.

A water heater is equipped with a temperature/pressure relief valve. This is an important safety device that is required by most codes and should be tested annually. Appropriate discharge piping is installed on this device to direct the discharge from any blow-off to a safe location. The T&P valve was not tested at the time of inspection as property damage may occur..

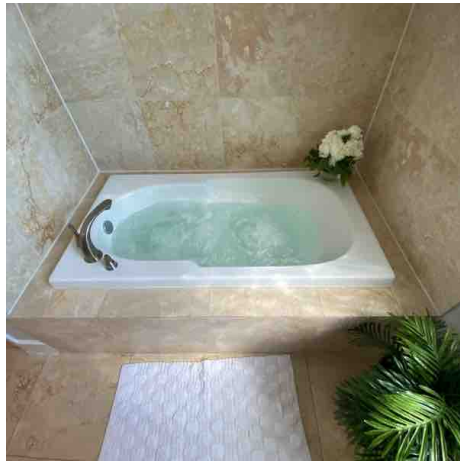
- Spa tub motor was working , GFCI was tested. GFCI located in the water closet.

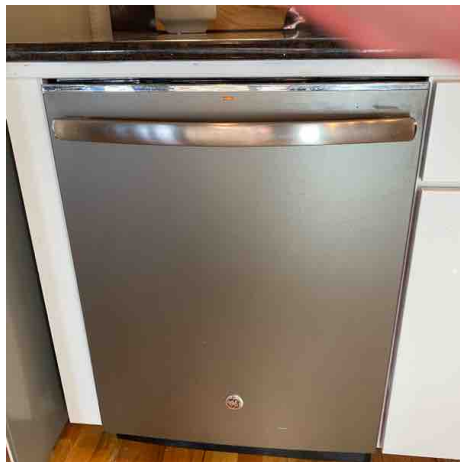
- Dishwasher was operated in normal mode, run through a complete, normal cycle. Function and operation appear to be normal. Lower access panel not removed. At the time of the inspection the dishwasher did not leak.

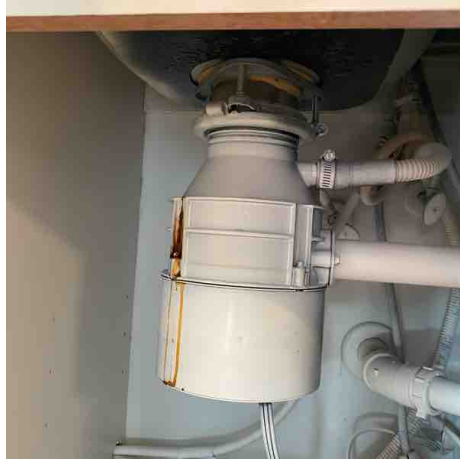
- Waste disposer is secure and appears to be in good condition. Disposer operates as designed. No problems found.

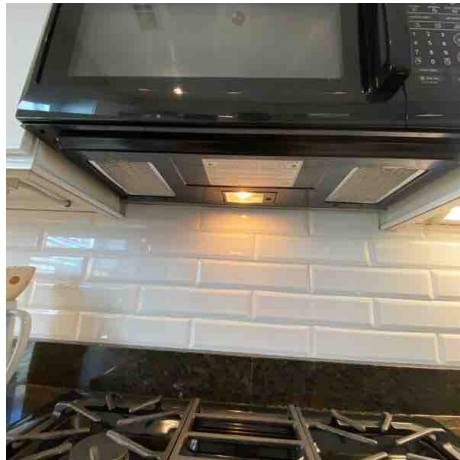
- Kitchen range hood exhaust and light are in good condition and operate satisfactorily.

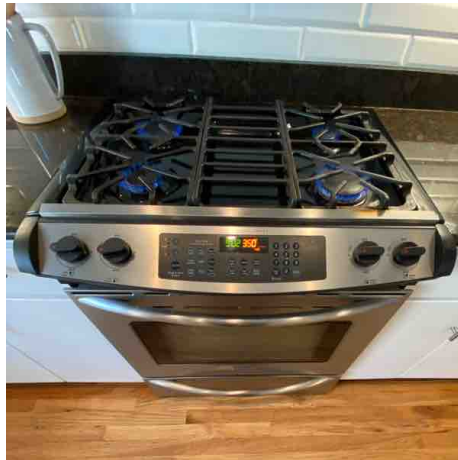
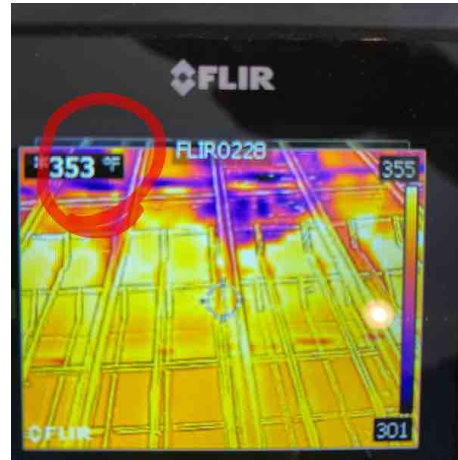
- Gas cook top and oven are in good condition. All burners on cook top were checked and oven set at 350, actual temperature was 353. No problems found.

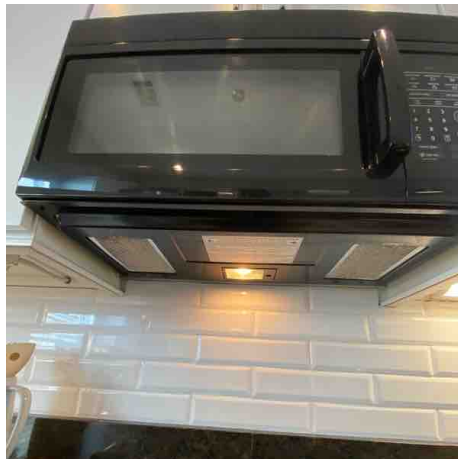
- Microwave oven is in good condition. It was tested by heating water and appears to function properly. Microwave not tested for radiation leak.
