PROPERTY INSPECTION REPORT

174 Almondell Way
Magnolia, TX 77354

Concerning: 174 Almondell Way, Magnolia, TX 77354
(Address or Other Identification of Inspected Property)

By: John Nobles, Lic #6907 11/15/2018
(Name and License Number of Inspector) (Date)

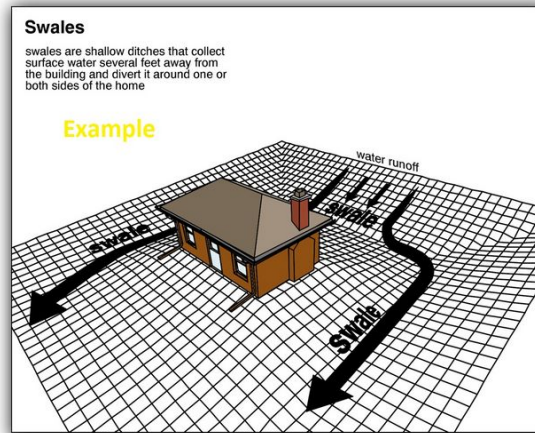
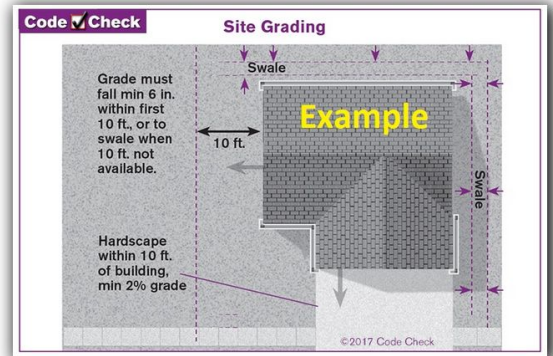
- Evidence of previous standing water was noted along some of the flatwork. This condition requires further investigation to determine the source of the effective areas and repairs undertaken as necessary to ensure proper water drainage to the street and prevent water pooling.

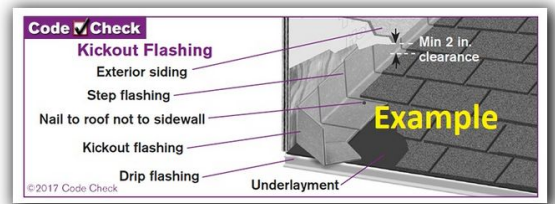
- The kick-out flashing appeared to be missing or not installed at some of the eaves and vertical wall junctions. This type of flashing helps minimize the water exposure along the walls below the roof eaves.

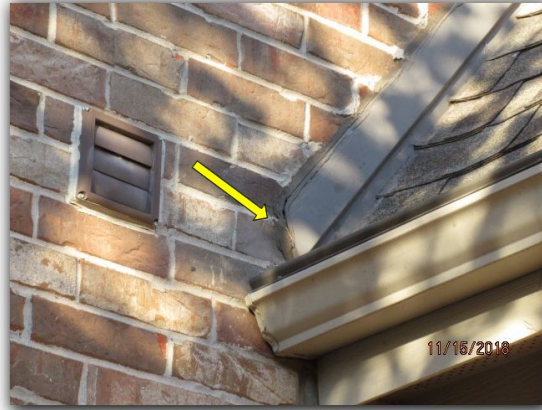
- All exposed nail heads along the roof flashing and roof jack flanges should be properly sealed to reduce the risk of water penetration.

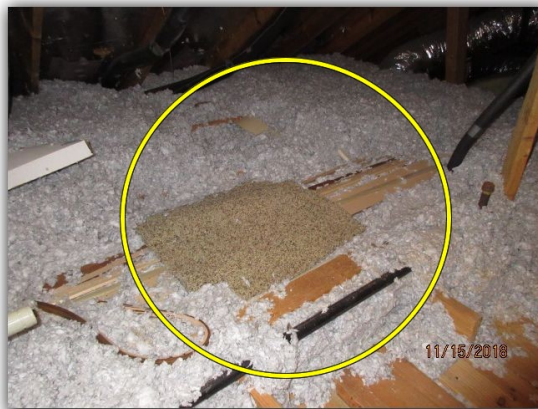
- Compressed insulation was noted in some areas of the attic. It is recommended that new insulation be installed/added in these areas to maintain the insulating value and conserve energy cost.

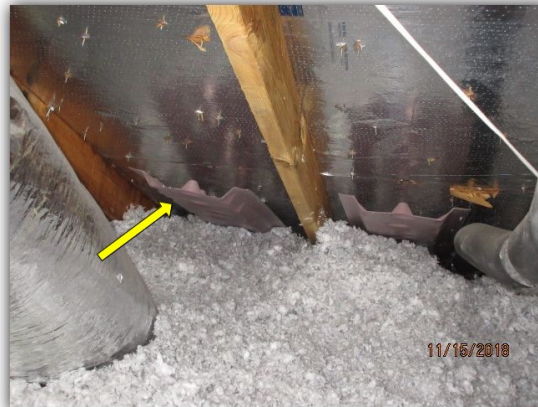
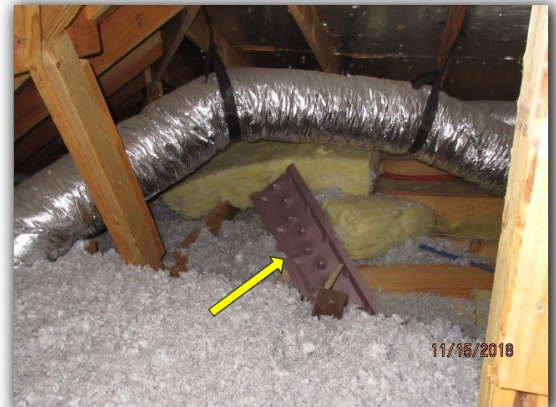
- Some of the soffit baffles in the attic area are loose and not properly secured. “Baffles” should be installed along these areas to hold back insulation and allow for free movement of air within the roof space. It is recommended that these conditions be further investigated and improved where necessary.

A qualified contractor should be consulted to further evaluate these conditions and remedies available for correction.

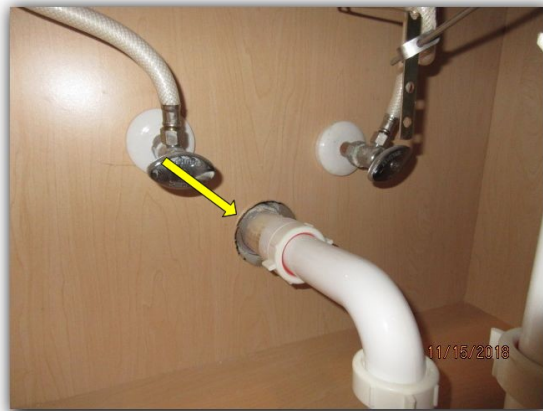
- The interior wall openings around the plumbing stub-outs should be sealed properly below all sinks. Sealing the openings will reduce the risk of drafts from within the walls and insect activity.

A qualified contractor should be consulted to further evaluate these conditions and remedies available for correction.

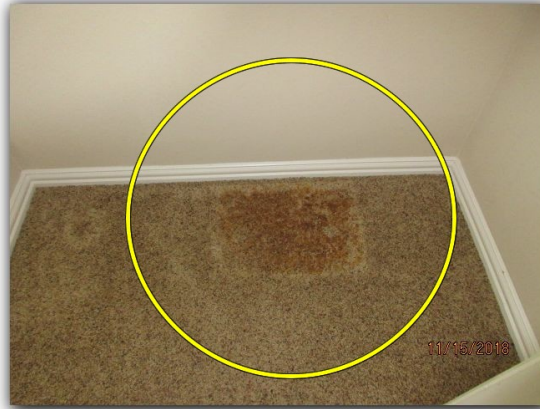
- Stains/damage was noted along some of the carpet coverings (Downstairs Guest Bedroom/Closet).
(See Exhibit Below)

A qualified contractor should be consulted to further evaluate these conditions and remedies available for correction.

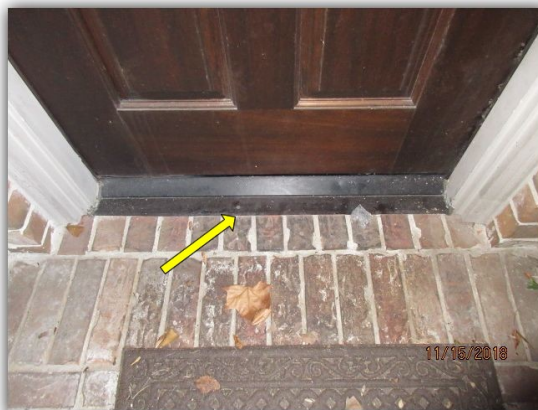
- As preventative measures, the threshold and step junctions along all exterior entry doors should be properly sealed to reduce the risk of water penetration and insect activity (Various Exterior Doors).

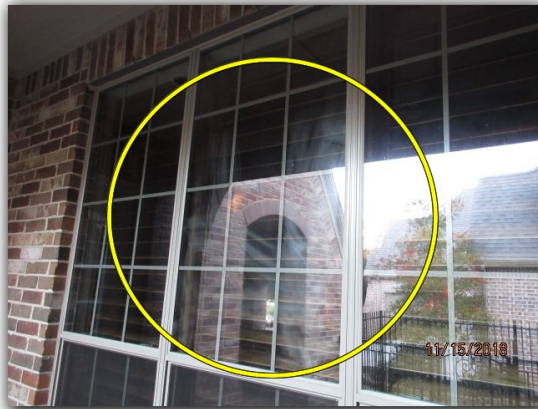
- Residue/glaze/moisture was noted along the insides of some double pane insulated windows (Front Side of House, Rear Side of House). These conditions may have resulted from a damaged/defective gasket between the glass panels. When this occurs, the insulating properties (Gas) will be lost, allowing condensation to develop between the glass panels and damaging the Low E coatings. These conditions require further investigation and repairs undertaken as necessary. It is recommended that a qualified window company be consulted to further investigate all of the installed windows to insure they're performing properly prior to closing.

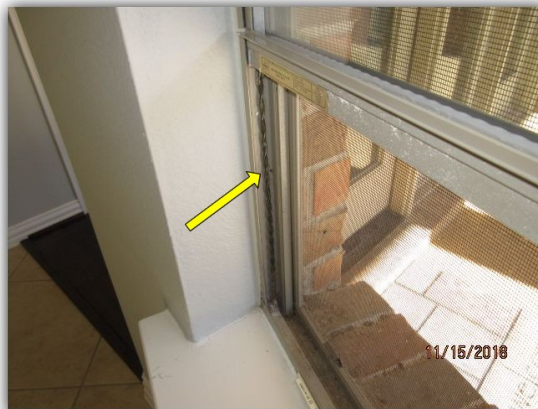
- The frame guide balances are loose/damaged and not properly secured along some of the windows (Breakfast Room). It is recommended that the guide balances at all windows be checked by a qualified company to ensure that they are installed properly and allowing for normal operation.

A qualified contractor should be consulted to further evaluate these conditions and remedies available for correction.

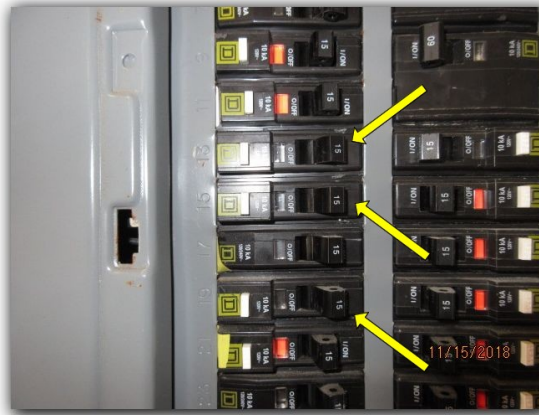
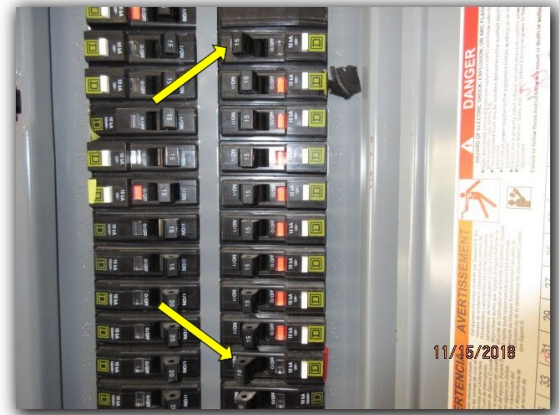
- Some of the AFCI electrical circuit breakers in the panel box did not function properly at the time of inspection. These breakers did not trip using the test buttons on the circuit breakers.

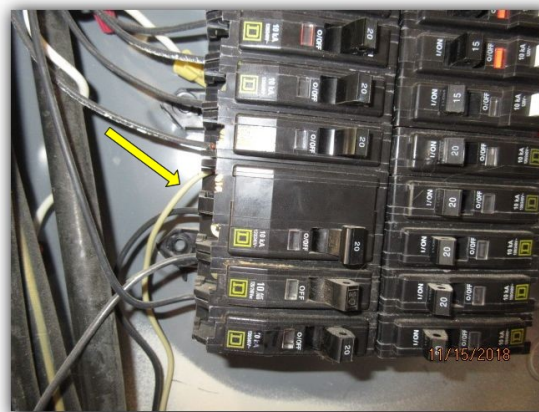
- The white wire to the 220/240 volt circuit is not marked as a hot wire. Under current building standards/practices, the white wire should be marked with black or red to indicate that it is a hot and not a neutral.

A qualified electrician should be consulted to further evaluate these conditions and remedies available for correction.

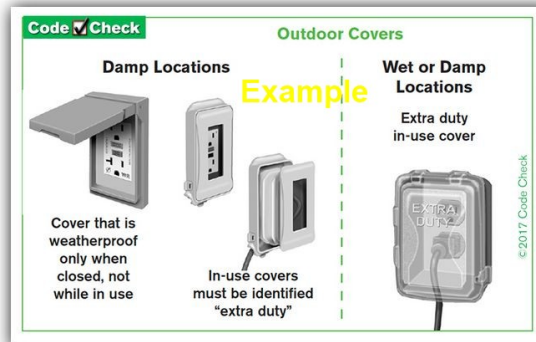
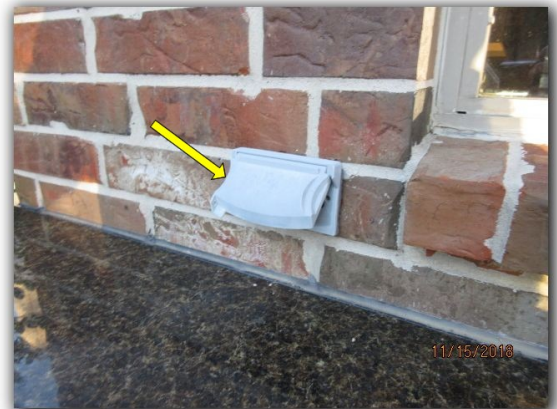
- Loose outlets were noted (Outdoor Kitchen). These outlets should be properly secured (anchored) in the wall.
- The installed cover plates at some of the exterior outlets are not an acceptable type of cover plate under current building standards. Water resistant/type cover plates should be installed to reduce the risk of water/moisture intrusion to the outlet face.

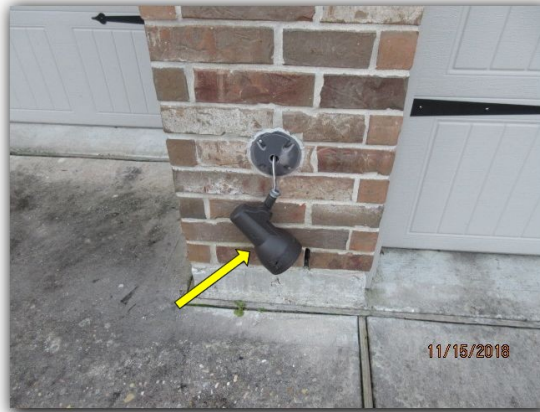
- Some of the light fixtures/light bulbs were inoperative at the time of inspection (Exterior, Pantry, Various Other Locations). If the bulbs are not blown, the circuits should be further investigated.
- Some of the light fixtures are damaged (Exterior).

A qualified electrician should be consulted to further evaluate these conditions and remedies available for correction.

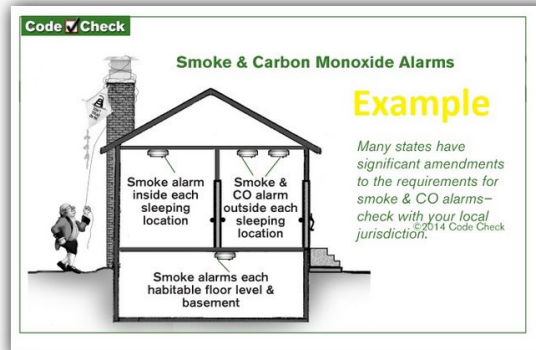
- Some of the smoke detectors were noted chirping at the time of inspection. This condition usually indicates that the batteries are low and in need of replacement.
- Some areas of the house are not equipped with carbon monoxide detectors (Hallways). Under current building standards, a combination type smoke and carbon monoxide detector should be provided for each hallway adjoining bedrooms.

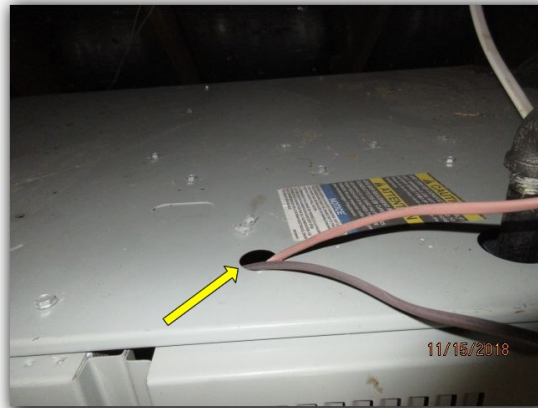
- Cable clamps (sometimes referred to as bushings or grommets) are required where thermostat wiring enters/exits through the metal HVAC cabinet. Cable clamps or bushings serve to protect the wires from the metal edges of the cabinet openings.

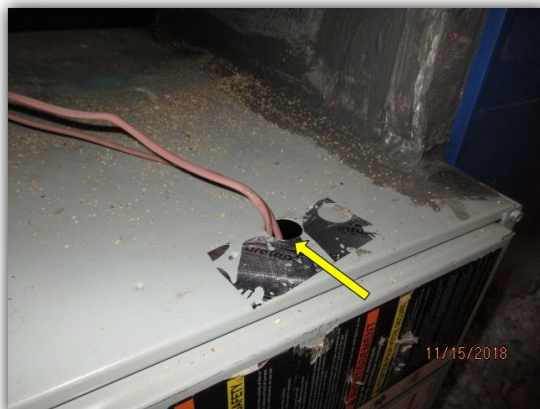
- Cable clamps (sometimes referred to as bushings or grommets) are required where thermostat wiring enters/exits through the metal HVAC cabinet. Cable clamps or bushings serve to protect the wires from the metal edges of the cabinet openings.

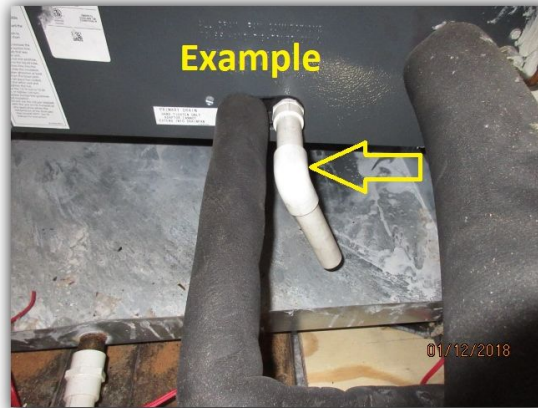
- The drain line to the over-flow opening along the evaporator cabinet does not terminate properly into the safety pan. This condition requires further investigation and repairs undertaken as necessary to reduce the risk of water damage to the structure.

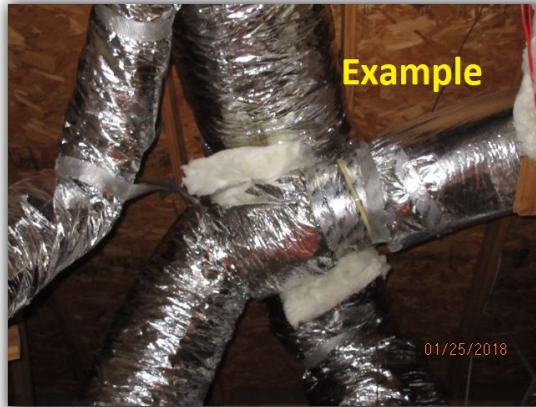
- Contact (touching) was noted at some of the intersecting supply/return ductwork in the attic area. These contact points are areas that can be conducive to accumulating condensation which can cause possible moisture damage to the sheetrock and ceiling areas. As preventative measures, it is recommended that additional support straps be installed along the ductwork runs or add insulation between the contact points to reduce the possibility of these conditions.

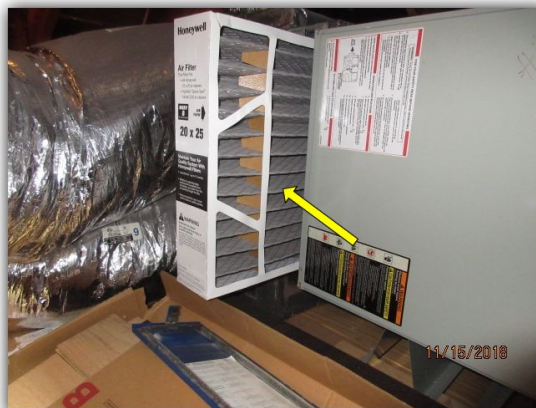
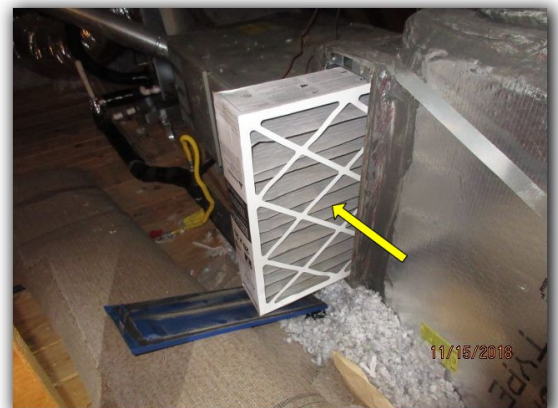
- The media filters at the HVAC systems are dirty and in need of replacement. As preventative measures, the replacement of the A/C media filters should be part of a regularly scheduled maintenance program.

A qualified HVAC company should be consulted to further evaluate these conditions and remedies available for correction.

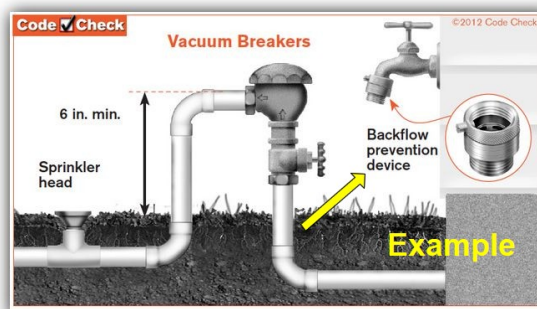
- The hose bib fixture appears to be loose and not secured properly inside the wall (Left Side of House). It is recommended that this condition be further investigated and repairs undertaken as necessary.
- The backflow preventer was noted missing or not installed at some of the hose bibs (Right Side of House). Backflow preventers should be installed on ALL exterior hose bibs as required by current standards. These are inexpensive screw-on devices that prevent backflow conditions and contaminating the potable water supply system.

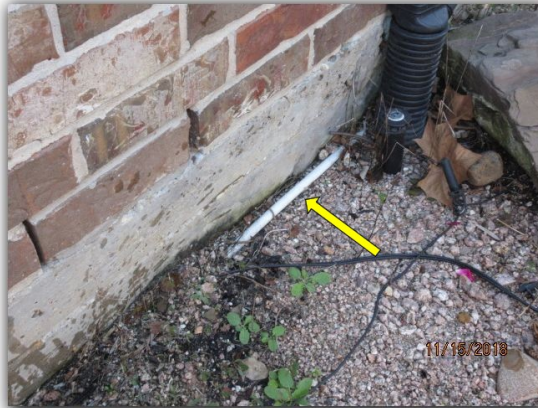
- Some of the water supply/sewage pipe systems are not properly buried in the soil. Under current building standards/practices, a water, soil or waste pipe shall not be installed outside of a building, in exterior walls, in *attics* or crawl spaces, or in any other place subjected to freezing temperature unless adequate provision is made to protect it from freezing by insulation or heat or both. Water service pipe shall be installed not less than 12 inches deep and not less than 6 inches below the frost line.

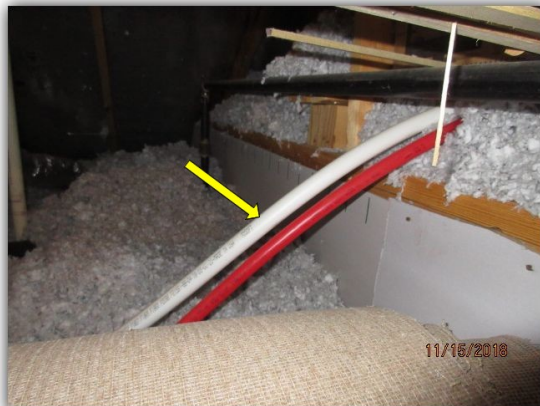
- All exposed water supply pipes in the attic area should be properly insulated to provide adequate protection during freezing conditions. It is recommended that this condition be considered for correction.

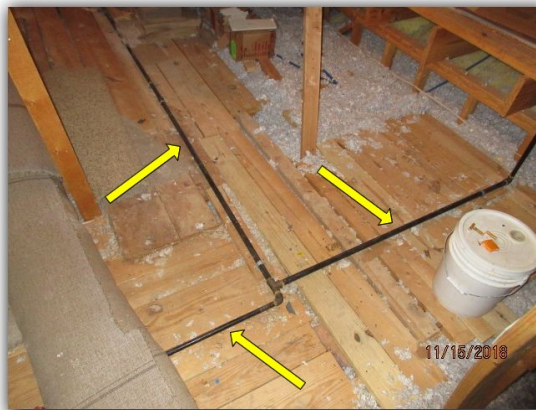
- The gas supply pipe installed across the service walkway platform in the attic area needs protection from possible damage.

A qualified plumbing company should be consulted to further evaluate these conditions and the remedies available for correction.

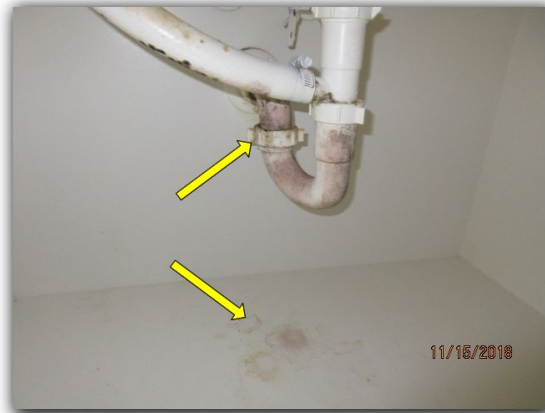
- The mechanical drain-stop is not functioning properly at some of the sinks (Upstairs Guest Bathroom).
- The mechanical drain-stop was noted missing or not installed at some of the sinks (Upstairs Guest Bathroom).
- Previous leaks were noted at some of the drain pipe connections to the sinks (Upstairs Powder Room). No active leaks were noted at the time of inspection. These conditions require further investigation and repairs undertaken as necessary.

A qualified plumbing company should be consulted to further evaluate these conditions and remedies available for correction.

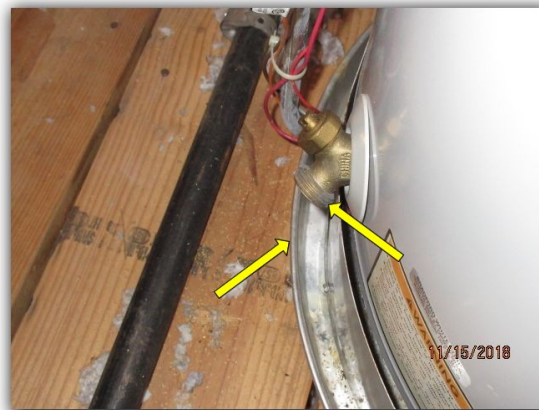
- The auxiliary (safety) drain pan installed below the water heater unit appears to be off-center of the unit and not properly installed below the tank drain valve. This condition requires further investigation and repairs undertaken as/if needed to reduce the risk of water damage in the event of a leak.

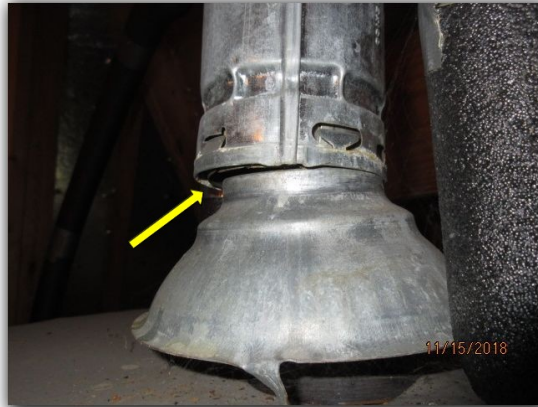
- The exhaust flue pipe to the water heater venting system is not installed properly above the “draft diverter” and could allow spillage of exhaust products. This is a potential safety concern that should be addressed promptly. This condition requires further investigation and repairs undertaken as necessary.

It is recommended that a qualified and licensed plumbing company be consulted to further evaluate these conditions and the remedies available for correction.

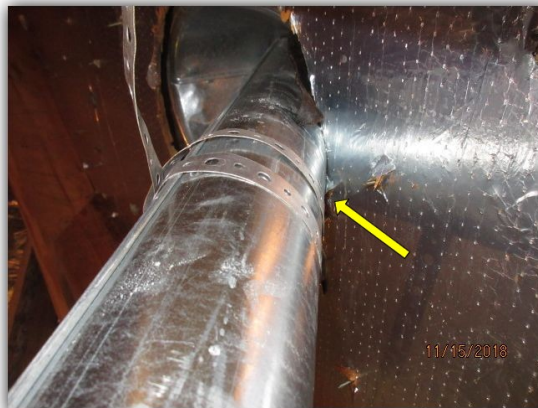
- The vent pipe serving the water heater does not have safe clearance from combustibles. This condition should be improved for safety reasons. Exhaust flues require a minimum 1” clearance from combustibles.

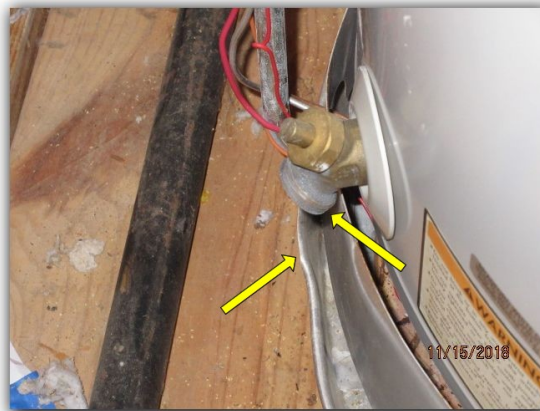
- The auxiliary (safety) drain pan installed below the water heater unit appears to be off-center of the unit and not properly installed below the tank drain valve. This condition requires further investigation and repairs undertaken as/if needed to reduce the risk of water damage in the event of a leak.

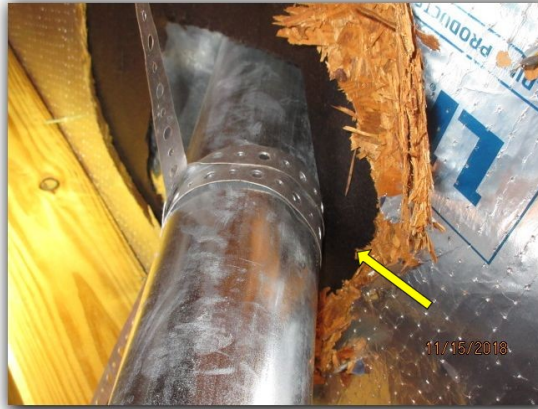
- The vent pipe serving the water heater does not have safe clearance from combustibles. This condition should be improved for safety reasons. Exhaust flues require a minimum 1" clearance from combustibles.

It is recommended that a qualified and licensed plumbing company be consulted to further evaluate these conditions and the remedies available for correction.

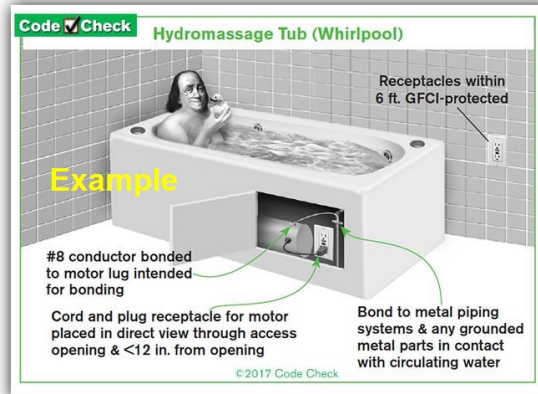
- The pump, hose and plumbing connections could not be visually inspected. The tub enclosure does not have an installed opening that would allow access to equipment for inspection. Under current building standards/practices, appliances shall be accessible for inspection, service, repair or replacement without removing permanent construction or building finish. The builder should be consulted to confirm that this was not overlooked on the building plans.

A qualified plumbing company should be consulted to further evaluate these conditions and the remedies available for correction.

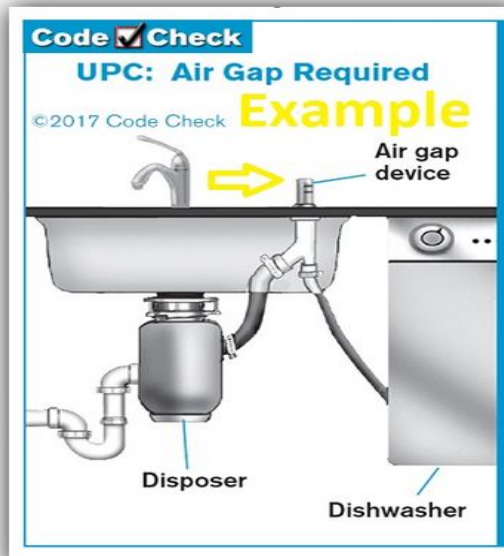
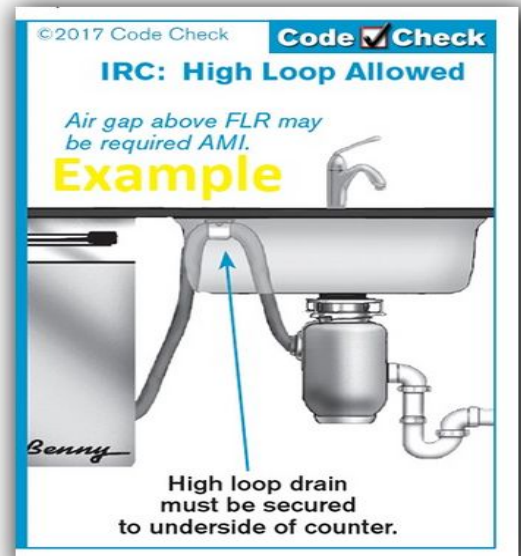
- The dishwasher lacks an adequate air-gap in the waste line. The waste line should rise to form a loop and be securely fastened to the underside of the counter before connecting to the sink tail piece or food grinder (food disposer), or a mechanical dishwasher air-gap device can be used. This condition requires further investigation and repairs undertaken as necessary.

A qualified appliance repair or plumbing company should be consulted to further evaluate these conditions and remedies available for correction.

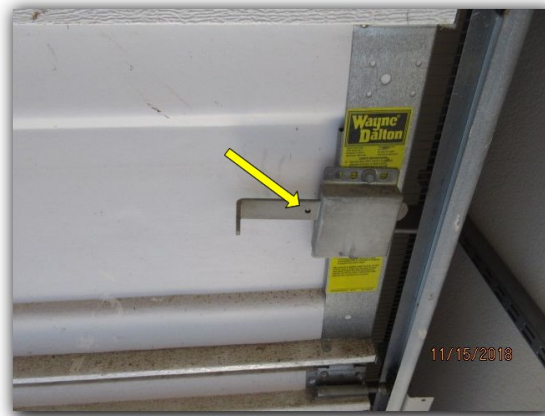
- The garage door locks have not been disabled. Disabling the door locks with the use of an automatic opener prevents accidental locking and reduces the risk of damage when the unit is operating.

A qualified garage door company should be consulted to further evaluate these conditions and remedies available for correction.

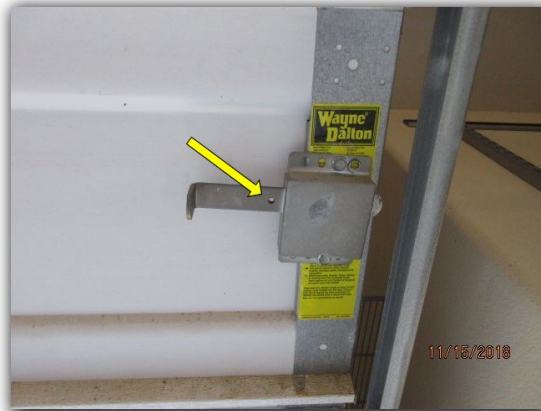
Middle Garage Door Unit

- The garage door locks have not been disabled. Disabling the door locks with the use of an automatic opener prevents accidental locking and reduces the risk of damage when the unit is operating.

A qualified garage door company should be consulted to further evaluate these conditions and remedies available for correction.

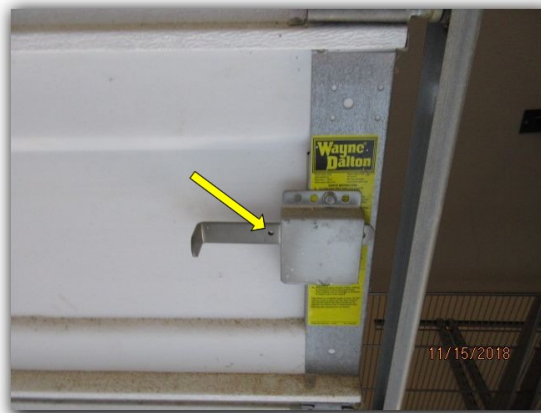
Right Garage Door Unit

- The garage door locks have not been disabled. Disabling the door locks with the use of an automatic opener prevents accidental locking and reduces the risk of damage when the unit is operating.

A qualified garage door company should be consulted to further evaluate these conditions and remedies available for correction.

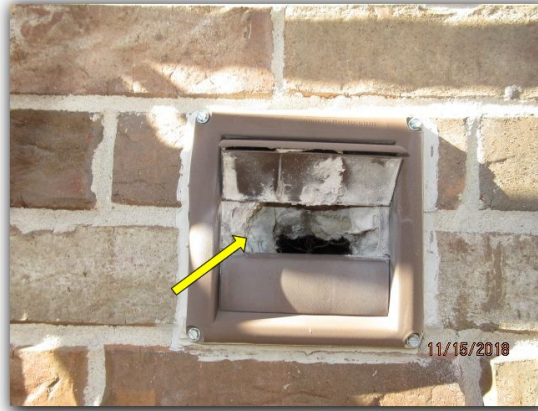
- Clean lint from dryer exhaust duct and exhaust vent opening. This should be part of a regular maintenance program as to prevent potential fire hazards. The design of the dryer duct to this house terminates vertically above the roof line through a vent jack. This type of configuration requires frequent cleaning as preventative measures to reduce the risk of clogs in the duct and prevent potential fire hazards.

A qualified company should be consulted to further evaluate this condition and the remedies available for correction.
