PREMIER HOME INSPECTIONS

RESIDENTIAL HOME INSPECTION

3014 Dallas St Houston TX 77003

> John Lam NOVEMBER 30, 2020

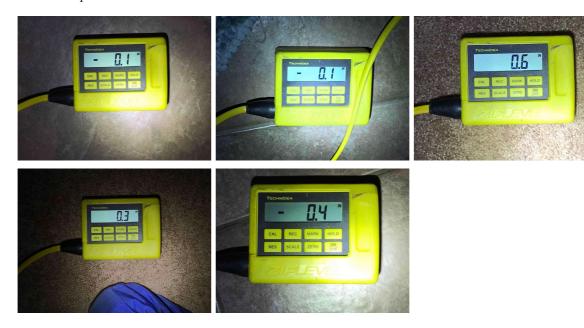
Performing as Intended:

This foundation was measured with the use of an electronic digital measurement tool. Multiple elevation points were registered on the foundation throughout the property to determine if there are elevation variations that indicate excessive movement of the foundation. At the time of this inspection, the measured areas did not indicate any variations that, in this inspectors OPINION, indicate any need for invasive repairs to the foundation.
