REXER Home Inspection Services

Property Inspection Report

5211 Eigel St. Unit C, Houston , TX 77007
Inspection prepared for: Omar Garza & Adolfo Garza
Date of Inspection: 2/20/2017 Time: 11:00AM
Age of Home: 2009 Size: 2219

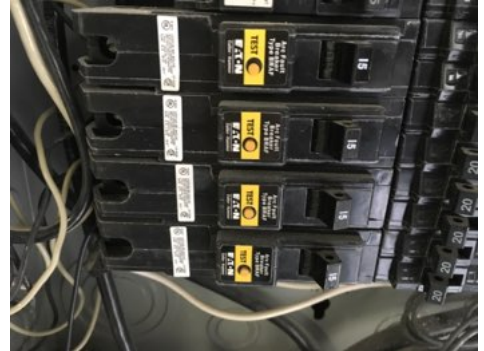
Branch feeder arc faults
