FIG Services LLC d/b/a FOX INSPECTION GROUP  
Property Inspection Report #201221JO-5211 Eigel Street, Unit C  
8616 Daffodil Street Houston, TX 77063  
(Office)713.723-3330 (Email) [office@foxinspectiongroup.com](mailto:office@foxinspectiongroup.com)

### **Stucco Moisture Inspection Report Prepared For: Allison Saxby**

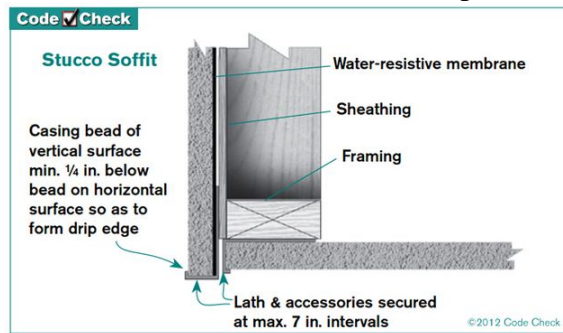
Fig. 1

Did not observe drip screed (drainage relief accessory) at bottom of the stucco wall, where it intersects with the soffit. The following diagram depicts a “best practice” procedure as defined in the Texas Lathing and Plastering Contractor's Association (TLPCA) Stucco Resource Guide. This detail provide a means for moisture to exit from behind the stucco if the wall assembly leaks (we seldom see a drip screed at these locations on most stucco homes / buildings). Due to moisture / soft substrate observed in these areas (see pages 12 & 13 above), installation of a drip screed is recommended.

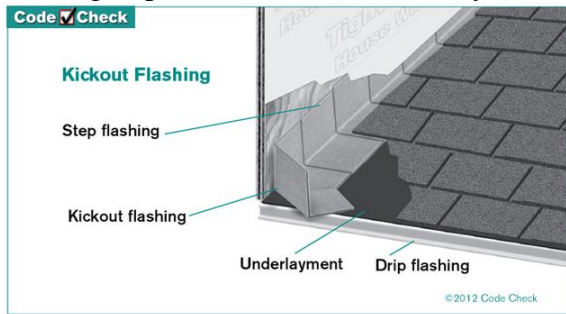
Fig. 7

Active moisture / soft substrate detected and / or suspected below one or more roof-wall intersections (see pages 6, 9, 11-12 & 14 above). Recommend further investigation by a qualified stucco contractor for repair of damaged substrate and re-work "kick out" flashing to prevent further water entry.
